National Register of Historic Places Registration Form

historic name Green-Reading House
other names/site number _____

Green-Reading House
Mercer County, New Jersey

Architectural Description

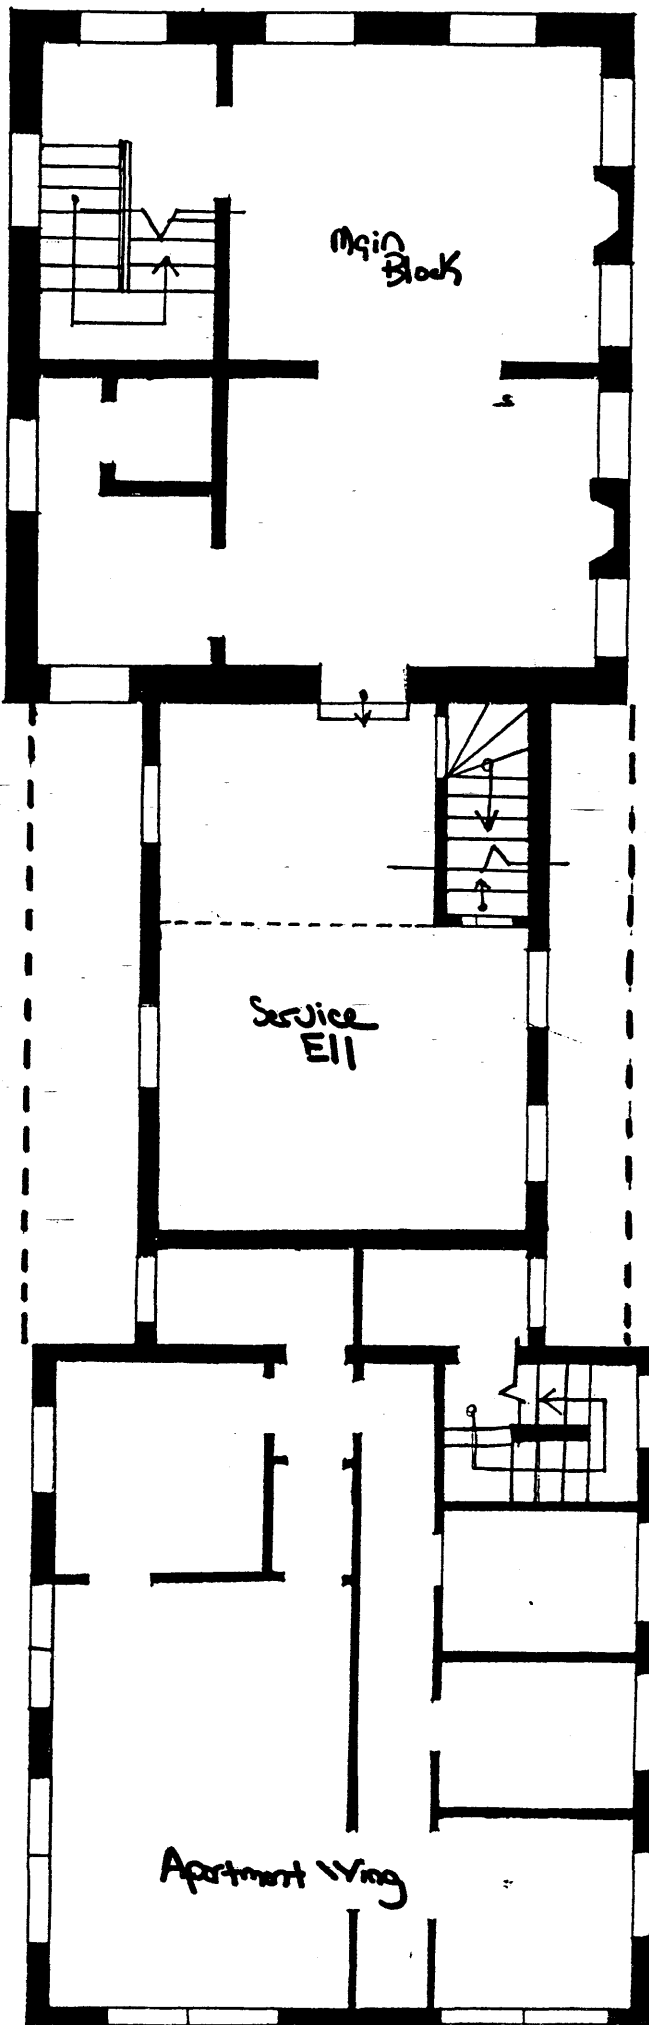
First Floor Plan
Not To Scale

The first floor is characterized by a double pile, side hall plan. The first floor has a side stairwell to the west with a double parlor to the east (Photo 17). The two parlors are divided by a double door. A number of decorative details still remain in both of the parlors on the first floor. Characteristic of the Federal era are the graceful decorative treatments such as the carved window and door casements, chair rails and fireplace mantels with their fine gouge work and reeding (Photo 13 & 14). Another high style detail of the interior is the raised panelling around the recessed window surrounds on the first and second floors. In addition to the fine carved mantels and casements throughout the home is a carved wooden pediment over

Green-Reading House
107 Wilburtha Road
Eving Township
Mercer County, New Jersey

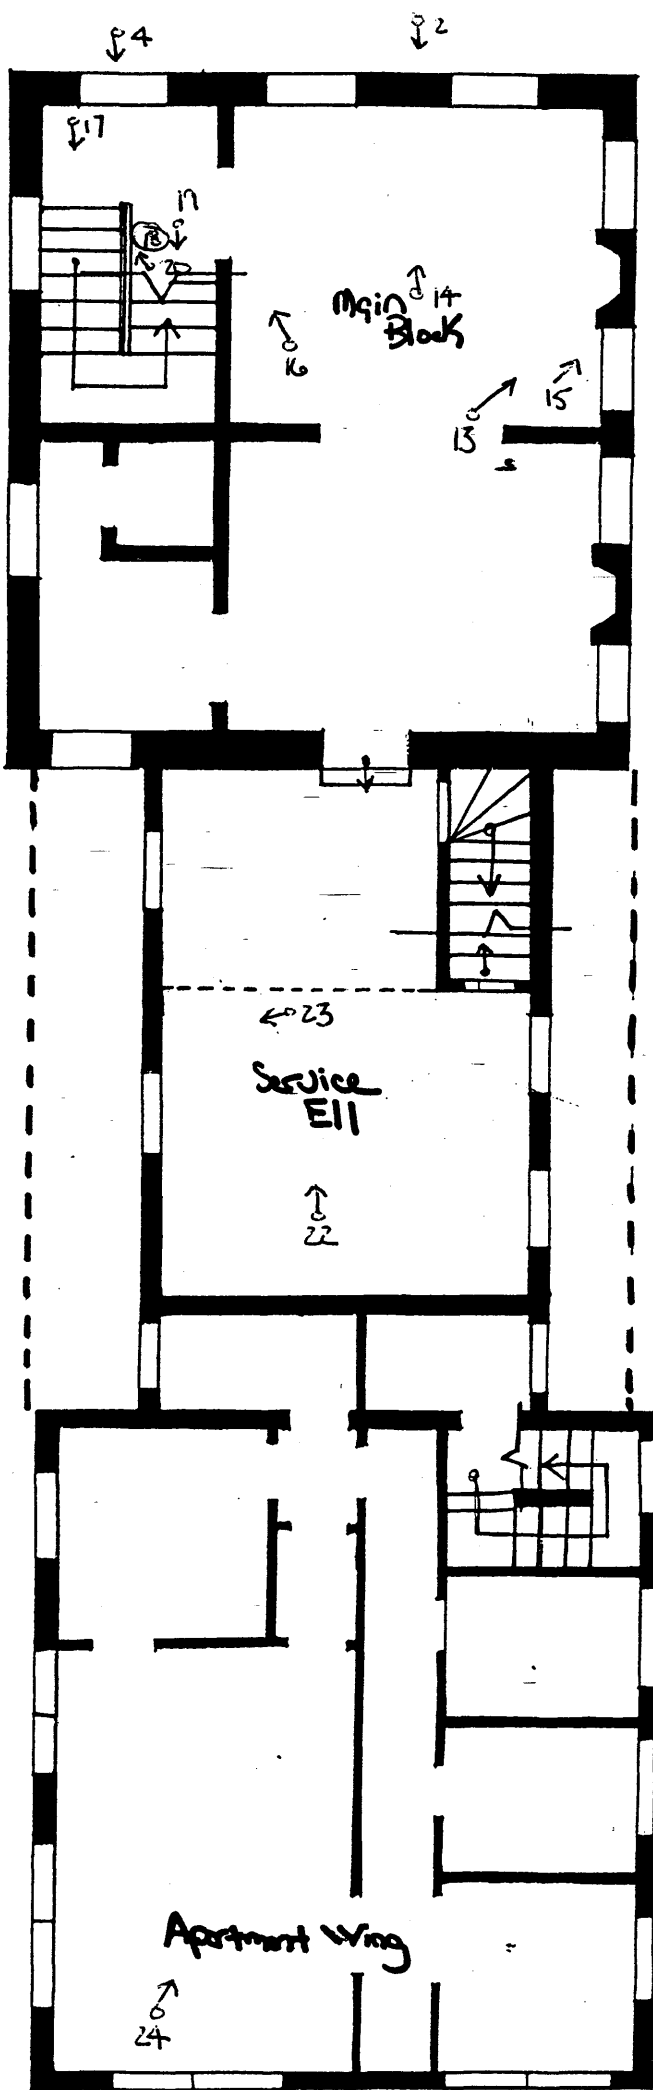
First Floor Plan
Not To Scale

Green-Reading House
 107 Wilburtha Road
 Ewing Township
 Mercer County, New Jersey
