National Register of Historic Places
Registration Form

historic name Shelby Cotton Mill

street & number 500 South Morgan Street

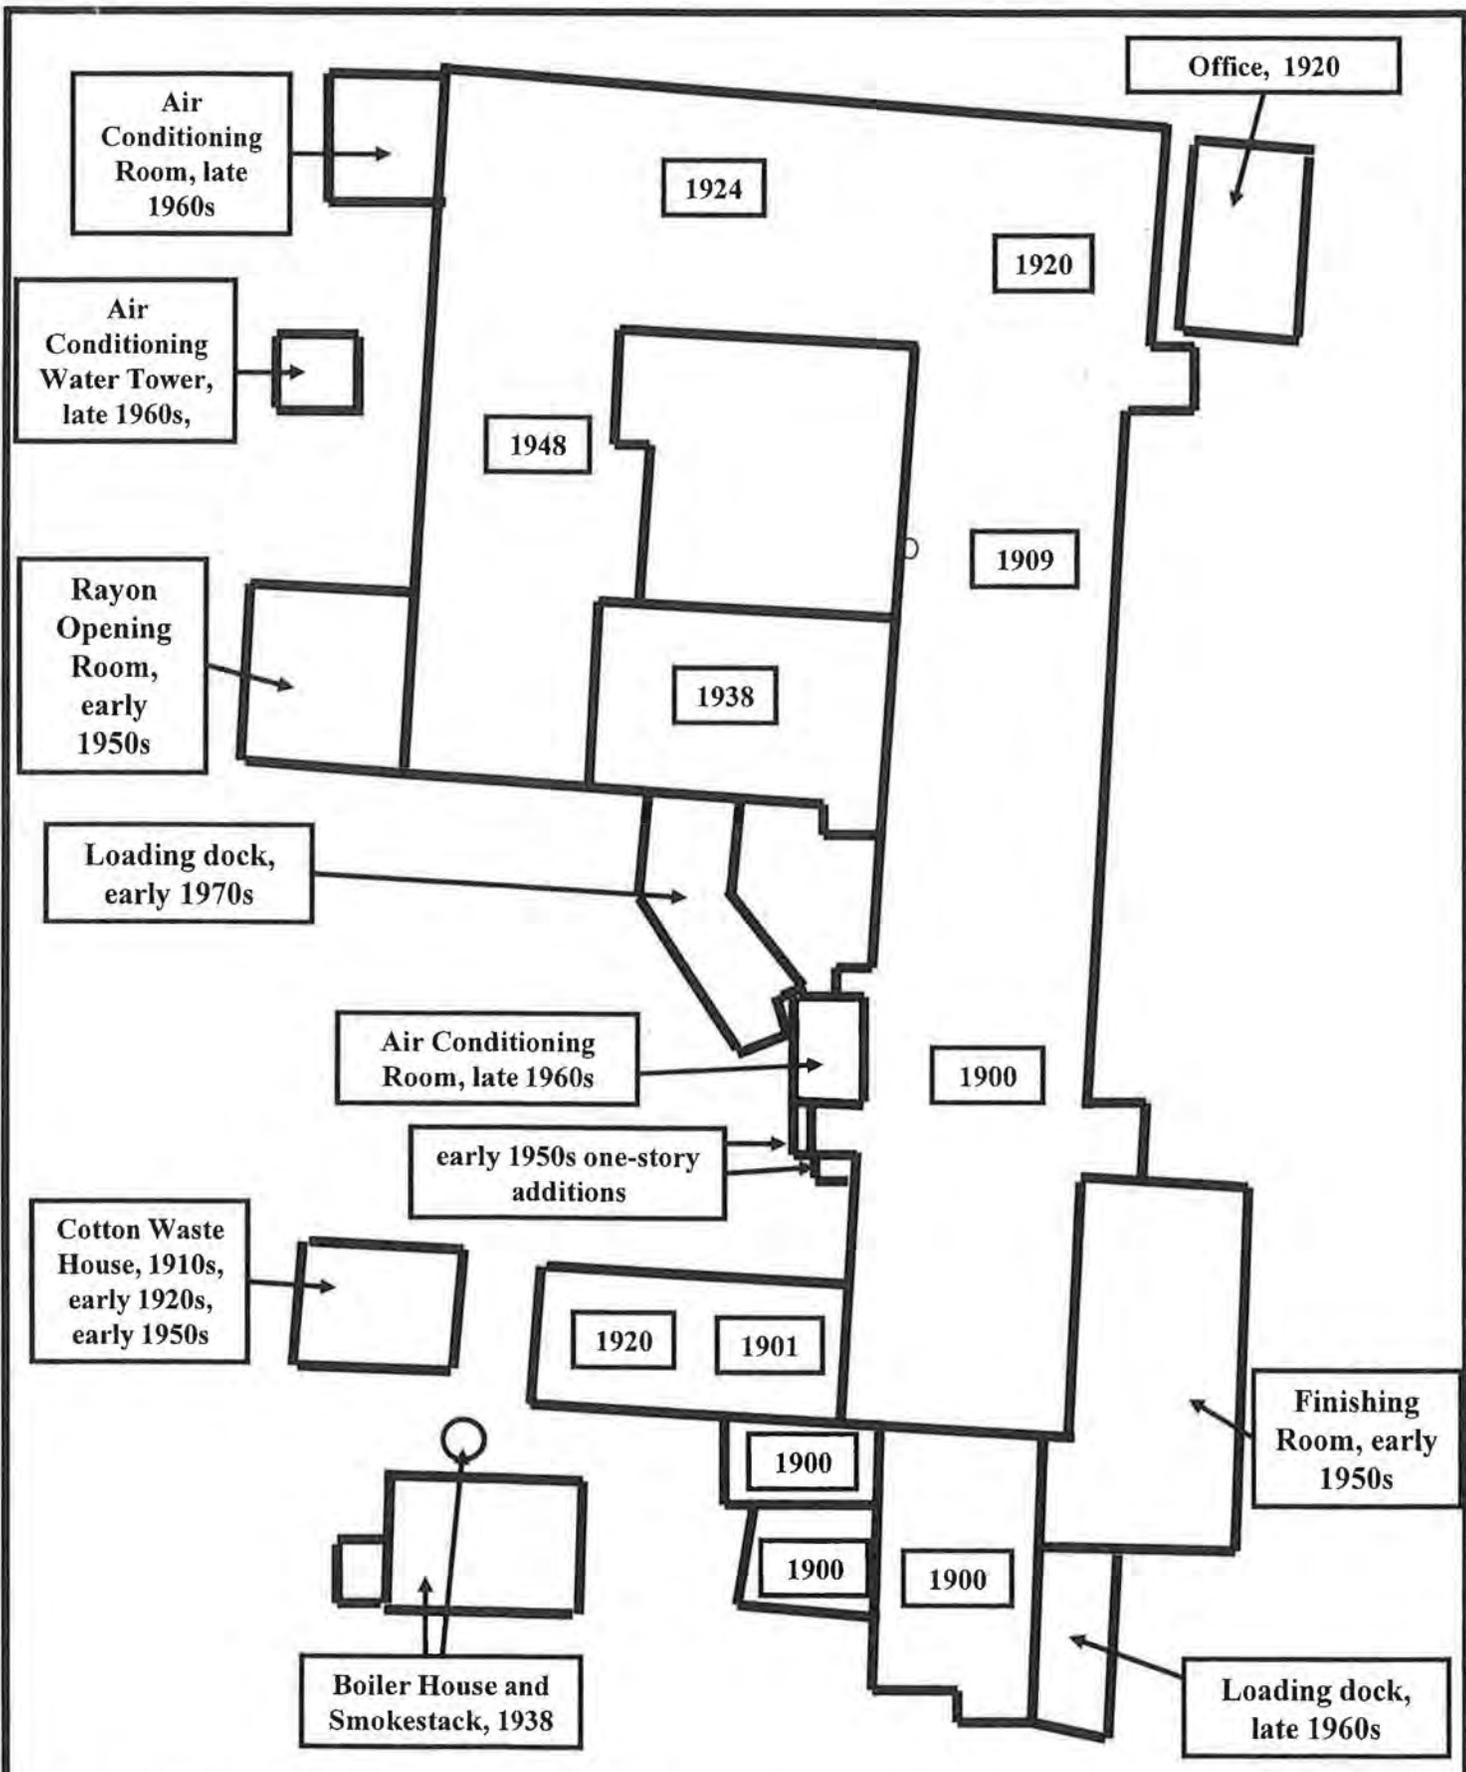
Shelby Cotton Mill, 500 South Morgan Street Shelby, Cleveland County, North Carolina

National Register Boundary = heavy dark line, Scale 1" = approximately 70'
