**National Register of Historic Places
Registration Form**

historic name Cunningham, Bert and Mary, Round Barn
other names/site number N/A

street & number E7702 A Upper Maple Dale Road N/A not for publication
city or town Town of Viroqua N/A vicinity
state Wisconsin code WI county Vernon code 123 zip code 54665

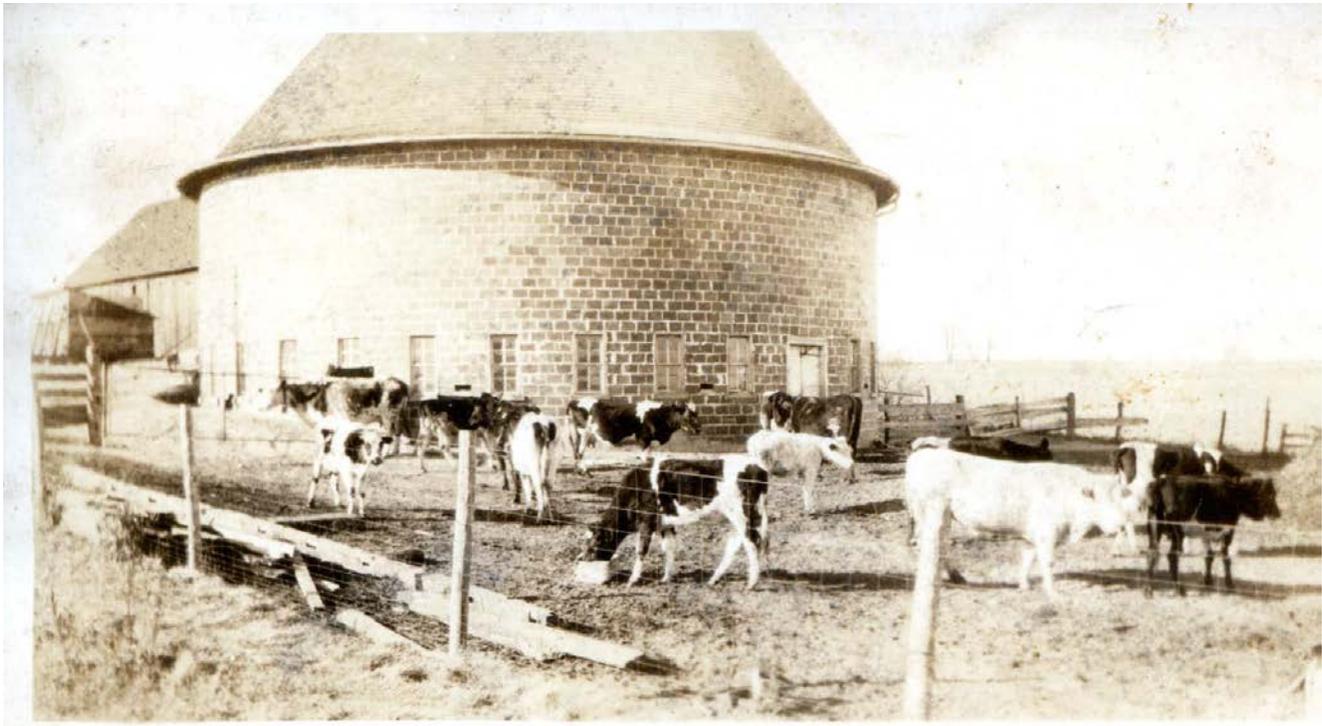
Photograph of the Bert and Mary Cunningham Round Barn from the southeast; dated November 21st, 1919.
Image courtesy of Angela Cina.
