Davol Rubber Company
Providence, Rhode Island

Photographer: Jeffrey Blydenburgh October 1979
Negative at: Beckman, Blydenburgh & Associates
116 Chestnut Street, Providence

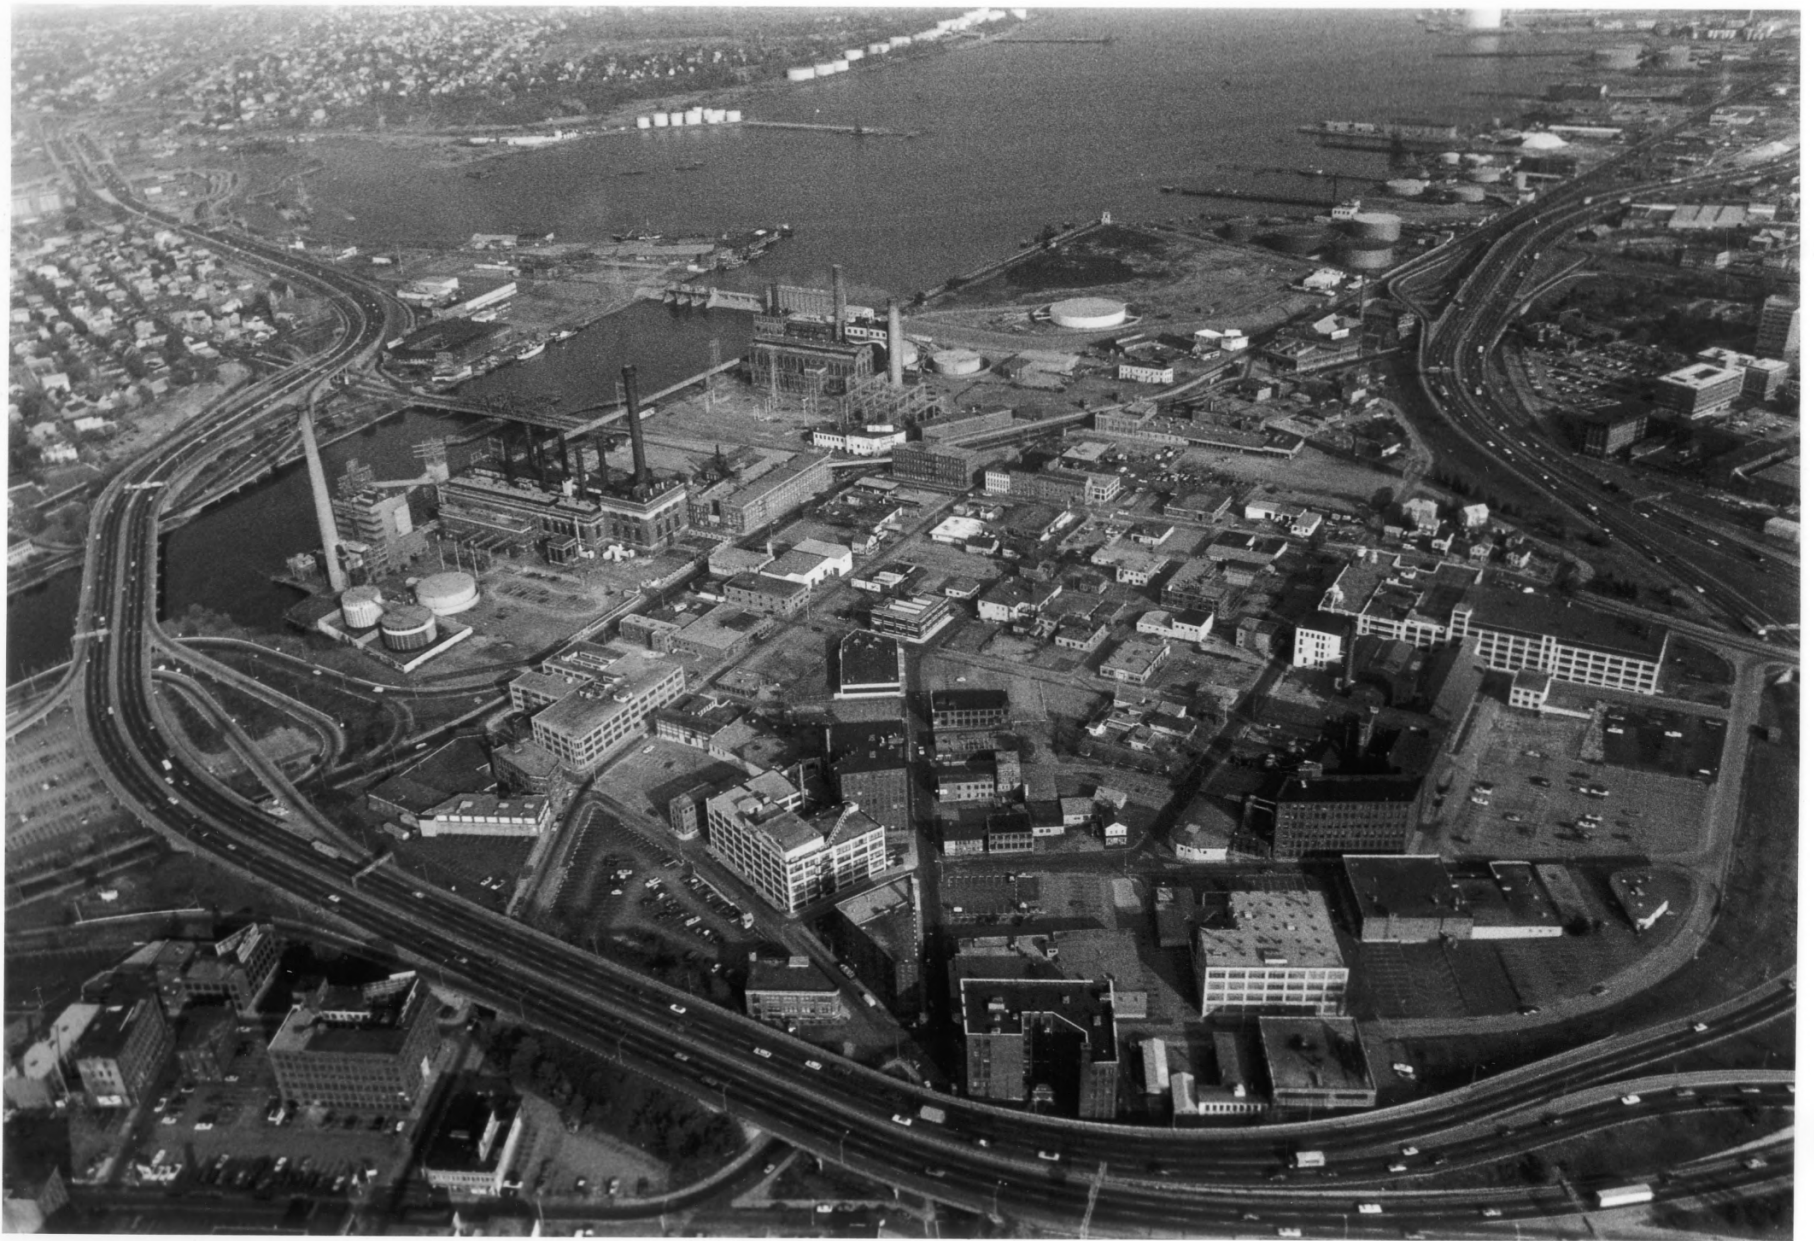
Photo #1 *of 13*

Aerial view: Davol Company and its industrial neighbors. Route 95 is to the right in the photograph and Route 195 is along the bottom. The narrow channel of water is the Providence River. Downtown Providence is out of the picture to the lower left.

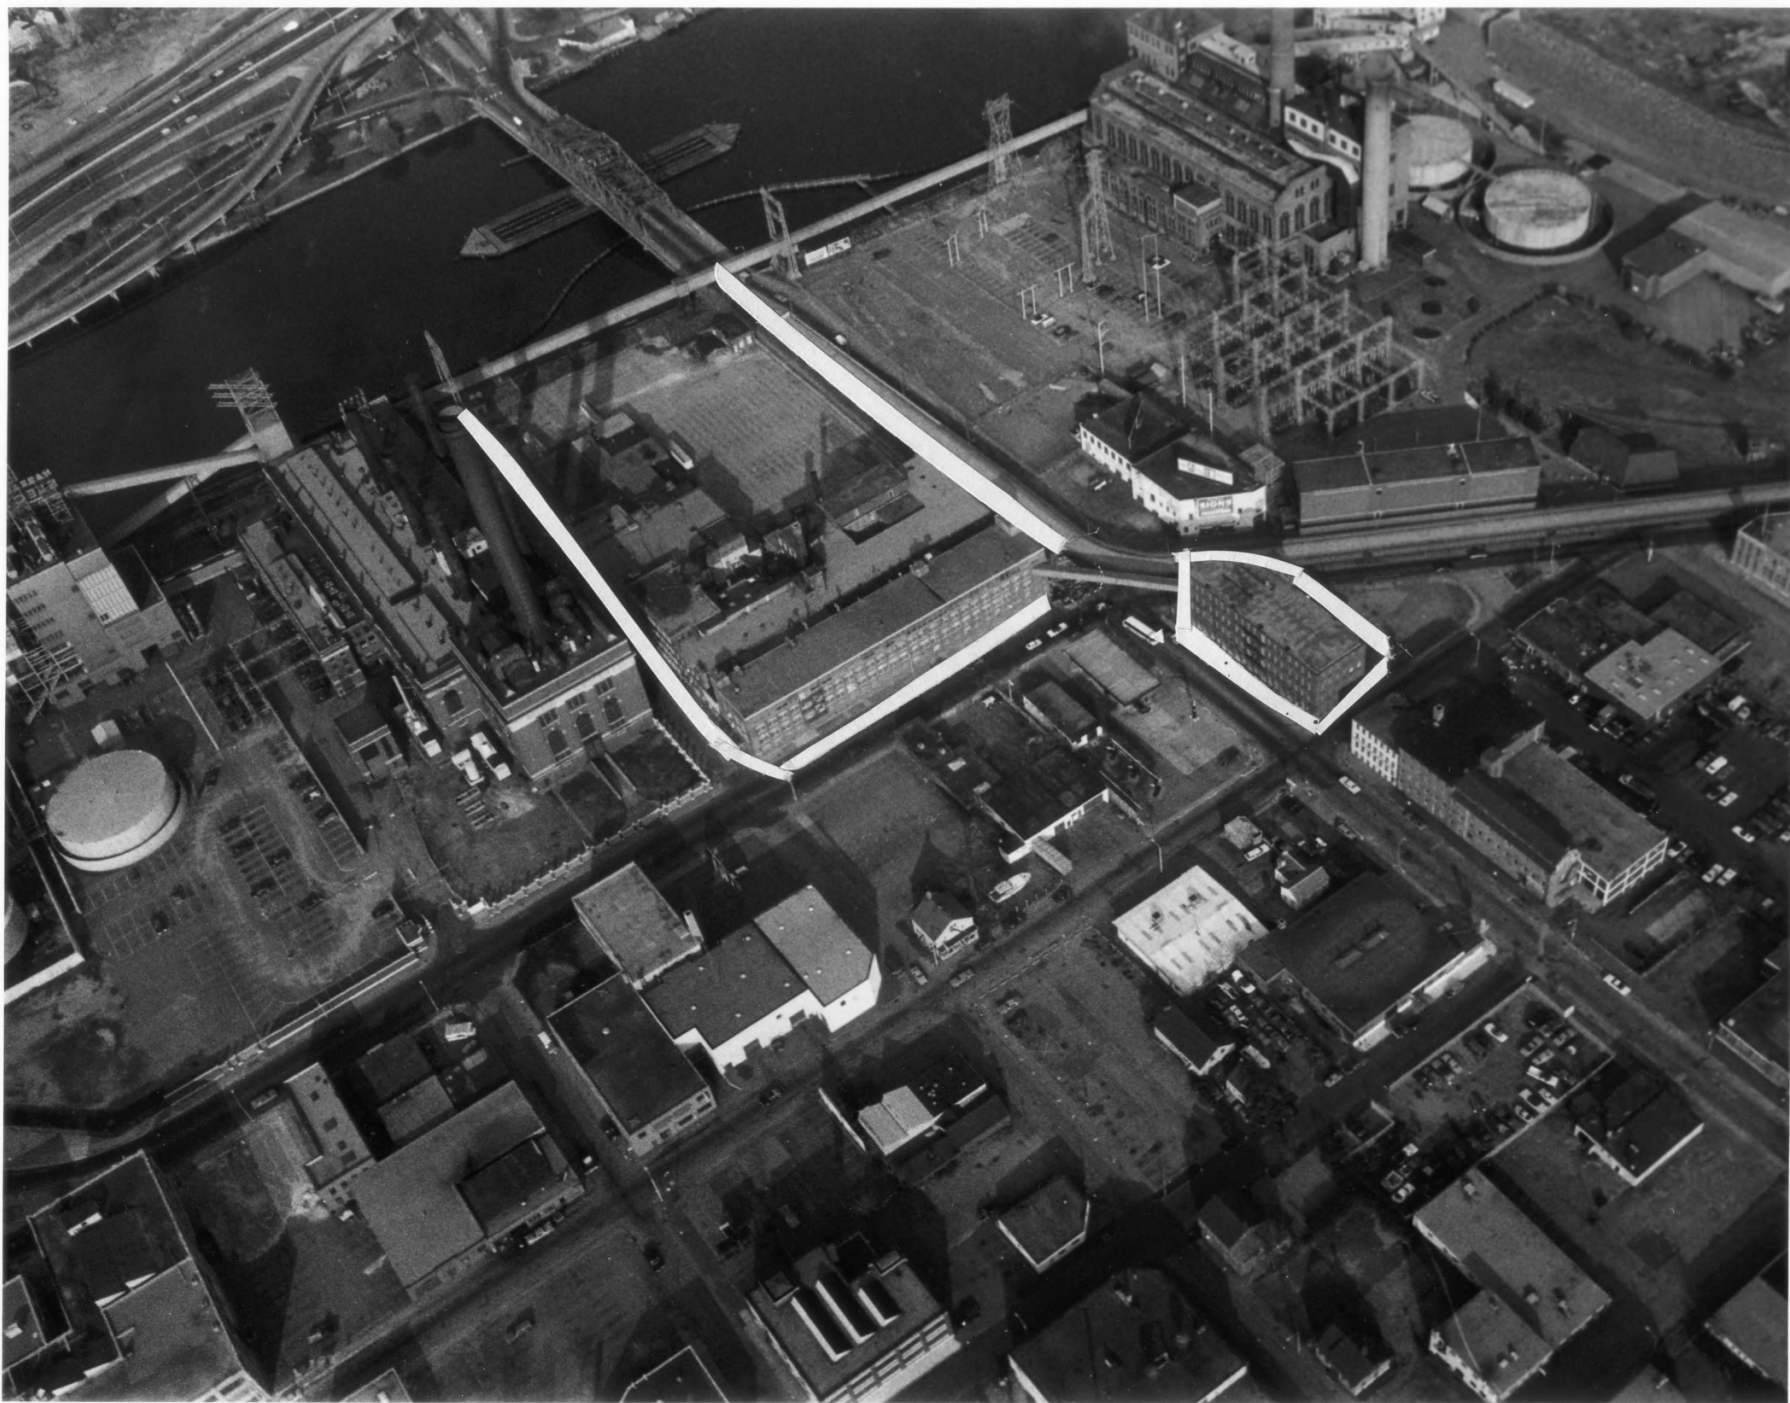
Photo #2 *of 13*

Aerial view showing relationship of Davol Company
to Narragansett Electric Company power generating
plants and Providence River. Viaduct running on
Point and Eddy Streets no longer (March 1980) exists.

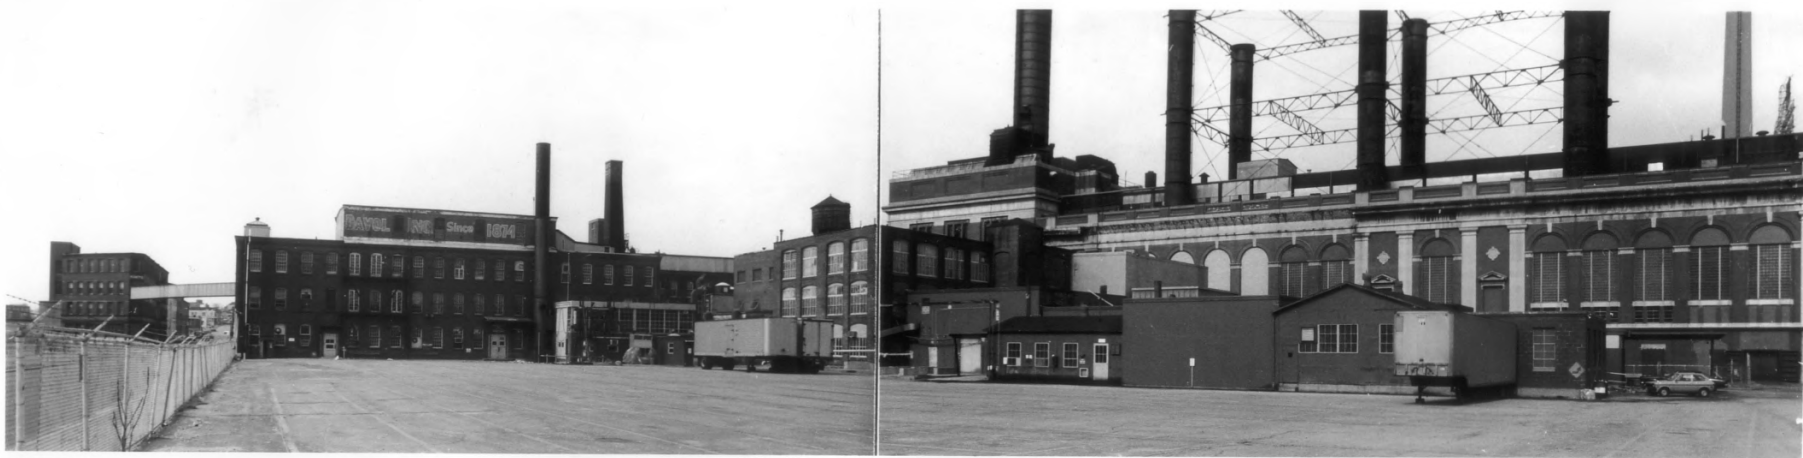
Photo # *3 of 13*

View from the southwest corner of property. Shown from left to right are the Simmons Building, the 1889 addition, the 1926 addition, and the metal storage sheds. Narragansett Electric South Street generating station is in the background.

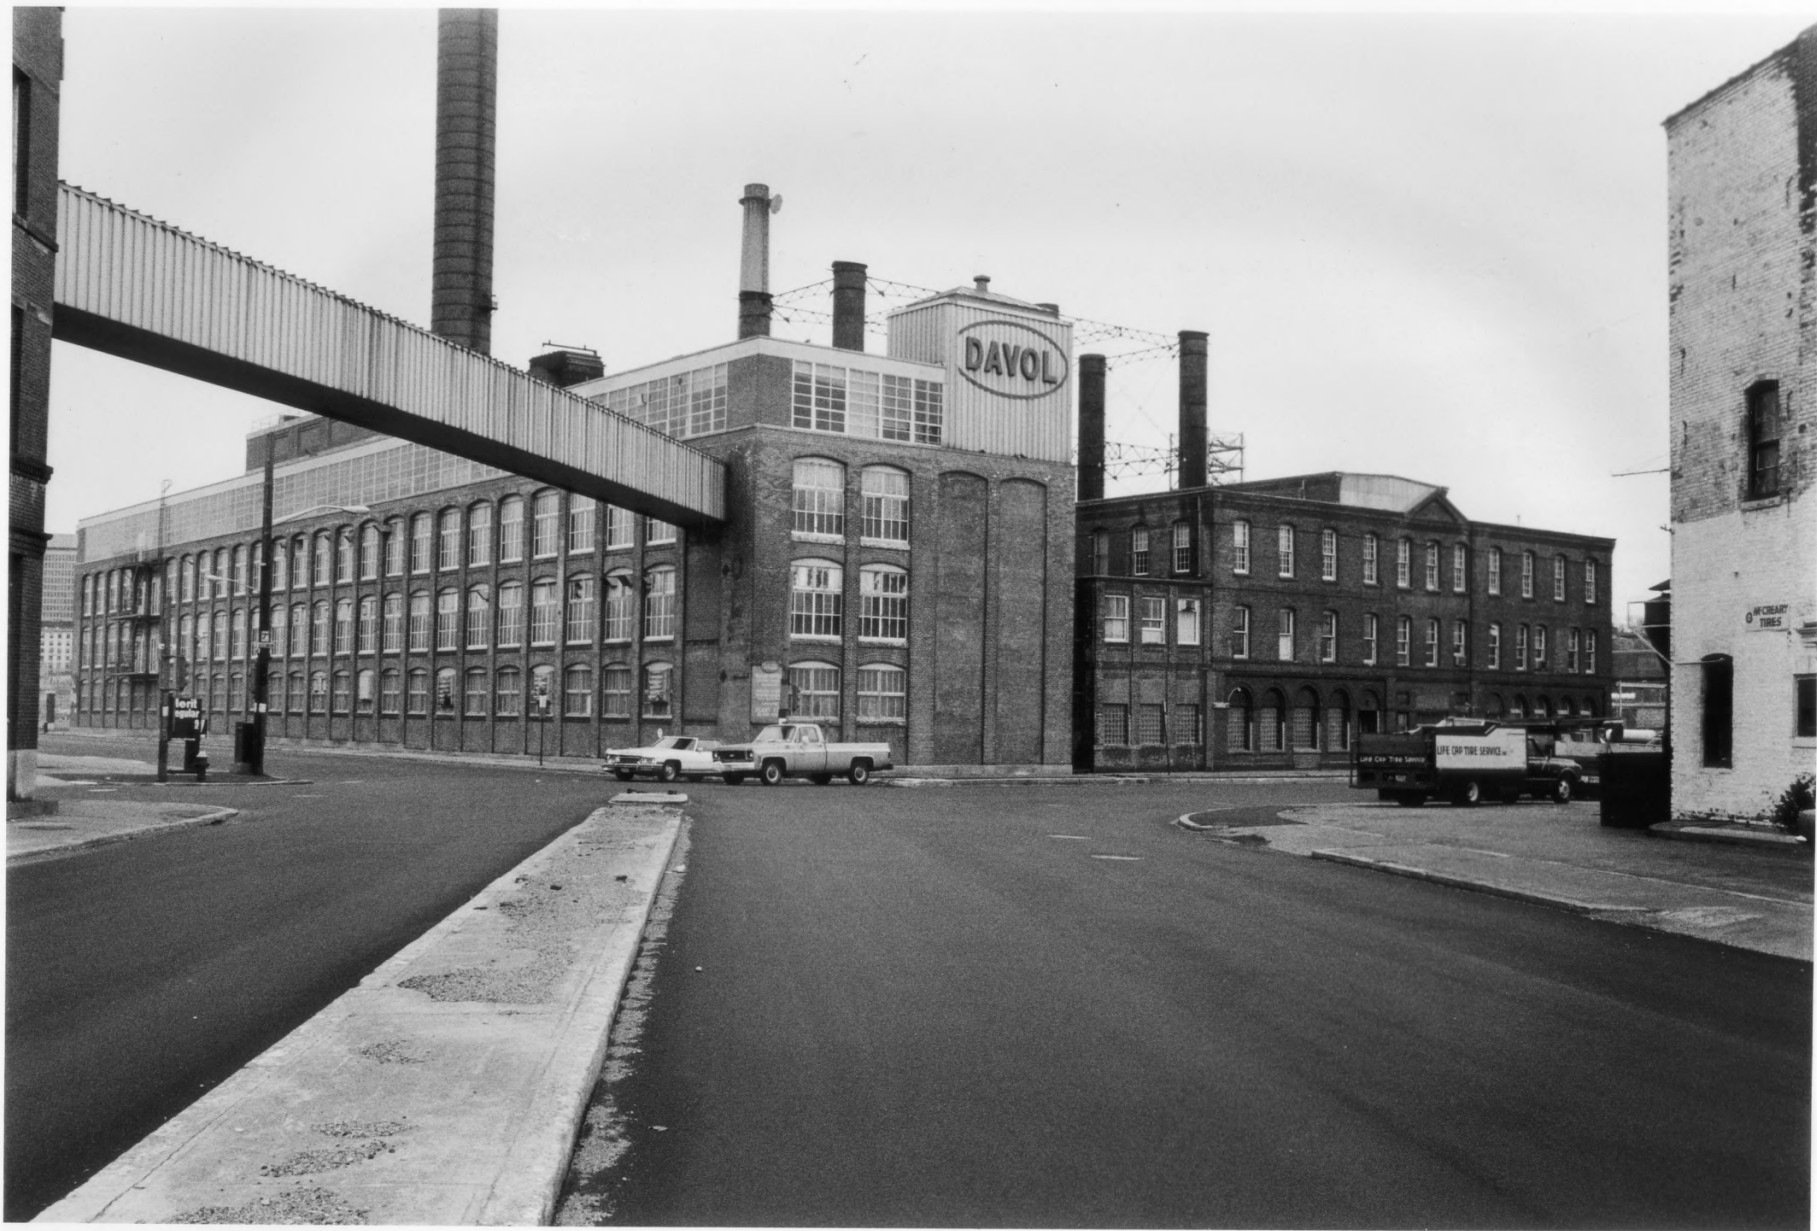
Photo # *40713*

The south elevation of the complex fronts on Point Street. The west elevation fronts on Eddy Street. The overhead connector is conveyor between the main complex and the Simmons Building. Photo was taken from Eddy Street looking north.

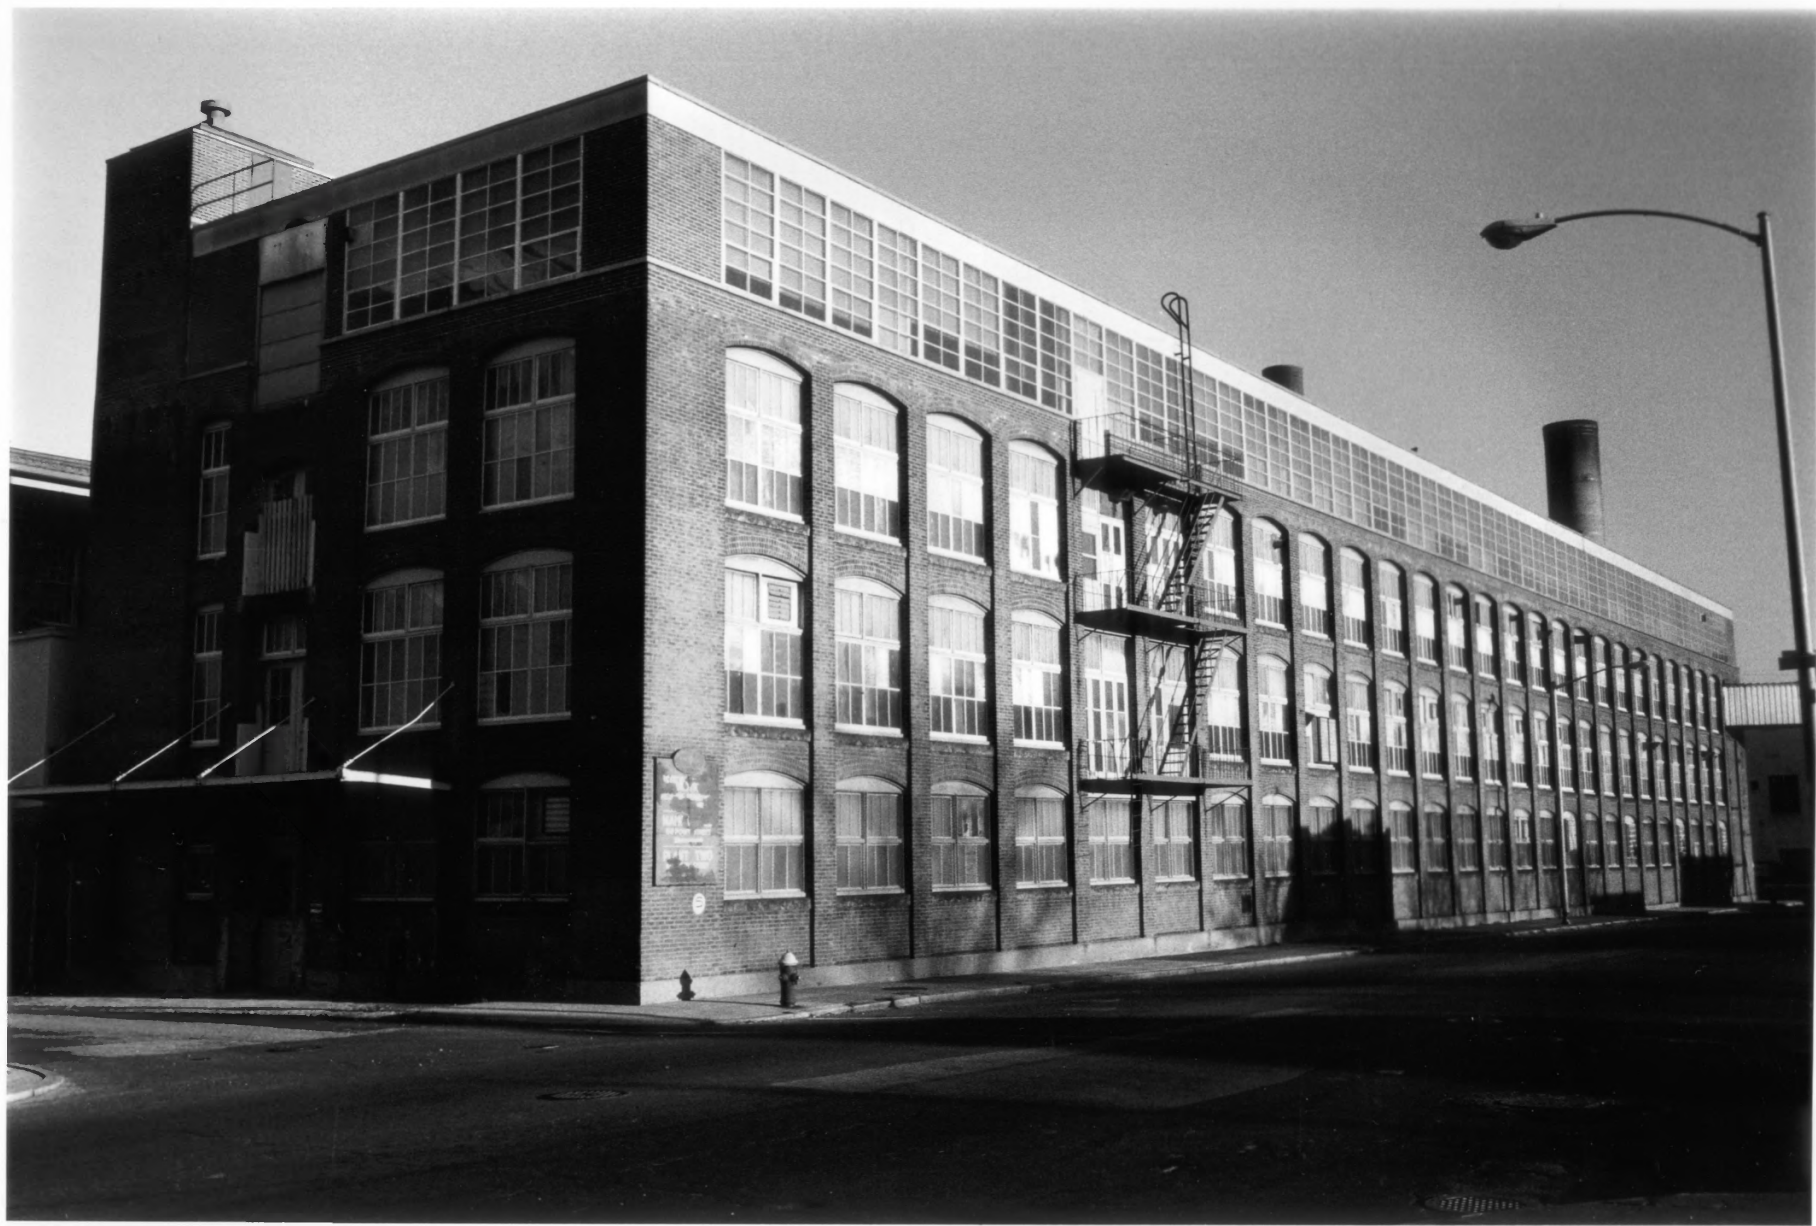
Photo #5 *of 13*

West elevation of 1913 addition. This building fronts on Eddy Street, South Street, and Point Street. This is the first steel frame structure built in the complex and features double-glazed wood-framed windows.

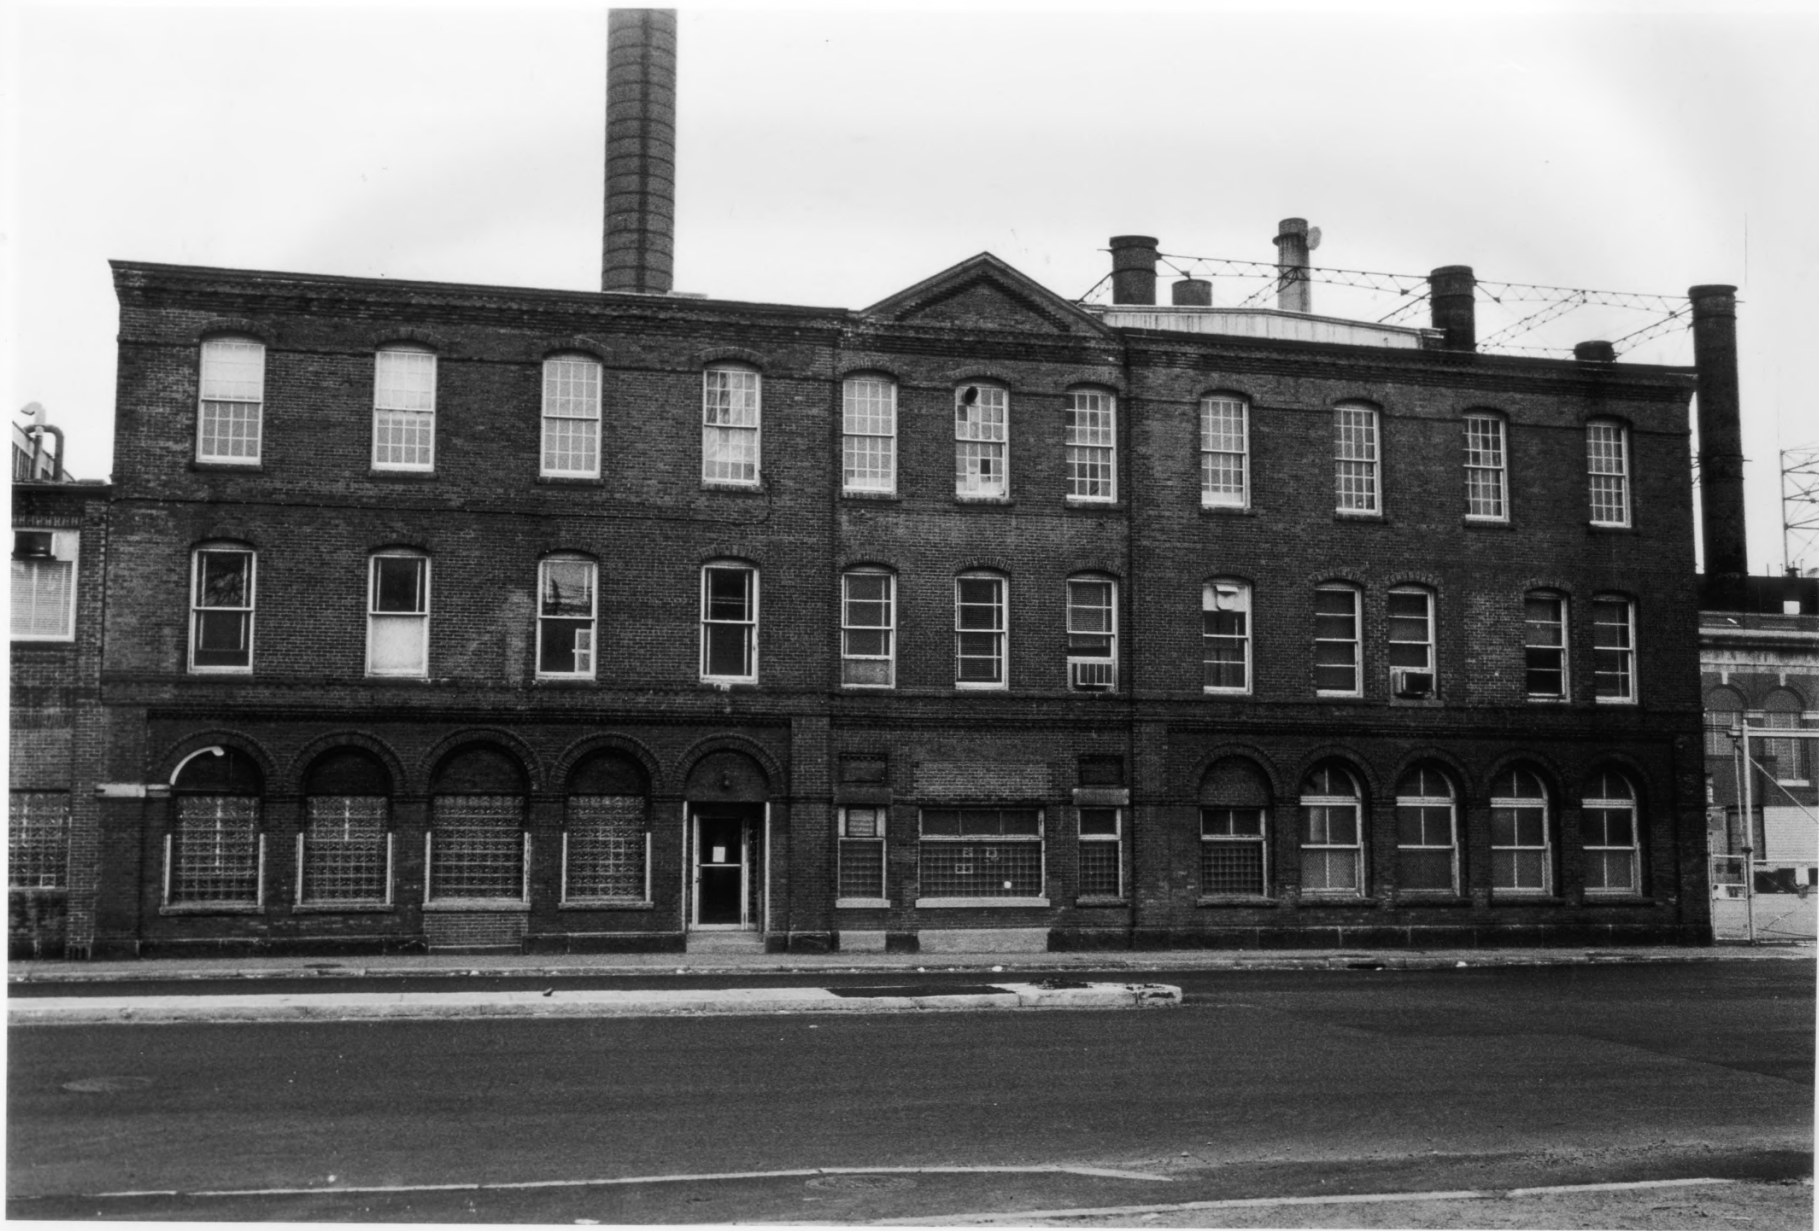
Photo #6 *813*

Point Street elevation of original building complex.
The left portion of the building (five bays at the
street level) was built by Joseph Davol in 1884.
The remainder was built in 1889.

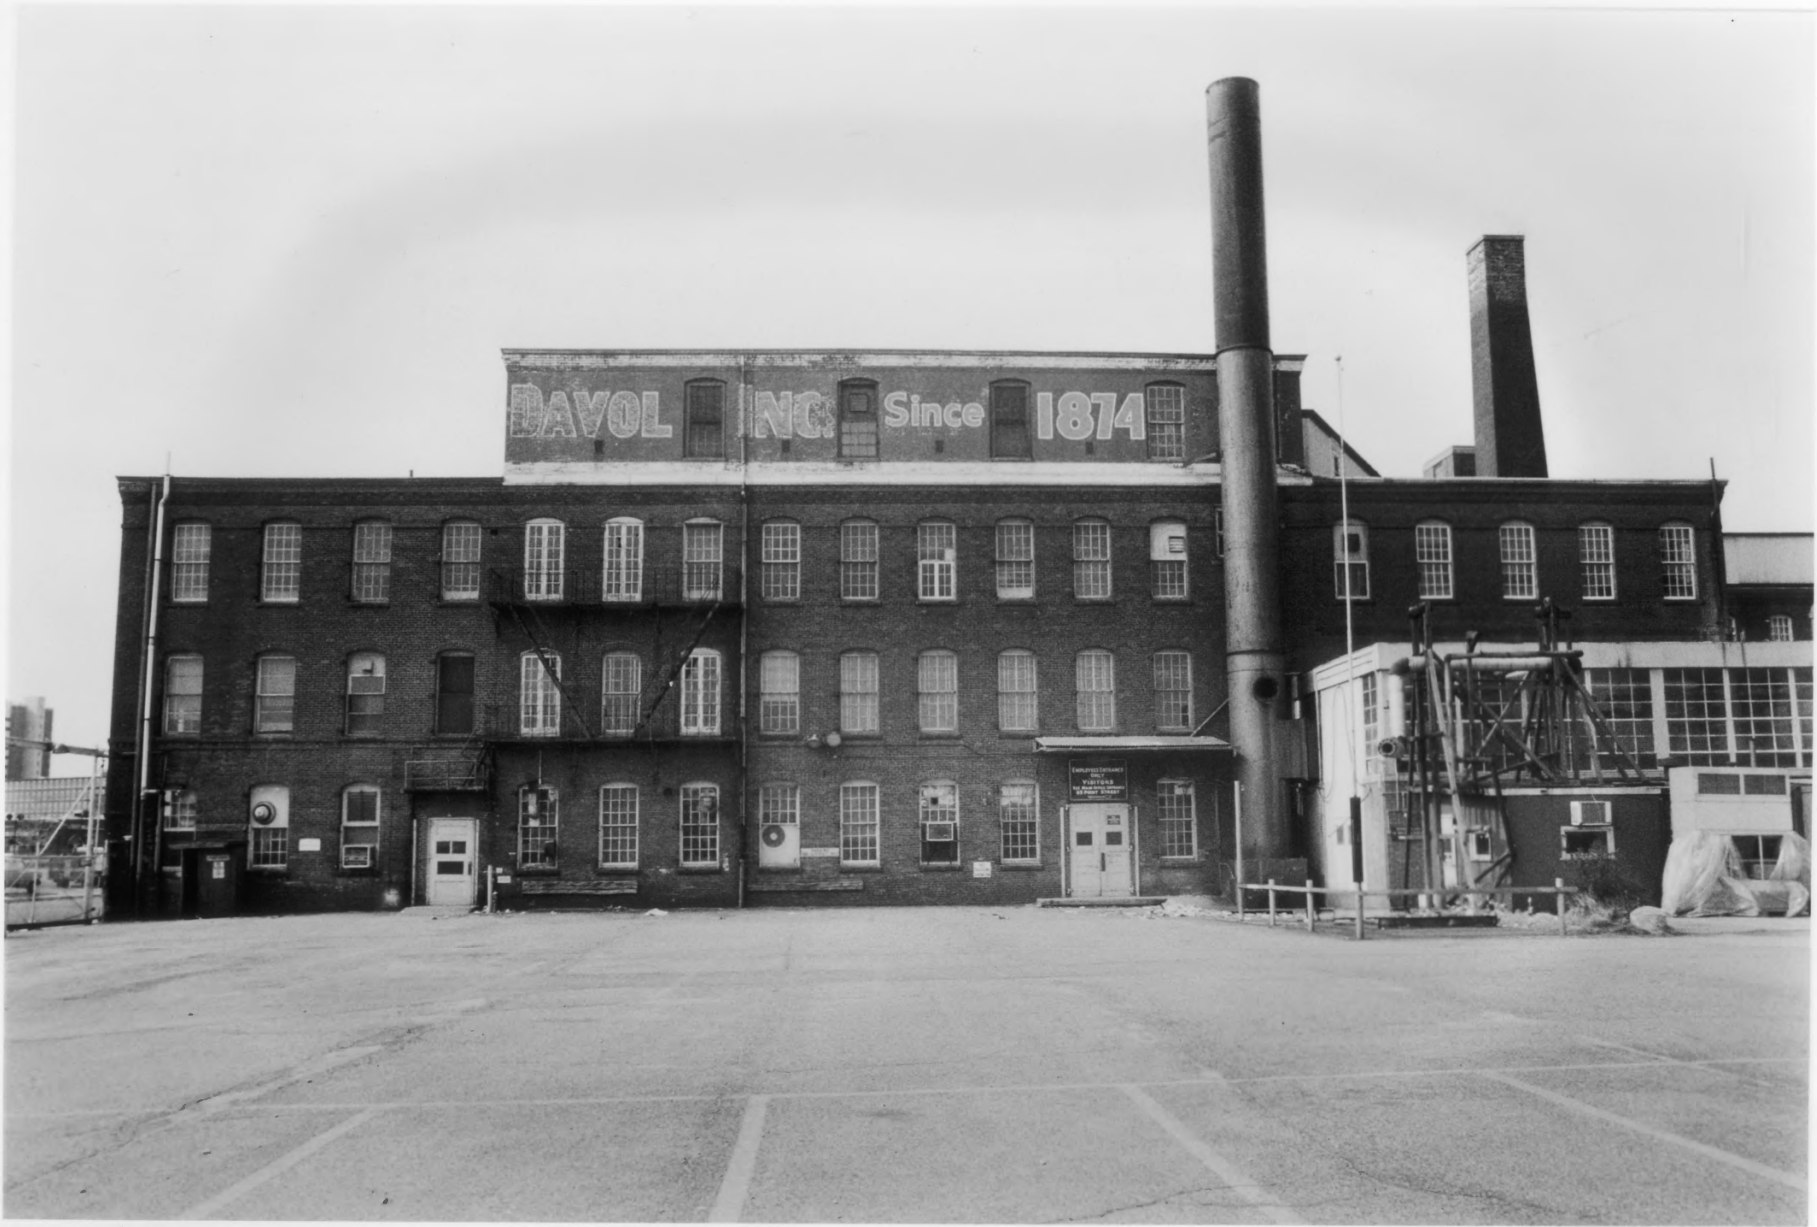
Photo #7813

East elevation of 1889 addition. The modern glass structure to the right of the photo is the control room for the heating plant.

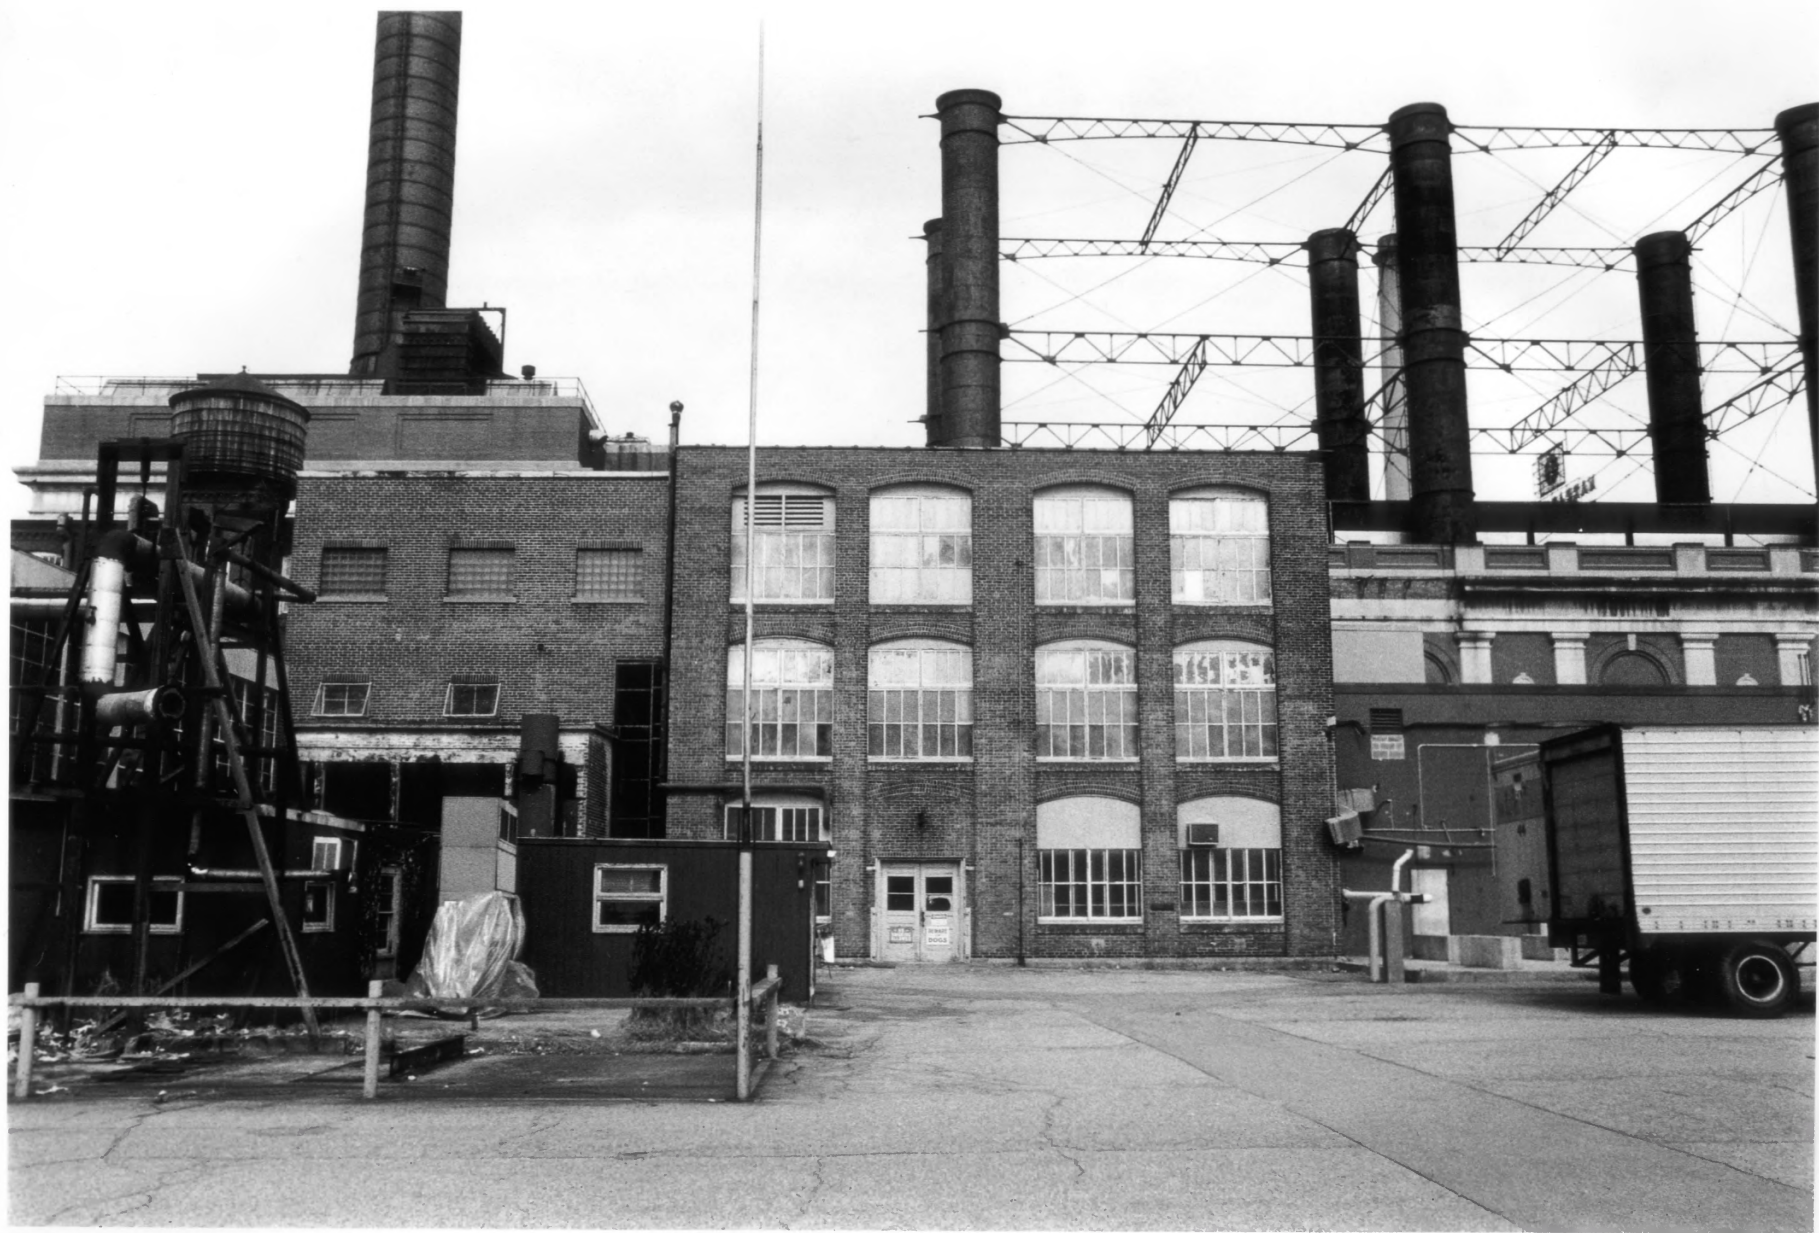
Photo #8 of 13

South elevation of the 1926 addition. This building has a steel frame structure, similar to the 1913 building.

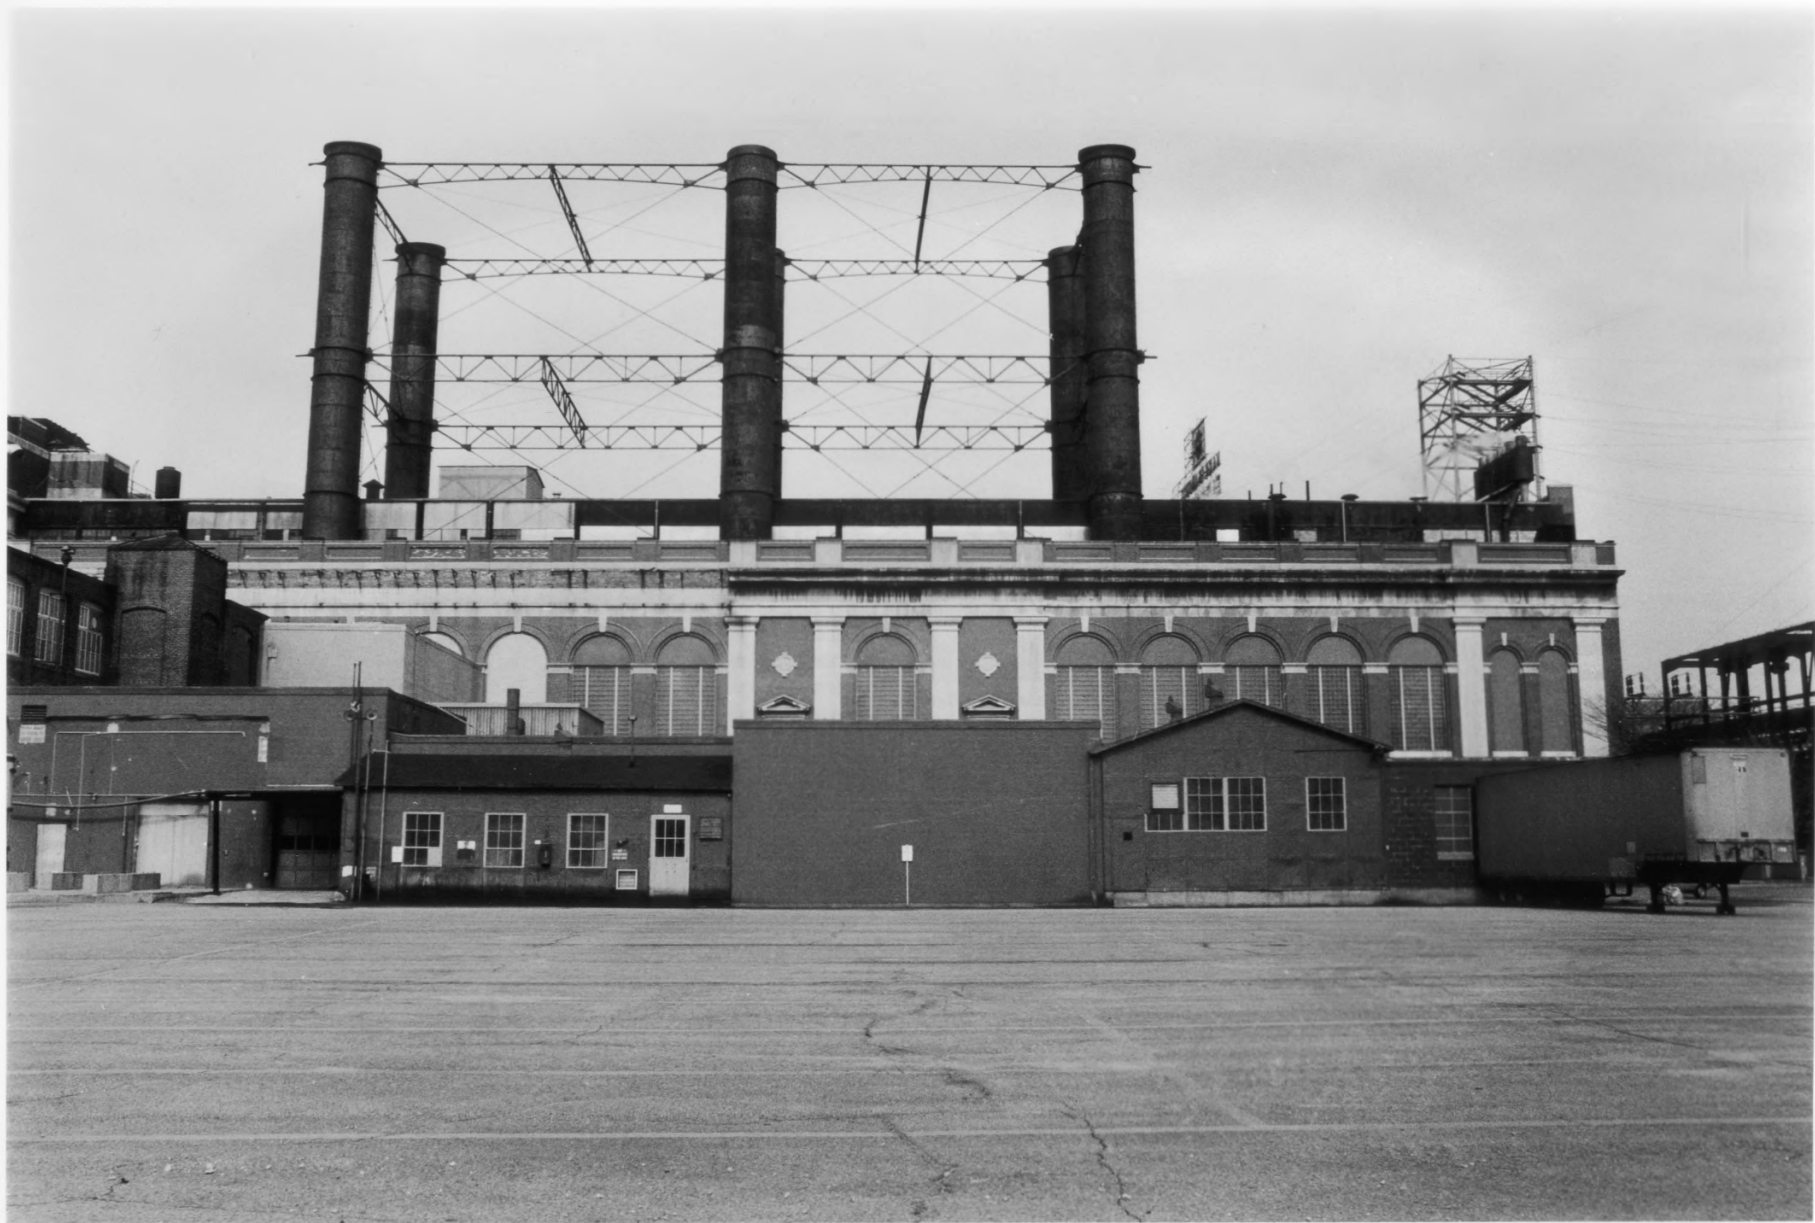
Photo #9 *of 13*

South elevation of metal-clad storage sheds. Their exact date of construction is unknown, but they are the newest structures in the complex.

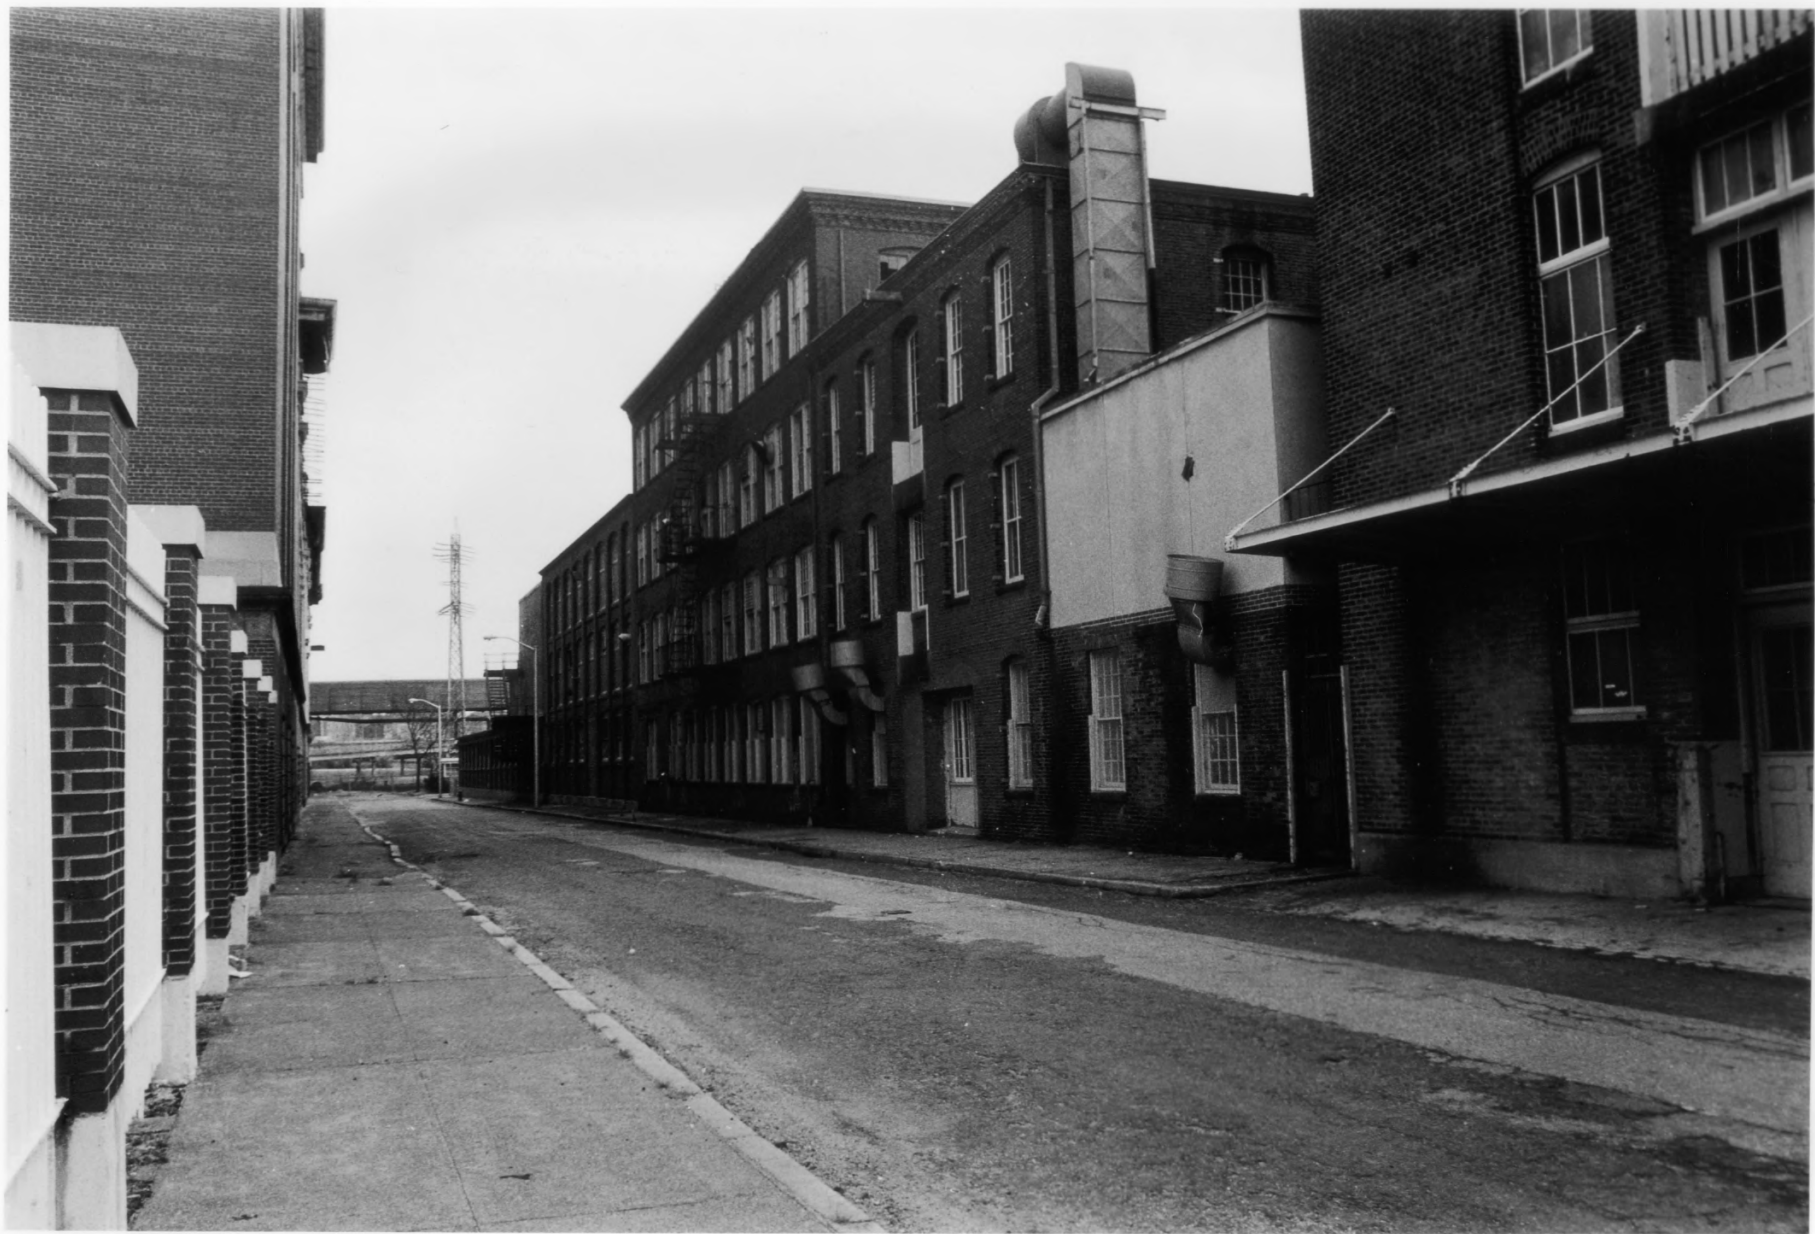
Photo #10 *of 13*

North elevation of building facing South Street.
Dates of construction range from 1892 to 1926.
Providence River is at end of South Street.
