Davol Rubber Company
Providence, Rhode Island

Photographer: Jeffrey Blydenburgh October 1979
Negative at: Beckman, Blydenburgh & Associates
116 Chestnut Street, Providence

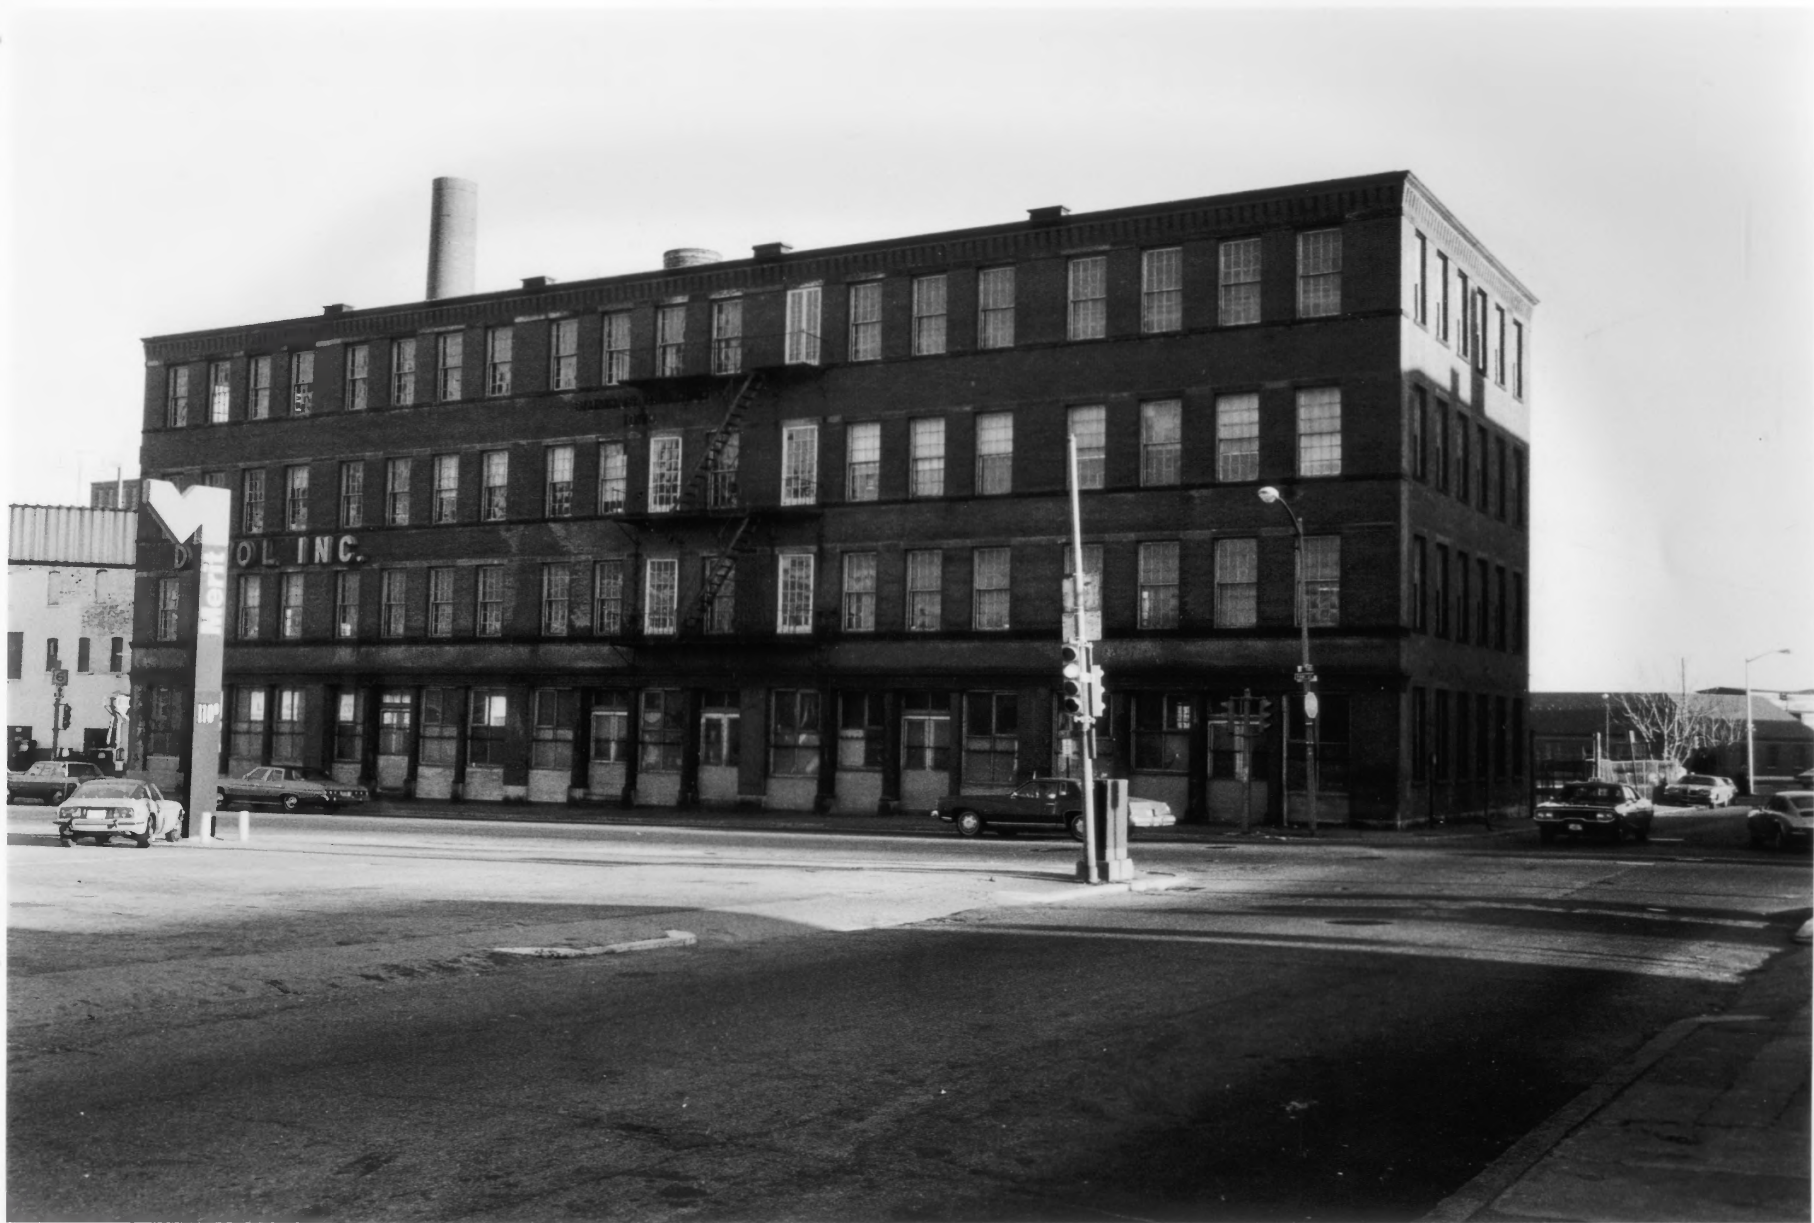
Photo #11 of 13

Simmons Building, north elevation. Built in 1880
by Eban Simmons, the building has cast iron store
fronts and granite belt courses over the windows.

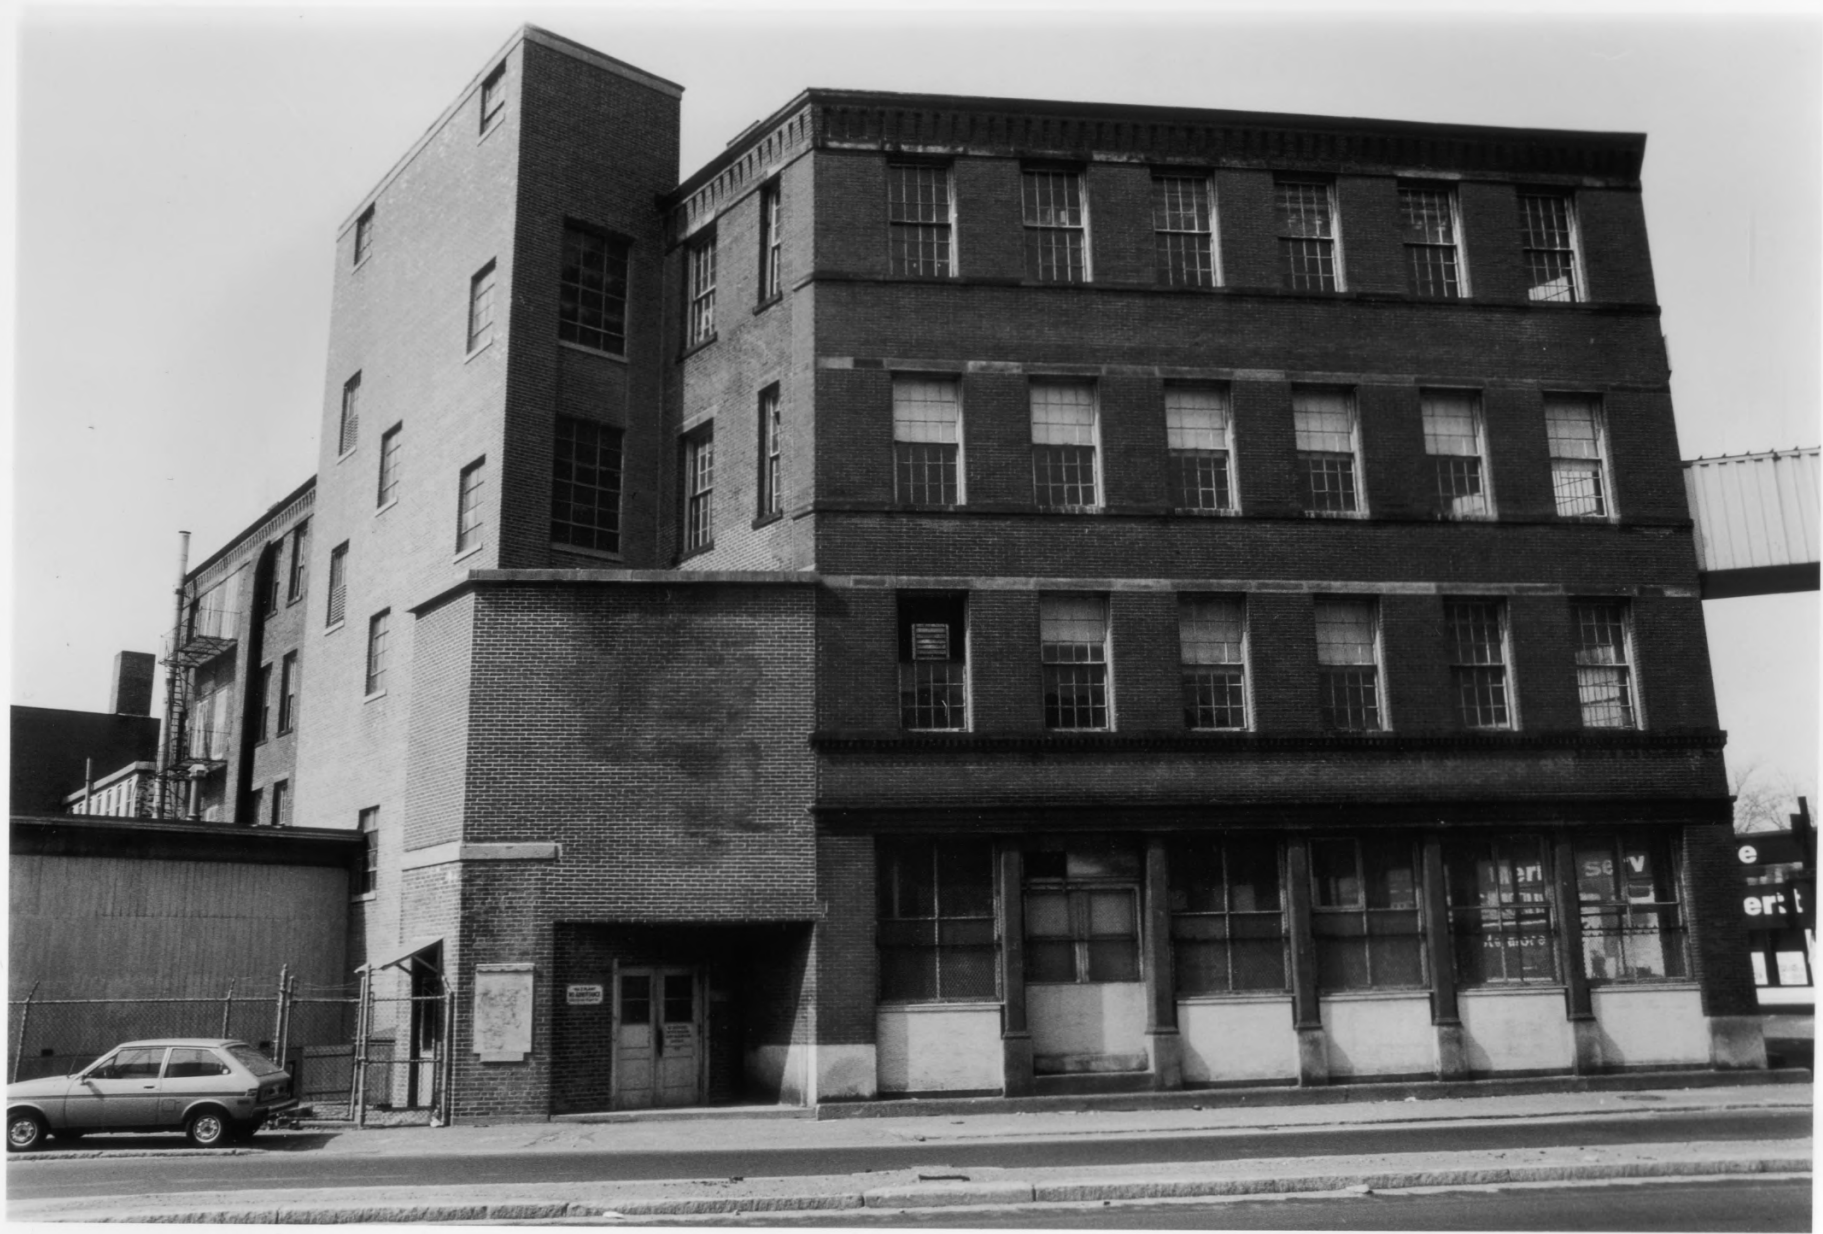
Photo #12 *of 13*

East elevation of Simmons Building fronts on
Eddy Street. Stair tower, elevator shaft, and
entry were added at a later date.

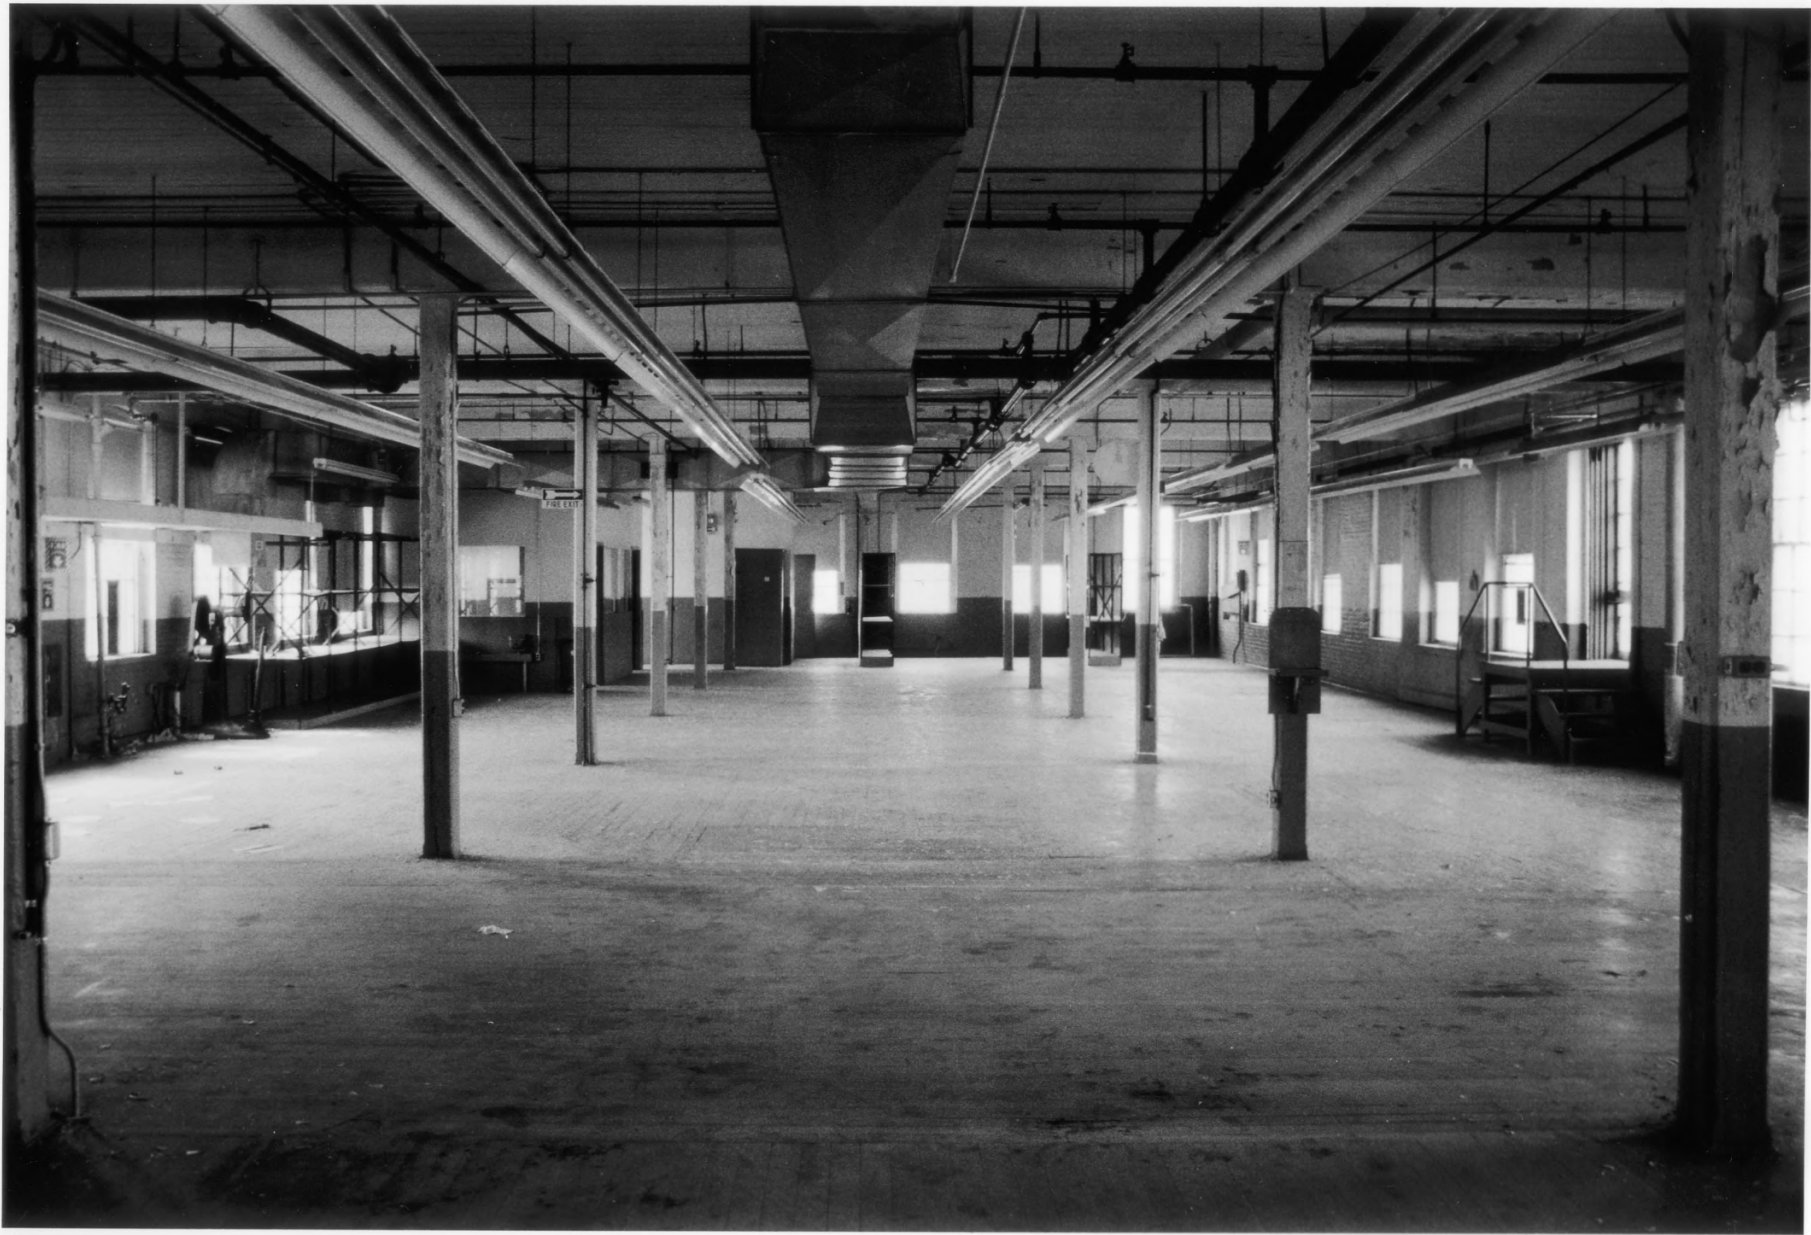
Photo #13 *of 13*

Typical interior of Simmons Building, showing existing condition. Wood timbers carry joists on 12" centers with floor decking and finish floors. Ceiling is covered with tongue and groove wood boards.
