**HISTORIC RESOURCES INVENTORY  
BUILDING AND STRUCTURES**

1. BUILDING NAME (Common) *(Historic)*  
Timothy Hart House

3. STREET AND NUMBER (and/or location)  
521 Flanders Rd. (map 150, parcel 16A) 1.12 acres

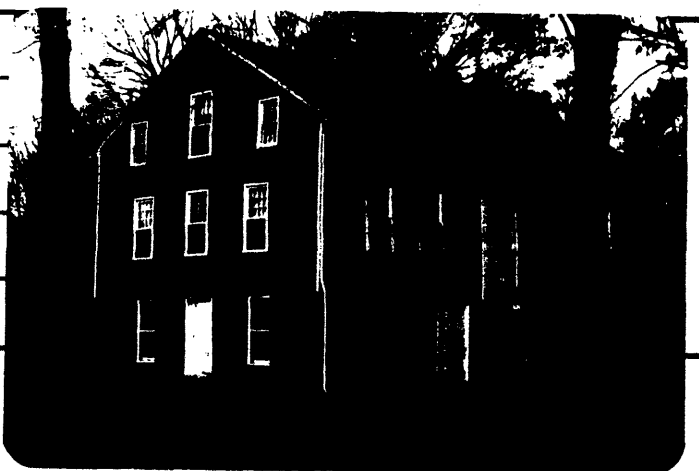
PHOTO

In the 5-bay front elevation the central door is flanked by small 12/12 windows. There are three such windows in the first floor in the end facing the street, and three in the second floor. Because of the slope of the land, basement is at grade at the end facing the street where there is a central paneled door flanked by 12/12 windows. The house has a central, corbeled, brick chimney that appears new, serving three fireplaces on the first floor and one in the basement.
