NEW JERSEY TRANSIT RAILROAD STATION SURVEY

A. Name: Common Upper Montclair ^{Station} Historic Line: Hoboken Div. - Boonton (Erie)

FACILITY NAME: Upper Montclair

Survey # RR-0713-7-9

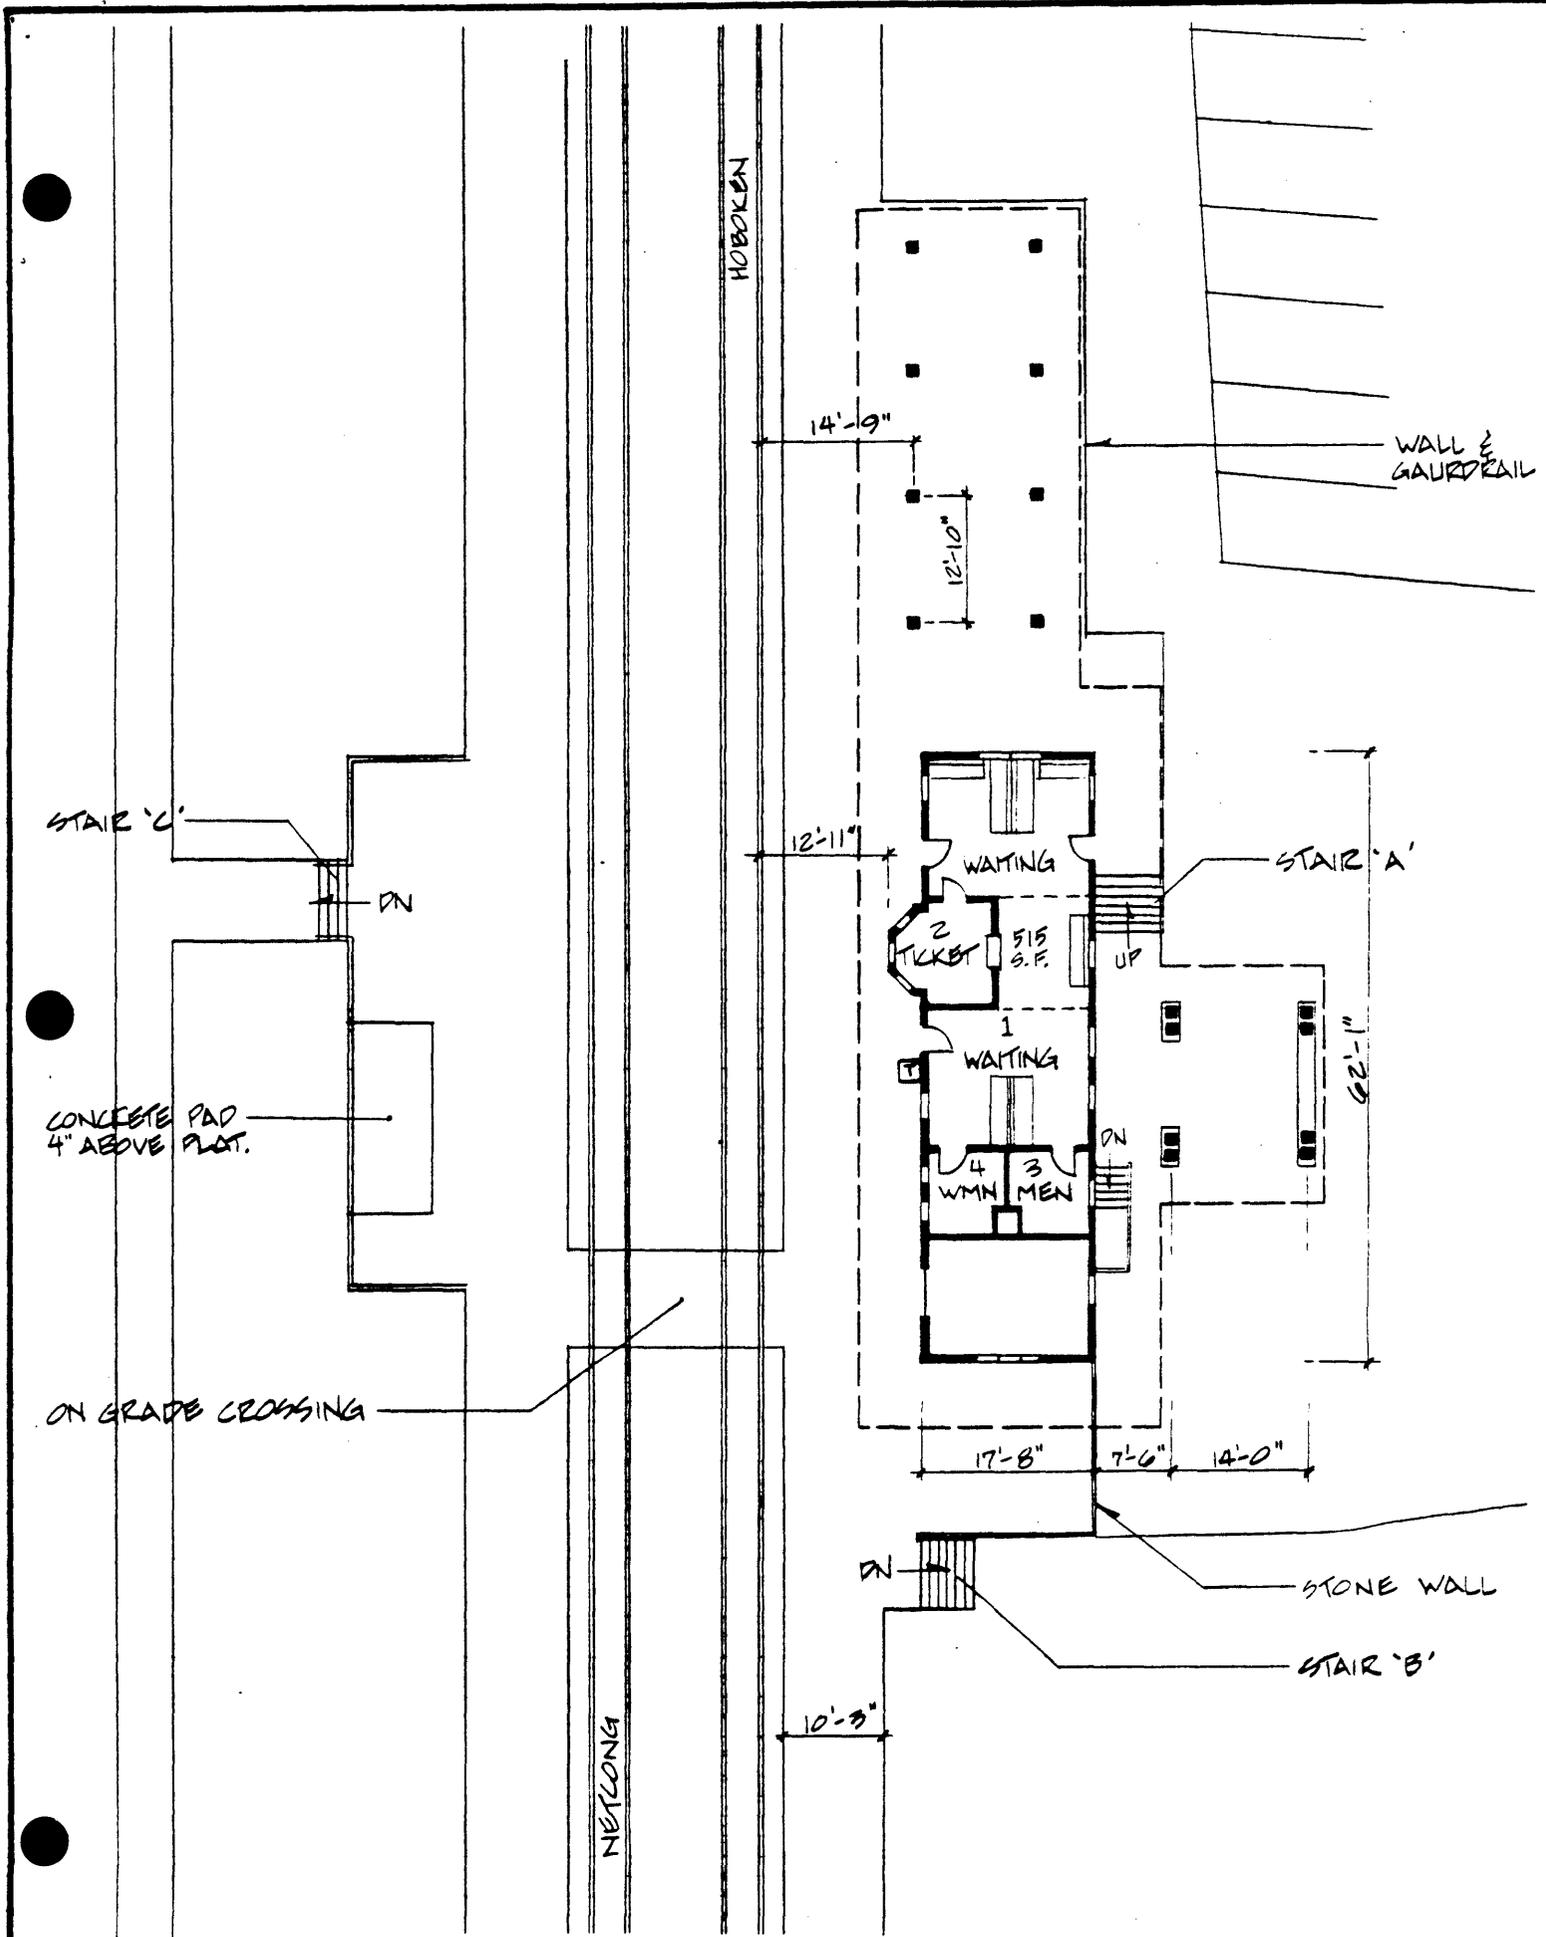
3 PLATFORMS & CANOPIES

PLATFORMS - BOTH PLATFORMS IN FAIR COND., CRACKED IN SPOTS ASPH. SLIGHTLY WAVY, EDGES DAMAGED IN PLACES.
 LIGHTING - IN GOOD CONDITION
 FENCE - CONC. POSTS W/ 2" PIPE RAILS - RUSTED, LEARNING IN PLAC RAIL MISSING IN TWO PLACES

GUTTERS - OLD + ROTTED - BROKEN (PHOTO) NEED REPLACING
 LEADERS - RUSTED THRU (PHOTO), MISSING, DAMAGED - REPLACE
 SLATE SHINGLES - BROKEN, MISSING - REPLACE
 SOFFIT - WOOD OLD + ROTTED
 COLUMNS. WOOD - OLD BUT SOUND
