National Register of Historic Places Registration Form

historic name Barn on Lot 8, Range G

other names/site number Brackley Barn, Durrell Barn, Staier Barn

The following five pages contain conceptual diagrams of the Barn on Lot 8, Range G, created in order to illustrate the structural evolution of this structure, as described in Section 8. The diagrams are not measured drawings and they are not to scale. No attempt has been made to depict joinery.

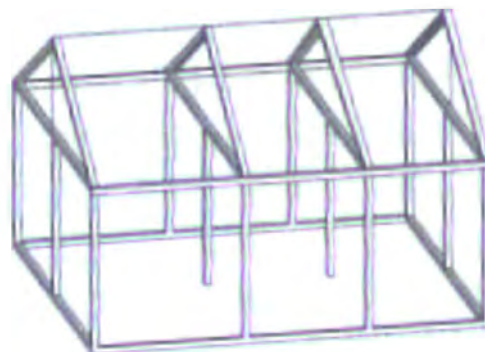
Figure 1: English Barn Frame

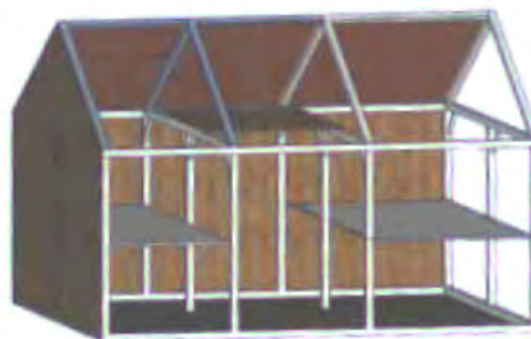
Figure 2: English Frame with hay lofts and scaffold.

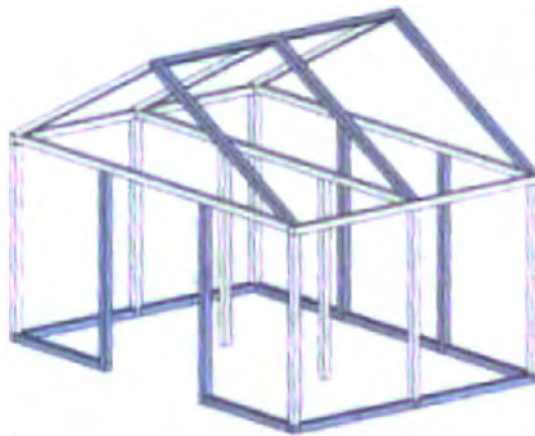
Figure 3. New England style barn frame.

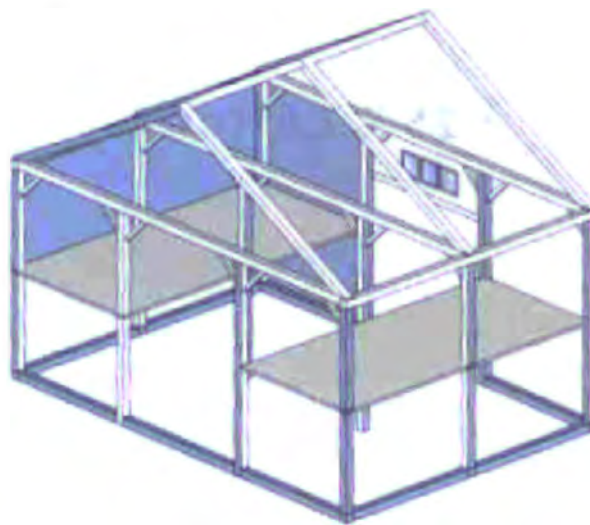
Figure 4. New England Barn Frame with hay lofts.

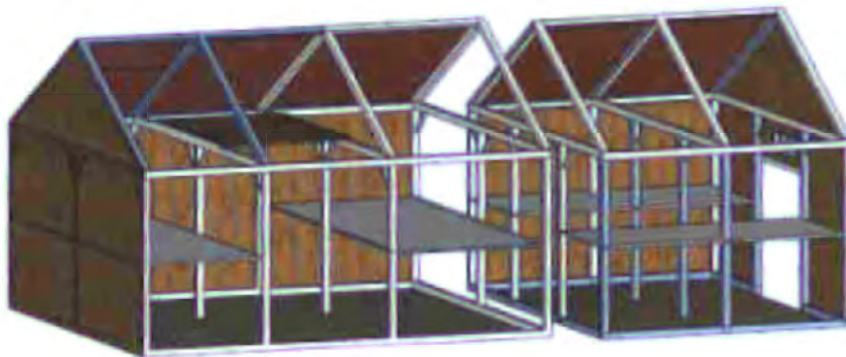
Figure 5: Relative positions of English barn frame and New England barn frame, with posts in original positions.

The expansion of the barn in Freeman does not follow either of these models. Instead of attempting to enlarge the barn and retain one long aisle, the expansion of the subject barn created a "T" shaped aisle system consisting of the original, short center aisle intersecting with a newly positioned, long aisle in the addition. In this approach the two new bents were positioned as they would be in a New England Barn (across the width of the building, spanning the aisle) and the plane of the roof remained consistent. (Figure 5) The design of the new bents did not really differ from a variation commonly seen in New England barns, but they did differ from the original English barn bents due to their two floor to rafter posts, versus the one found in the earlier barn. (Figure 6) In order to make the transition one original interior post in the west bay was repositioned and another post added. (Figure 7). That section of what had been hay loft was then converted to open aisle. (Figure 8.) Otherwise this method required little interior alteration. Indeed, while there are slight differences in the materials and workmanship between the two sections, to the un-trained eye the roof structure has a consistent pattern of rafters, girts and posts (except at the east end of the building). What is significantly different is the orientation of the central aisle to the ridge. After the expansion it would have relatively simple for the barn to be lengthened again if necessary. Figures 9 and 10 show exterior views of the expanded barn.

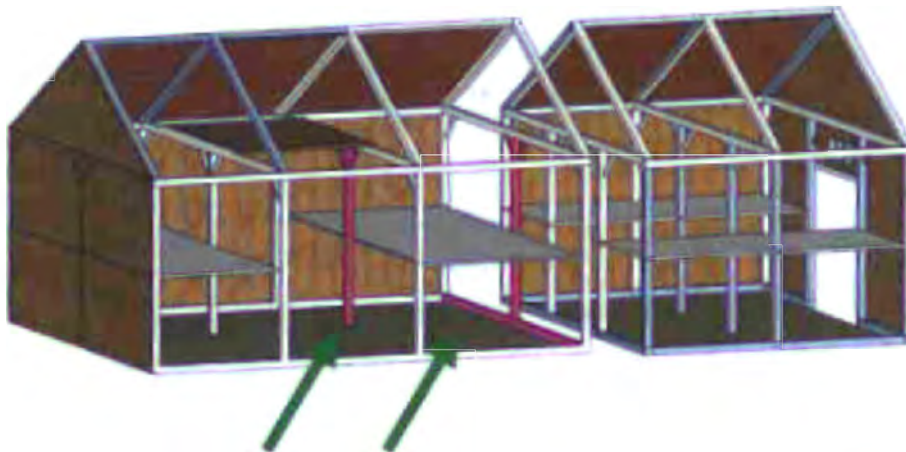
Figure 6: Relative positions of English barn frame and New England barn frame. The arrows point to the posts and sill in the English barn that had to be repositioned.

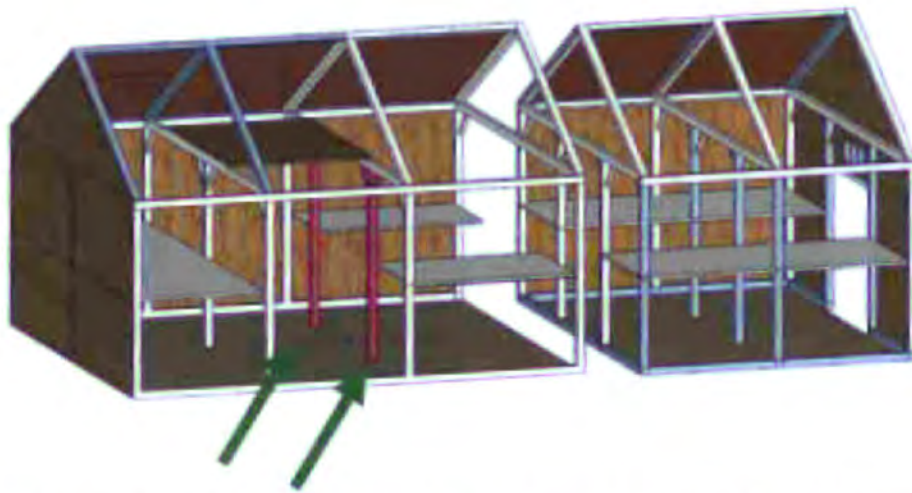
Figure 7. Relative positions of English barn frame and New England barn frame. The arrows point to the relocated posts.

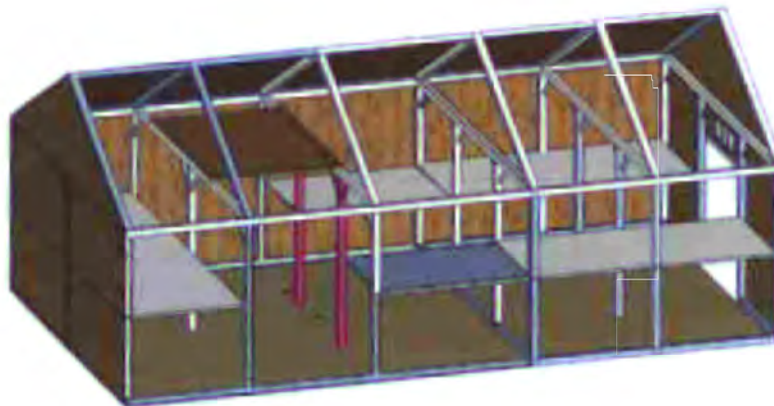
Figure 8: Final structural configuration of the expanded barn.

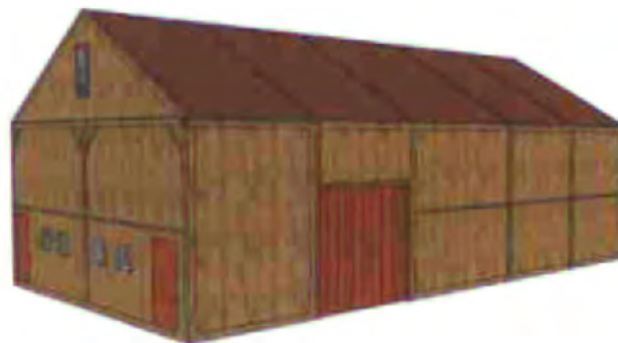
Figure 9: Exterior of expanded English barn, facing southwest.

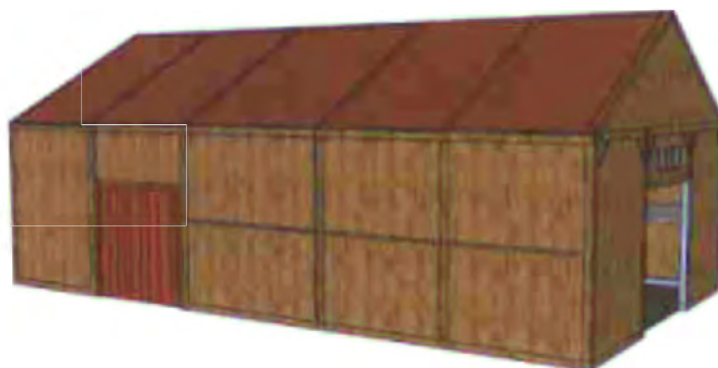
Figure 10: Exterior of expanded English barn, facing southeast.
