# National Register of Historic Places Registration Form

Hilgeman, Franklin, House Name of Property	Maricopa, Arizona County and State	
4. National Park Service Certification		
I hereby certify that this property is:		
entered in the National Register		
determined eligible for the National Register		
determined not eligible for the National Register		
removed from the National Register		
other (explain:)		
Sinderin	4/24/17	
Signature of the Keeper	Date of Action	
5. Classification Ownership of Property		
(Check as many boxes as apply.) Private:		
Public – Local		
Public – State		
Public – Federal		
Category of Property		
(Check only one box.)		
Building(s)		
District		
Site		
Structure		
Object

# **Narrative Description**

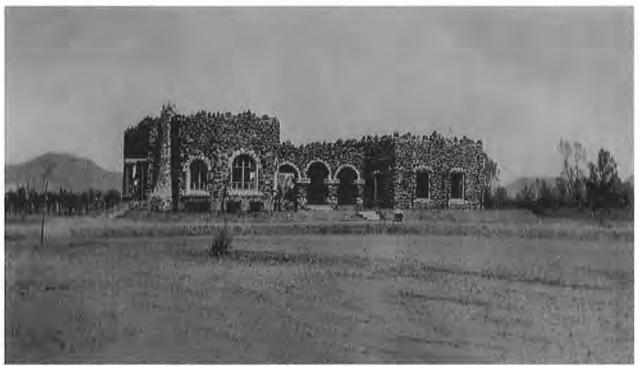
Figure 2. Hilgeman House nearing completion, looking north-northeast, circa 1924.

When first built, the center room had a rock wall with three large arched openings on the south side, a truss on the north side and a roof suspended between. Below the truss was open. According to family lore, the original floor was flagstone and the room was used for open-air sleeping in the summer.

The three south side arched openings were later filled in with two windows and French doors. The north side opening below the truss was filled in with four windows and French doors. The floor of the enclosed room was covered with concrete. This center room alteration was done sometime between 1941 and 1948 by the second owner, Henry Delno.

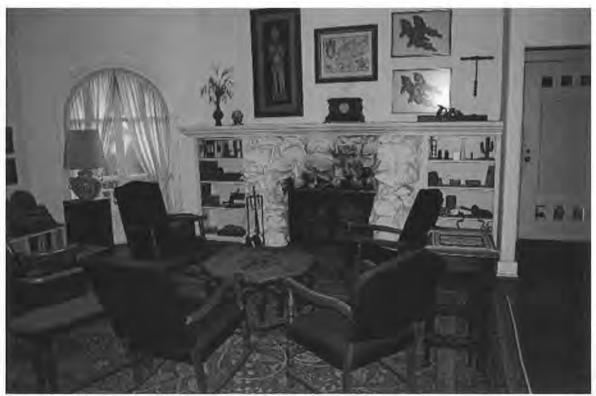
Figure 5. Living room fireplace, looking west.

Sometime around 1940 the Home Owner's Loan Corporation, which temporarily owned the house and 10 acres at that time, performed a "renovation". Part of that endeavor included painting the living room fireplace facing white. The facing under the paint is quartz and petrified wood oriented to display end grains.

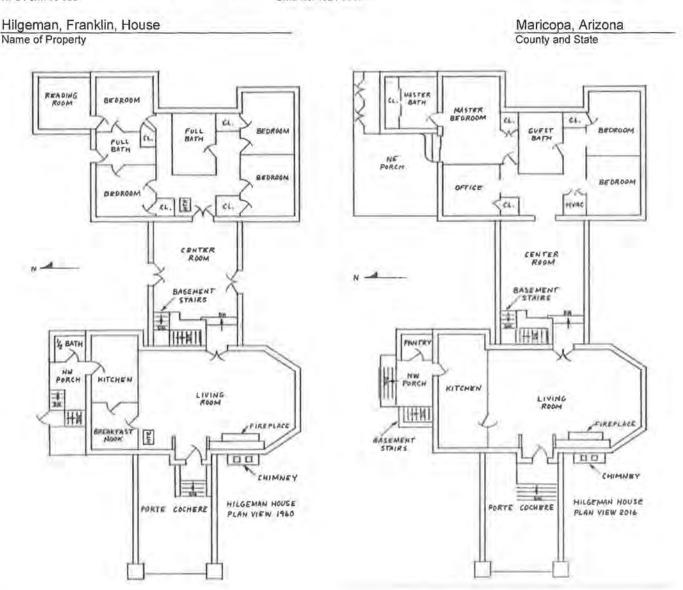
Figure 6. Plan views before (on left) and after renovations, 1960 and 2016, respectively.

Around 1964 the east wing of the house was extensively remodeled to change it from a residence to an office for a small firm. An air conditioning and gas-fired heating unit that serves the center room and east wing was installed along with suspended ceilings to accommodate HVAC ducts. The original plastered ceilings remain several feet above the suspended ones. The plastered bedroom and hall walls were covered with wood paneling mounted on furring strips. Duplex electrical outlets were added throughout in comparative profusion. There are now eight per room where there were formerly two. Closets were changed to accommodate filing cabinets, catalogs and ledger books. Three bedroom doors were removed.

The old reading room in the northeast corner became a master bathroom. The room's three archtop windows disappeared. The east one was filled in with a stud wall and covered with cedar shingles. The north one was concealed behind what is now a small laundry room. The west window and the rock wall around it were covered with a stud wall and cedar shingles.

The old bathroom, when removed, allowed the adjacent northeast bedroom to expand to become the master bedroom. The floors in both rooms are now surfaced with a Formica product that resembles the red oak floors in the rest of the house. The floor in the old bathroom was shiplap pine under linoleum and couldn't become red oak without removing and rebuilding a wall. Also, the floor in the new master bathroom needed to be more water repellant than real red oak.

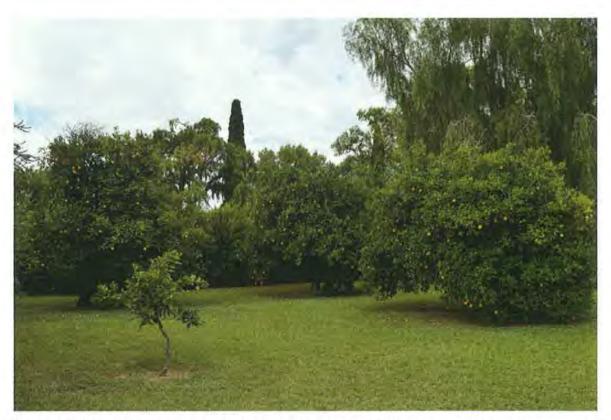
Figure 23. Three orange trees nearly 100 years old and still bearing, looking south-southwest.

The new Loma Lane setback is about 80 feet and the lot is 1.24 acres. The exterior of the house remains much the same as it was when built. The surrounding area has changed considerably but there are still a few of the original citrus trees scattered about the neighborhood. Three of them are in the southeast corner of the Hilgeman east yard. They bear Arizona Sweet oranges.

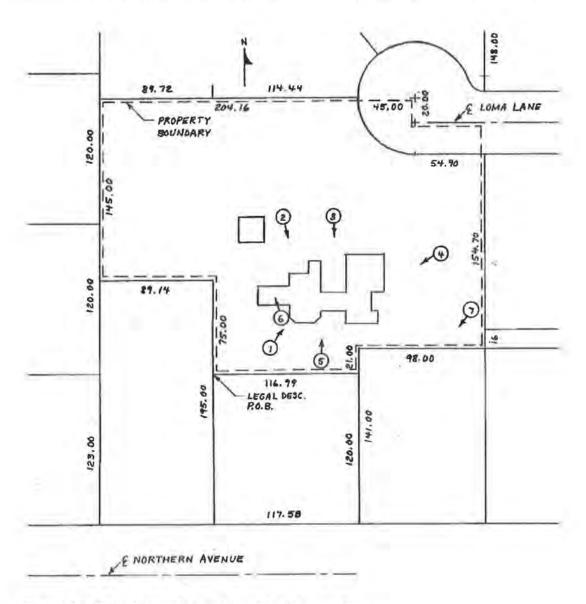
Figure 29. Sketch map / site plan with photo markers.

- 1 of 7. south and west sides of house, looking northeast
- 2 north and west sides of house, looking south-southeast
- 3 north side of house, looking south
- 4 east side of house, looking southwest
- 5 south side of house, looking north
- 6 south and east sides of shed, looking north-northwest from porte cochere
- 7 Three original citrus trees in NE corner of property, looking southwest
