KENTUCKY HISTORIC RESOURCES
Individual Inventory Form

Resource # Be-156
Boone County

1. Name of Resource:
Delph, W.T., House

5. Location:
6180 Rogers Lane
Burlington, KY

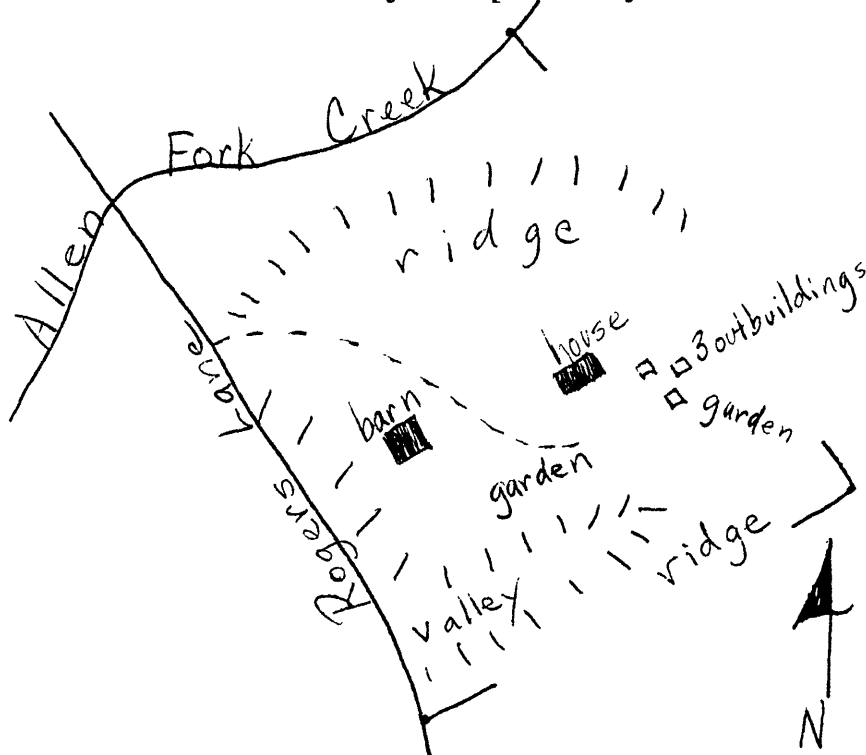
44. Site Plan (and boundary description and justification for N.R. sites):

Beginning at the point where the north bank of Allen Fork intersects with the east side of Rogers Lane (C), proceed along Allen Fork 650' northeastward (D). Then proceed 600' southeast across the ridge (A) turning southwest for 700' to Rogers Lane (B). Then proceed northwest along the east side of Rogers Lane to the point of origin. The boundary polygon includes the farmhouse, all outbuildings and sufficient acreage to provide a setting.

Contributing: 2 buildings (house & barn)
 Noncontributing: 3 buildings

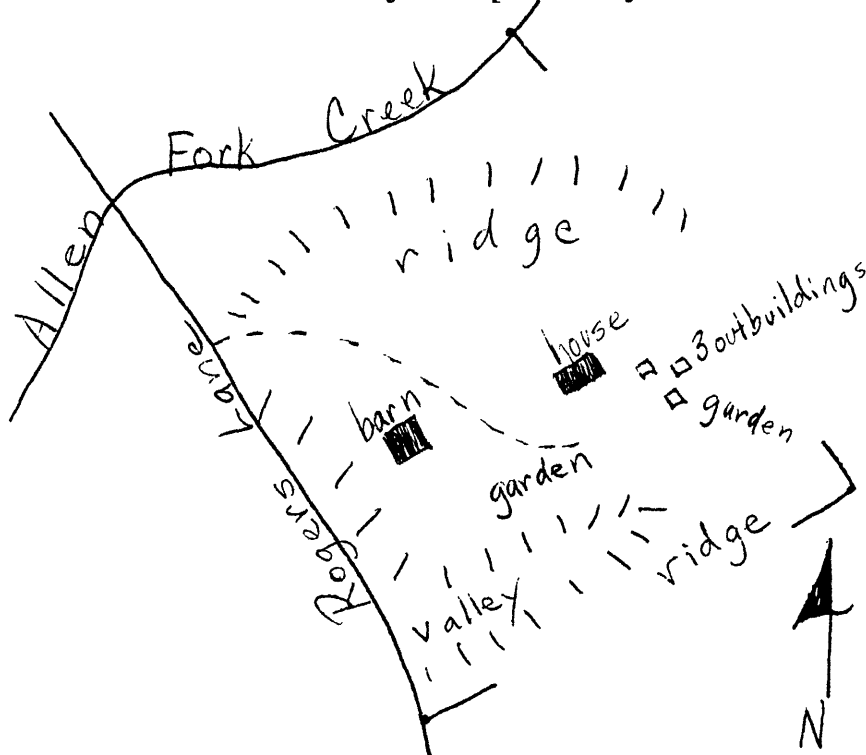
44. Site Plan (and boundary description and justification for N.R. sites):

Beginning at the point where the north bank of Allen Fork intersects with the east side of Rogers Lane (C), proceed along Allen Fork 650' northeastward (D). Then proceed 600' southeast across the ridge (A) turning southwest for 700' to Rogers Lane (B). Then proceed northwest along the east side of Rogers Lane to the point of origin. The boundary polygon includes the farmhouse, all outbuildings and sufficient acreage to provide a setting.

Contributing: 2 buildings (house & barn)
 Noncontributing: 3 buildings
