Casa de Augusto Deberme
calle Benítez Guzmán #7
Vieques, Puerto Rico

General view of main or south facade.

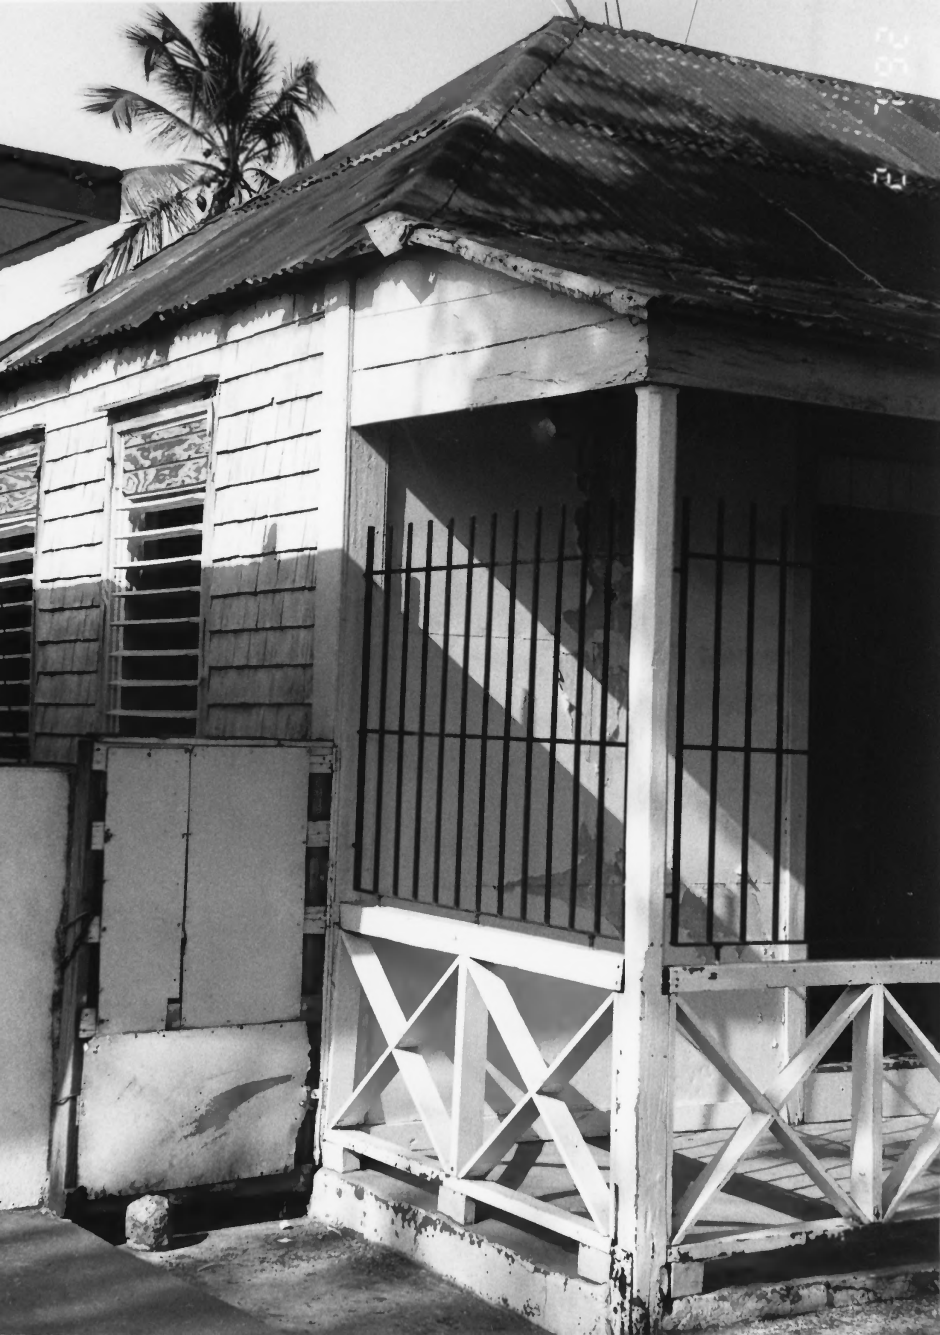
Detail of original "tejamaní" shingles,
cross-rails and roof-line at south-
west corner.
