National Register of Historic Places  
Registration Form

historic name ANDERSON, CHARLES B., HOUSE

**United States Department of the Interior  
National Park Service****National Register of Historic Places  
Continuation Sheet**Section number 7 Page 1**CHARLES B. ANDERSON HOUSE,  
HOLIDAY, PASCO CO., FL****SUMMARY**

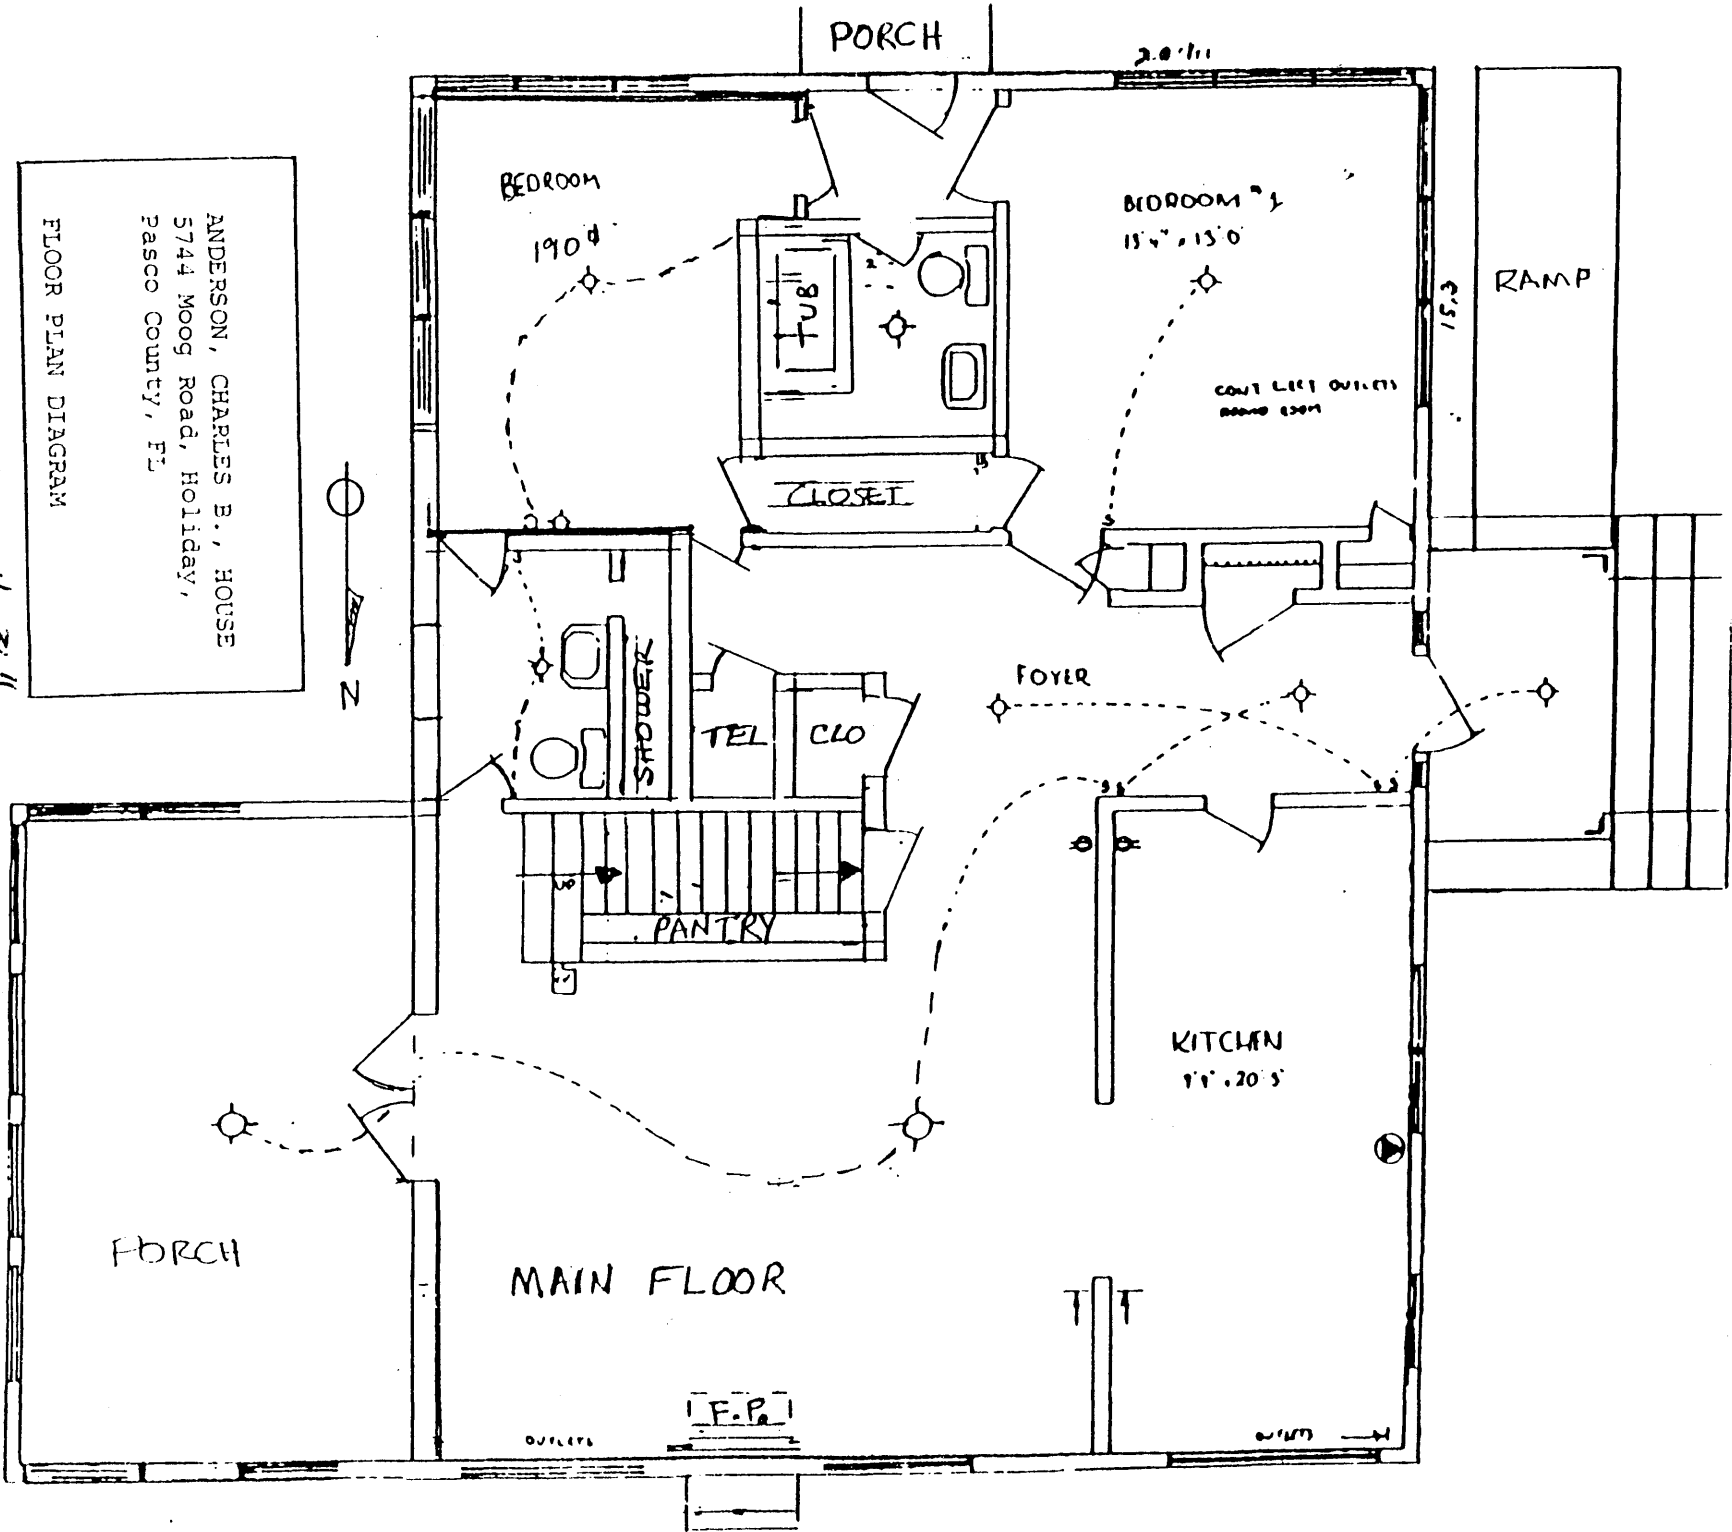
FLOOR PLAN DIAGRAM

ANDERSON, CHARLES B., HOUSE  
5744 Moog Road, Holiday,  
Pasco County, FL

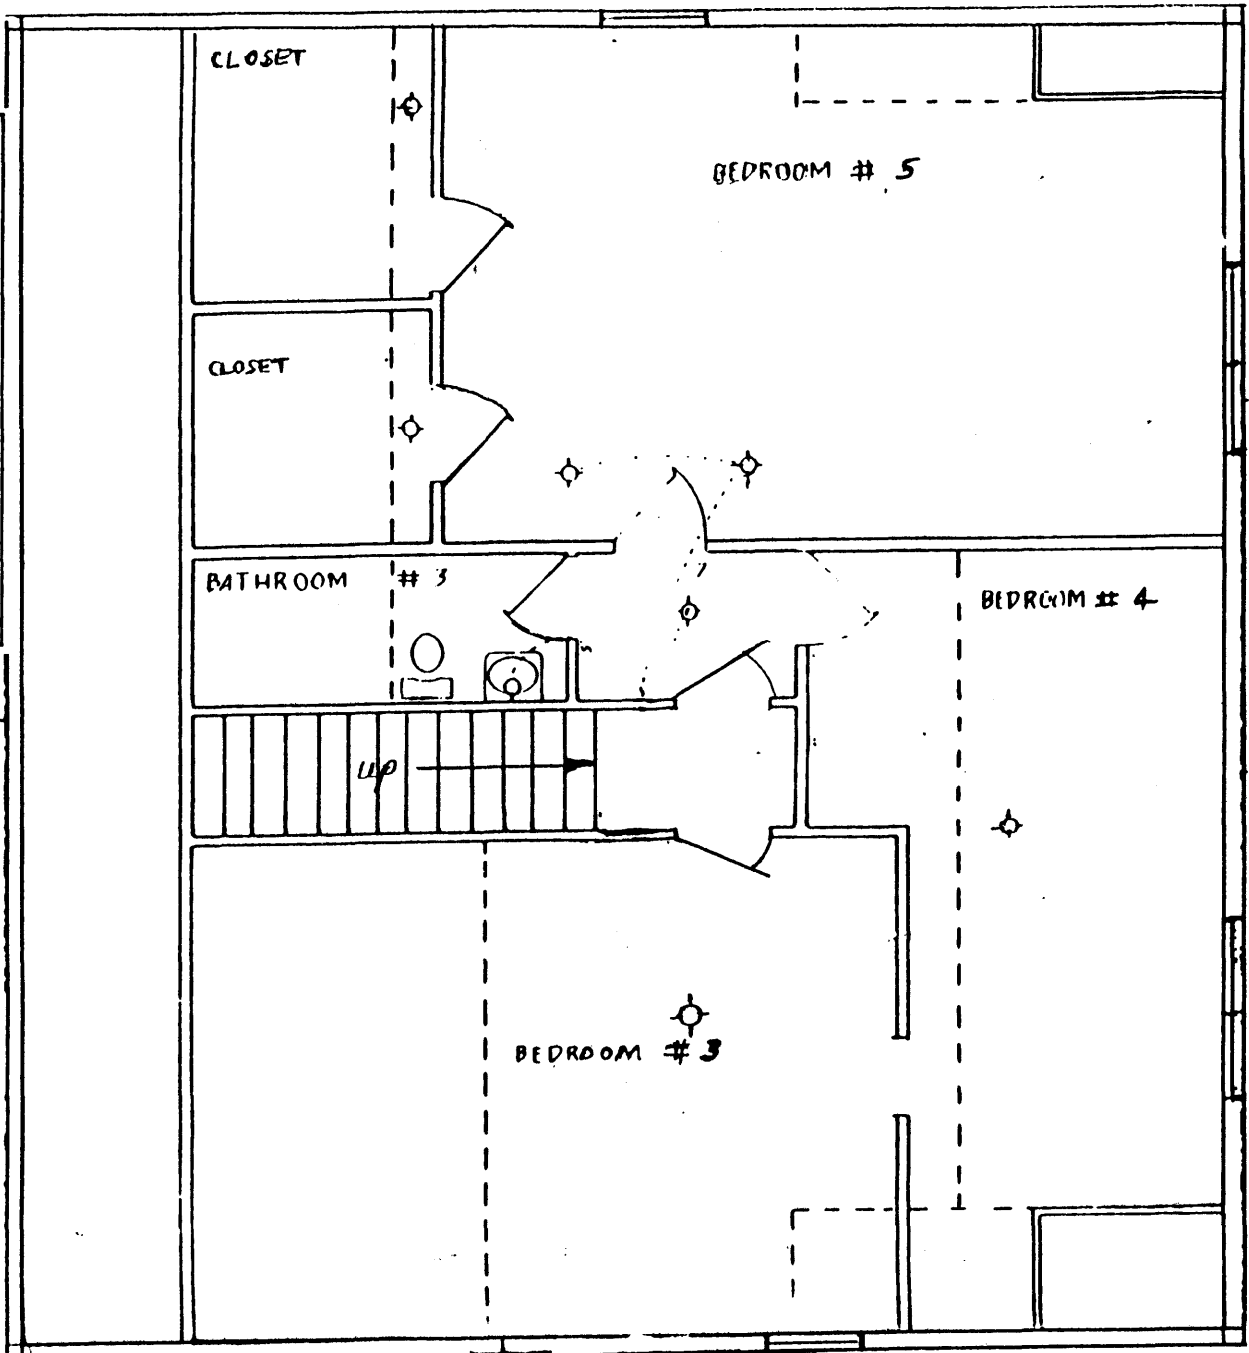
SECOND FLOOR

The wooden stairs in the living room rise to the second floor which historically contained three bedrooms, a bathroom, and two walk-in storage closets. The rooms are currently used for art classes (Photo 12). From a landing at the top of the stairs are two doors, to the north and south, which access the workrooms and bathroom. The room to the south has two storage closets that open off of the east side of the room. One closet has cedar lining.
