HISTORIC PROPERTY INVENTORY FORM

Site No.: 726
Site Name: Historic JOHN BRINING HOUSE
Common _____
Field Recorder: NC/ER
Date Recorded: 11-6-85
Owner's Name: Goldie & Gladys Boldman
Street: 410 N. First
City/Town: Dayton
County: Columbia
Zip Code: 99328

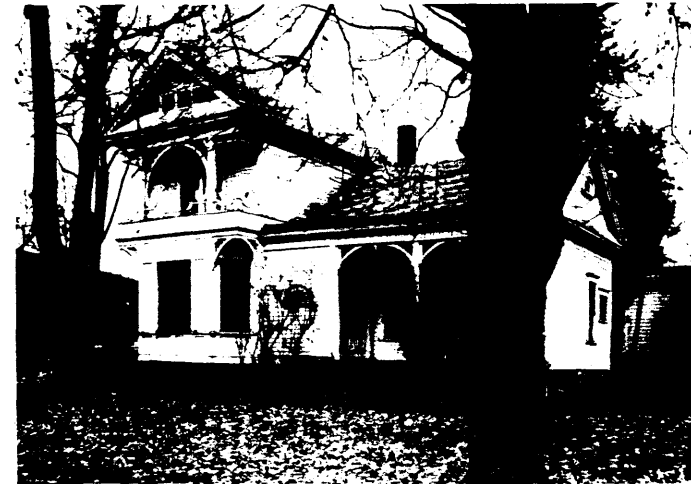
Photography Neg. No.: 7+26
(Roll No. + Frame No.)
View: West facade
Date: 11-6-85

Situated on the banks of Patit Creek on North First on a large corner lot, this tri-gabled ell shaped house has many unique features. The second story of the projecting cutaway bay has a full pediment return with closed eave, pendant in point of gable, dentil and decorative coursing and blue glass chips. There is a plain fascia under this pediment and an open balcony with spindlework frieze, balustrade and horseshoe shaped wooden arch. There are two cutaway bays with spindlework, corner brackets and pendants. The partial front porch has curved wooden brackets forming arches, with pendants in the center and plain square porch supports and small turned balustrades. There are panels of wood slate under the windows in the bay. There is a half round window on main floor and the entry door is the original double glass and paneled door with transom. Most windows are one over one double hung although some are single sash with transom.
