# National Register of Historic Places Registration Form

Historic name: Brown/Koerner House

Other names/site number: William C. Brown Farm; Koerner, Susan House; Weadon Place; DHR No. 053-0342

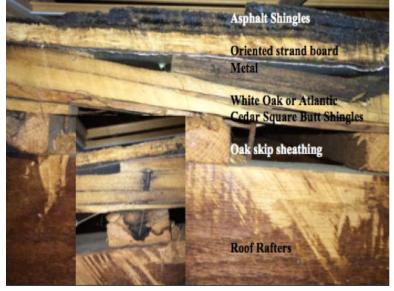
The attic is accessed by another boxed winder staircase located in the second-story hallway. The attic provides phenomenal visuals of the house's construction. With no ridge beam present there are common rafters resting on a false plate connected along the ridge with pegged mortise-and-tenon joinery. Another feature found in the attic is a roof hatch with a circular iron pull. This hatch is now inaccessible and it is likely a later addition based on the wood variation that frames the opening. The ceiling joists are spaced at roughly 20 inches on center. The wood lath attached to the bottom of the joists is supported at mid-point by an intermediate ceiling joist made from rough-cut logs, and the attic floor is sheathed with tongue and groove boards. When the current owners began construction of the 1998 addition, an image of a cross section of the original roof assembly became apparent. The layers include roof rafters at the bottom level, followed by oak skip sheathing, white oak or Atlantic cedar square butt shingles, metal, oriented strand board, and asphalt shingles, as shown below.
