National Register of Historic Places Registration Form

Historic name: Fall River Road (Boundary Increase and Amendment)
Other names/site number: Fall River Road/5LR.885
Name of related multiple property listing: Rocky Mountain National Park Multiple Resource Nomination (1987)
(Enter "N/A" if property is not part of a multiple property listing)

Street & number: Fall River Road, Rocky Mountain National Park (ROMO)
City or town: Estes Park State: Colorado County: Larimer
Not For Publication: Vicinity:

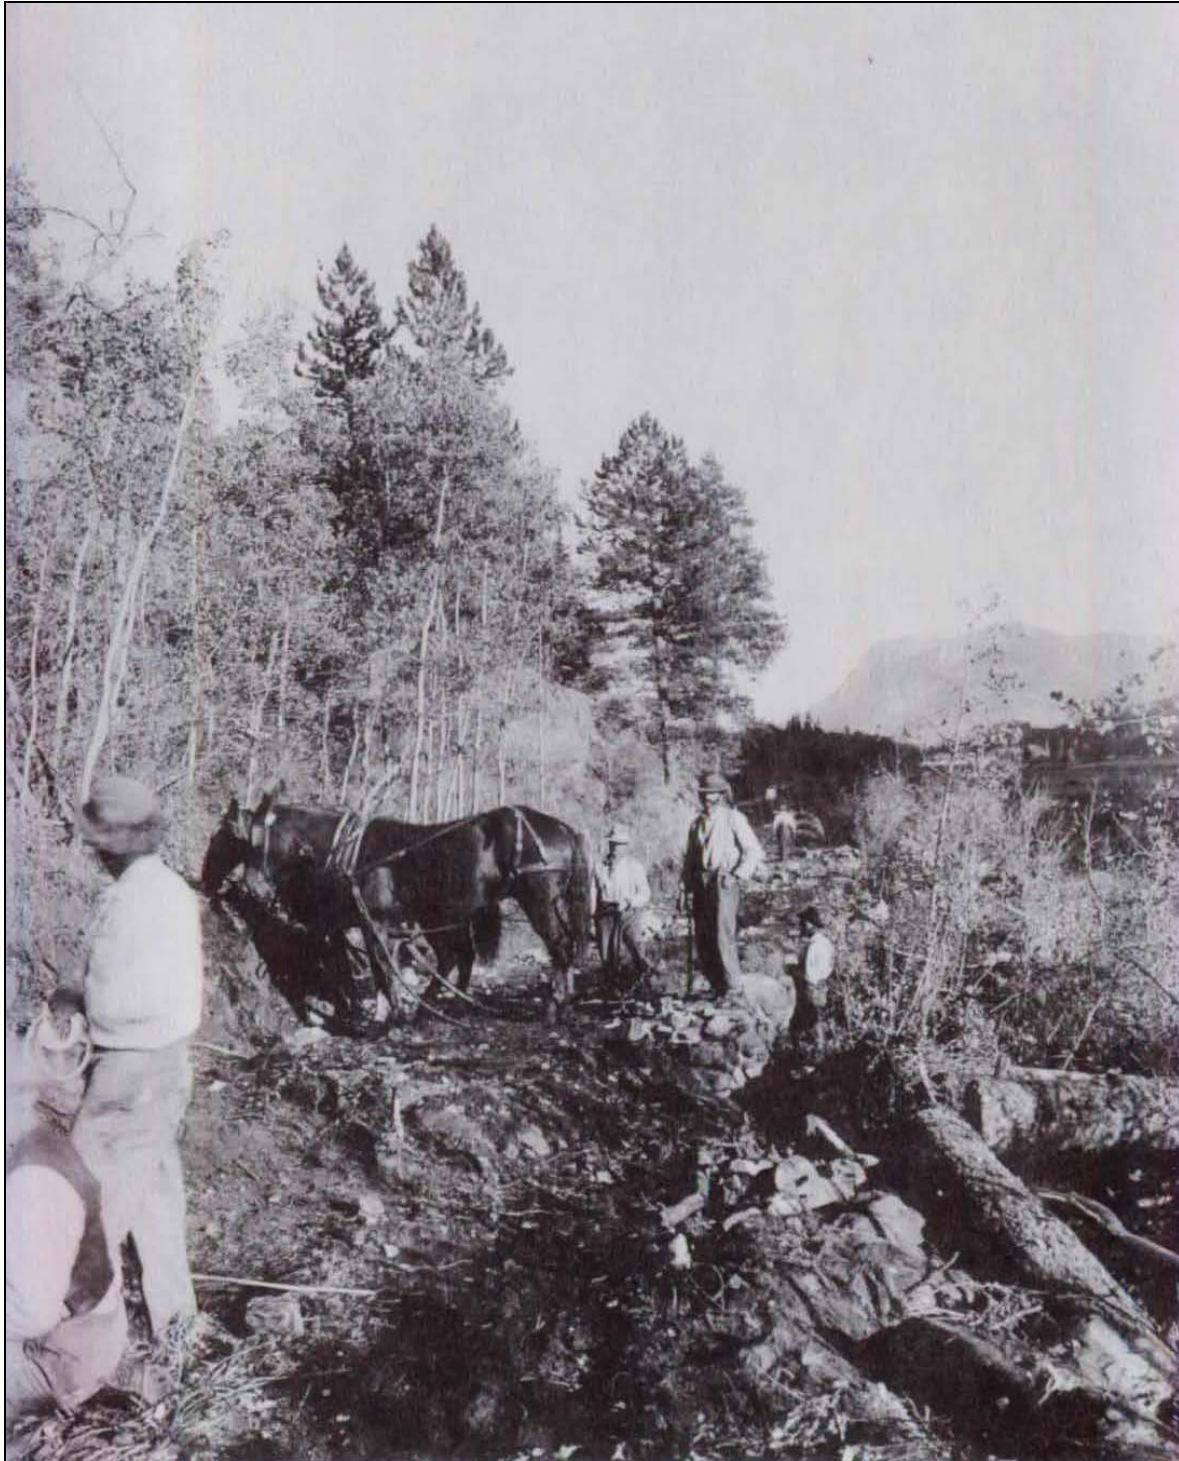
Figure 25. Constructing Fall River Road, c. 1915 (source: W. T. Parke Collection, Rocky Mountain National Park. Reprinted from Fall River Road Historic American Engineering Record CO-73 [Quin 1993a]).

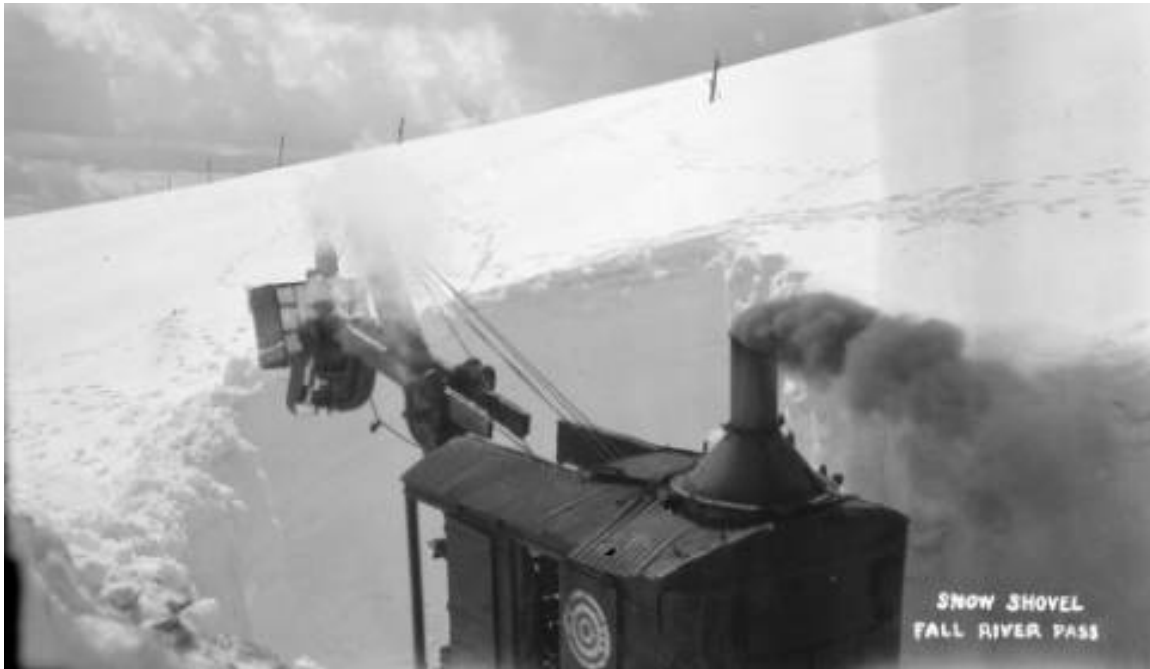
Figure 26. Snow shovel Fall River Pass, June 5, 1928 (source: Accession No. 99.164.21, Call No. CHS.x446, History Colorado, Fred P. Clatworthy Collection, Denver Public Library).

precarious (Quin 1993a). Improvements to the road began in 1921, including enlarging the hairpin turning radii to accommodate busses and the addition of 27 pipe culverts in 1922 (Quin 1993b). However, inclement weather created washouts, deep mud puddles, and rockslides. During the winter months, the route always was covered with snow, and clearing snow and fallen trees in the spring was a massive undertaking (Figure 26). Methods to remove the snow included steam shovels and dynamite (Quin 1993a).

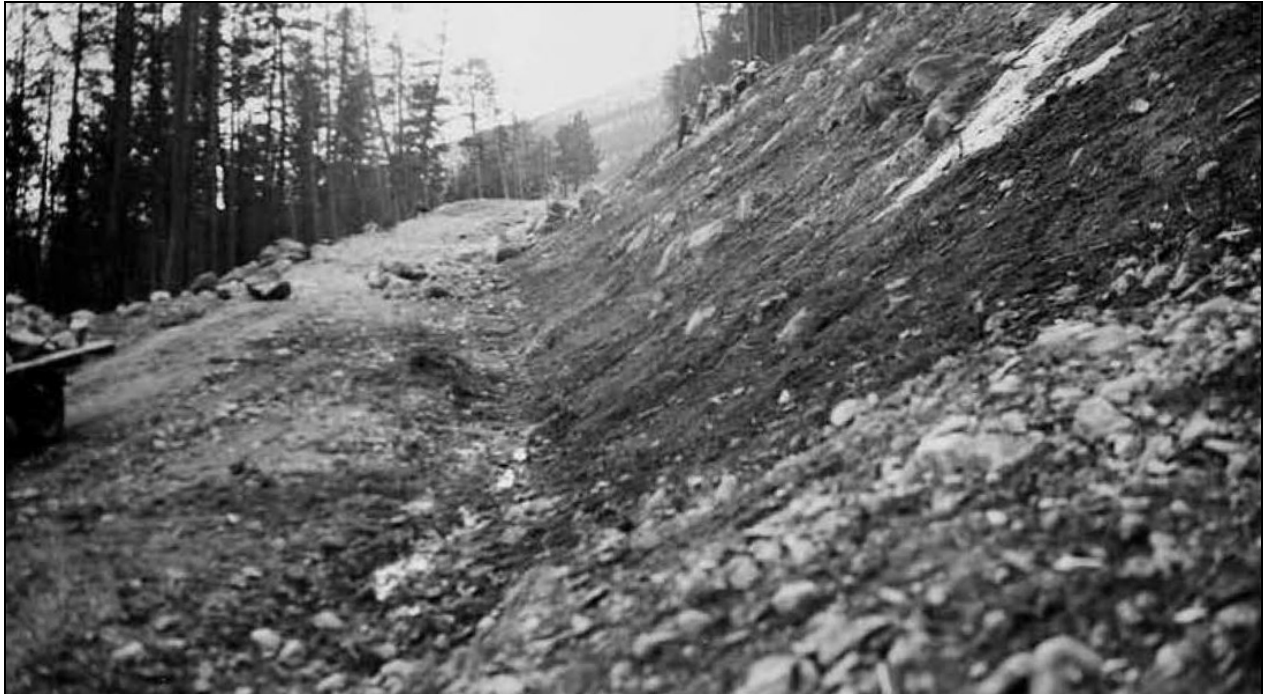
Figure 28. Construction of a new curve of Fall River Road below Horseshoe Park. (source: Superintendent's Monthly Report April 1934 [Rogers 1934a]).

The lower section of Fall River Road from the Fall River Entrance Station to approximately Sheep Lakes underwent improvements from 1929–1932 and incorporated into the Trail Ridge Road (Highway 34A). The Trail Ridge Road was completed and opened to the public in 1932 and became immensely popular as the majority of park visitors arrived through the Fall River Entrance Station, west of Estes Park. A park superintendent's report for October 1933 noted that 47 percent of the park's visitors had made the trip between Estes Park and Grand Lake over the Trail Ridge Road in that year, bypassing Fall River Road (Rogers 1933a). Due to its rising popularity as well as an alteration to the park's eastern boundary, plans were drawn for the realignment and re-grading of Fall River Road between the entrance station and Horseshoe Park (Figure 27). This project involved remediation of a steep grade and a sharp curve (Rogers 1934a); the contractor, Everly and Allison, completed culvert construction and grading for the new alignment along the modified alignment before May 1934 (Figure 28) (Bureau of Public Roads 1930; Rogers 1933b, 1934b).

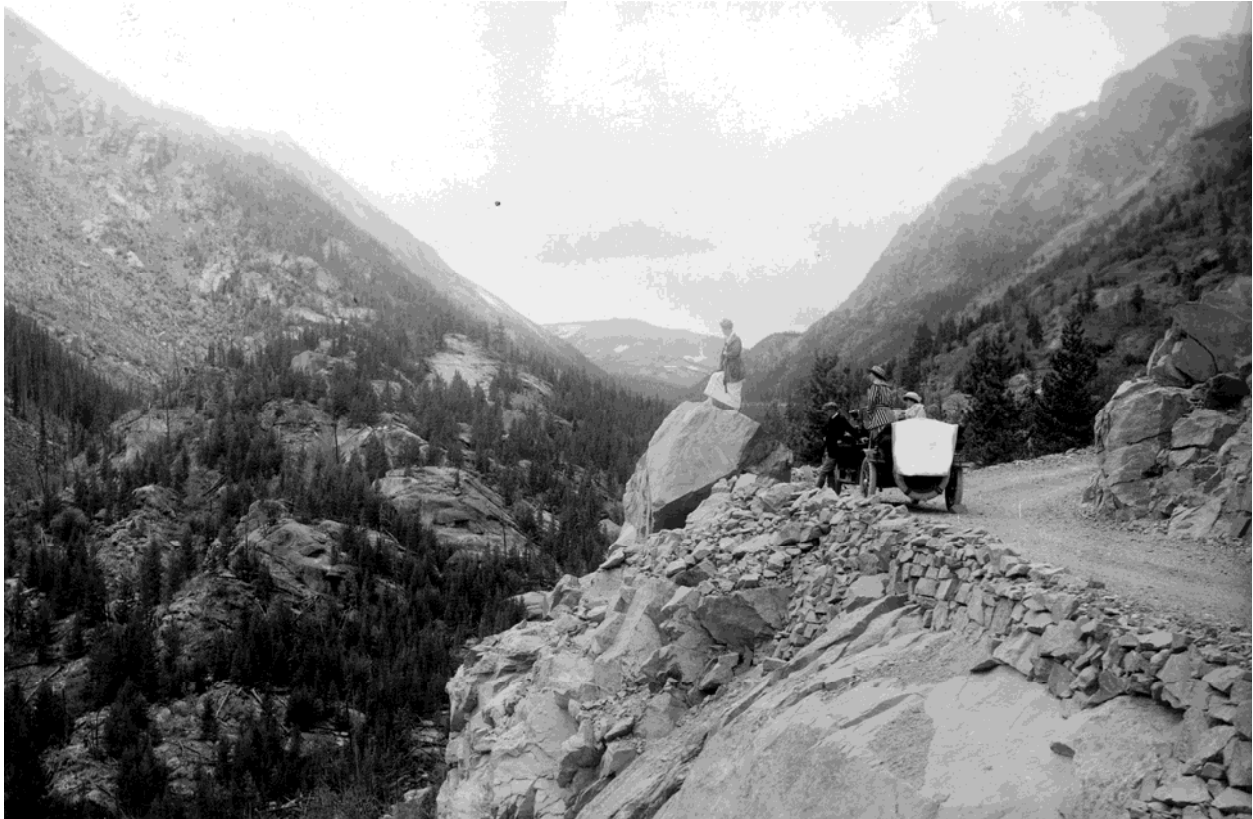
Figure 32. Switchback convict road to Grand Lake, R.M.N.P., 1910–1920 (source: Z-7172, Denver Public Library).

Construction of the road through this terrain was rendered more difficult by the absence of mechanical equipment during the initial construction period of 1913–20. Up to 38 convict laborers completed the first 3 miles of the road, stopping work at Chasm Falls (MP 10.5). The State of Colorado issued contracts to private companies that hired crews of 50–60 workers to complete the road, but found it difficult to keep employees. The extremely harsh conditions at higher elevations and limited seasonal work made the task very difficult and protracted (Figure 32).

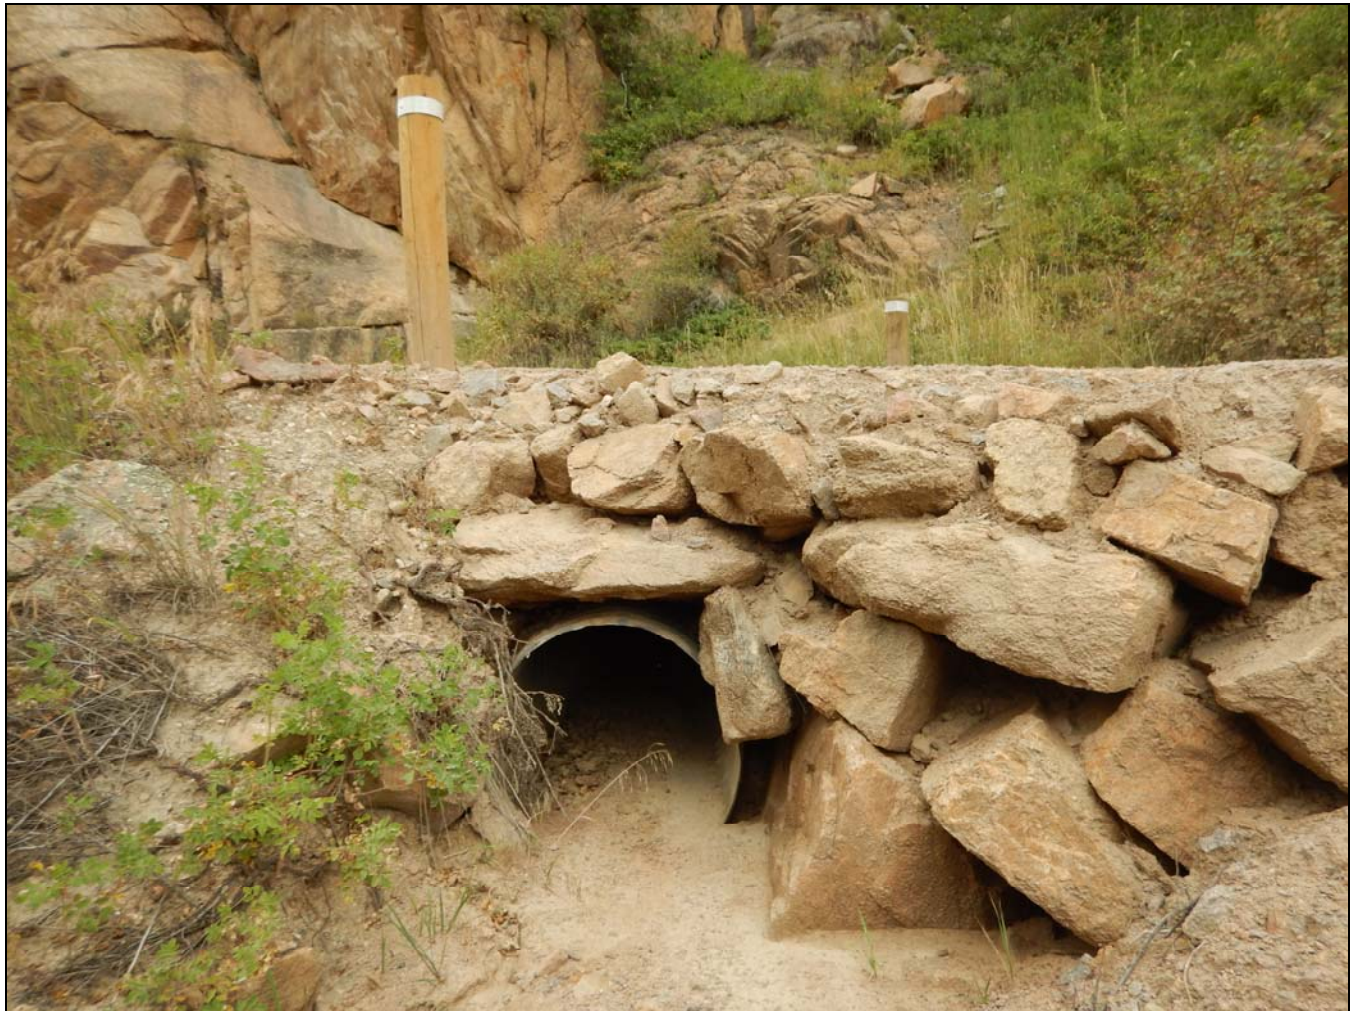
Photograph 1. Corrugated pipe culvert, camera facing northeast.
CO_LarimerCounty_Fall River Road_Amendment_Boundary Increase_Rocky
Mountain National Park MRA_0001

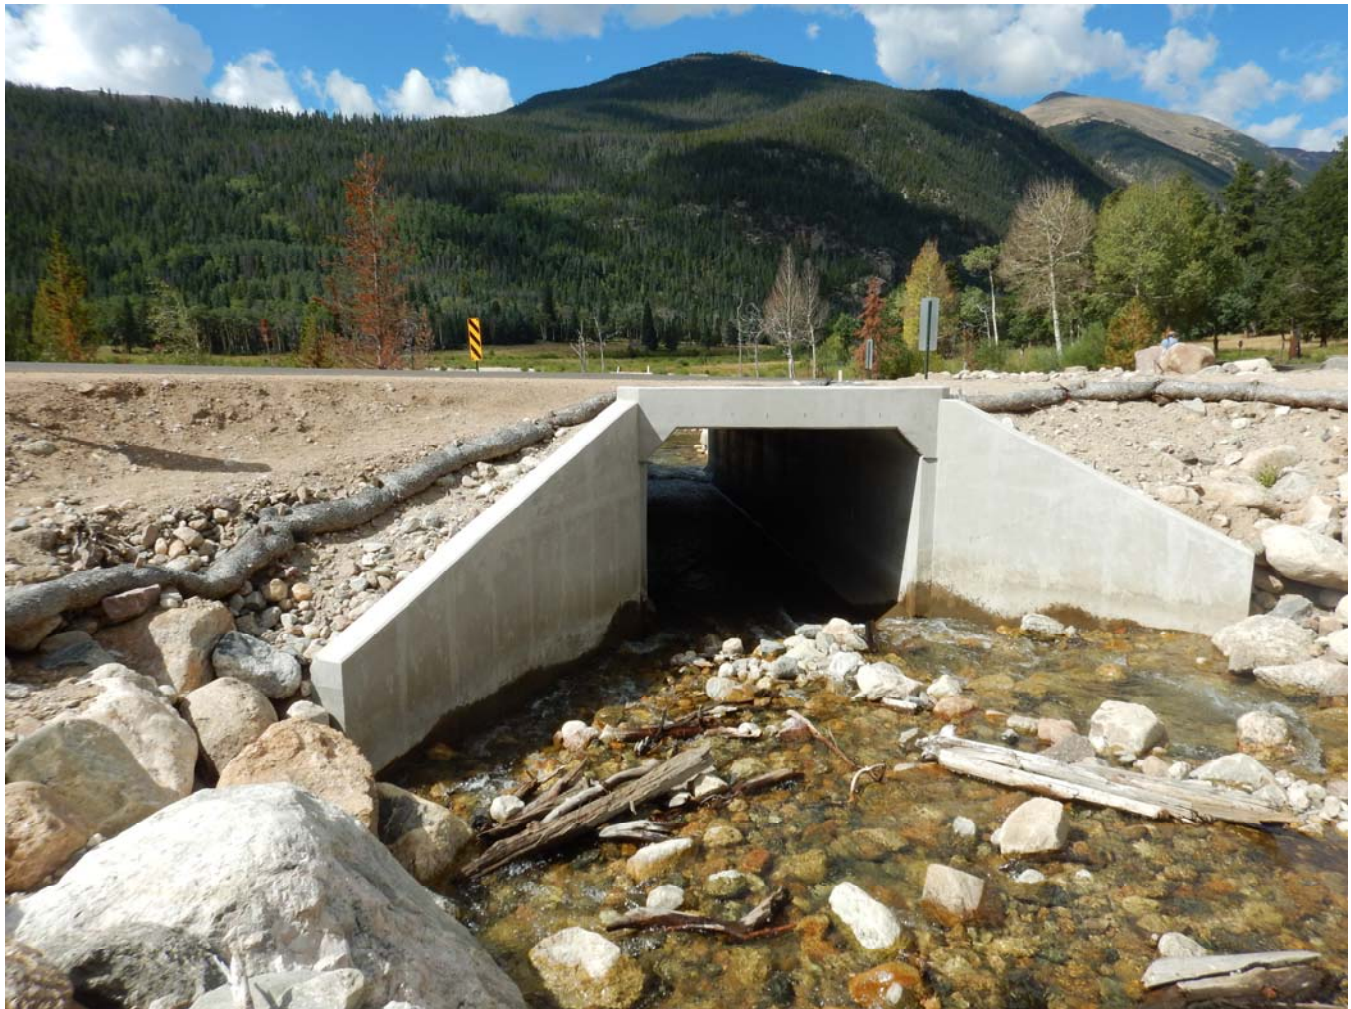
Photograph 2. Concrete box culvert, camera facing east.
CO_LarimerCounty_Fall River Road_Amendment_Boundary Increase_Rocky
Mountain National Park MRA_0002

^d The concrete box culvert is known as the Roaring River Bridge or Alluvial Fan Bridge.

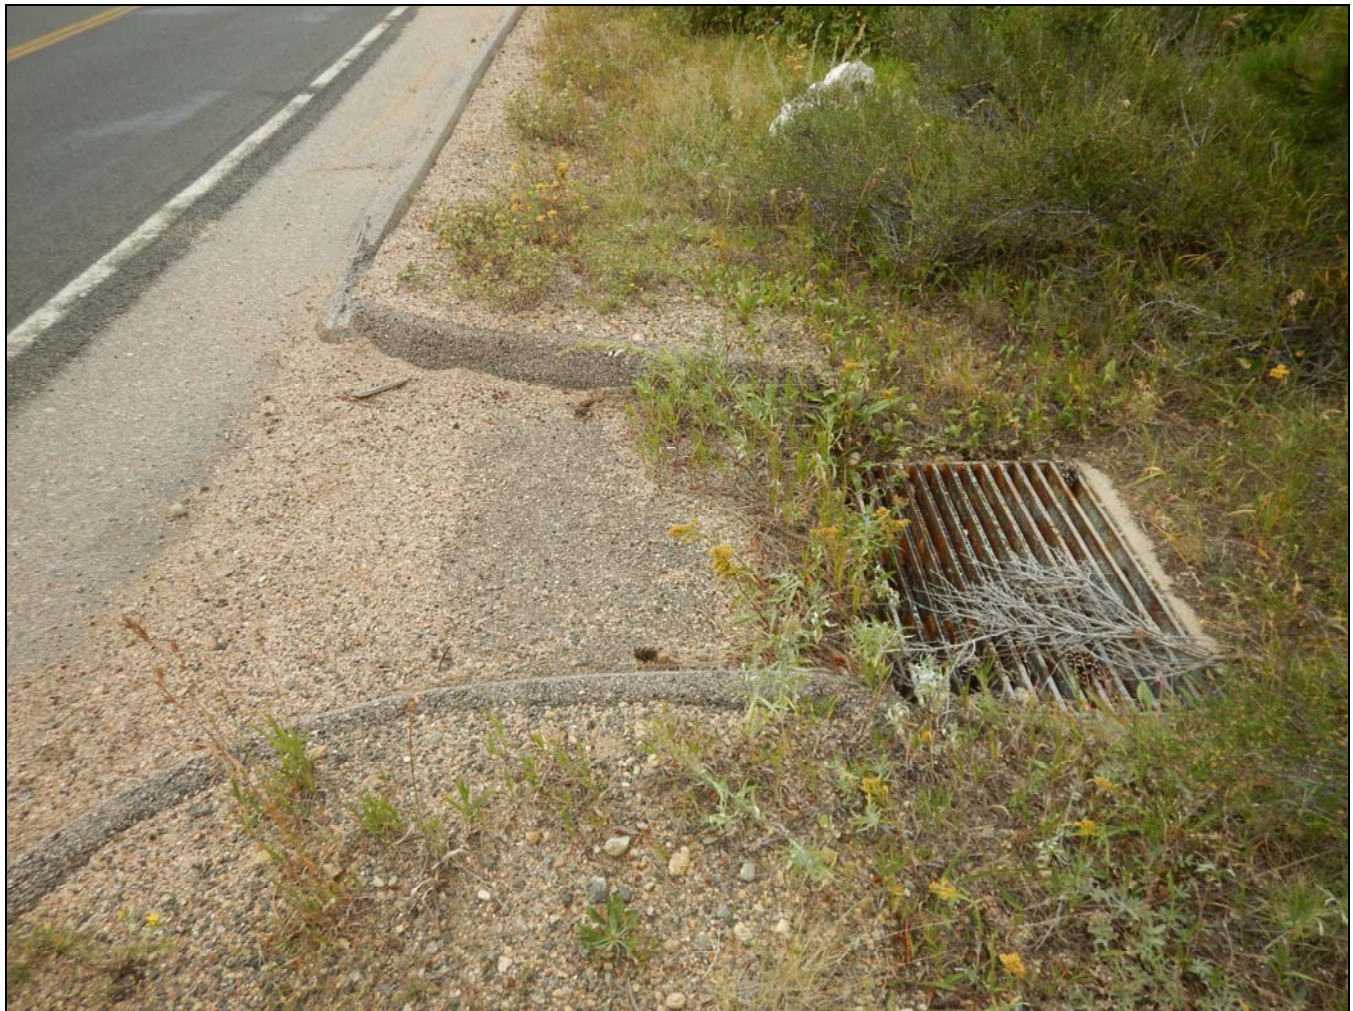
Photograph 3. Gutter/spillway, camera facing northeast.
CO_LarimerCounty_Fall River Road_Amendment_Boundary Increase_Rocky
Mountain National Park MRA_0003

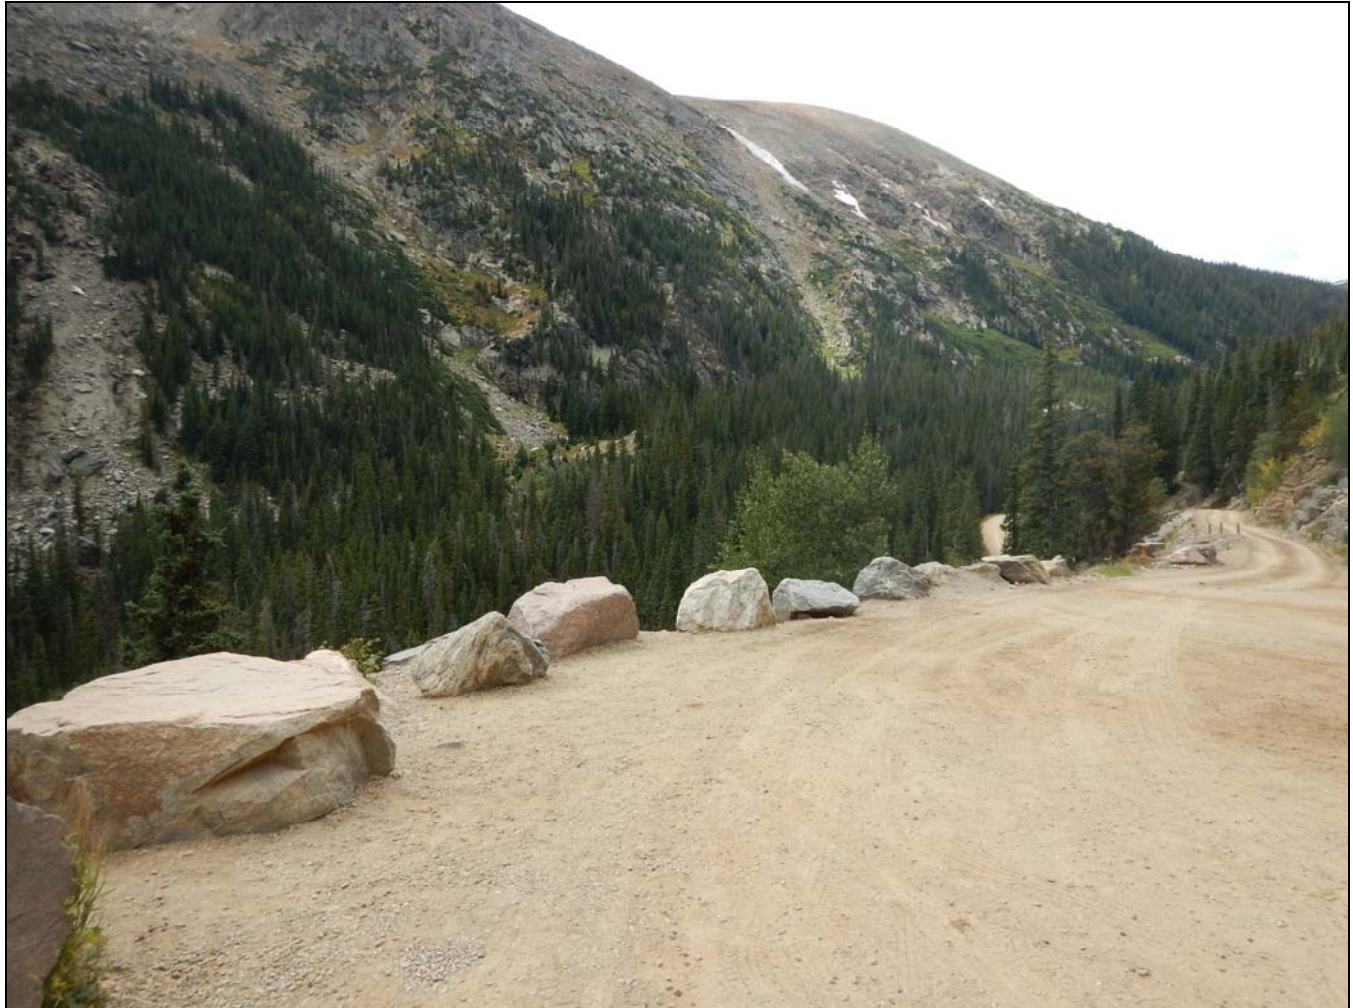
Boulders used as curbing (1913–1968) line the edges of parking areas and serve as traffic barriers, and are representative of NPS-Rustic style (Table 1-Map Nos. 120 and 156; Figure 12 and Figure 5; Meinecke 1937). Boulders used as barriers measure approximately 2' long x 3' wide, or greater, and consist of unmodified local rock (Photograph 4). Two segments of boulder curbing are contributing features located along both paved and unpaved sections of the road.

Photograph 4. Boulder curbing, camera facing southwest.
CO_LarimerCounty_Fall River Road_Amendment_Boundary Increase_Rocky
Mountain National Park MRA_0004

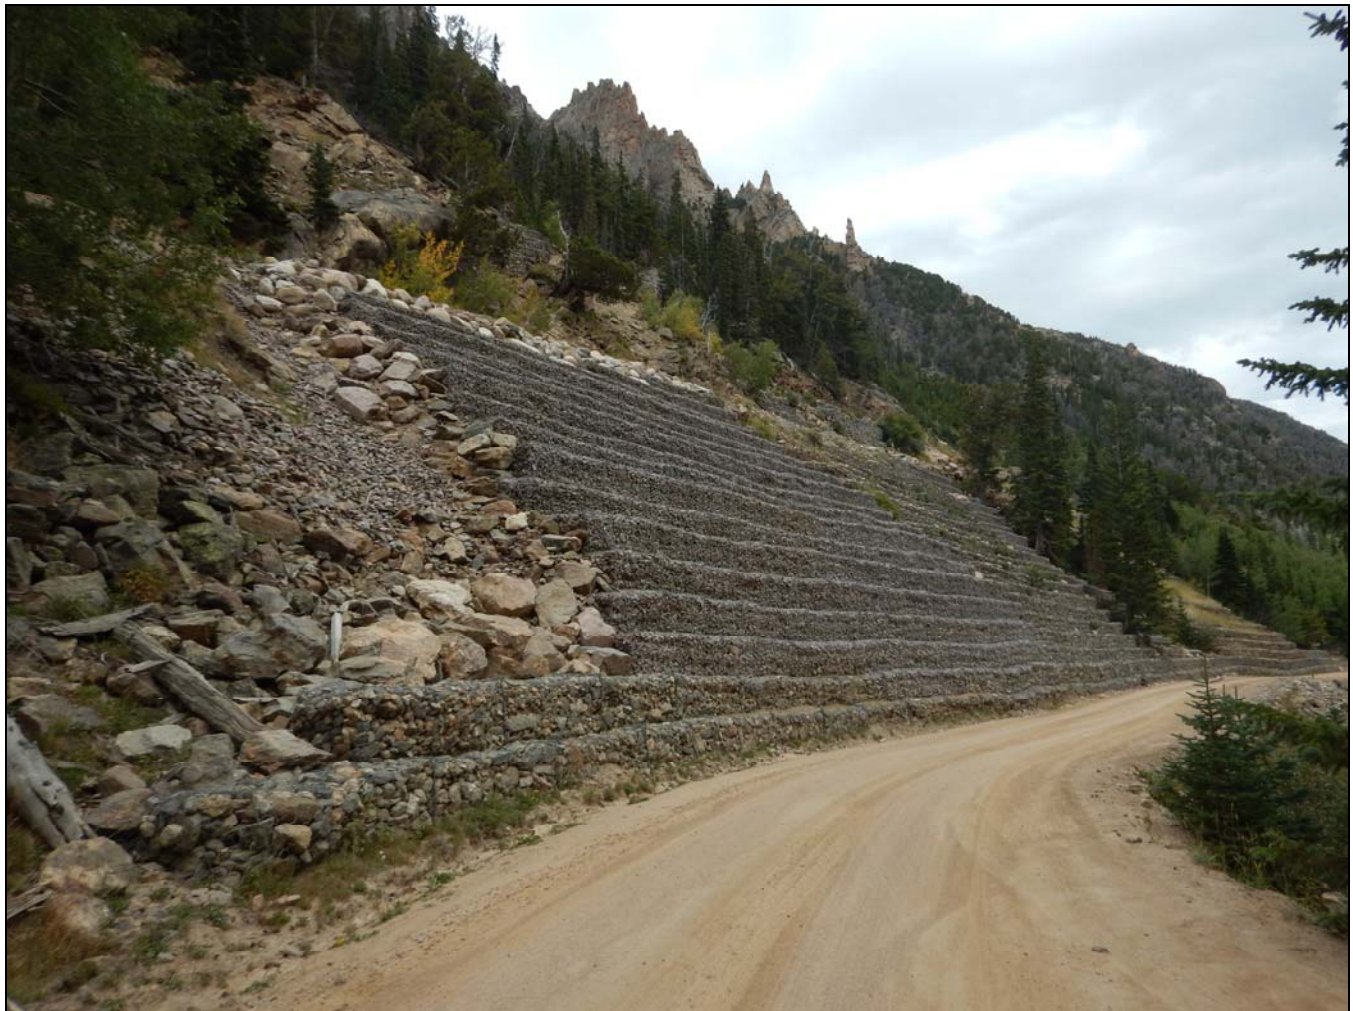
Of the four gabions present along the roadway, only one of them is contributing as it was constructed in 1968 to replace an earlier retaining wall. The gabion wall helps to stabilize exceptionally steep sections of the road along Mount Chapin's southern flank (subalpine forest zone), between adjoining switchbacks at approximately 10,000' elevation (Photograph 5, Table 1, Map No. 78, Figure 6).

Photograph 5. Gabion, camera facing north.
CO_LarimerCounty_Fall River Road_Amendment_Boundary Increase_Rocky
Mountain National Park MRA_0005

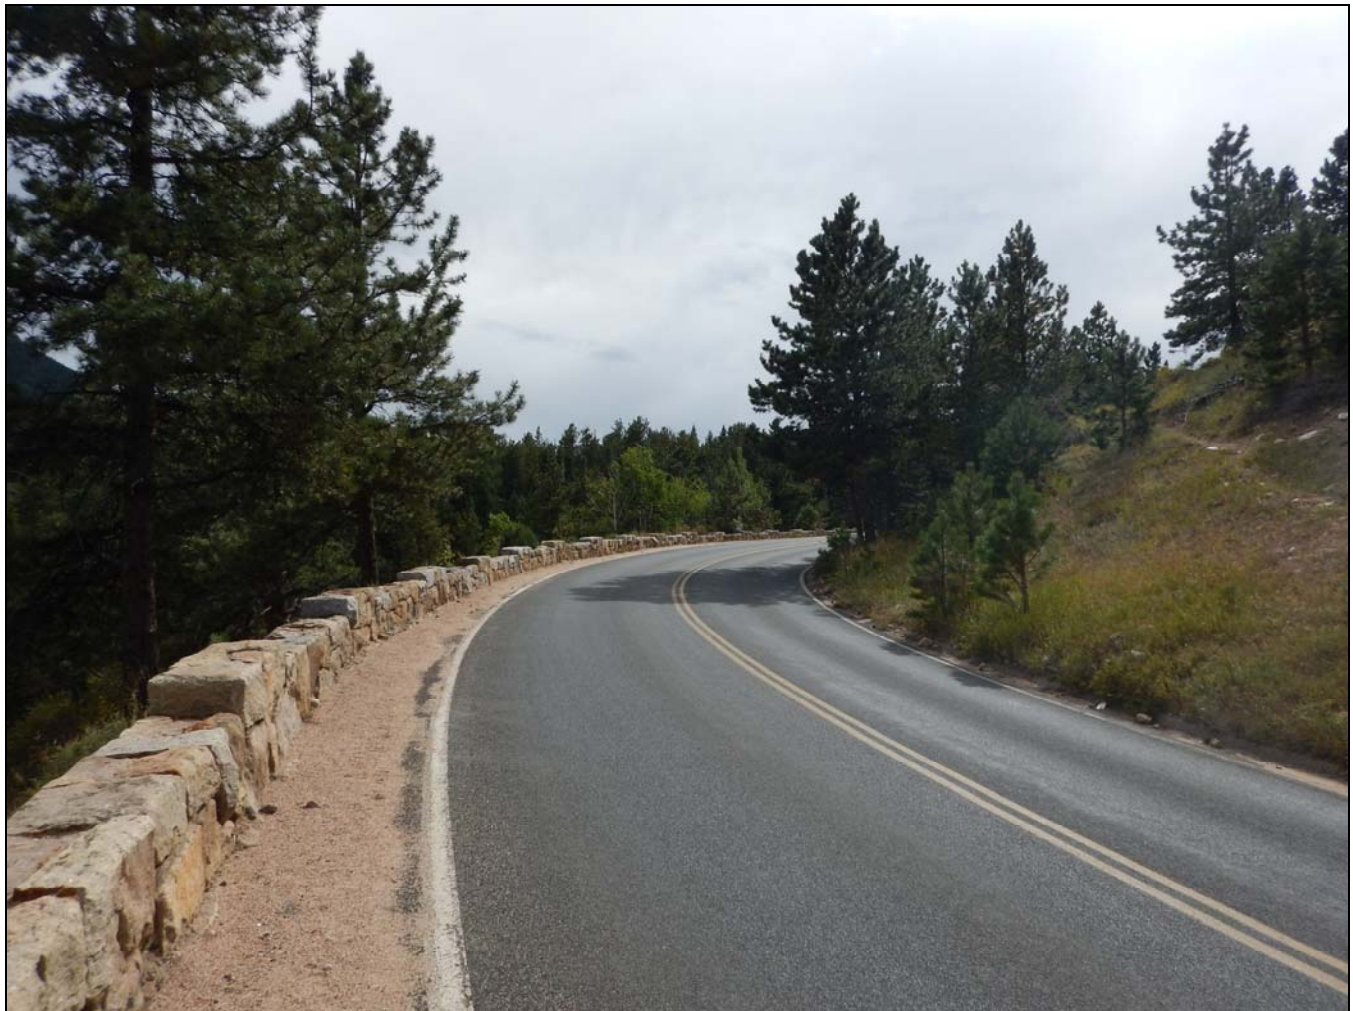
Photograph 6. Guard wall, camera facing south.
CO_LarimerCounty_Fall River Road_Amendment_Boundary Increase_Rocky
Mountain National Park MRA_0006

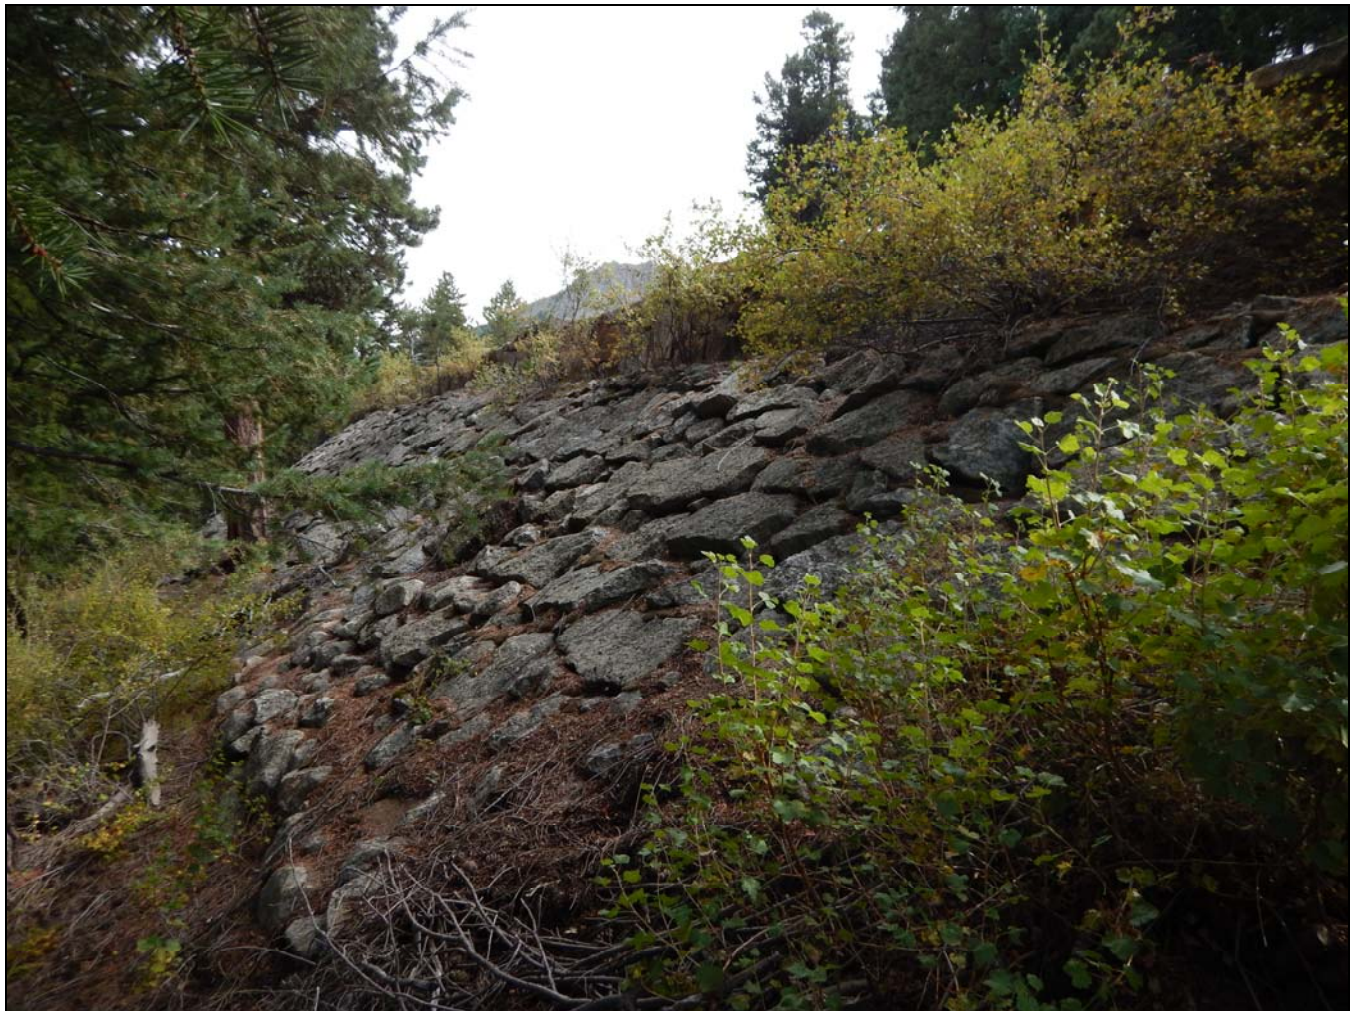
Photograph 7. Guard wall revetment, camera facing southwest. CO_LarimerCounty_Fall River Road_Amendment_Boundary Increase_Rocky Mountain National Park MRA_0007

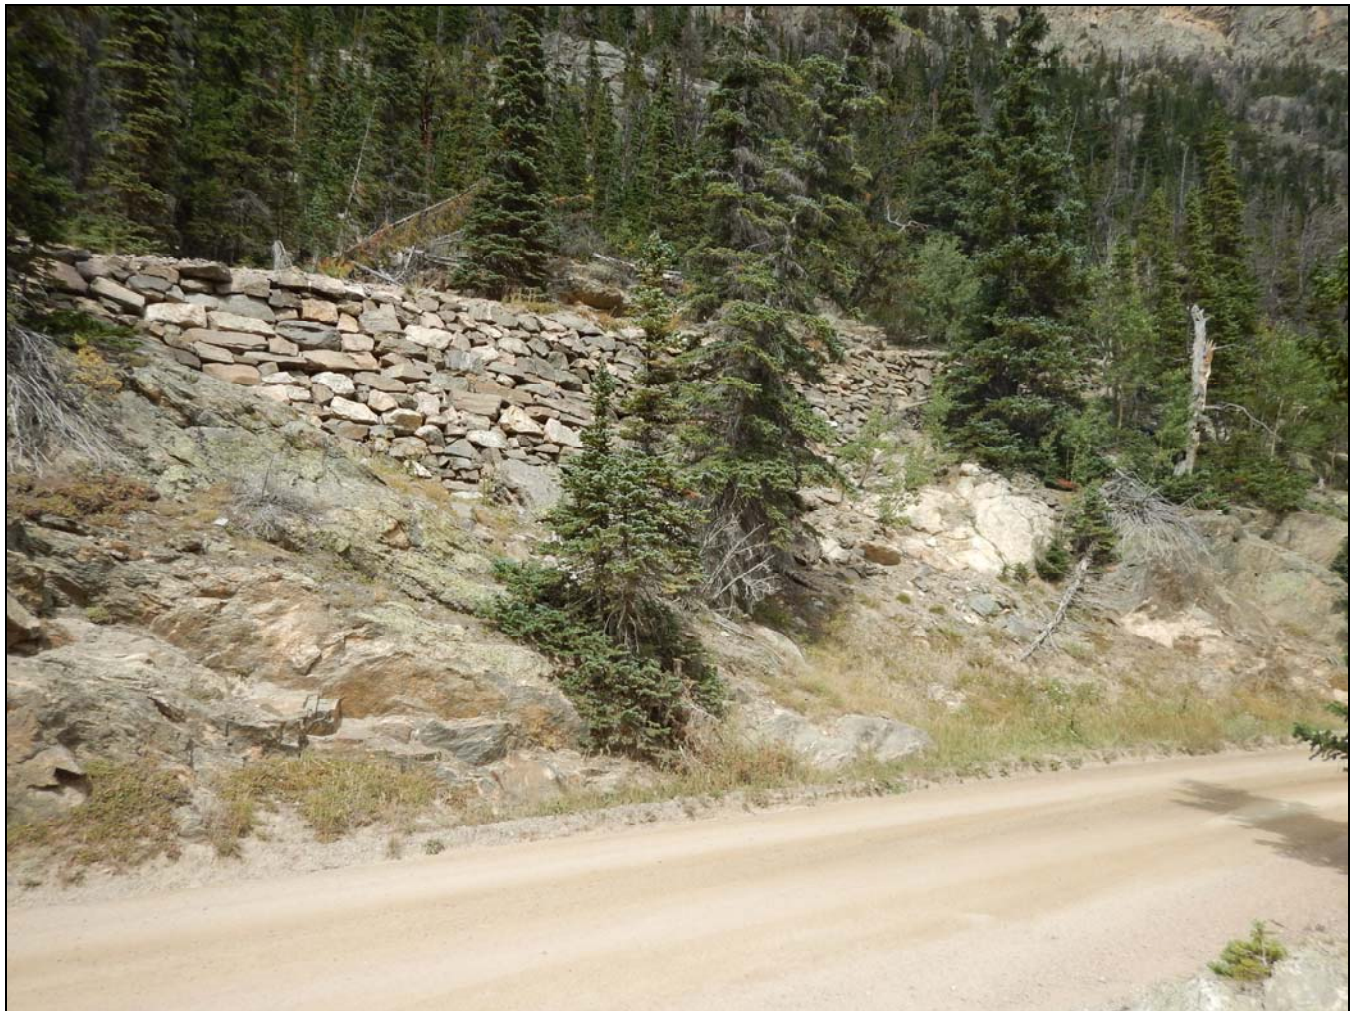
Photograph 8. Retaining wall, camera facing southeast.
CO_LarimerCounty_Fall River Road_Amendment_Boundary Increase_Rocky
Mountain National Park MRA_0008

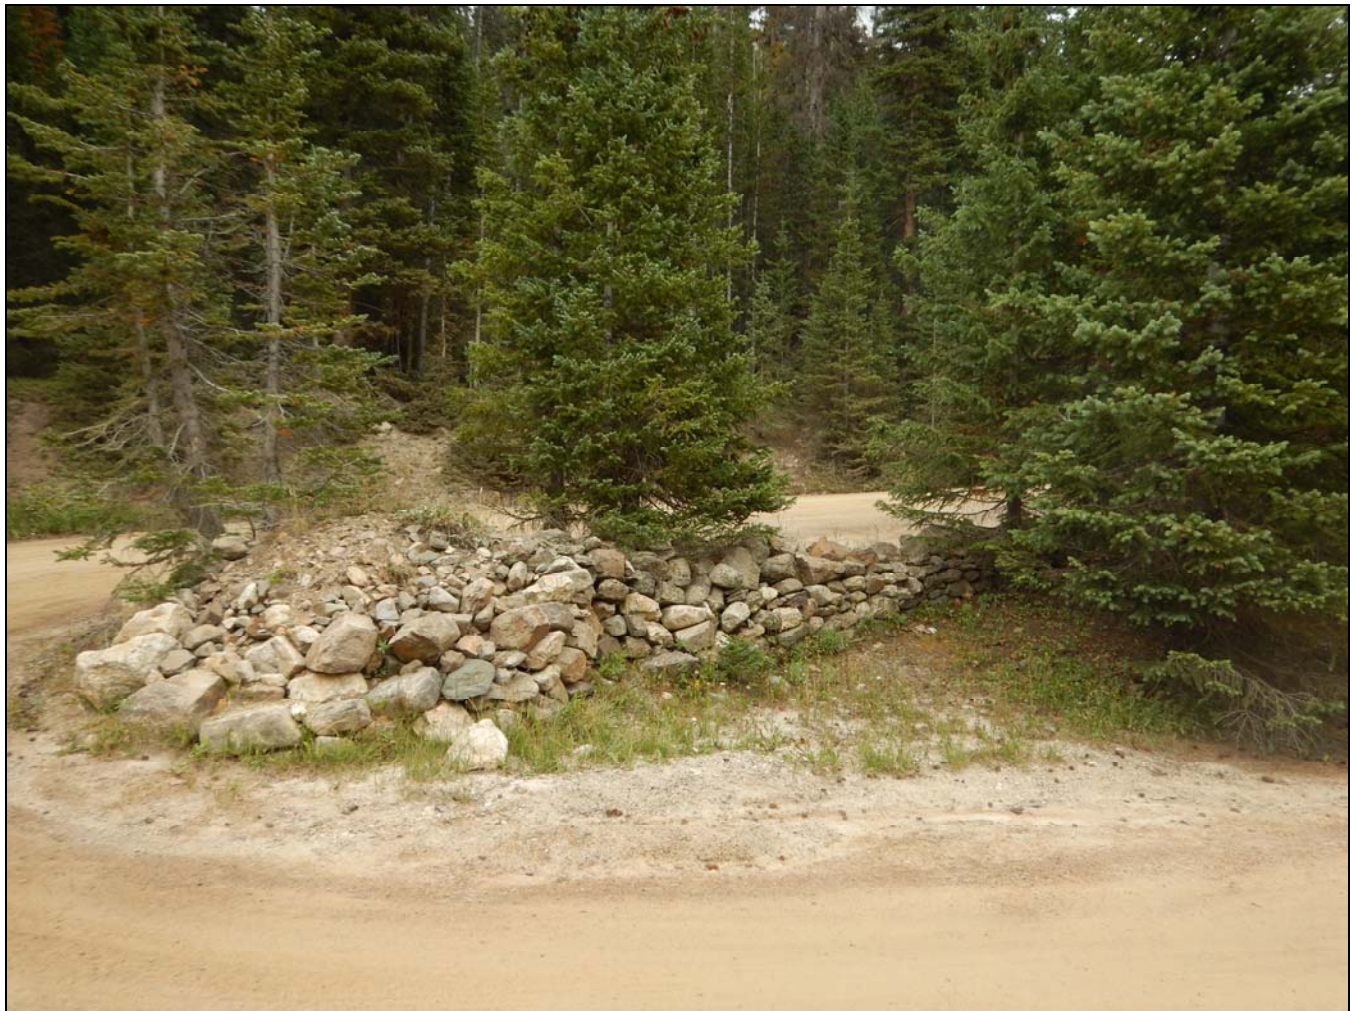
Four rock buttresses are situated on the inside curve of hairpin/switchback curves and are composed of cobbles and boulders attached to lengths of low walls (Table 1-Map Nos. 55, 58, 75, and 149; Figure 3, Figure 4, Figure 5, and Figure 8). The buttresses are dry-stacked with native angular rock that range in size from 2 to 3' tall with walls and 10 to 15' long (Photograph 9). The hairpin/switchback curves have been enlarged and re-engineered, possibly altering the original condition of the rock buttresses. Although the exact construction dates for the current

Photograph 9. Rock buttress, camera facing east.
CO_LarimerCounty_Fall River Road_Amendment_Boundary Increase_Rocky
Mountain National Park MRA_0009

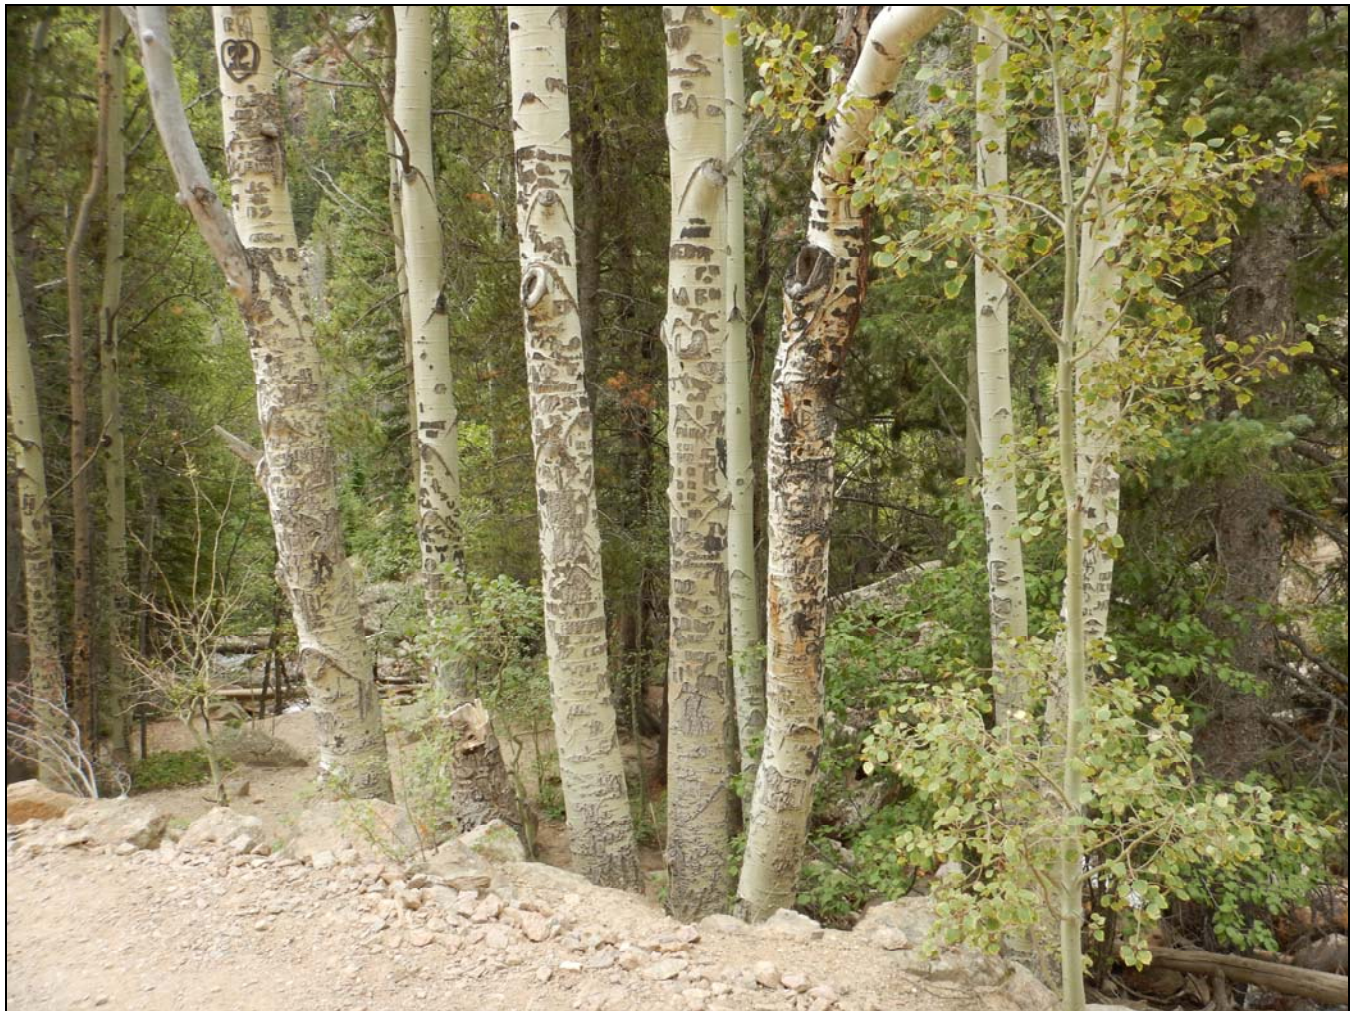
Photograph 10. Arborglyphs, camera facing south.
CO_LarimerCounty_Fall River Road_Amendment_Boundary Increase_Rocky
Mountain National Park MRA_0010

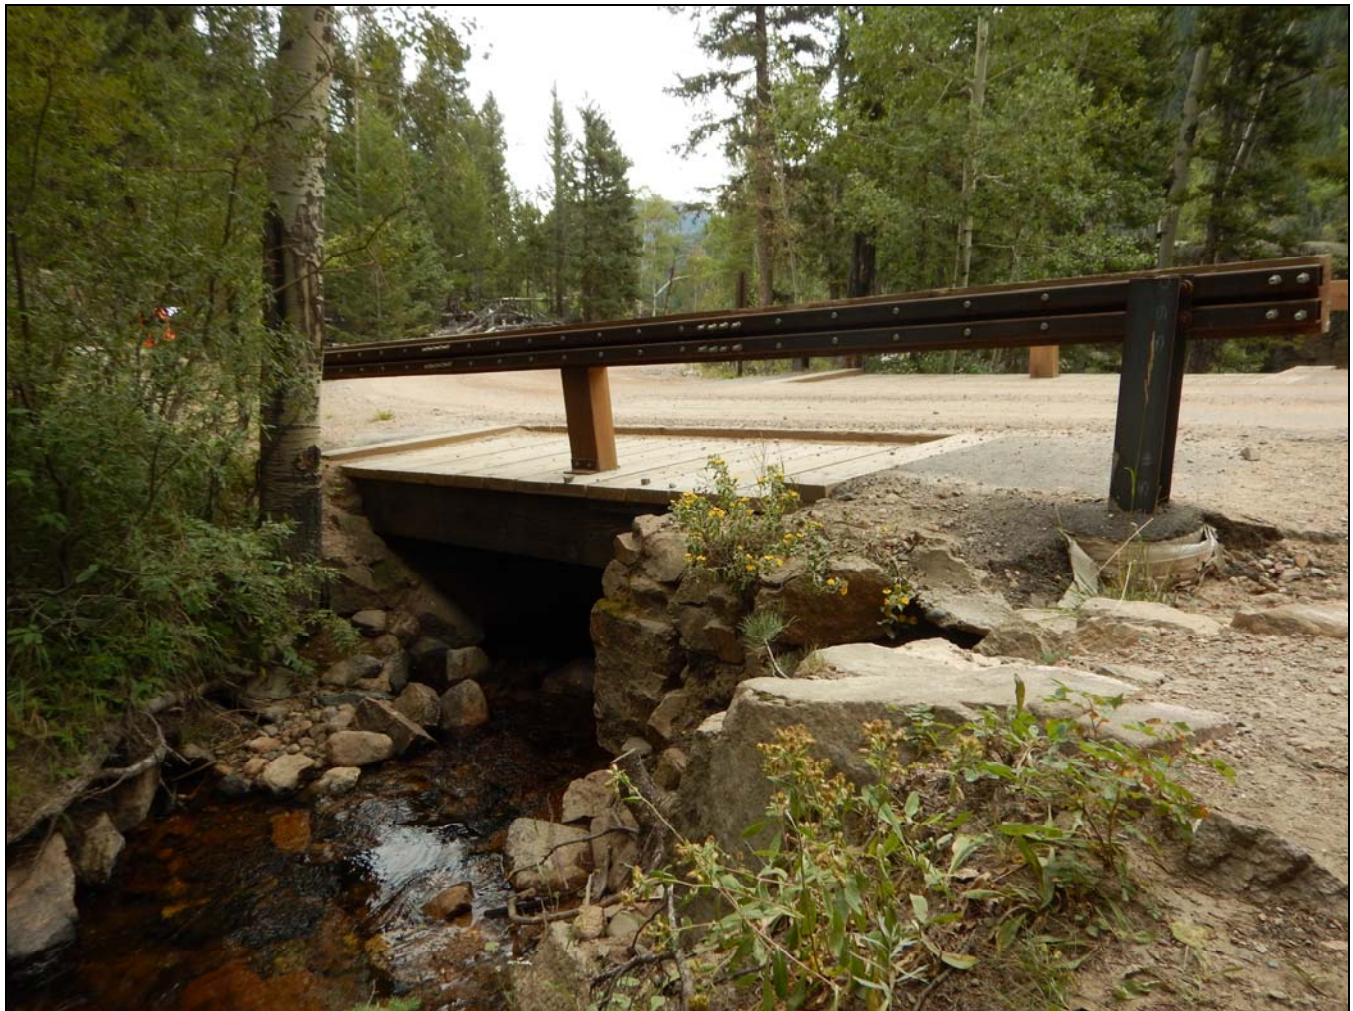
Photograph 11. Roaring River Bridge, camera facing southeast.
CO_LarimerCounty_Fall River Road_Amendment_Boundary Increase_Rocky
Mountain National Park MRA_0011

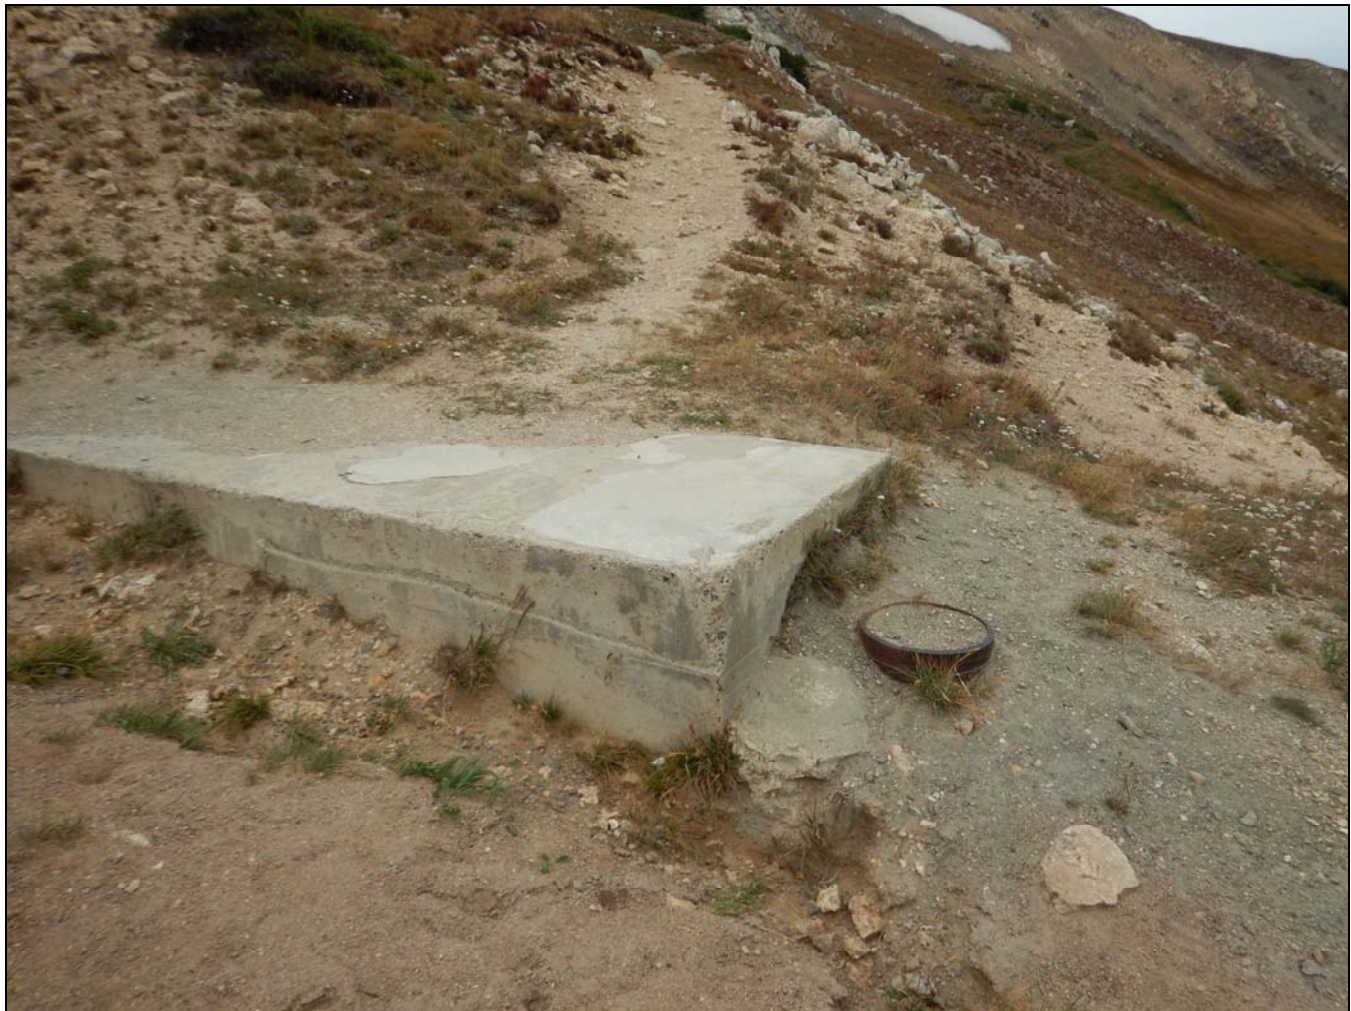
A cast-in-place concrete pad is located on the western edge of the road (MP 3.7), approximately ¼ mile below the summit at Fall River Pass in the alpine tundra zone (Table 1-Map No. 20; Figure 2). The concrete pad measures more than 8" thick by 8' long by 3' wide and has an unknown age of construction. The concrete surface is slightly weathered and has a damaged surface and repairs/patches; it is an unremarkable example of construction and, unlike other elements of the roadway, does not incorporate native materials. A possible wellhead pipe is located immediately south of the concrete pad (Photograph 12). The wellhead pipe is abandoned. The concrete pad and wellhead are small-scale features, likely postdating 1968, the end of the period of significance.

Photograph 12. Concrete pad/wellhead, camera facing west.
CO_LarimerCounty_Fall River Road_Amendment_Boundary Increase_Rocky
Mountain National Park MRA_0012
