National Register of Historic Places Registration Form

Historic name: Fall River Road (Boundary Increase and Amendment)
Other names/site number: Fall River Road/5LR.885
Name of related multiple property listing: Rocky Mountain National Park Multiple Resource Nomination (1987)
(Enter "N/A" if property is not part of a multiple property listing)

Street & number: Fall River Road, Rocky Mountain National Park (ROMO)
City or town: Estes Park State: Colorado County: Larimer
Not For Publication: Vicinity:

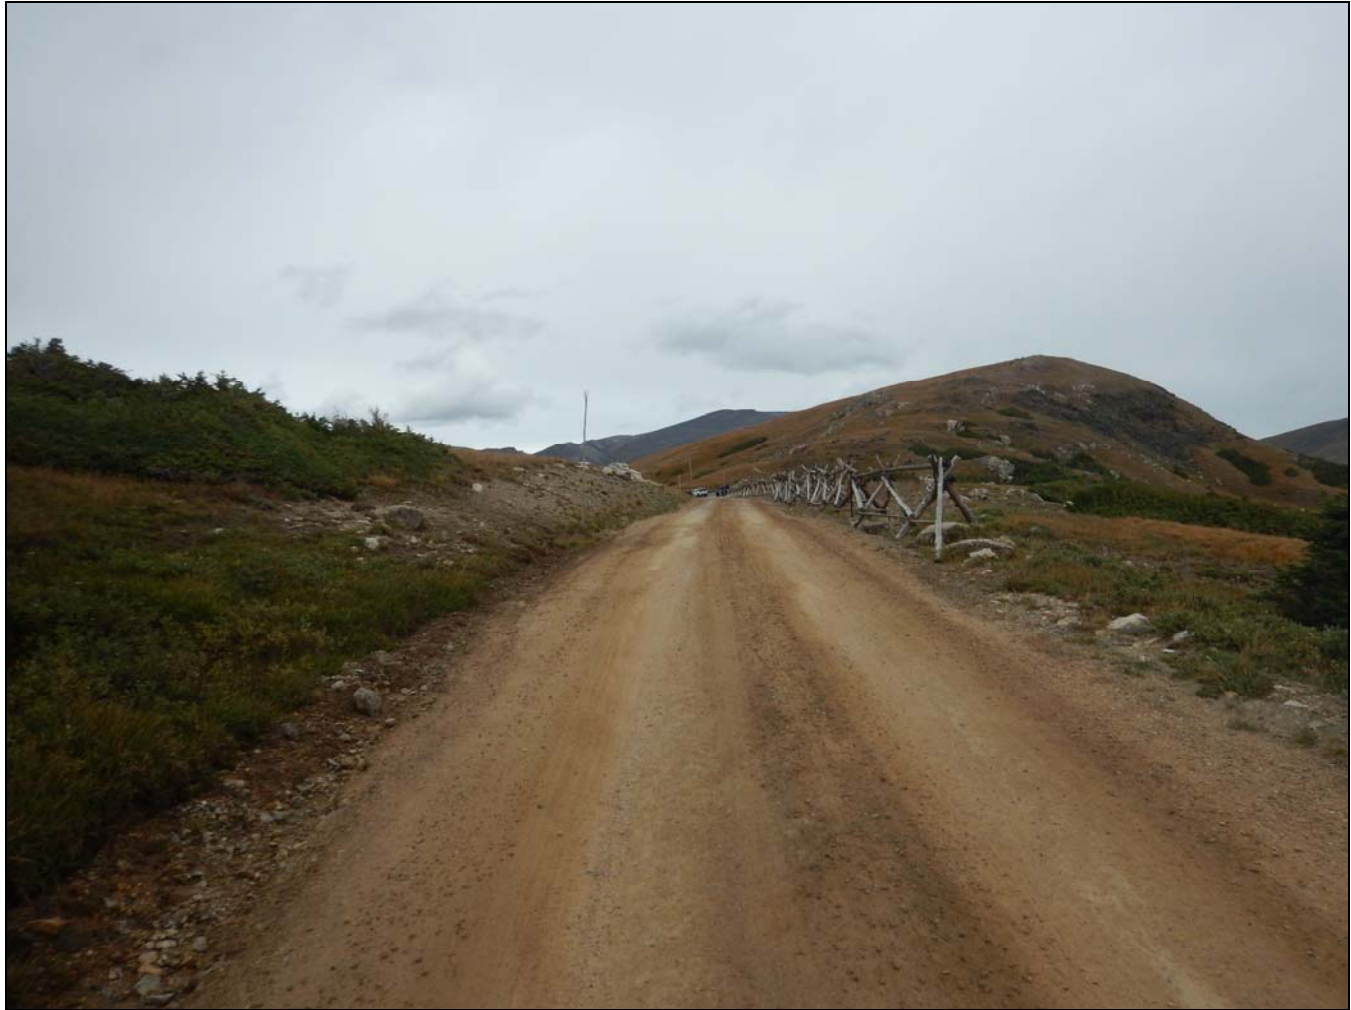
Buck-and-rail fencing has been installed by the NPS in three areas along the shoulders of the road to deter visitor parking, discourage foot traffic in sensitive locations, and delineate road intersections (Table 1-Map Nos. 27, 121, and 126; Figure 2 and Figure 12). The fencing also is commonly used to abut edges of visitor-created pullouts. The fences vary in length and utilize local unpeeled logs that are easily replaced (Photograph 13). The fences have a rustic appearance and are subject to deterioration. Written records do indicate fences were constructed as part of the original roadway (Way 1920a), but they weather rapidly and have been replaced.

Photograph 13. Fence, camera facing east.
CO_LarimerCounty_Fall River Road_Amendment_Boundary Increase_Rocky
Mountain National Park MRA_0013

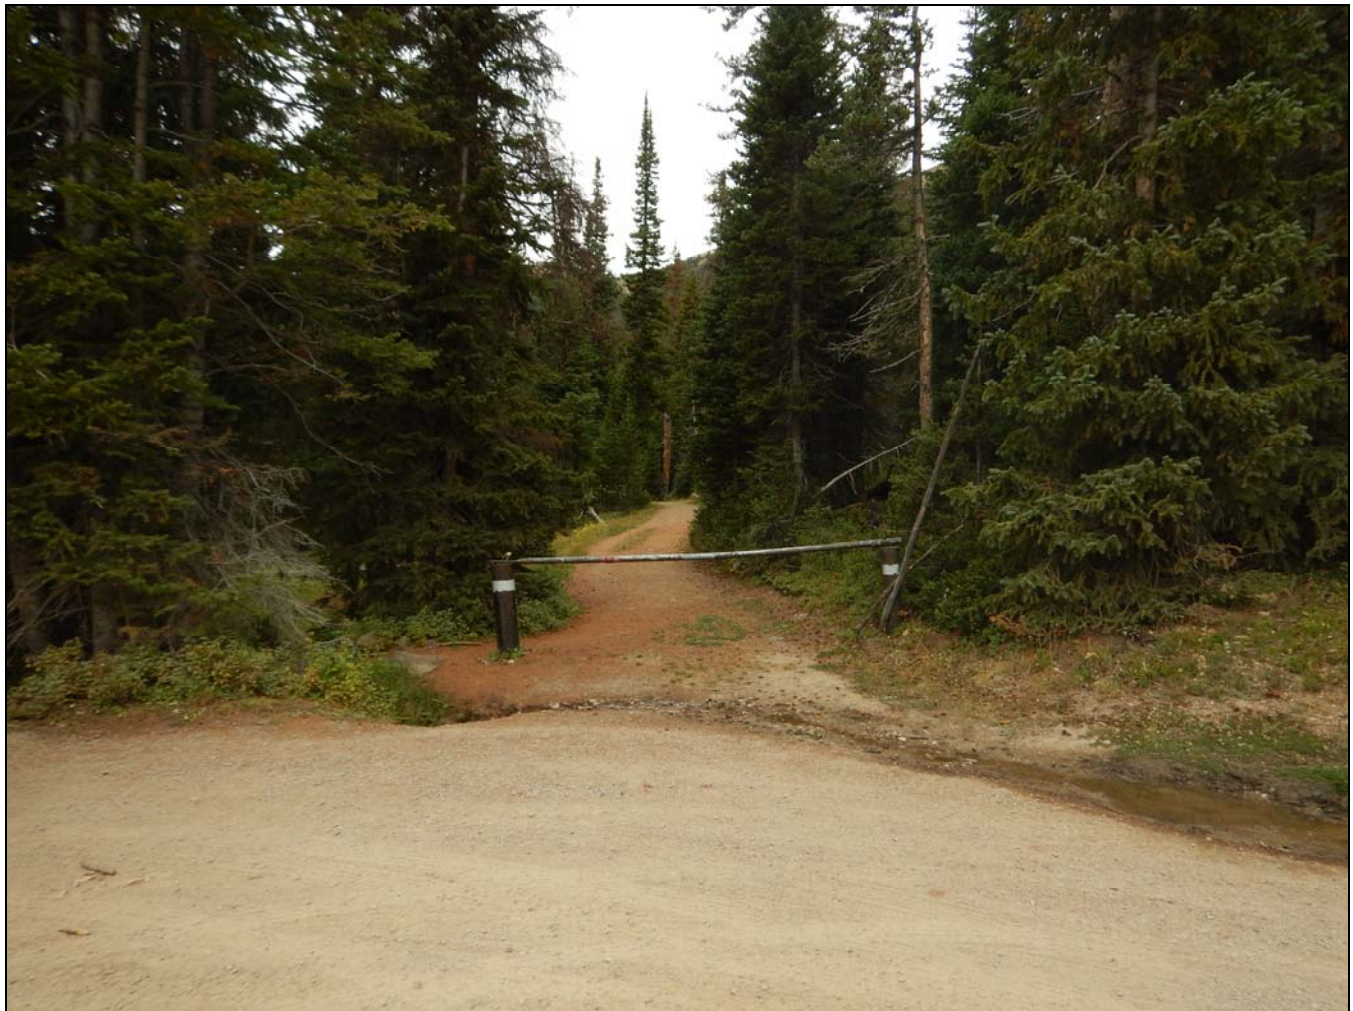
Photograph 14. Gate, camera facing west northwest.
CO_LarimerCounty_Fall River Road_Amendment_Boundary Increase_Rocky
Mountain National Park MRA_0014

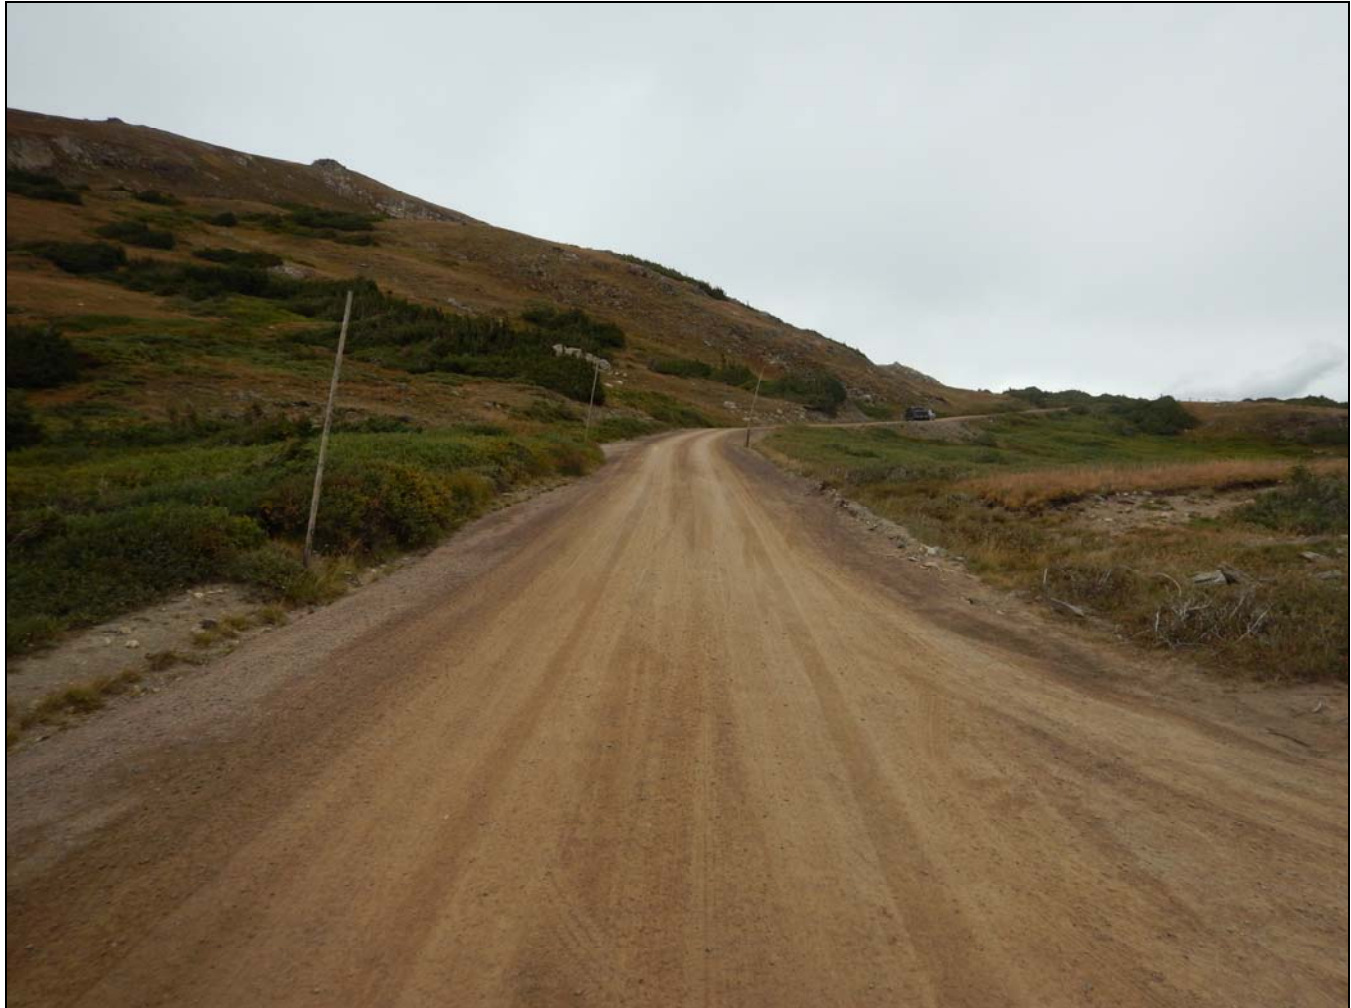
Peeled log poles are restricted to the alpine tundra section of the road. Twenty-eight peeled log poles are located along the road in the upper elevations to delineate the road edge during snowy conditions (Table 1-Map Nos. 1–6, 9, 10, 13, 14, 16, 18, 19, 21, 22, 24–26, 28, 31, 36, 39, 40, 42, 43, 45, 47, and 49; Figure 2 and Figure 3); the logs are set vertically in the ground and measure 12 to 15’ high and are spaced as little as 50’ apart (Photograph 15). Two locations have a pair of peeled logs, one on each side of the road. All peeled poles have unknown dates of installation. The peeled poles use materials that readily decay and have been replaced in the past, as needed.

Photograph 15. Signs/Markers, peeled log, camera facing north.
CO_LarimerCounty_Fall River Road_Amendment_Boundary Increase_Rocky
Mountain National Park MRA_0015

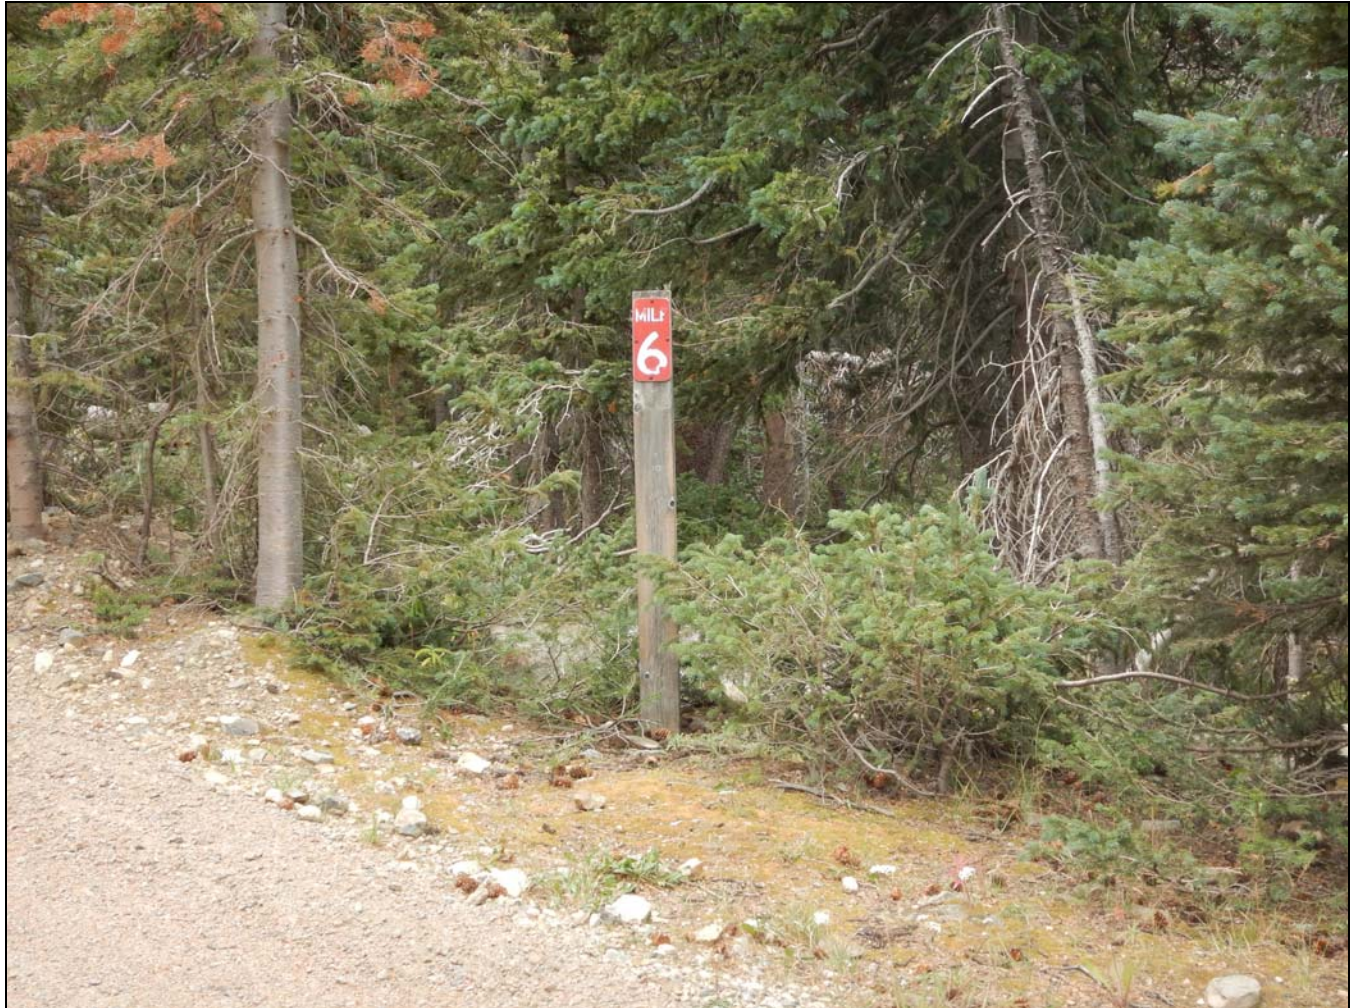
This amended nomination documents the roadbed and associated features within a 10' buffer on either side of the shoulders between the Fall River Entrance Station and the Alpine Visitor Center (Figure 15–18). The original roadway was 8–14' wide as constructed during the period of significance 1913–1920. Later improvements and repairs extend the period of significance to 1968. The current road's width (approximately 20–25') is greater than the original width of the road because of historic and modern improvements to the road, and therefore, a 10' buffer zone extending beyond both sides of the current road encompasses all historic elements of the roadway. The following discussion uses the State of Colorado mile posts (MP) for Highway 34A. The historic Fall River Road lacks official Colorado Highway System MP; therefore, mile markers depicted on Figure 2–17 showing the unpaved historic Fall River Road are based on the distances from the only historic signpost that exists on the road. The historic signpost has the designation "MP 6"; other MP sign posts are not present along the NPS roadway.

Photograph 17. Mile Post 6 sign post, camera facing southwest.
CO_LarimerCounty_Fall River Road_Amendment_Boundary Increase_Rocky
Mountain National Park MRA_0017

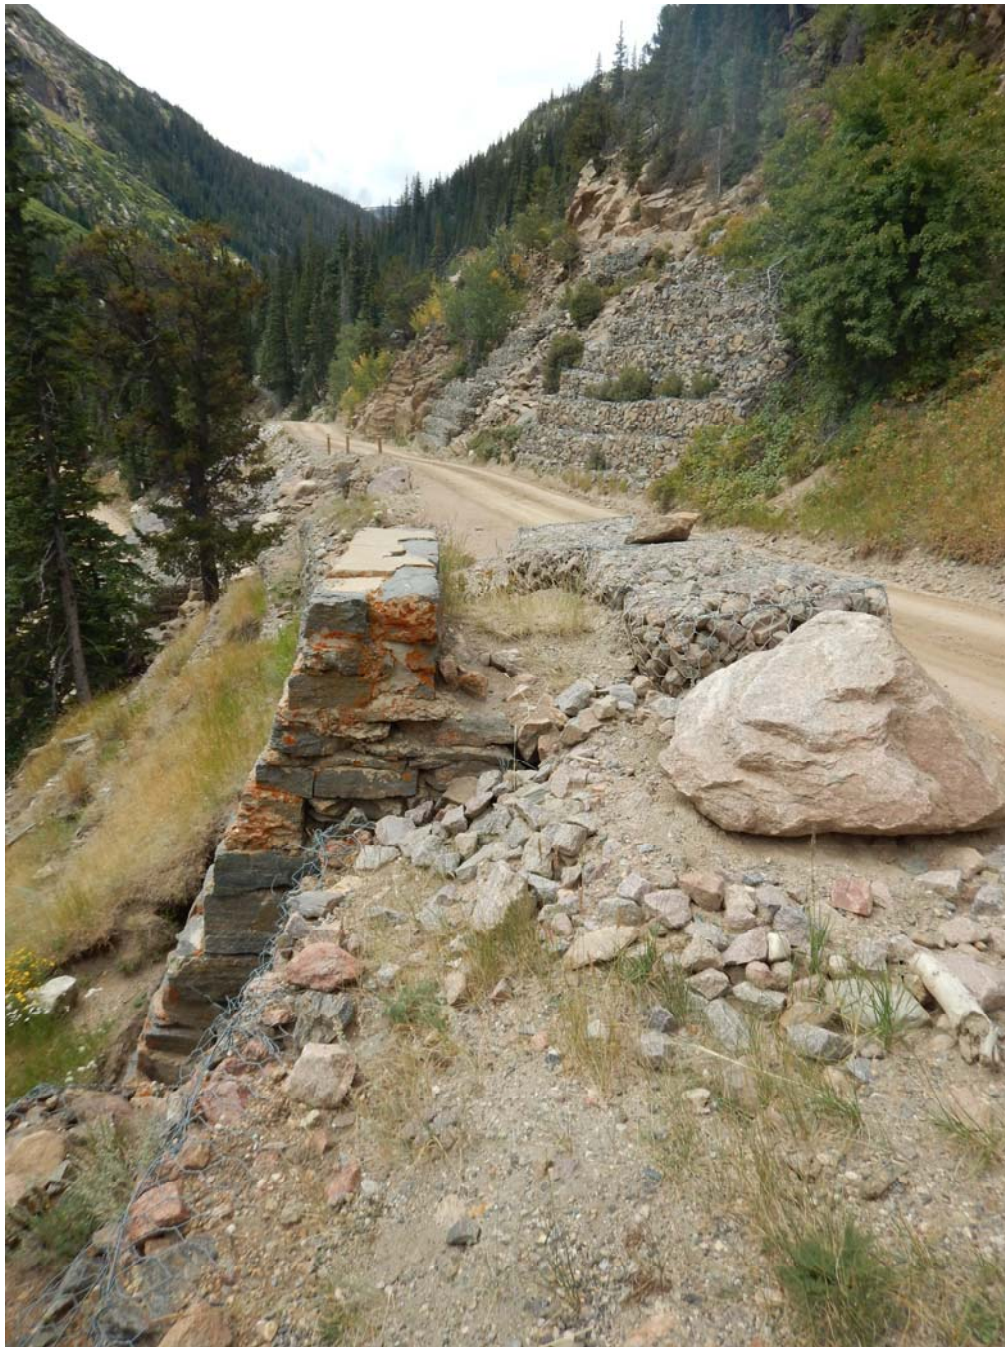
Photograph 18. Gabion and retaining wall, camera facing west.
CO_LarimerCounty_Fall River Road_Amendment_Boundary Increase_Rocky
Mountain National Park MRA_0018

expanded and repaired, to rehabilitate flood damage from 2013 and additional gabions placed around the mortared retaining wall to prevent further erosion. This rehabilitation adhered to the NPS Standards for Rehabilitation and Guidelines for Rehabilitation Historic Buildings (36 CFR 67).
