NATIONAL REGISTER OF HISTORIC PLACES REGISTRATION FORM

1. Name of Property
historic name <u>Valdez Trail (Copper Bluff Segment)</u>
other names/site number _Abercrombie Trail; Trans-Alaska Military Trail; Eagle Trail;
Fairbanks Trail; Richardson Road.
2. Location
street & number <u>Milepost 106.5, Richardson Highway</u> not for publication
city or town <u>Copper Center</u> vicinity <u>X</u>
state <u>Alaska</u> code <u>AK</u> county <u>Valdez-Cordova</u> code <u>261</u>
zip code <u>99573</u>
3. State/Federal Agency Certification
As the designated authority under the National Historic Preservation Act of 1986, as amended, I hereby certify that this

COPPER BLUFF SEGMENT name of property

VALDEZ-CORDOVA, ALASKA county and state

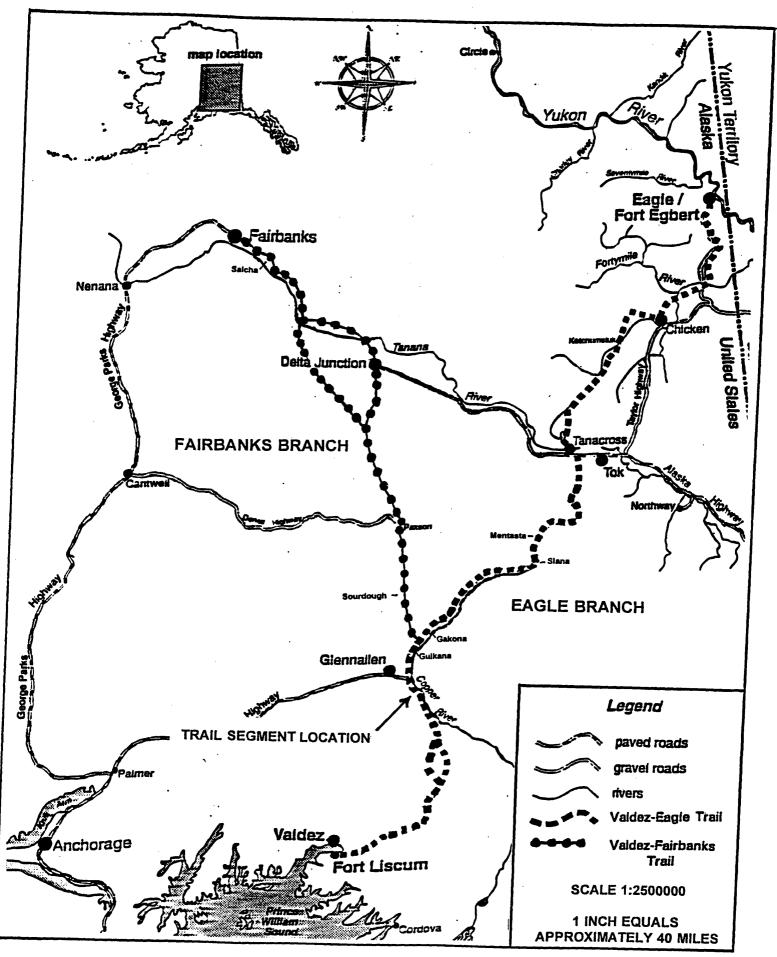
FIG. 1

Fig. 1:
The Valdez Trail

THE VALDEZ TRAIL

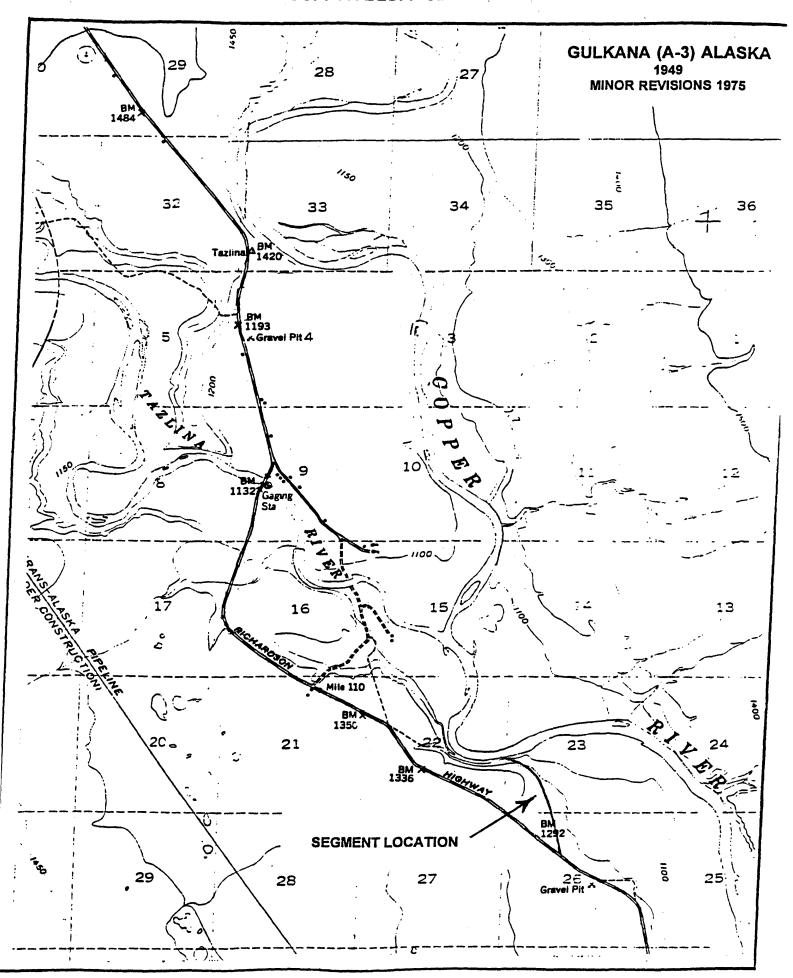
FIG. 2

Fig. 2:
Copper Bluff Segment Location

COPPER BLUFF SEGMENT

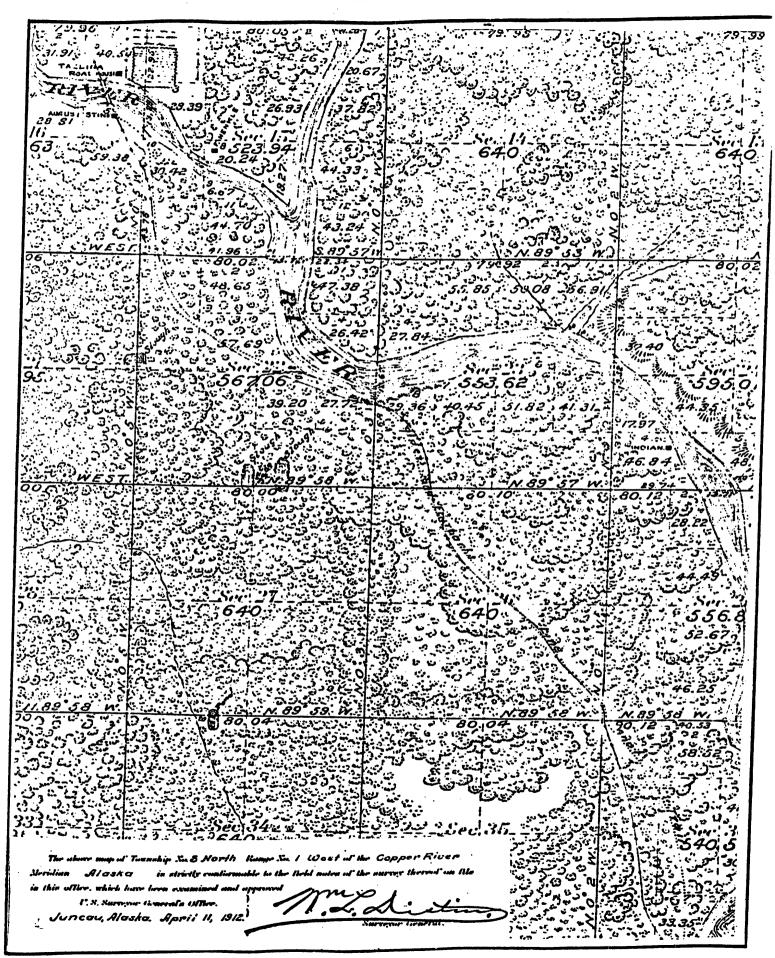
Fig. 3:
1912 Valdez Trail Survey Showing Copper Bluff Segment

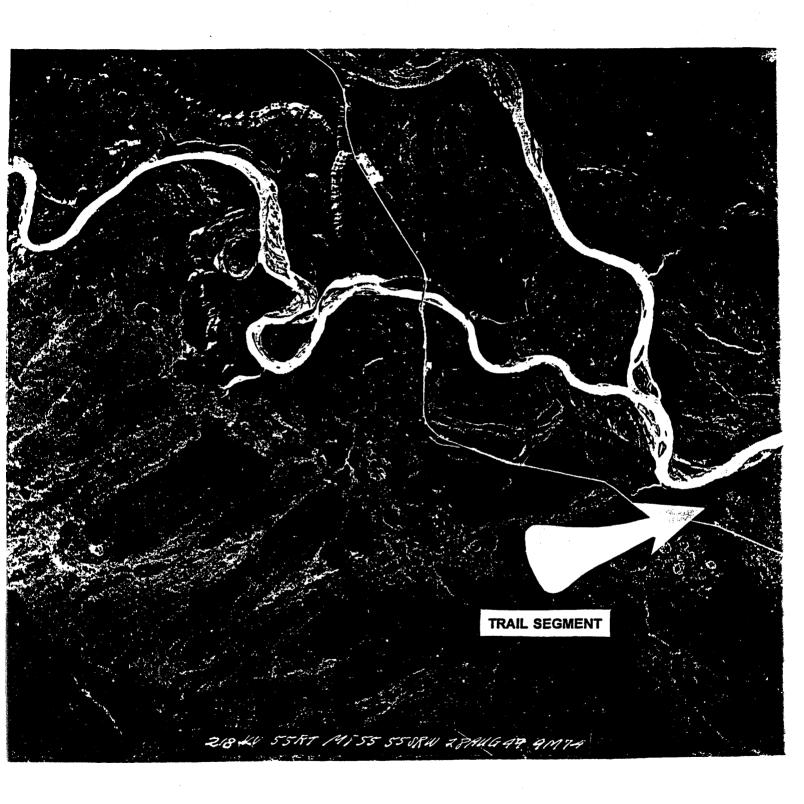
FIG. 4

Fig. 4:
1949 Aerial Photo Showing Copper Bluff Segment

1949 AERIAL PHOTO

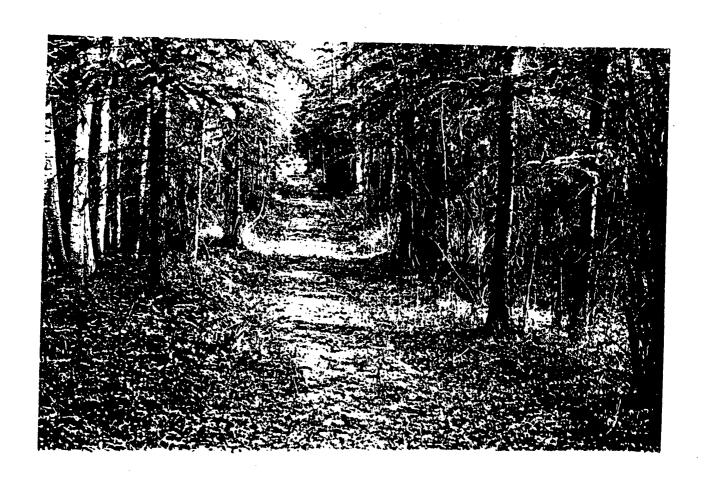
FIG. 5

Fig. 5:
Typical shot of the Copper Bluff Segment today

TYPICAL SHOT OF THE COPPER BLUFF SEGMENT TODAY

This long forsaken piece of the Valdez Trail is primarily distinguished by its eight- to tenfoot-wide, cleared corridor through the subarctic forest. Few constructed features remain, although the northern end of the fragment retains some evidence of having once been crowned and ditched. Historic artifacts, including cans and telegraph wire, litter the forest along its length (see Fig. 6).

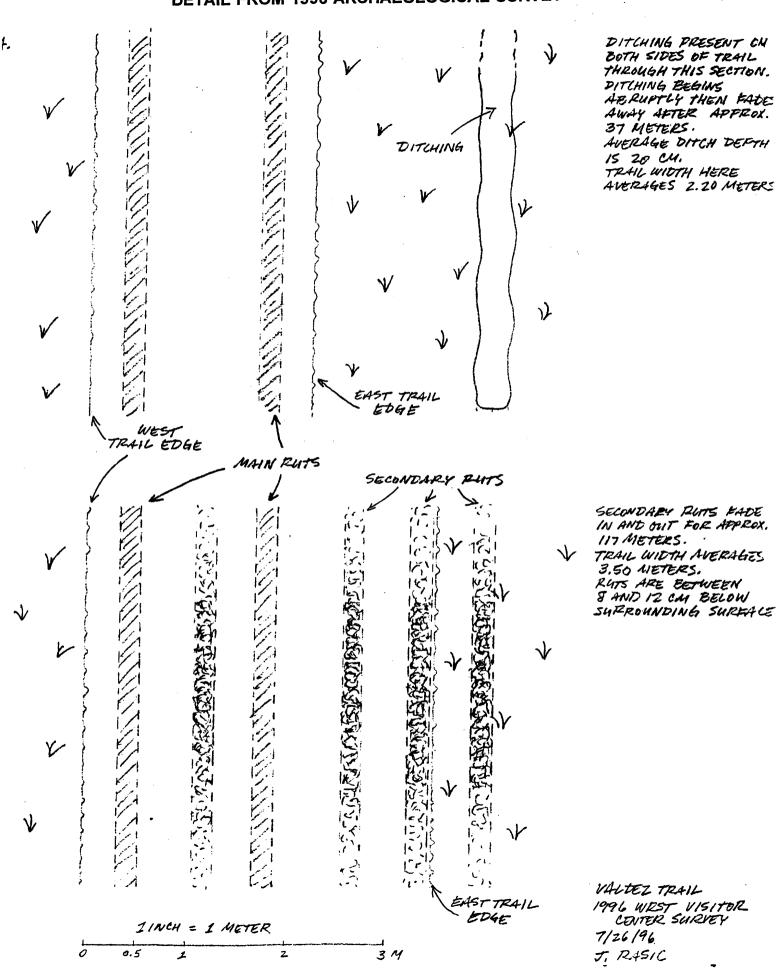
Fig. 7:
Detail from 1996 Archaeological Survey

DETAIL FROM 1996 ARCHAEOLOGICAL SURVEY
