**NATIONAL REGISTER OF HISTORIC PLACES
INVENTORY - NOMINATION FORM**

COMMON:
Windsor Ruins

Supplemental Nomination
Windsor Ruins, Claiborne County, Mississippi

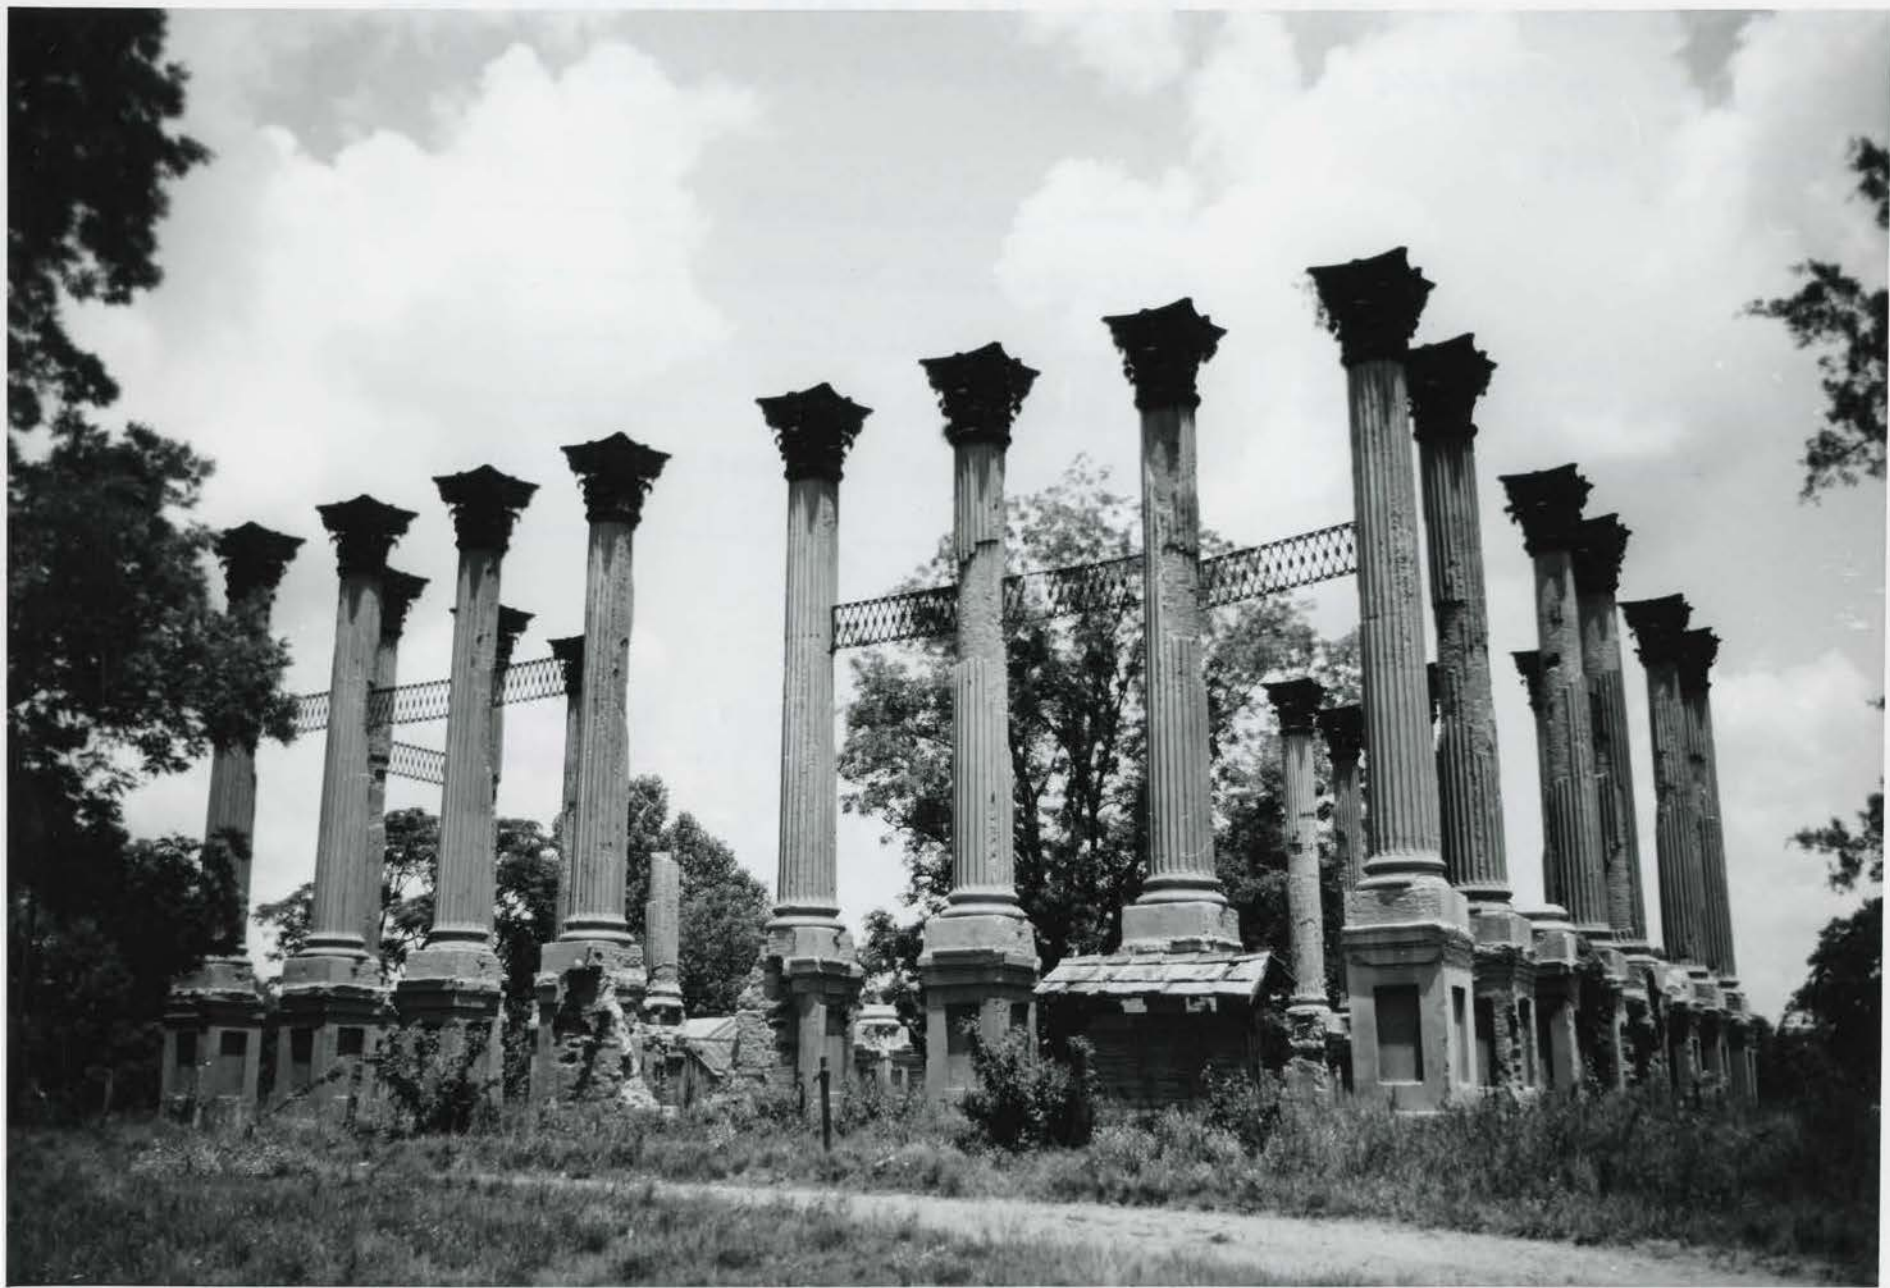
①

WINDSOR RUINS
12 MILES S.W. OF PORT GIBSON ON STATE HIGHWAY 552
COLUMNS OF FAÇADE AND SOUTH ELEVATION, LOOKING N.E.

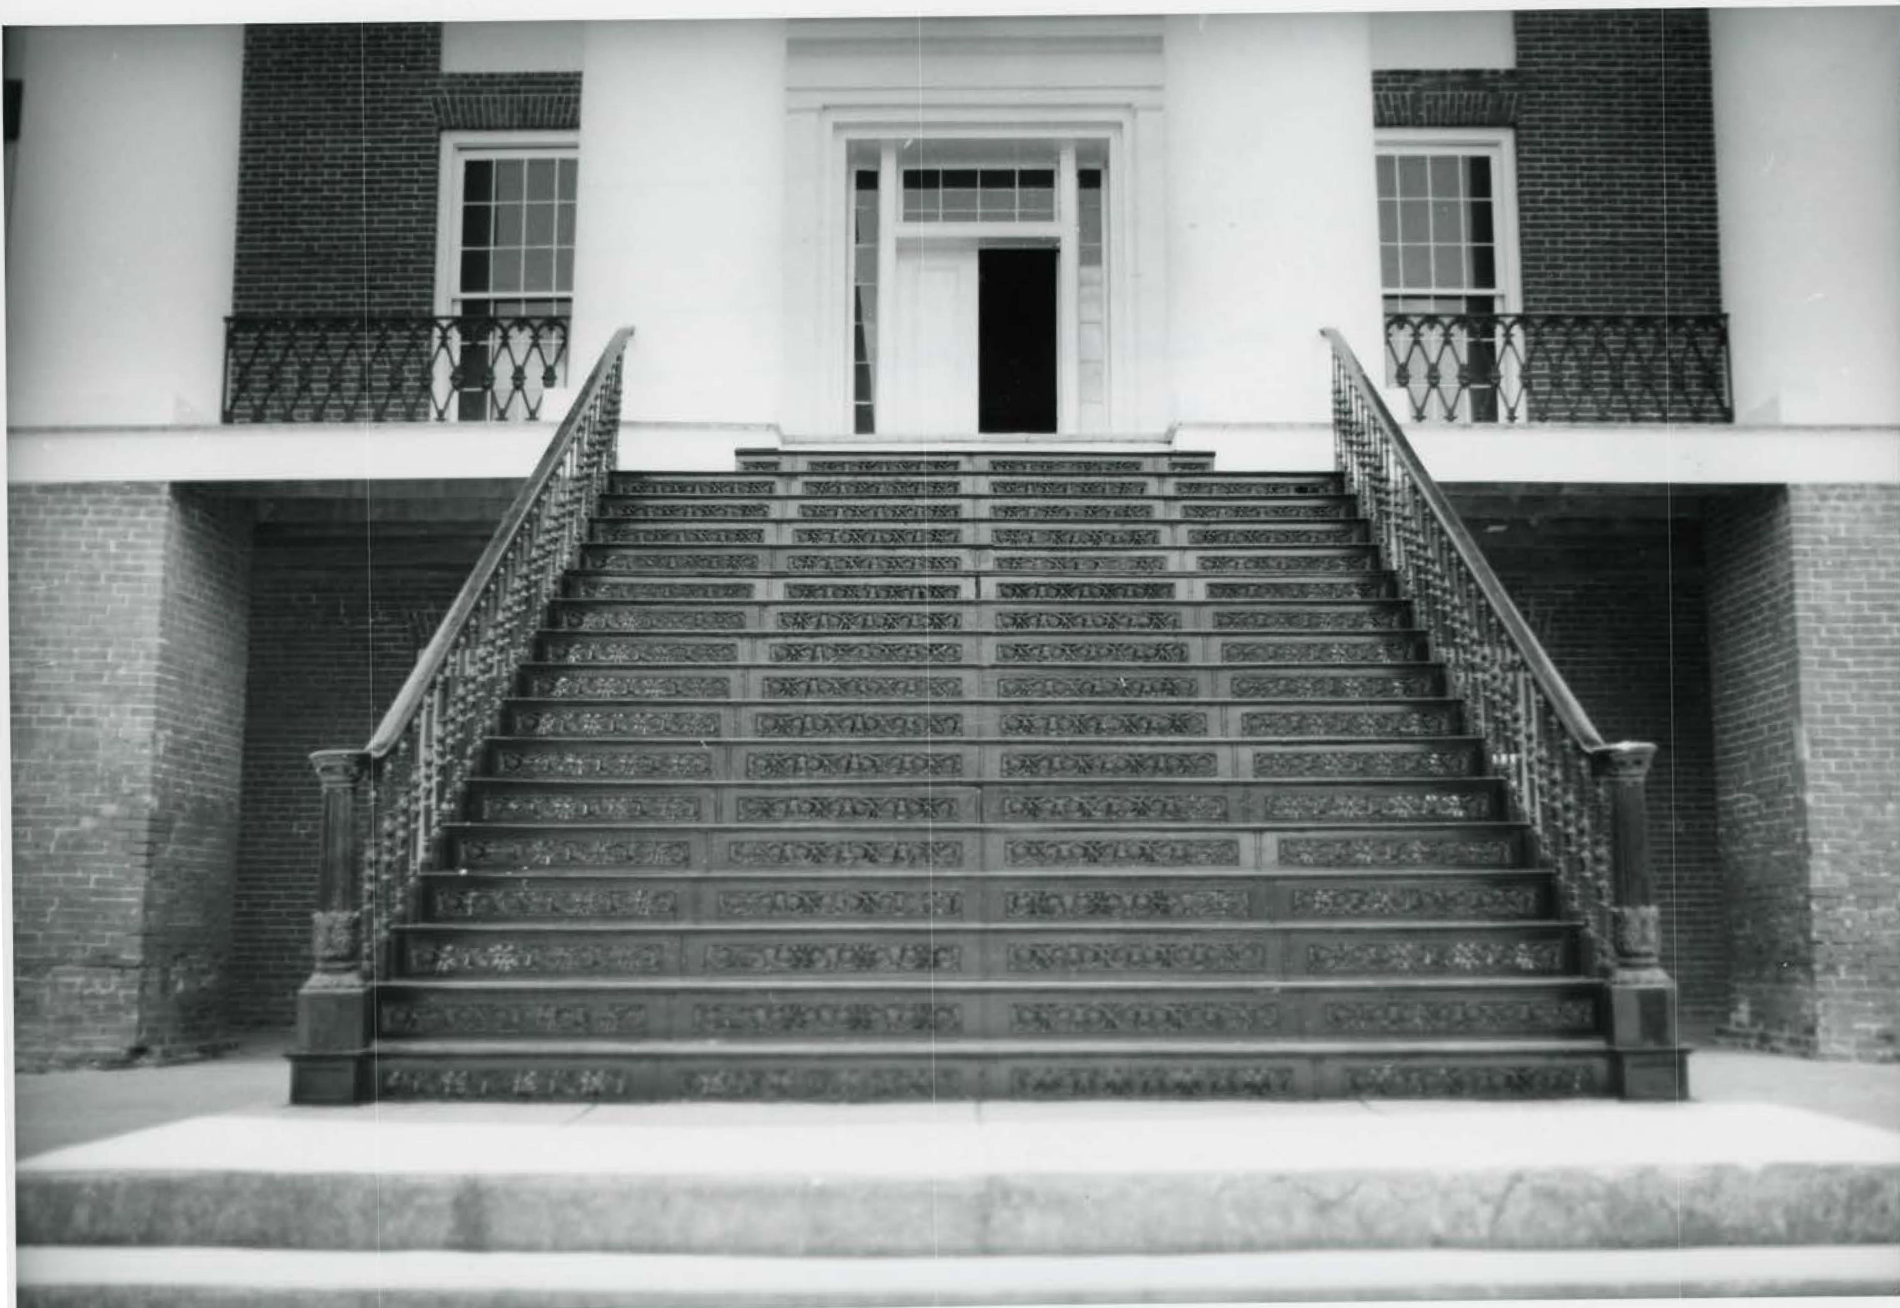
FLIGHT OF WINDSOR STAIRS AND PORTION OF BALUSTRADE AT
ENTRANCE TO CHAPEL, ALCORN COLLEGE, LORMAN, MISS.

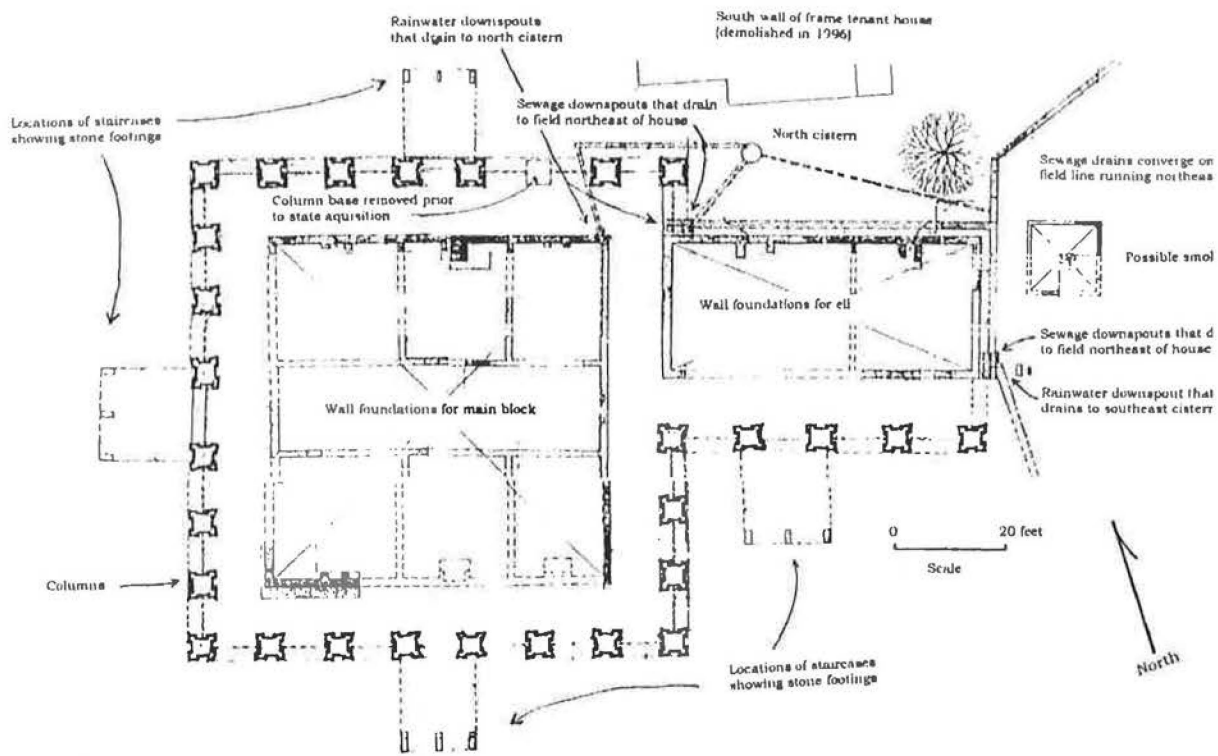
Figure 2. Windsor Ruins architectural plan based upon Townsend et. al.

Daniell's recollection of interior bathrooms on the second and third floors is corroborated by the archaeological study. The Milner archaeologists found evidence of an elaborate drainage system (FIGURE 2), a part of which apparently carried sewage away from the house. At the northwest corner of the ell, two vertical drains emptied into a horizontal brick box drain that ran along the base of the north side of the ell and emptied into an arched culvert at the northeast corner of the ell. The culvert extended twelve feet to the north to discharge into an open wooden trough that angled away to the northeast, extending some forty feet into a field. These two drains may have serviced the second and third floor bathrooms, which Daniell's floor plan shows in the northeast corner of the main block. In a similar drain complex at the southeast corner of the ell, two apparent sewage drains emptied into a brick box drain extending northward along the base of the east side of the ell to join the

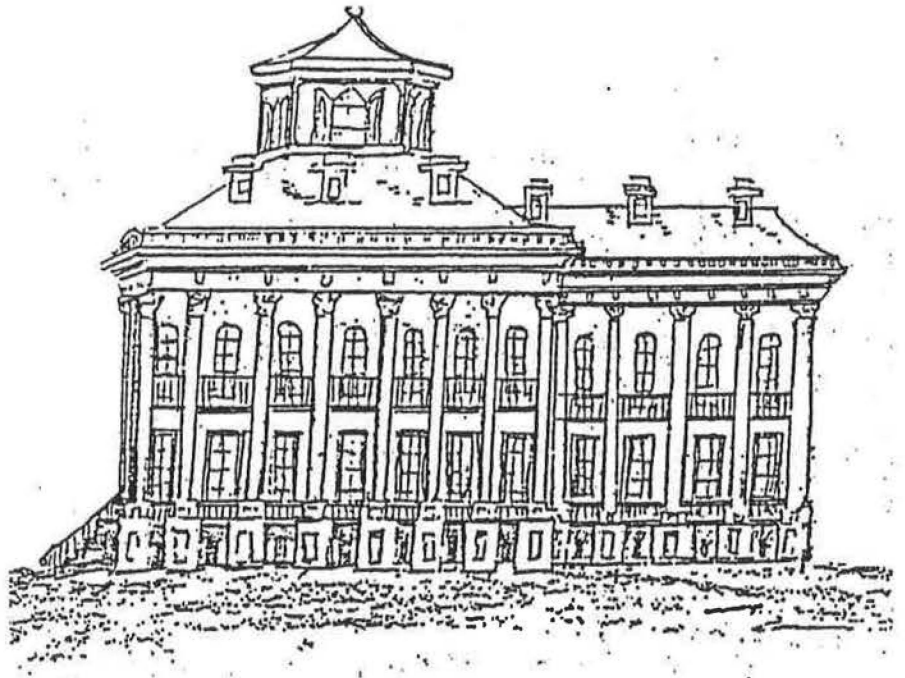
Figure 3

Sketch of Windsor by Union Soldier during Grant's Vicksburg Campaign.
Mississippi Department of Archives

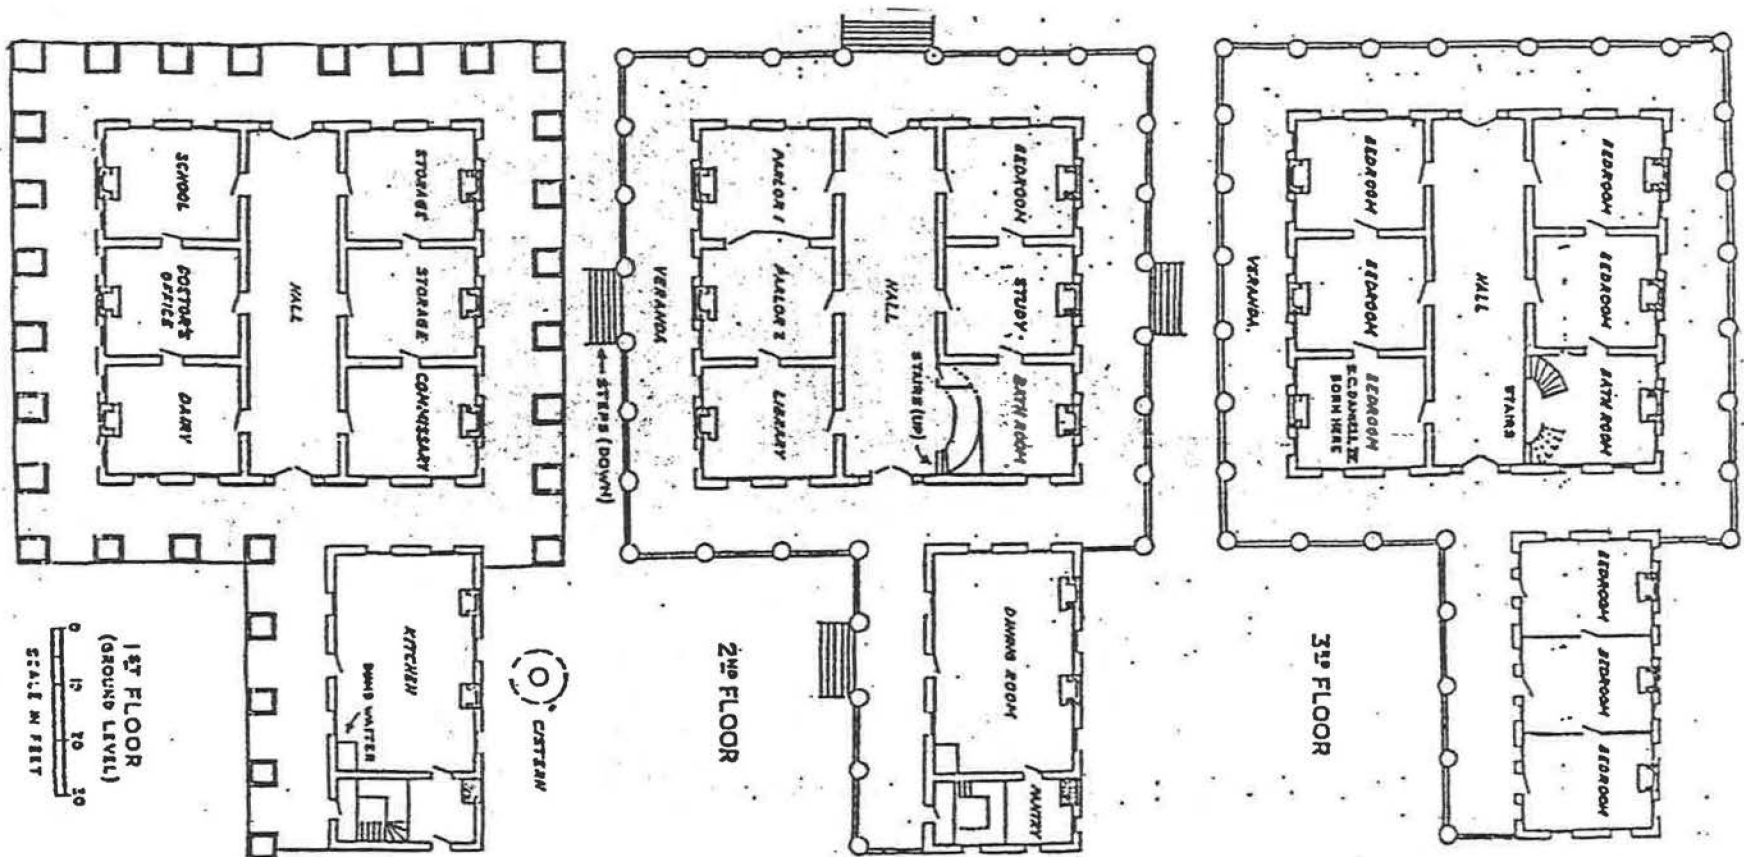
Figure 4

FLOOR PLAN OF WINDSOR as drawn by Smith C. Daniell, IV, from memory and from measurements made of the ruins. The original plans were burned when the house was destroyed. The first floor was at ground level. There was a smaller fourth floor which contained only a ballroom, never finished and above this was the observation tower.
