National Register of Historic Places Registration Form

historic name BUFFALO MILK COMPANY BUILDING

other names/site number Queen City Dairy Company Building

street & number 885 Niagara Street [] not for publication

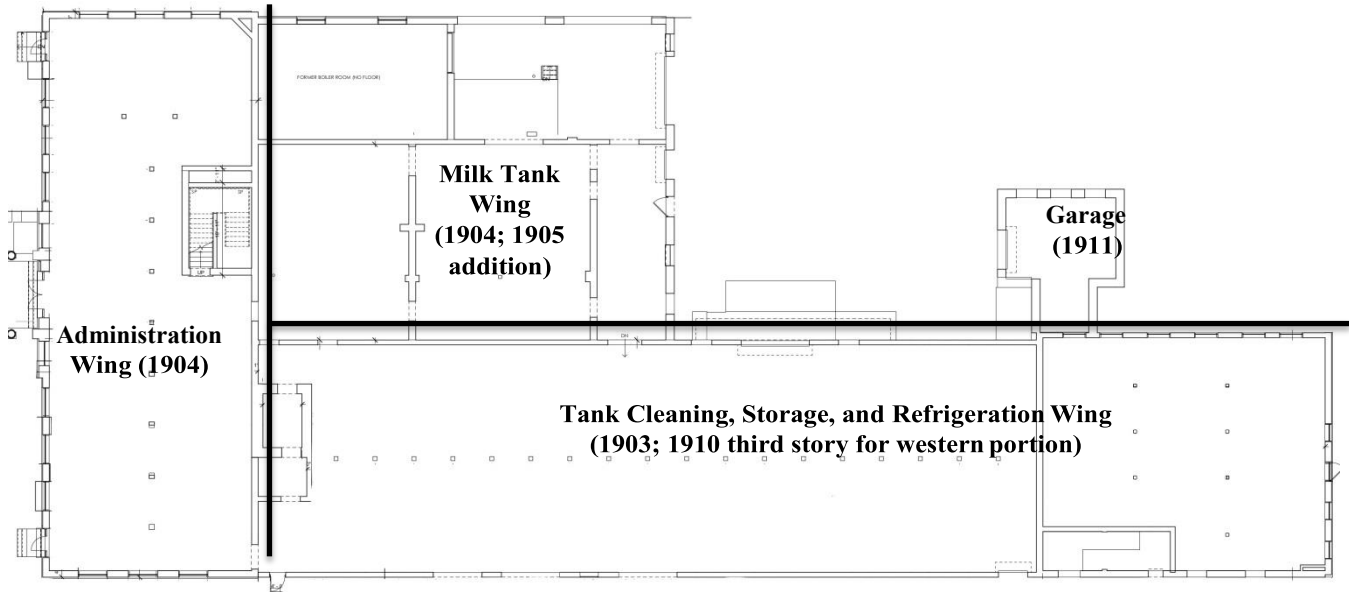
Figure 1: Layout of Buffalo Milk Company Building

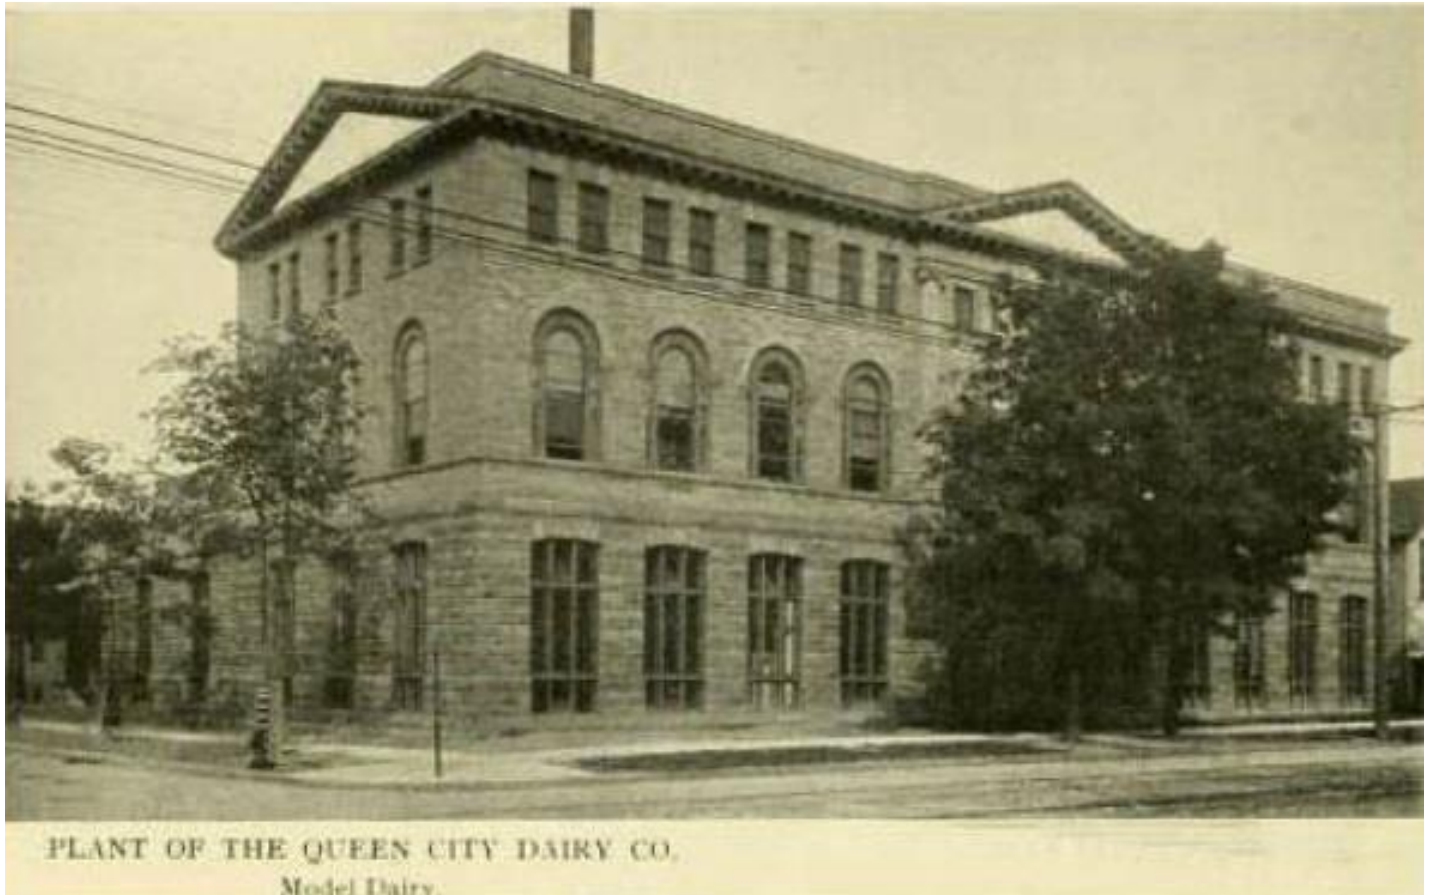
**Figure 3: 1909 Photograph of the
Buffalo Milk Company Building**
Buffalo To-Day: Industrial and Commercial
(Buffalo: Publicity Committee for National Conference of
Charities and Correction), 54.
Accessed via WKfinetools.com

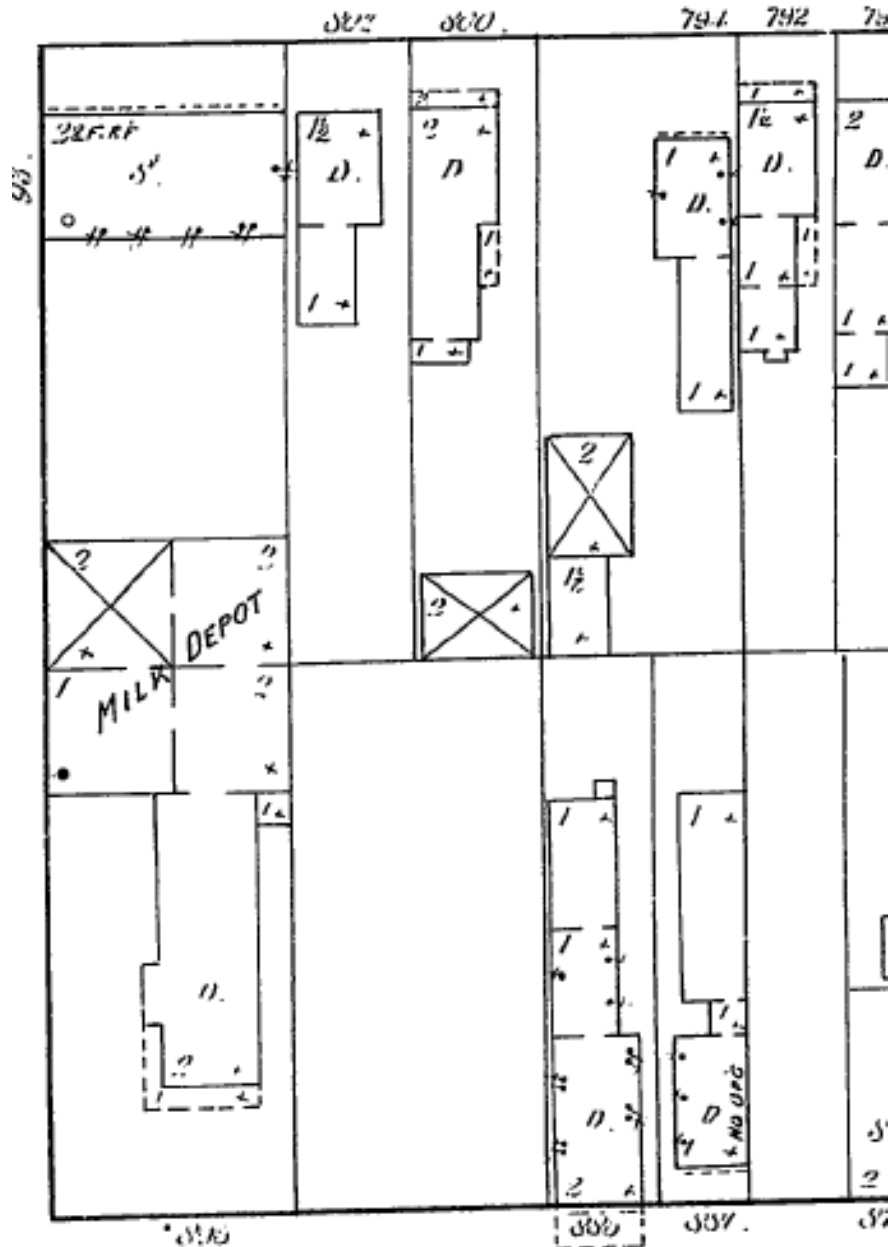
Figure 4: Sanborn Fire Insurance Map (1889, Vol. 3 Sheet 110)
Prior to the construction of the Buffalo Milk Building, there was a more traditional milk depot on the corner of Massachusetts and Niagara Streets. In 1889, the site consisted of a stable and refrigerated buildings containing milk tanks.

In these regards, the corner of Niagara Street and Massachusetts Avenue was perfectly suited location for a depot. According to city directories, Charles May operated a milk depot facility, then numbered at 895 Niagara Street, by 1889 (see below), although it is unknown if the facility was related to the Buffalo Milk Company, which later occupied the site. Nothing of this early facility remains extant.

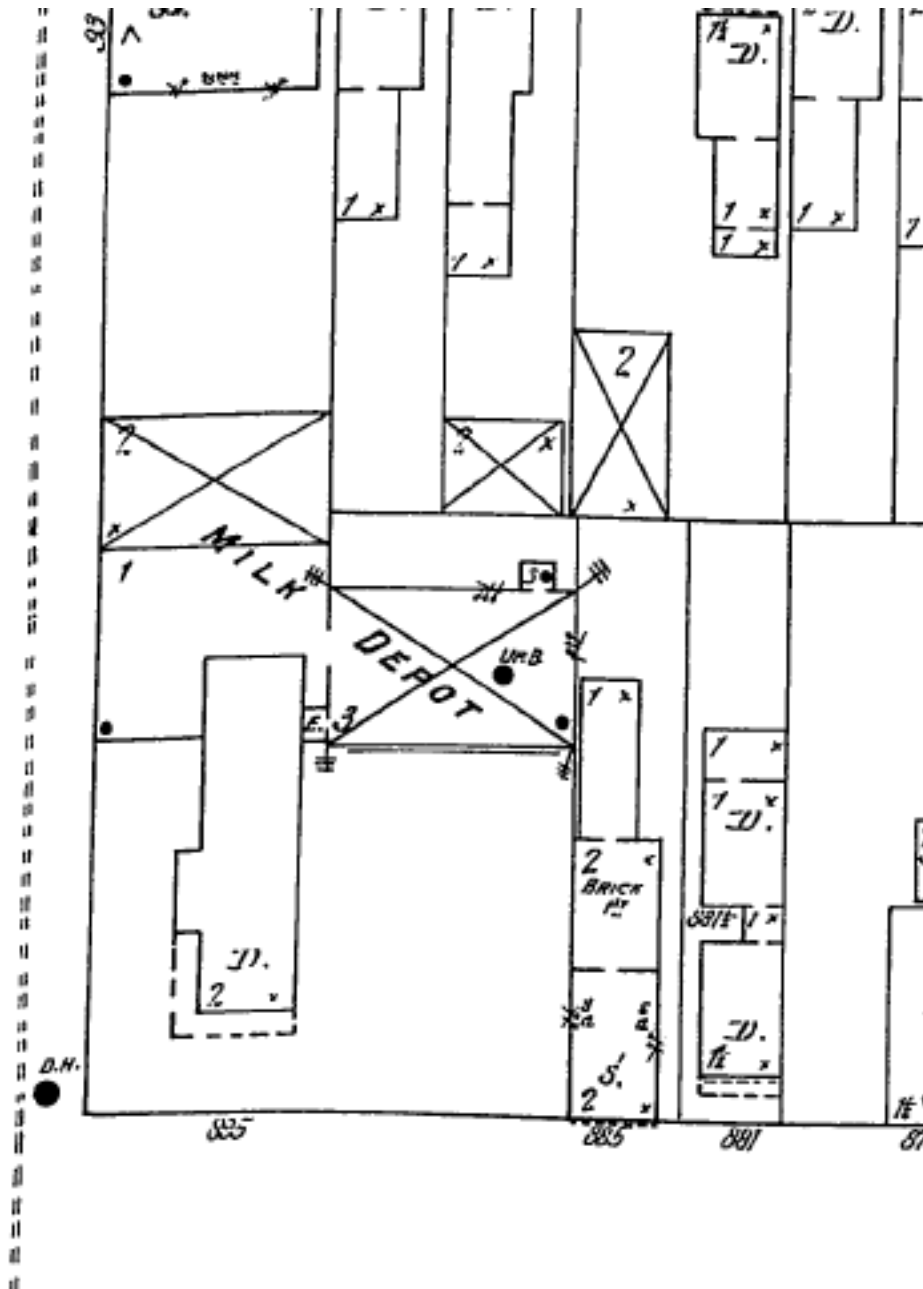
Figure 5: Sanborn Fire Insurance Map (1899, Vol. 1 Sheet 86)
By 1899, the milk depot at Massachusetts and Niagara Streets had been enlarged.

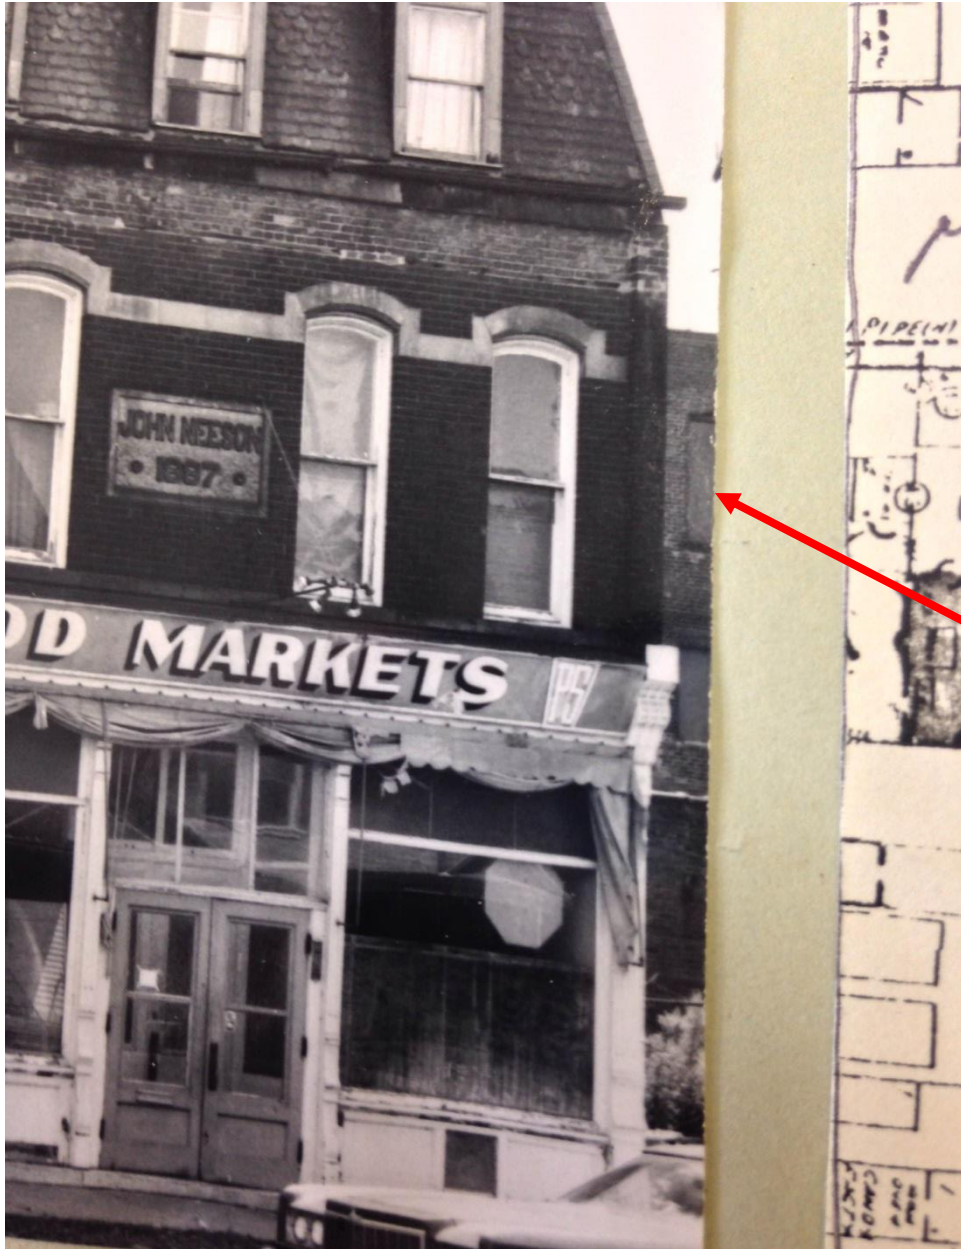
Figure 7: Partial image of the intact Tank Cleaning, Storage & Refrigeration Wing (1980)

Partial image of the intact, three-story configuration of the Tank Cleaning, Storage & Refrigeration Wing in 1980 taken from a Building-Structure Inventory Form of the adjacent building at 93 Massachusetts Avenue

The side elevations of this wing are similar, although not identical, to each other. The south elevation is constructed of Roman brick, while the north elevation is of common red brick. As noted, this wing was originally constructed as three full stories; however, a significant fire in 1982 resulted in the removal of the majority of the second and third floors. A three-story portion four bays deep stands at the eastern end but the remainder of the wing retains only the ground floor. On the north and south sides of the three-story portion there are regular brick openings with segmental arches above and stone sills; with few exceptions, the original windows remain. The single-story portion of the south elevation originally contained regular openings as well but all of these have since been filled in with brick. The single-story portion of the north elevation contains one non-original garage door opening at the western end; a shed-roofed porch on a CMU foundation shelters the opening. An exposed brick wall—the upper two stories of the three-story portion—is visible above the remaining single story wing.

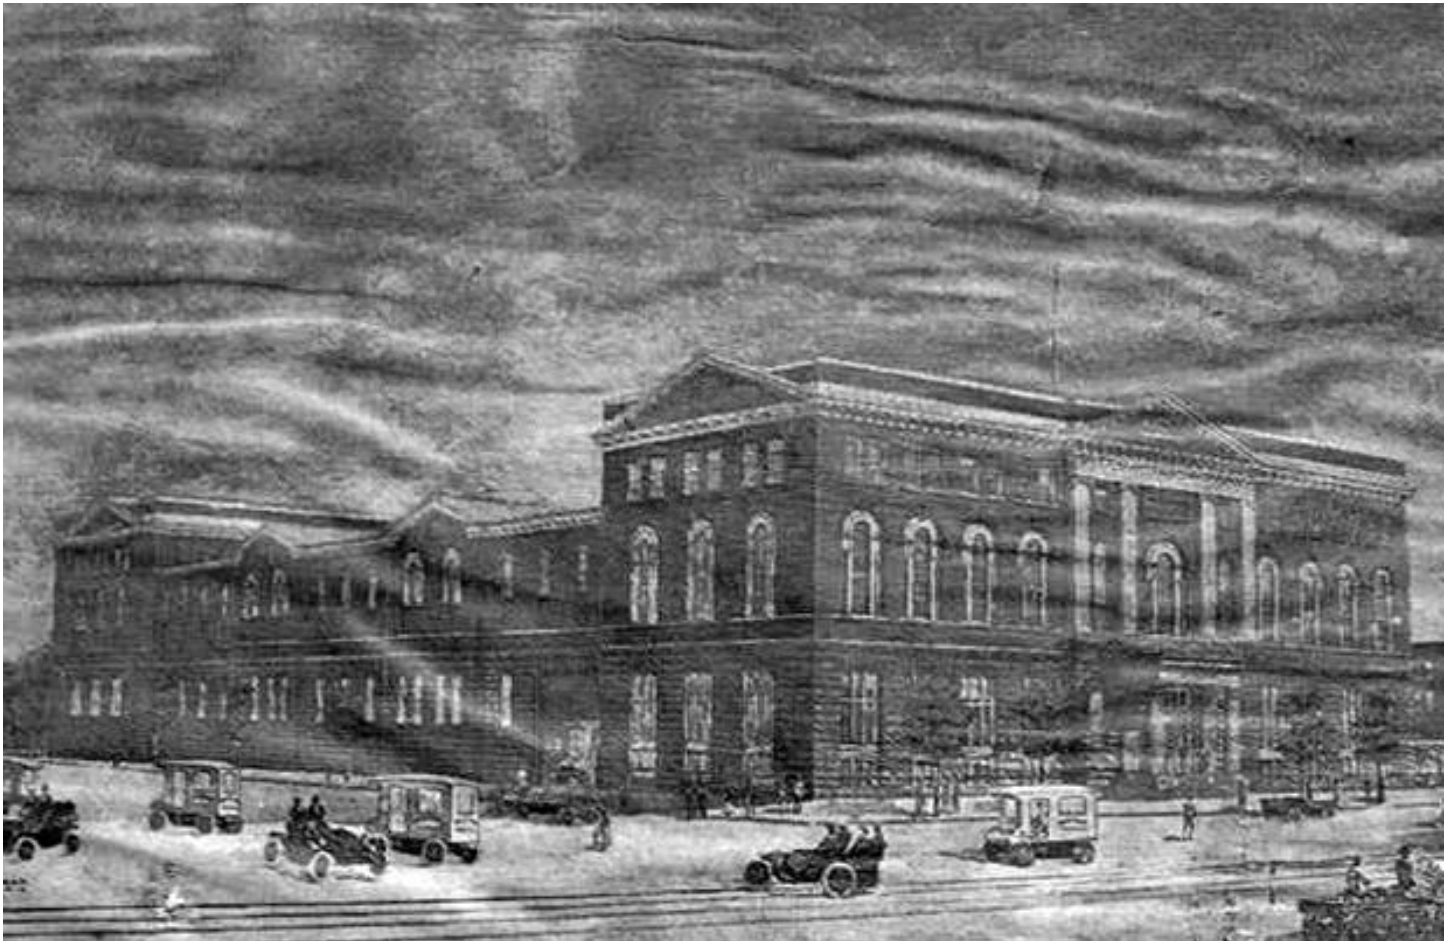
Figure 8: Rendering of Proposed Design for Buffalo Milk Company Building (ca. 1903)

This rendering shows the proposed design for the Buffalo Milk Company Building, which was never fully realized along the north elevation. But note that the main elevation of the administrative building (at right) was constructed largely as this rendering depicts, realizing the architect's original vision for an imposing and stately milk facility.

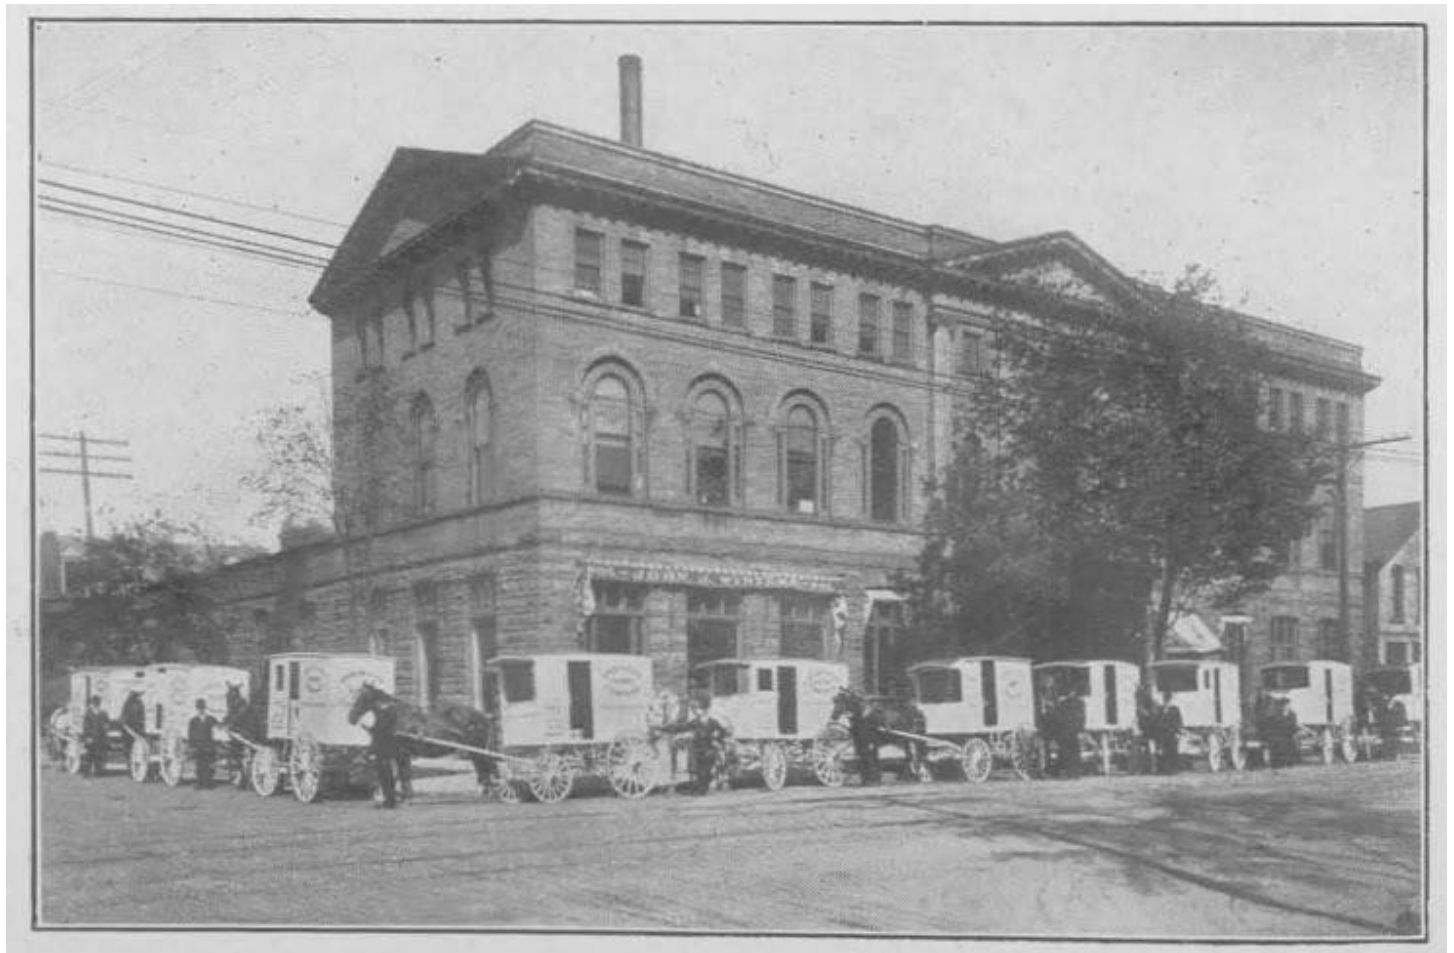
Figure 9: Photograph from 1911. Caption: “HOME OF THE QUEEN CITY DAIRY CO. Extends from Niagara Street to Prospect Avenue and along Massachusetts Avenue. One of the finest buildings occupied by any milk company in U.S.”

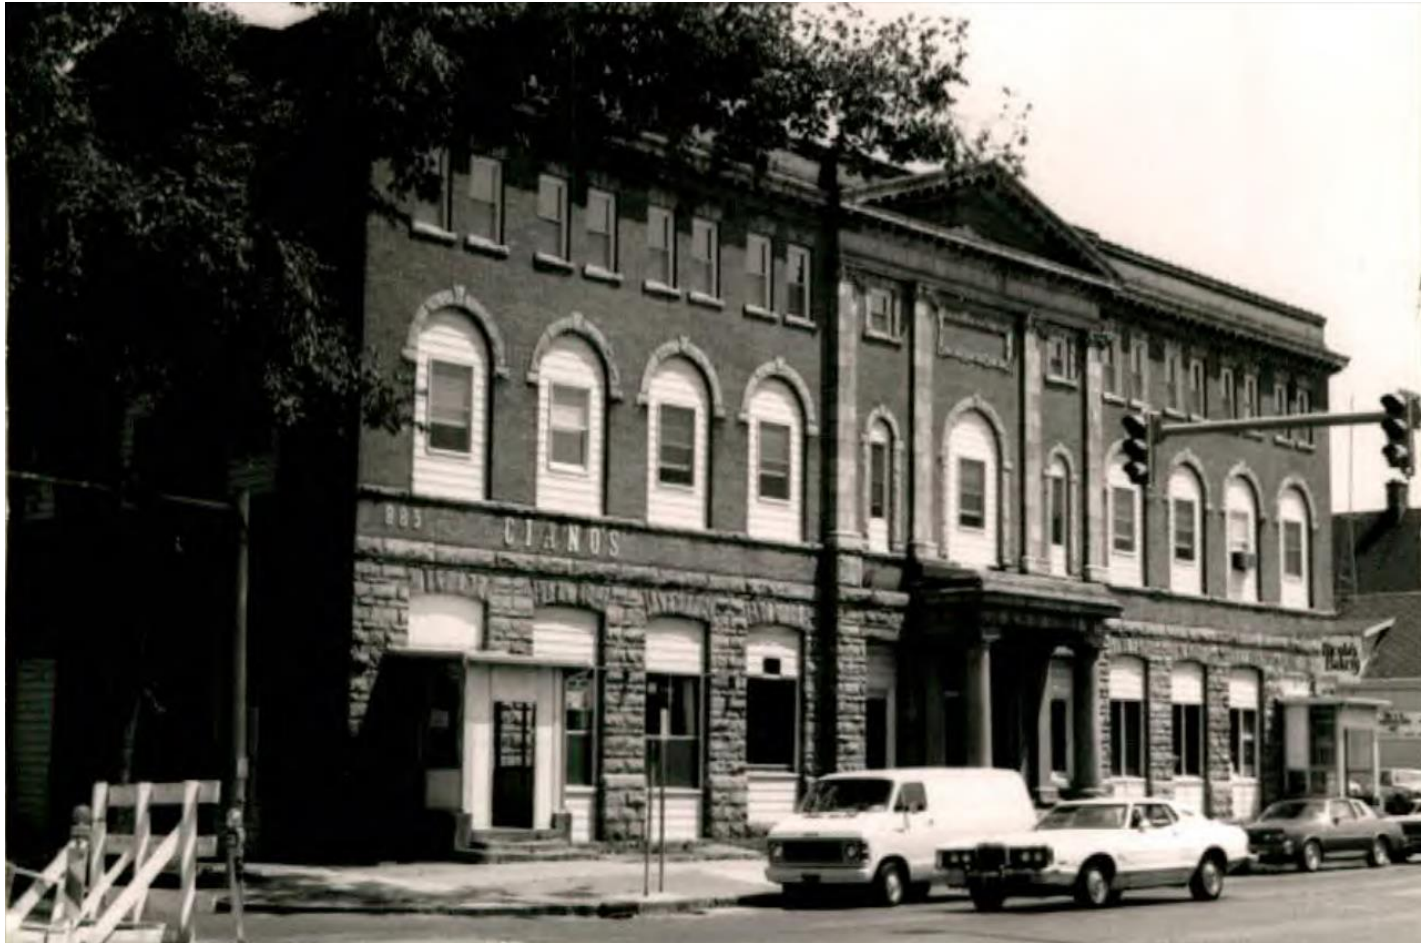
Figure 10: View of the former Buffalo Milk Company Building (ca. 1980)
