Round Lake Logging Dam

Price County, Wisconsin

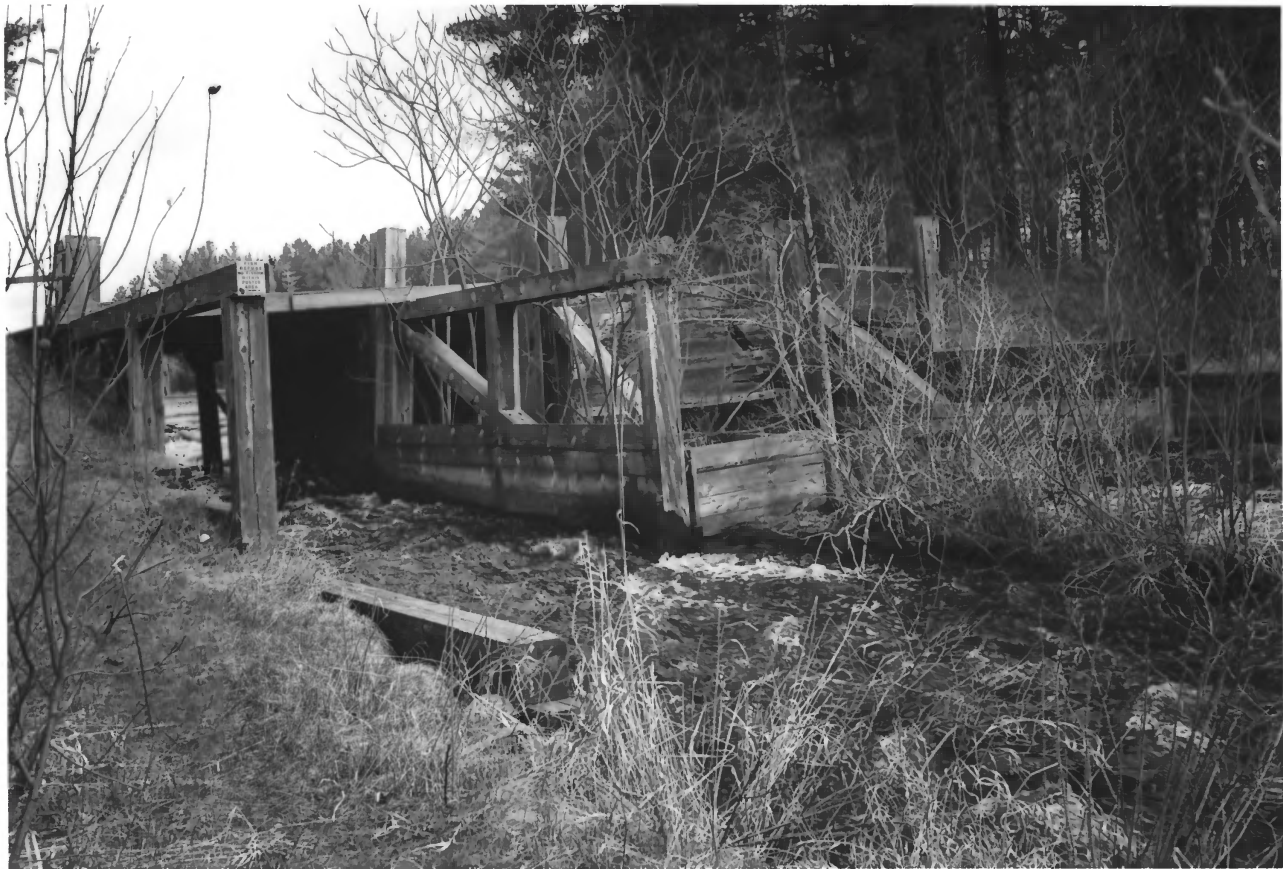
Photograph No. 1

Northwest elevation. This photograph shows the north sluiceway. This is the sluiceway through which the greatest volume of water flows. This sluiceway no longer has its plank bottom.

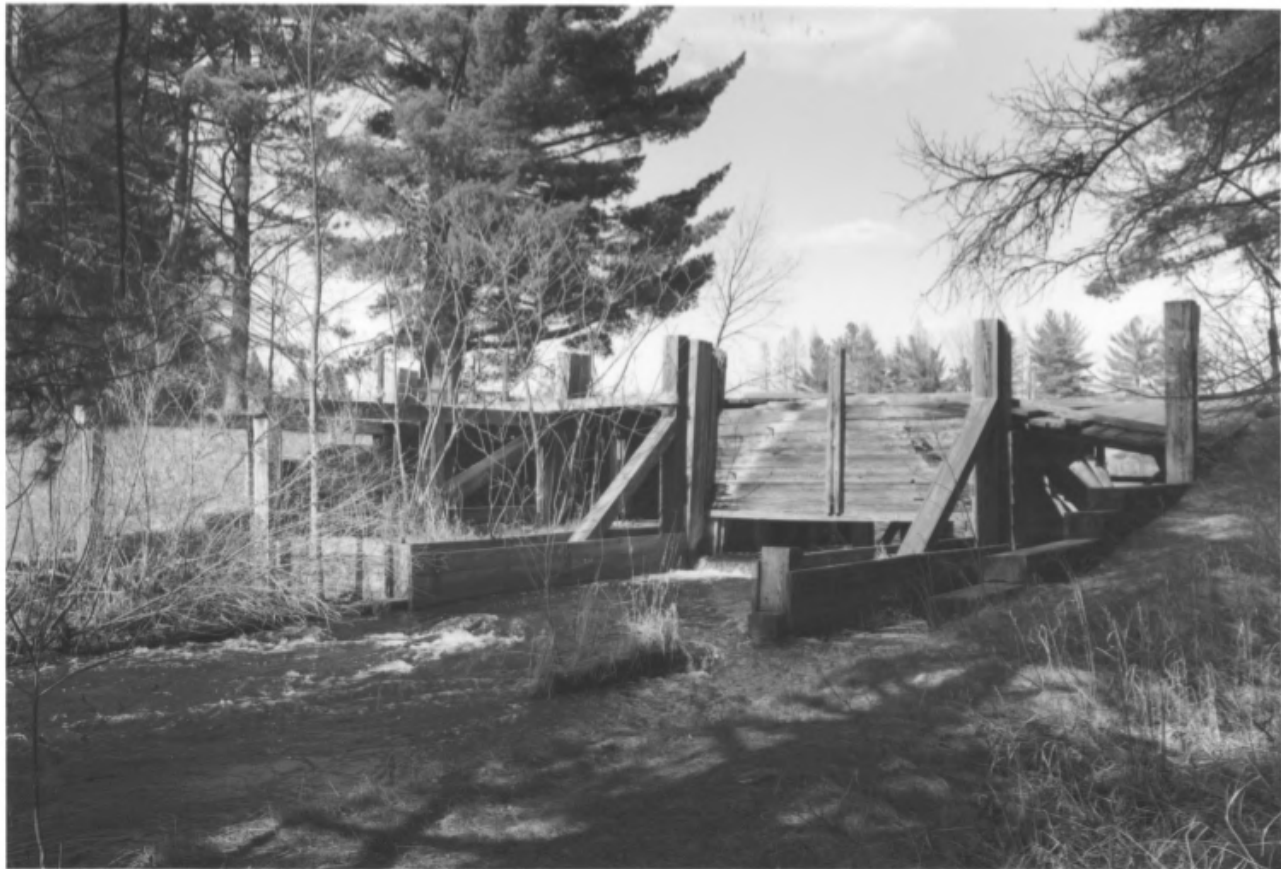
Photograph No. 2

Southwest elevation. This photograph shows the floodgate that is made of the original timber. It also shows the sagging decking on the south side, created by the collapsing of the south abutment.

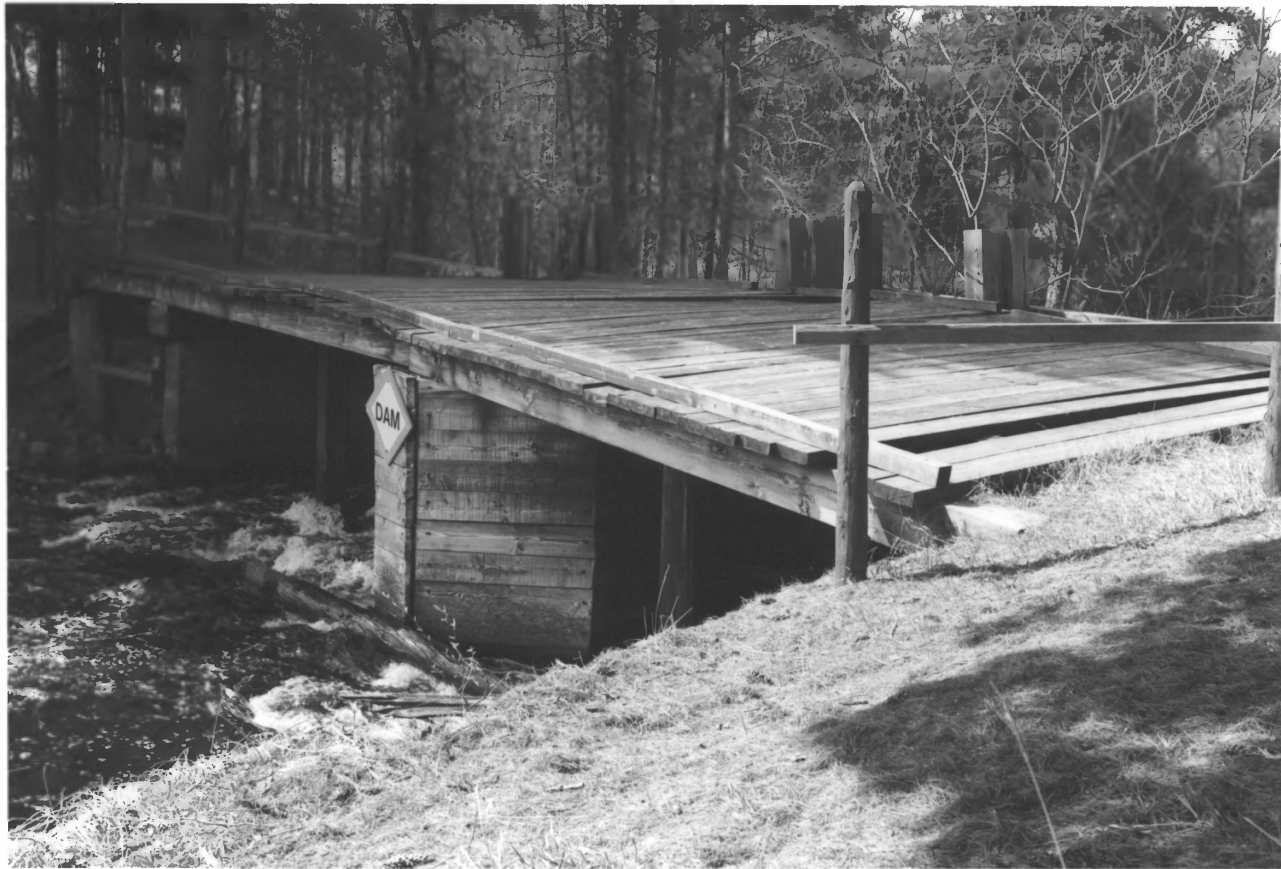
Photograph No. 3

Northeast elevation. This photograph shows the dam's decking, or working platform.

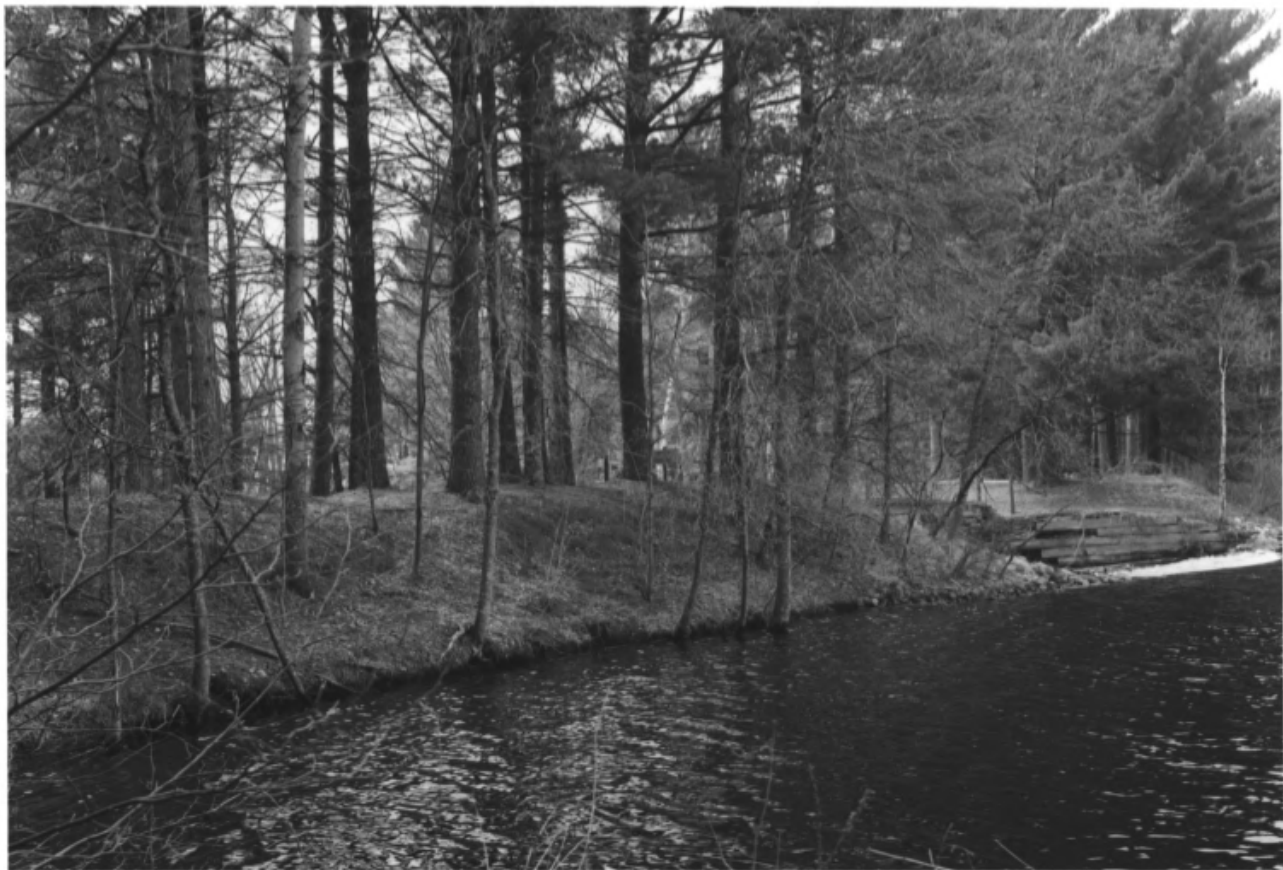
Photograph No. 4

Southeast elevation. This photograph shows the embankment to the south. This section comprises the greater part of the dam's length. Also seen on the right hand side is the deteriorating upstream abutment on the north embankment.

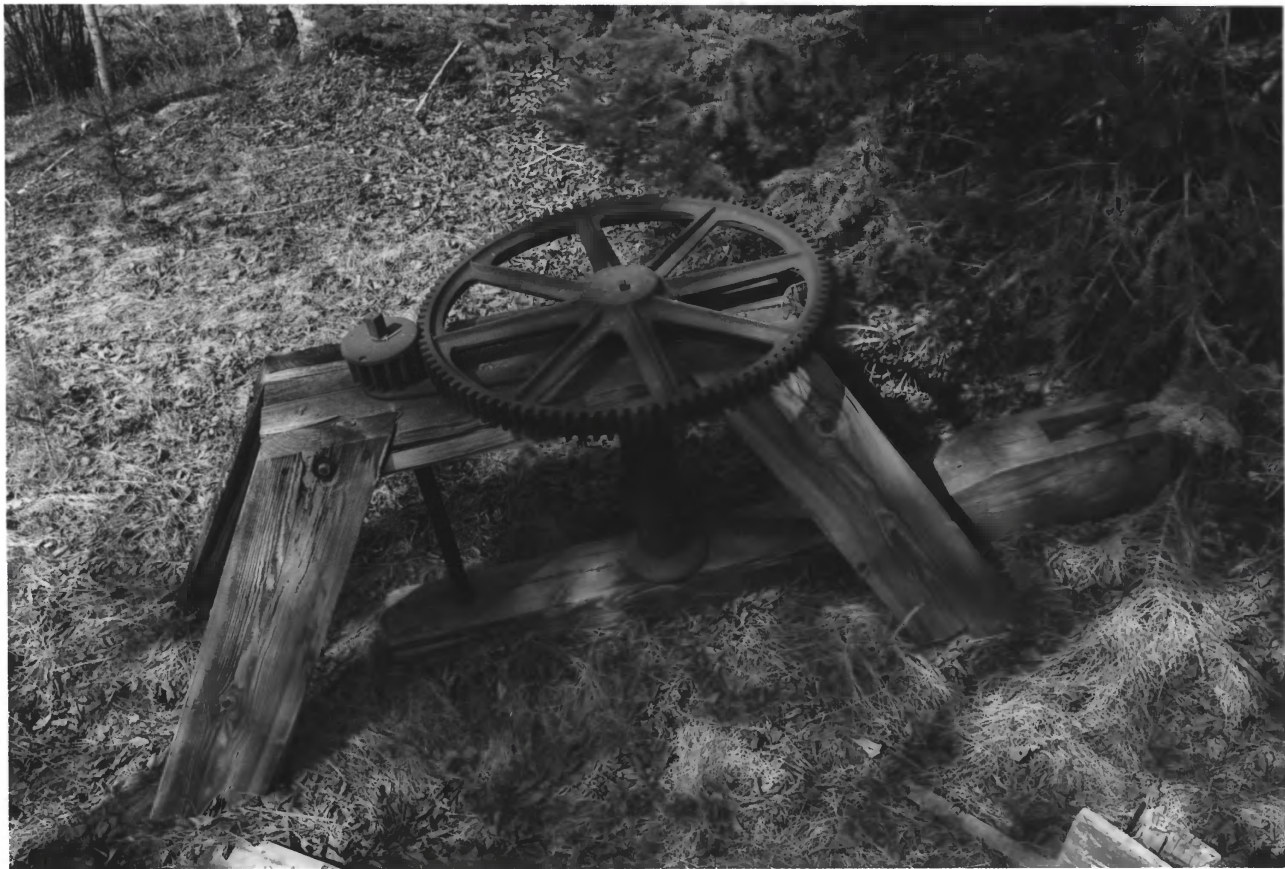
Photograph No. 5

This photograph shows the
machinery used for raising and
lowering the floodgates on the
dam.
