KENTUCKY HISTORIC RESOURCES INVENTORY

Site No. Sc 60

1. Historic Name(s) <u>Ash, Emison, slave quarters</u>		22. ADD/County <u>Bluegrass, Scott</u>	
Original Owner <u>Ash Emison</u>		23. U.S.G.S. Quadrant (15'/75') <u>Plain v.c.</u> G.I.S. Mod. <input type="checkbox"/>

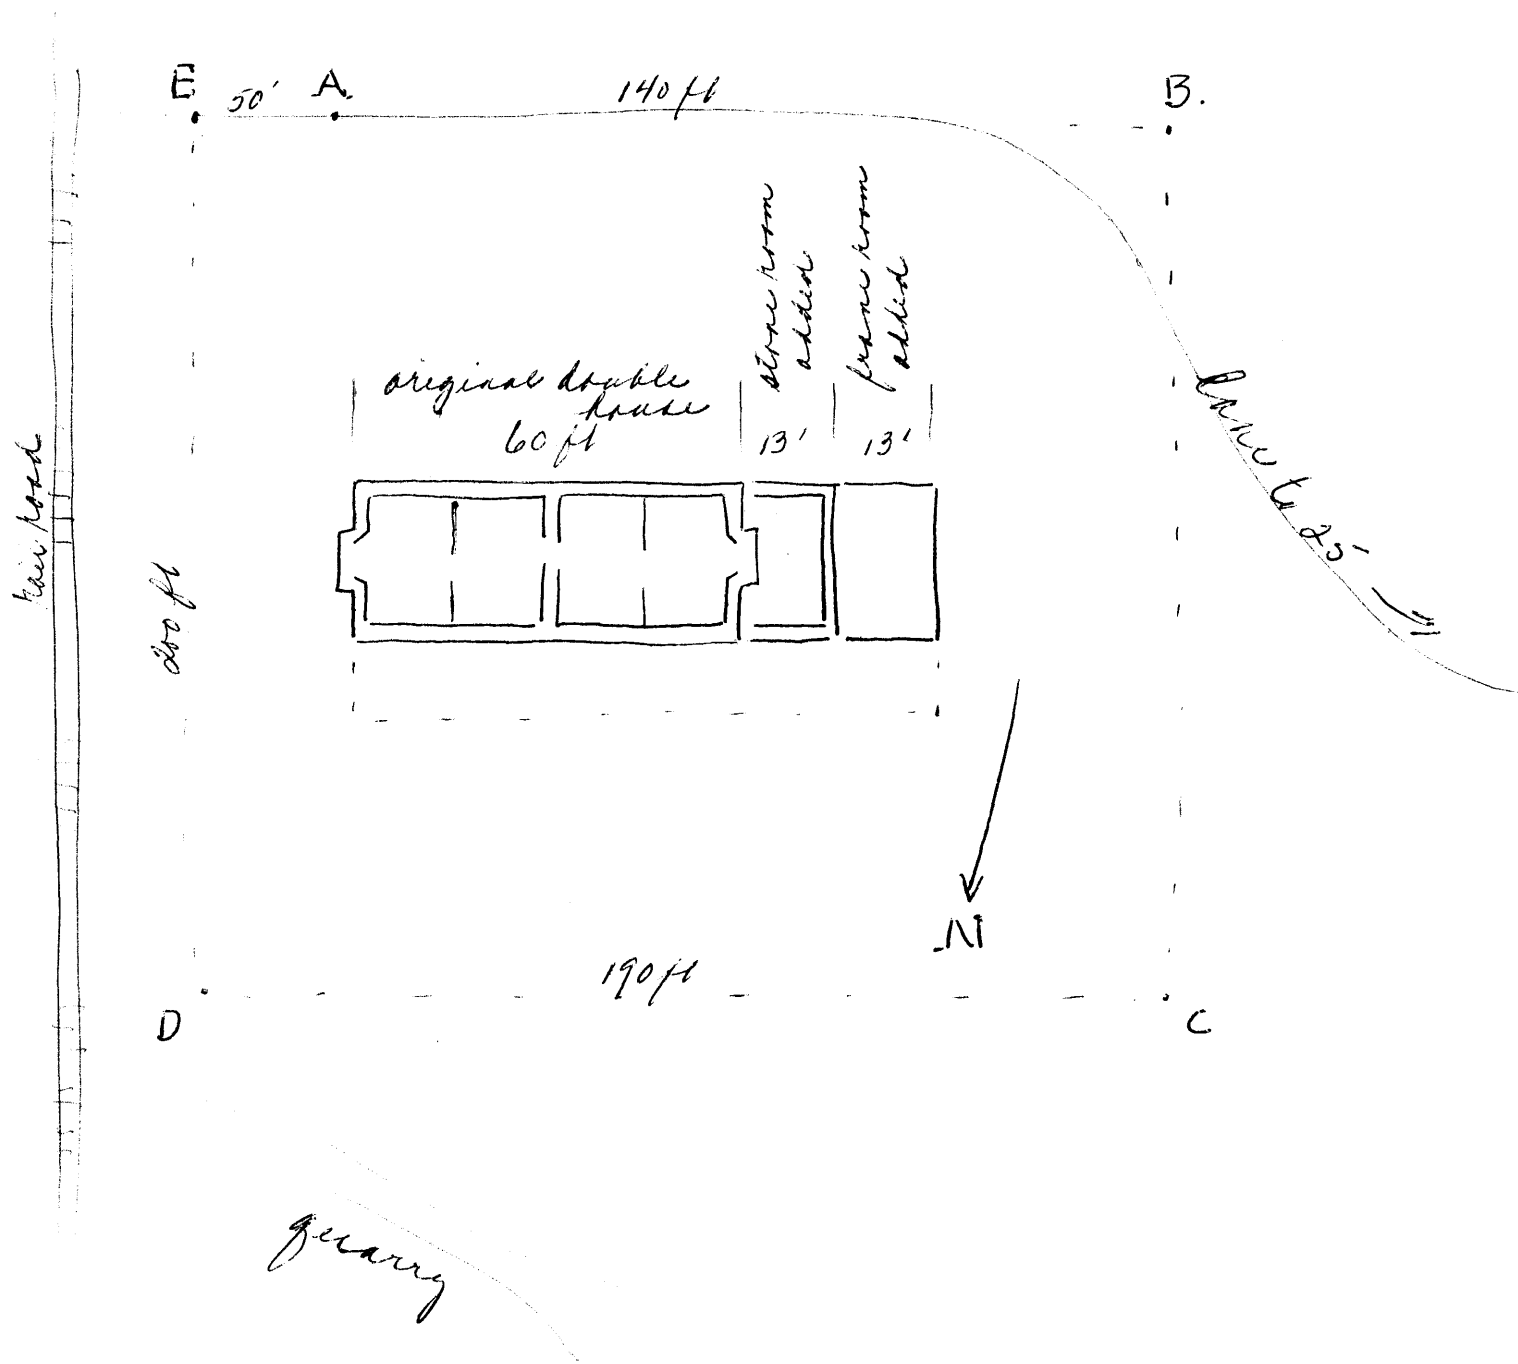
SKETCH MAP OF SITE SHOWING BOUNDARIES AND KEY BUILDINGS AND FEATURES WITH NORTH ARROW.

Beginning at a point 100 ft S of the S.E. corner of the building and on a line w. E. end of same, thence W. 140 ft parallel w S wall of building to B, thence at right angles, N 200 ft to C, thence parallel to A-B E 190 ft to D, thence S 200 ft to E, thence W at right angles 50 ft to the beginning, containing 9/10 acre.
