KENTUCKY HISTORIC RESOURCES Individual Inventory Form

Resource # SH 260

The office has a stone foundation, measures approximately 15 feet square, with a hip roof; 5' plain weatherboard walls with corner trim; an off-centered chimney flue; single light sash windows; original operable shutters and a recessed entry beneath a porch in the southeast SH 260 Dr. Morris house and office

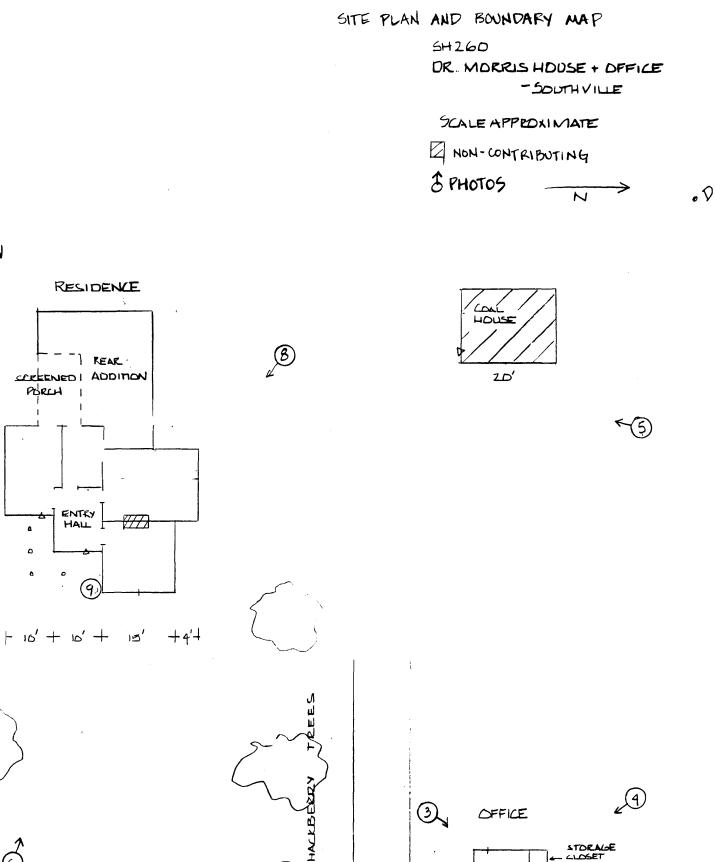
corner of the building. There are two half light entries, one into the waiting room and the other into the office. The office has a built in bookcase from floor to ceiling and there is a small room, said to have been used to store medicines. All interior woodwork is unpainted pine and floors are also of pine. See photos 12-1-3,5.
