National Register of Historic Places Registration Form

historic name Searcy-Matthews-Tarpley Farm

street & number 455 West Jefferson Pike

city or town Walter Hill

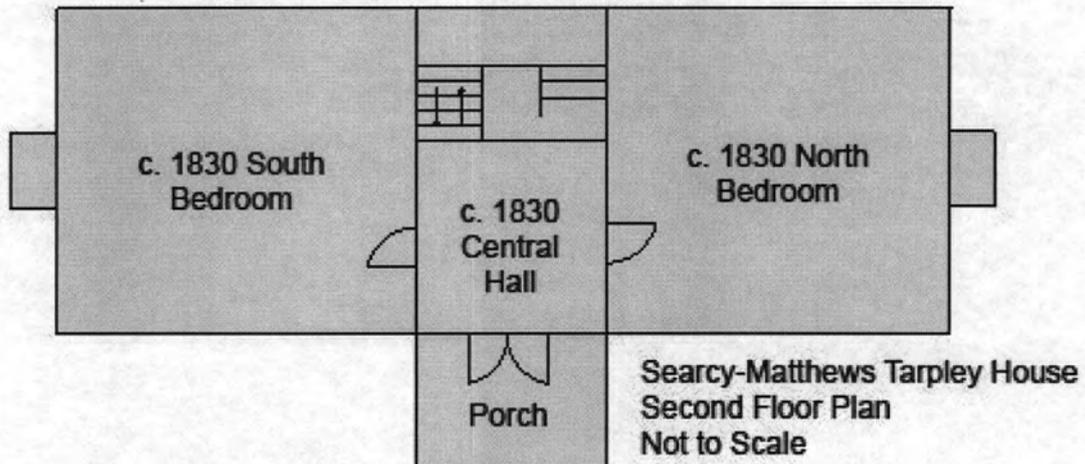
Figure 3. Second Floor Plan.

The second floor of the c. 1830 I-house has a central hall and two original bedrooms. The original staircase extends upward along the north wall to a landing, which extends along the west wall, then continues upward along the south wall to the second floor. The second floor central hall is used as a small sitting area and has original wood floors, original baseboards, an original chair rail, original door surrounds, and an original balustrade with turned wood balusters. The walls and ceiling are plaster. On the east wall is the original door surround with original transom and sidelights that led out onto the second floor balcony. C. 1952, the door was replaced with a pair of eight-light casement window for safety purposes. The north and south bedrooms are accessed from the hall through original four-panel wood doors with original hardware. The bedrooms have original wood floors, original wood baseboards, and original wood window and door surrounds. The walls and ceiling are plaster. The south bedroom has a fireplace that has been filled in. The hearth and surround are glazed brick. The wood mantel dates to c. 1952, has wood paneled pilasters supporting a denticulated wood frieze and mantelshelf. The fireplace in the north bedroom has been removed.

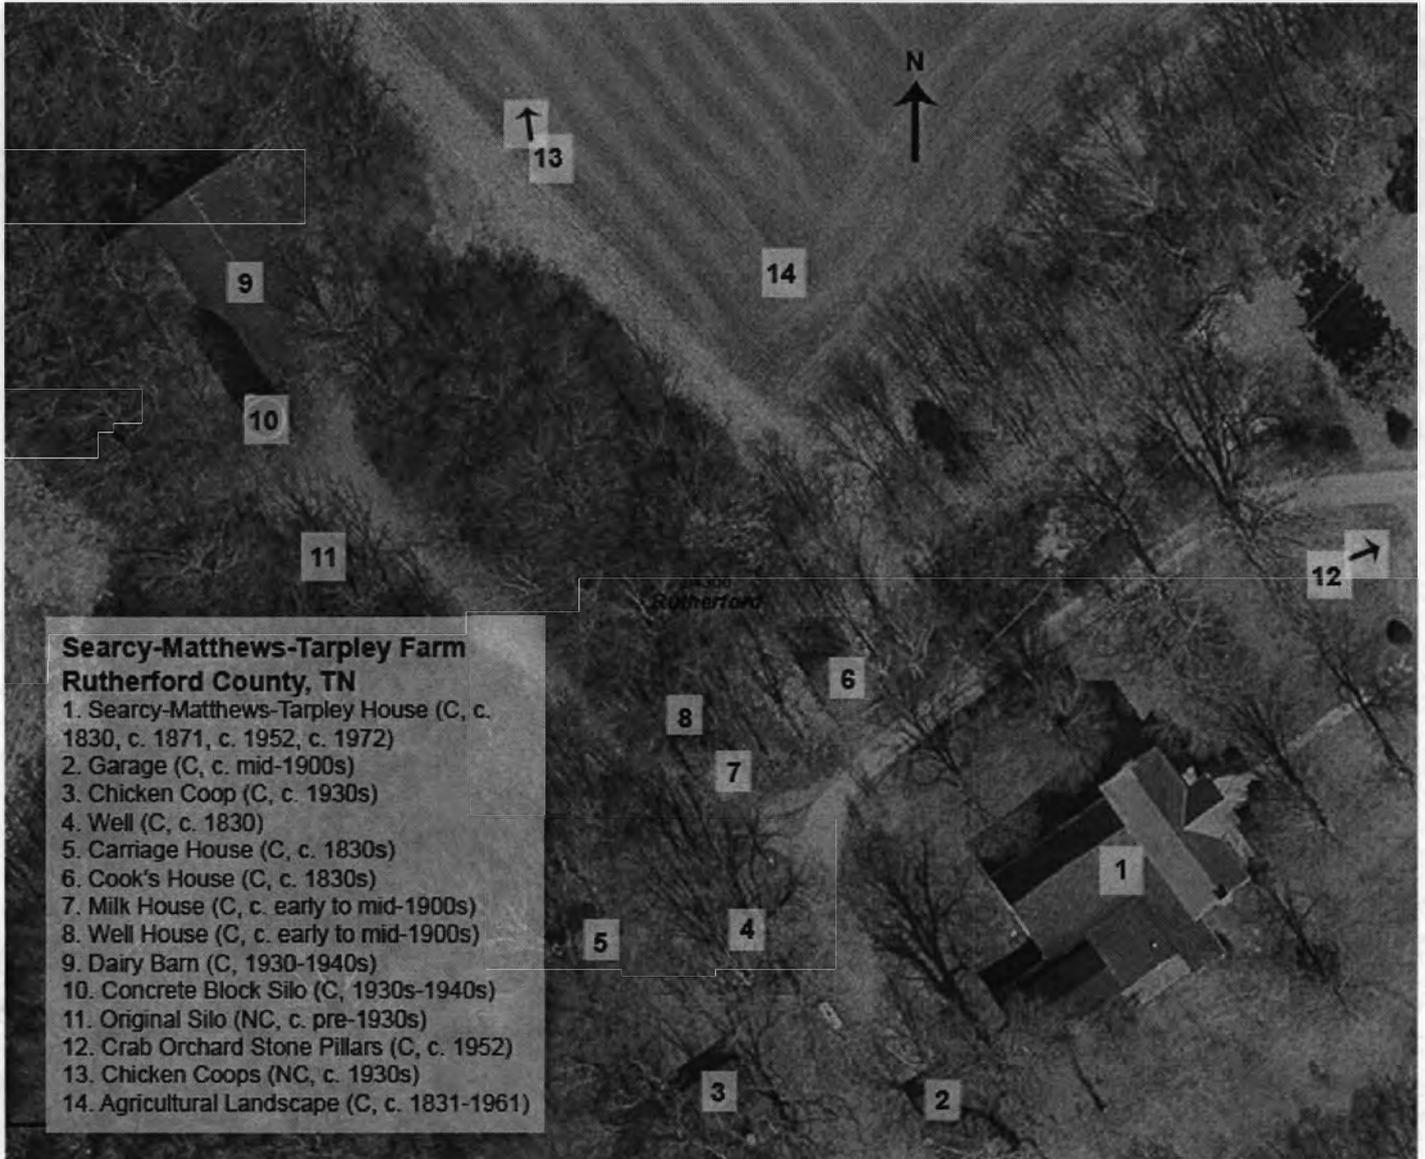
Figure 4. Site Plan.

The house and adjacent outbuildings sit on a relatively cleared area with several mature trees. Eleven contributing outbuildings are extant. Located behind the house are a garage, chicken coop, carriage house and well. Toward the north of the house and leading back to the dairy barn and silo are additional contributing outbuildings including a cook's house, milk house, and well house. One non-contributing structure, the foundation of a demolished silo, is located in the area between the dairy barn and the carriage house, and three non-contributing chicken coops are vacant and in poor condition in the woods at the north end of the property. A line of mature trees separates the domestic complex from the agricultural fields to the north, south, and west.
