# National Register of Historic Places Registration Form

Historic name: Chisholm Commercial Historic District

City or town: Chisholm State: MN County: St. Louis - 137

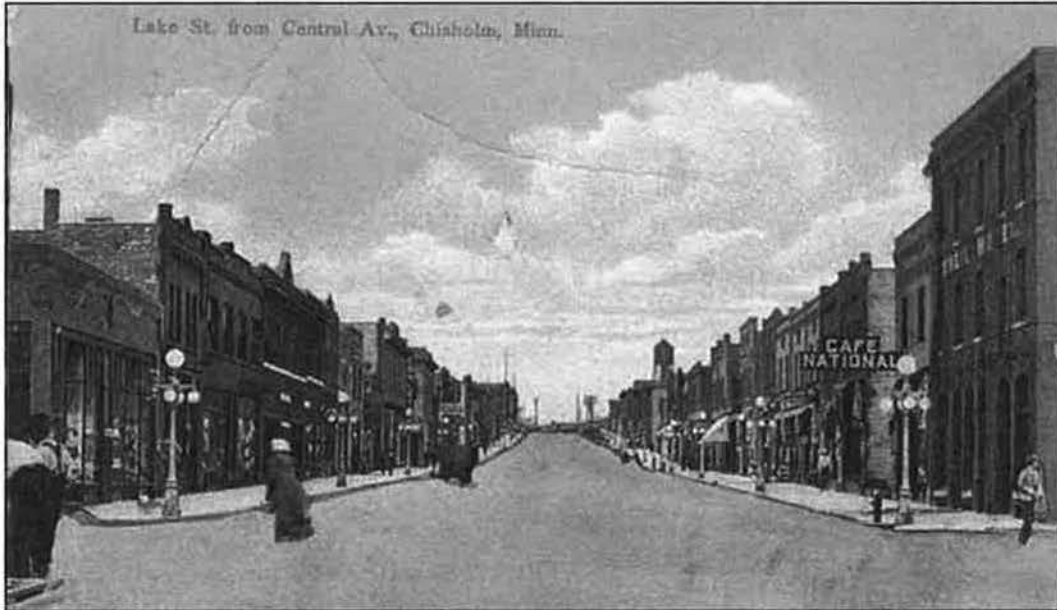
Figure 1. Chisholm Commercial District, 1910

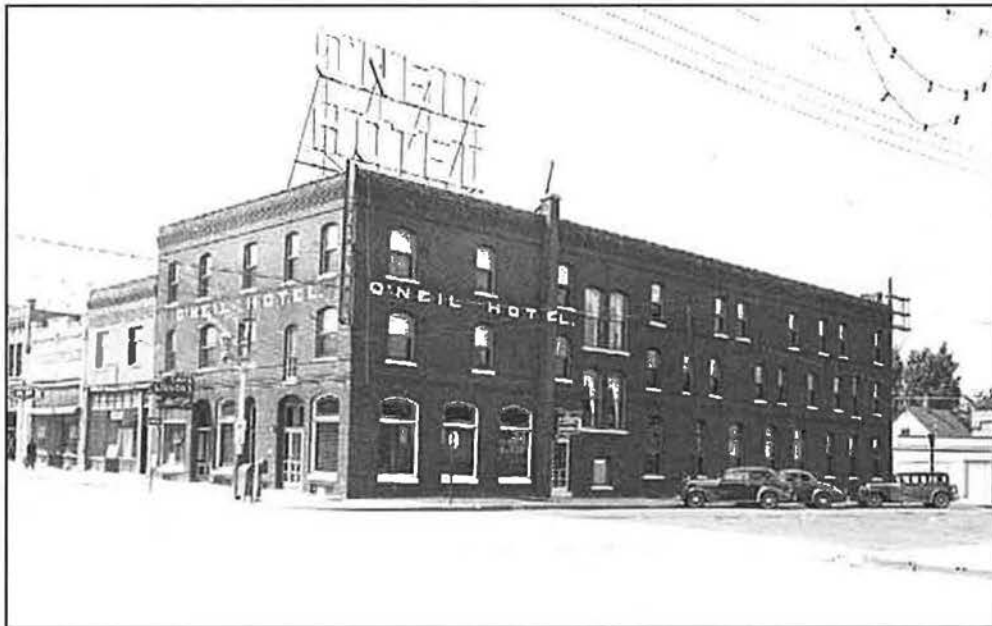
Figure 2. O'Neil Hotel Building 2 W. Lake Street (#2), 1945

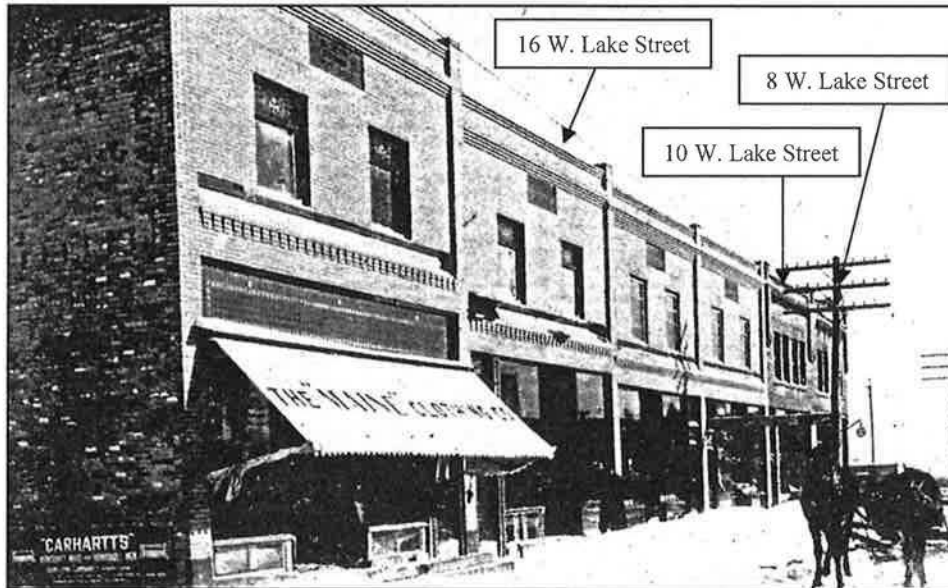
Figure 3. 8, 10, and 16 W. Lake Street (#5, #6, and #9), 1909

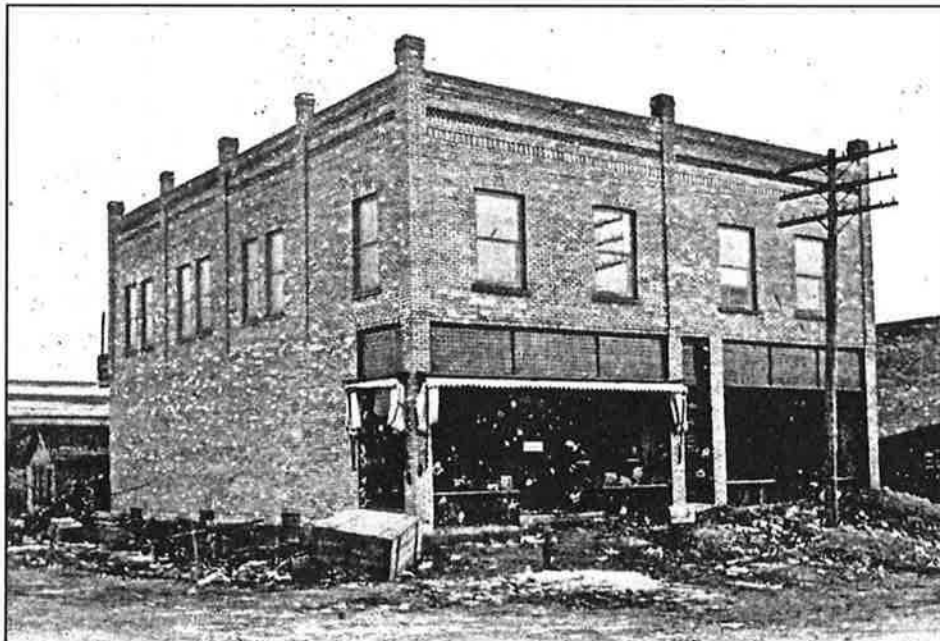
Figure 4. Bergeron Block, 28-30 W. Lake Street (#14), 1909

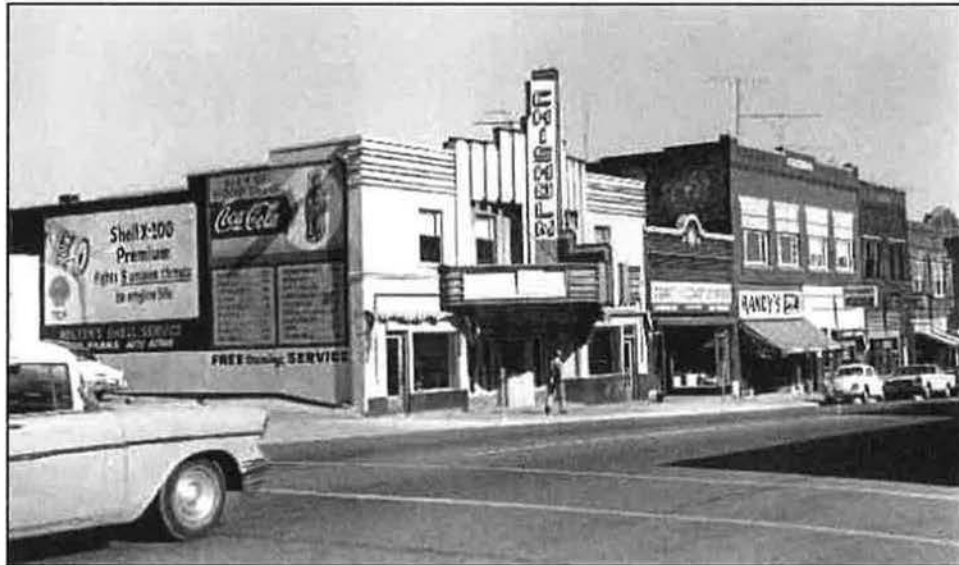
Figure 5. 124-126 W. Lake Street (#22), 1964

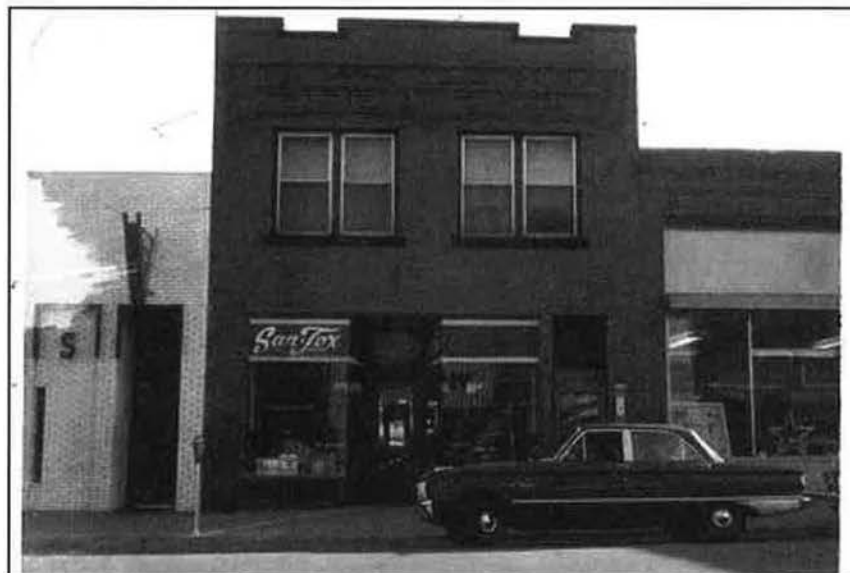
Figure 6. 21 W. Lake Street (#45), 1966

This 1908, two-story commercial building, historically a restaurant, then a clothing store, and then a drug store, exhibits a two-part commercial block form. It is clad in orange brick in a stretcher-bond pattern, and it has a corbelled brick drip course. The storefront is clad in vinyl panels framed in blue-painted wood, somewhat emulating half-timbering. The upper story holds two three-light replacement casement windows with stone sills and white metal surrounds. The building features a flat roof with a brick parapet and metal coping. It has been substantially altered from its historical appearance, which a historical photograph shows included an off-center recessed entry, from which angled large glass display windows, and a crenellated parapet (Figure 6).

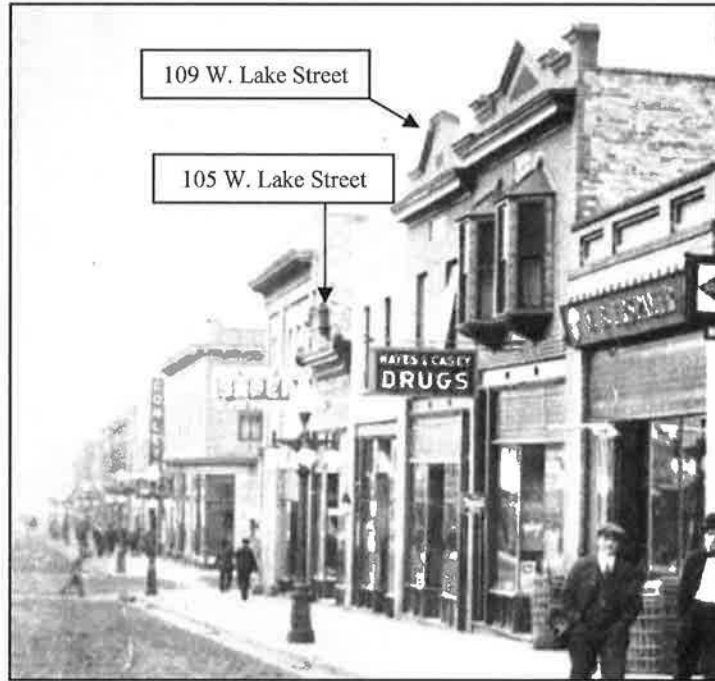
Figure 7. 105 and 109 W. Lake Street (#50 and #52), 1911

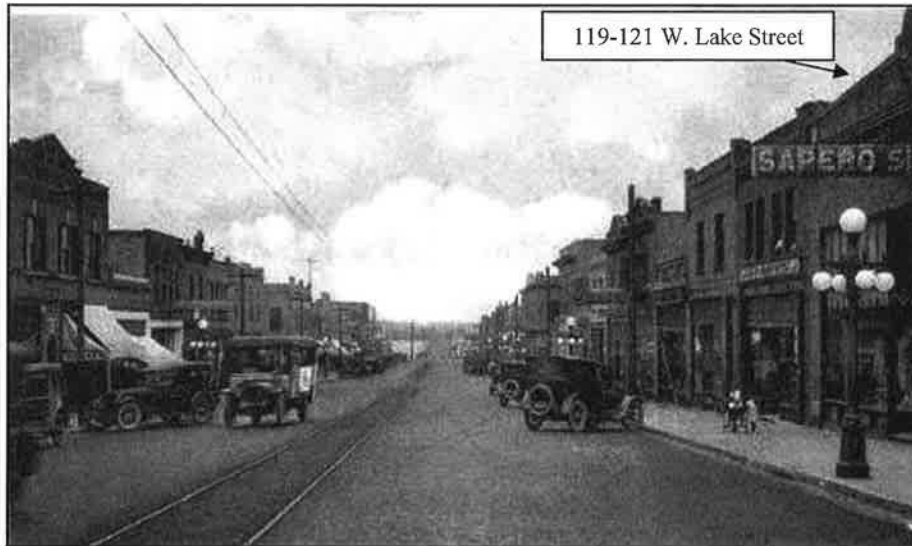
Figure 8. 119-121 W. Lake Street (#57), 1920s

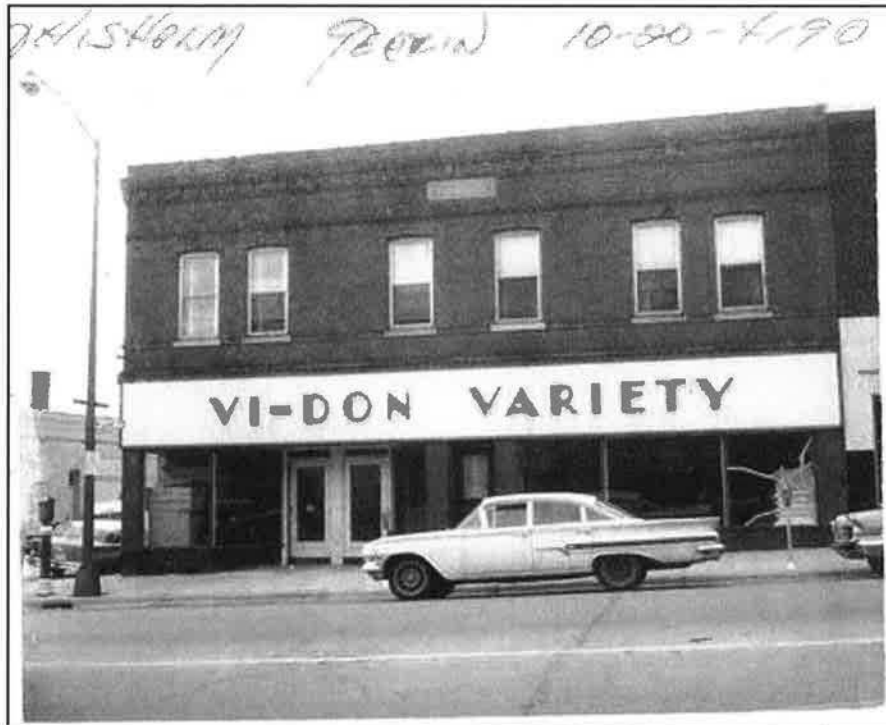
Figure 9. F. Klink Building, 201-203 W. Lake Street (#62), 1966
