National Register of Historic Places
Registration Form

historic name Griffin Auto Company Building

street & number 117 E. Locust Street

city or town El Dorado

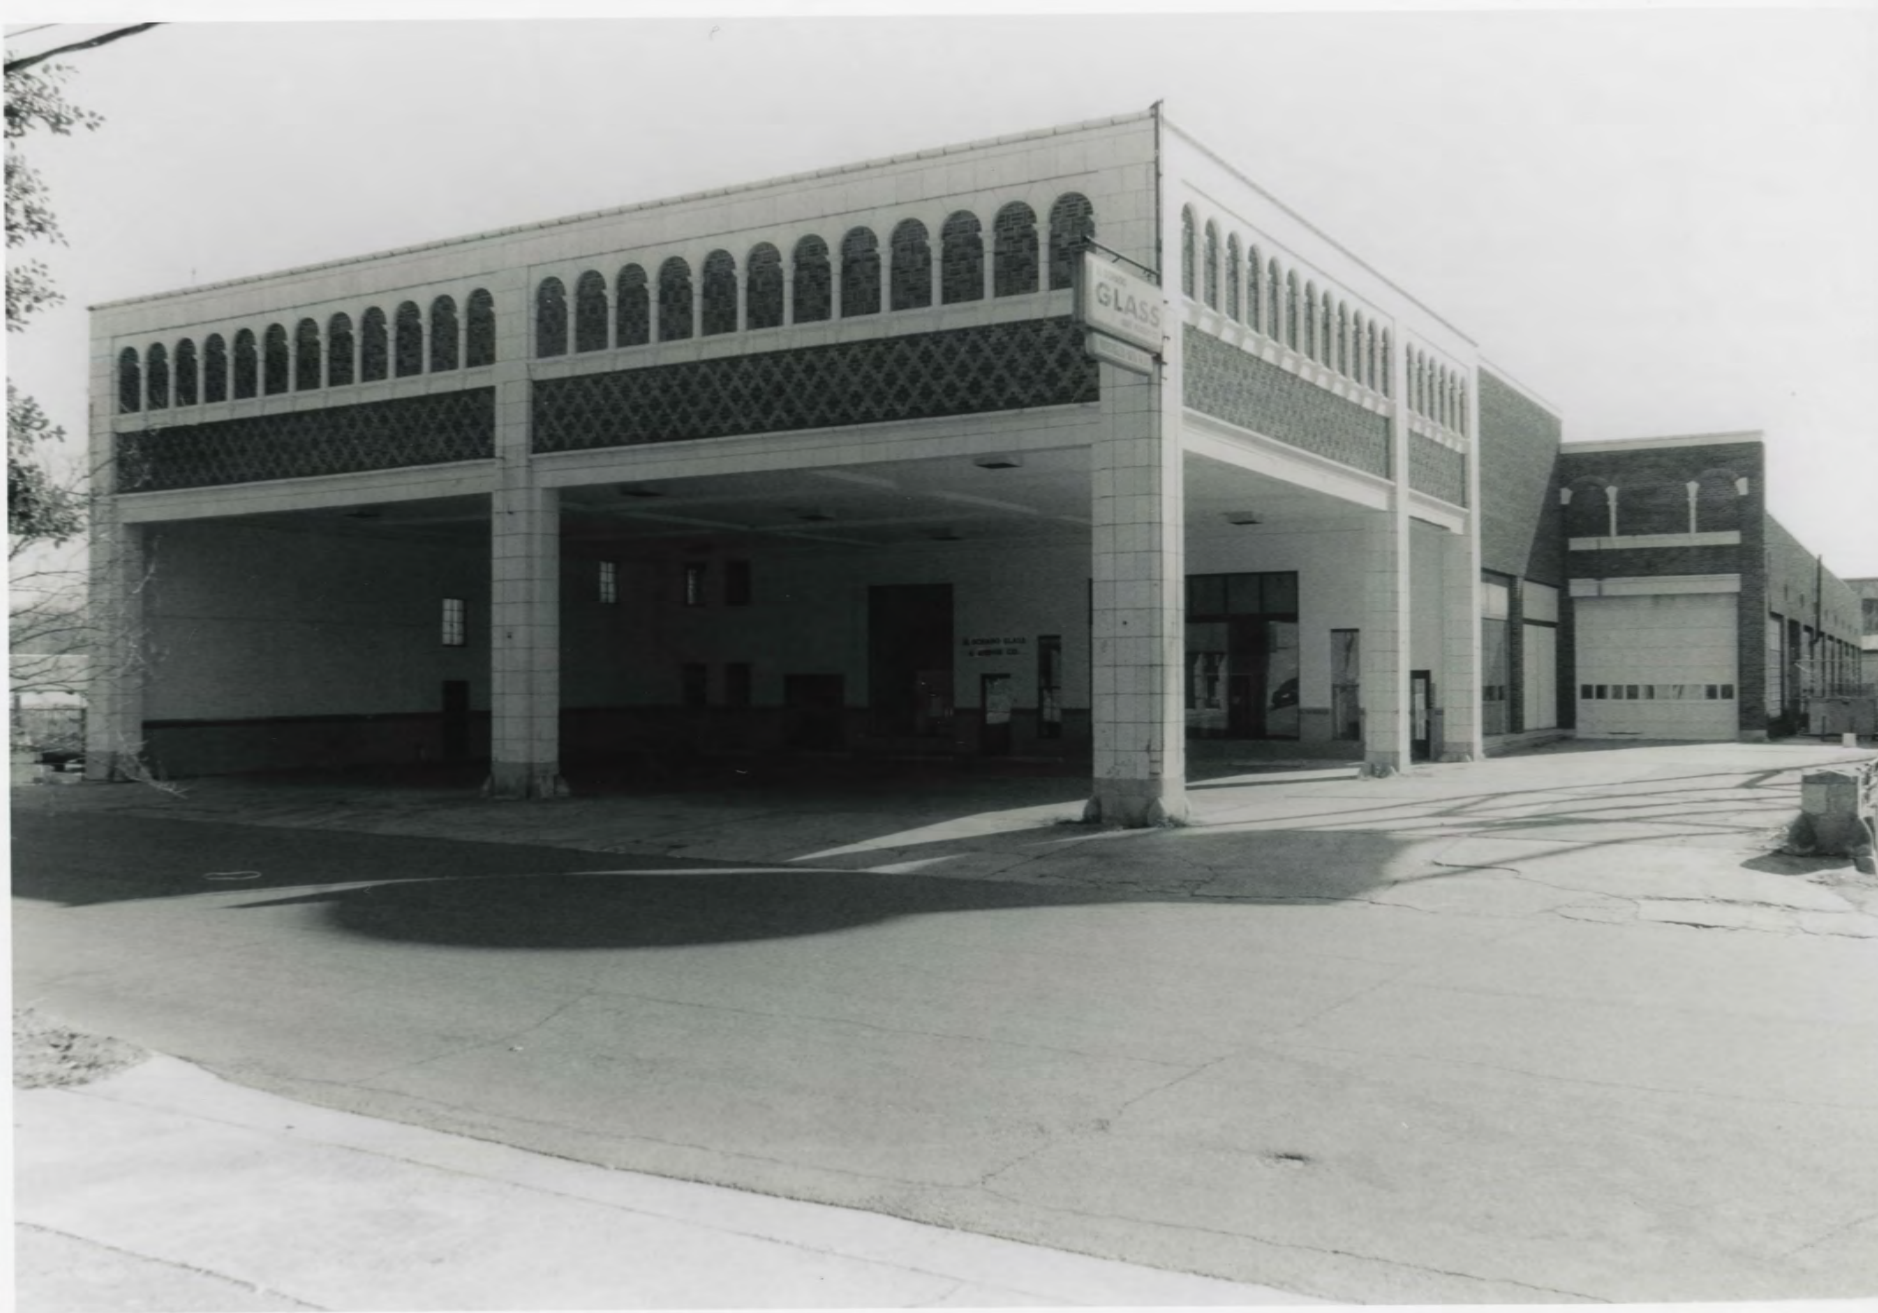
View of North facade and part
of west elevation, looking southeast
(left to right: filling station, showroom,
service station area)

The north and east, or principle, elevations are visible from Locust and S. Jefferson Streets. Three large square columns and two pilasters frame the drive of the filling station. The area above the opening for the car shelter is broken up into ornamental horizontal bands. The decorative bands include a terra cotta cornice over the openings for the car shelter, a lattice pattern of tapestry brick, a string of terra cotta punctuated by corbels, a blind arcade of collonnettes with a variation of a basket weave pattern decorating the wall between them, and plain cornice of terra cotta topping the wall. Originally, metal exterior lamps were positioned on each exterior side of the massive square columns; however, today the only lamp that remains on the exterior of the building is over the garage door of the service area.

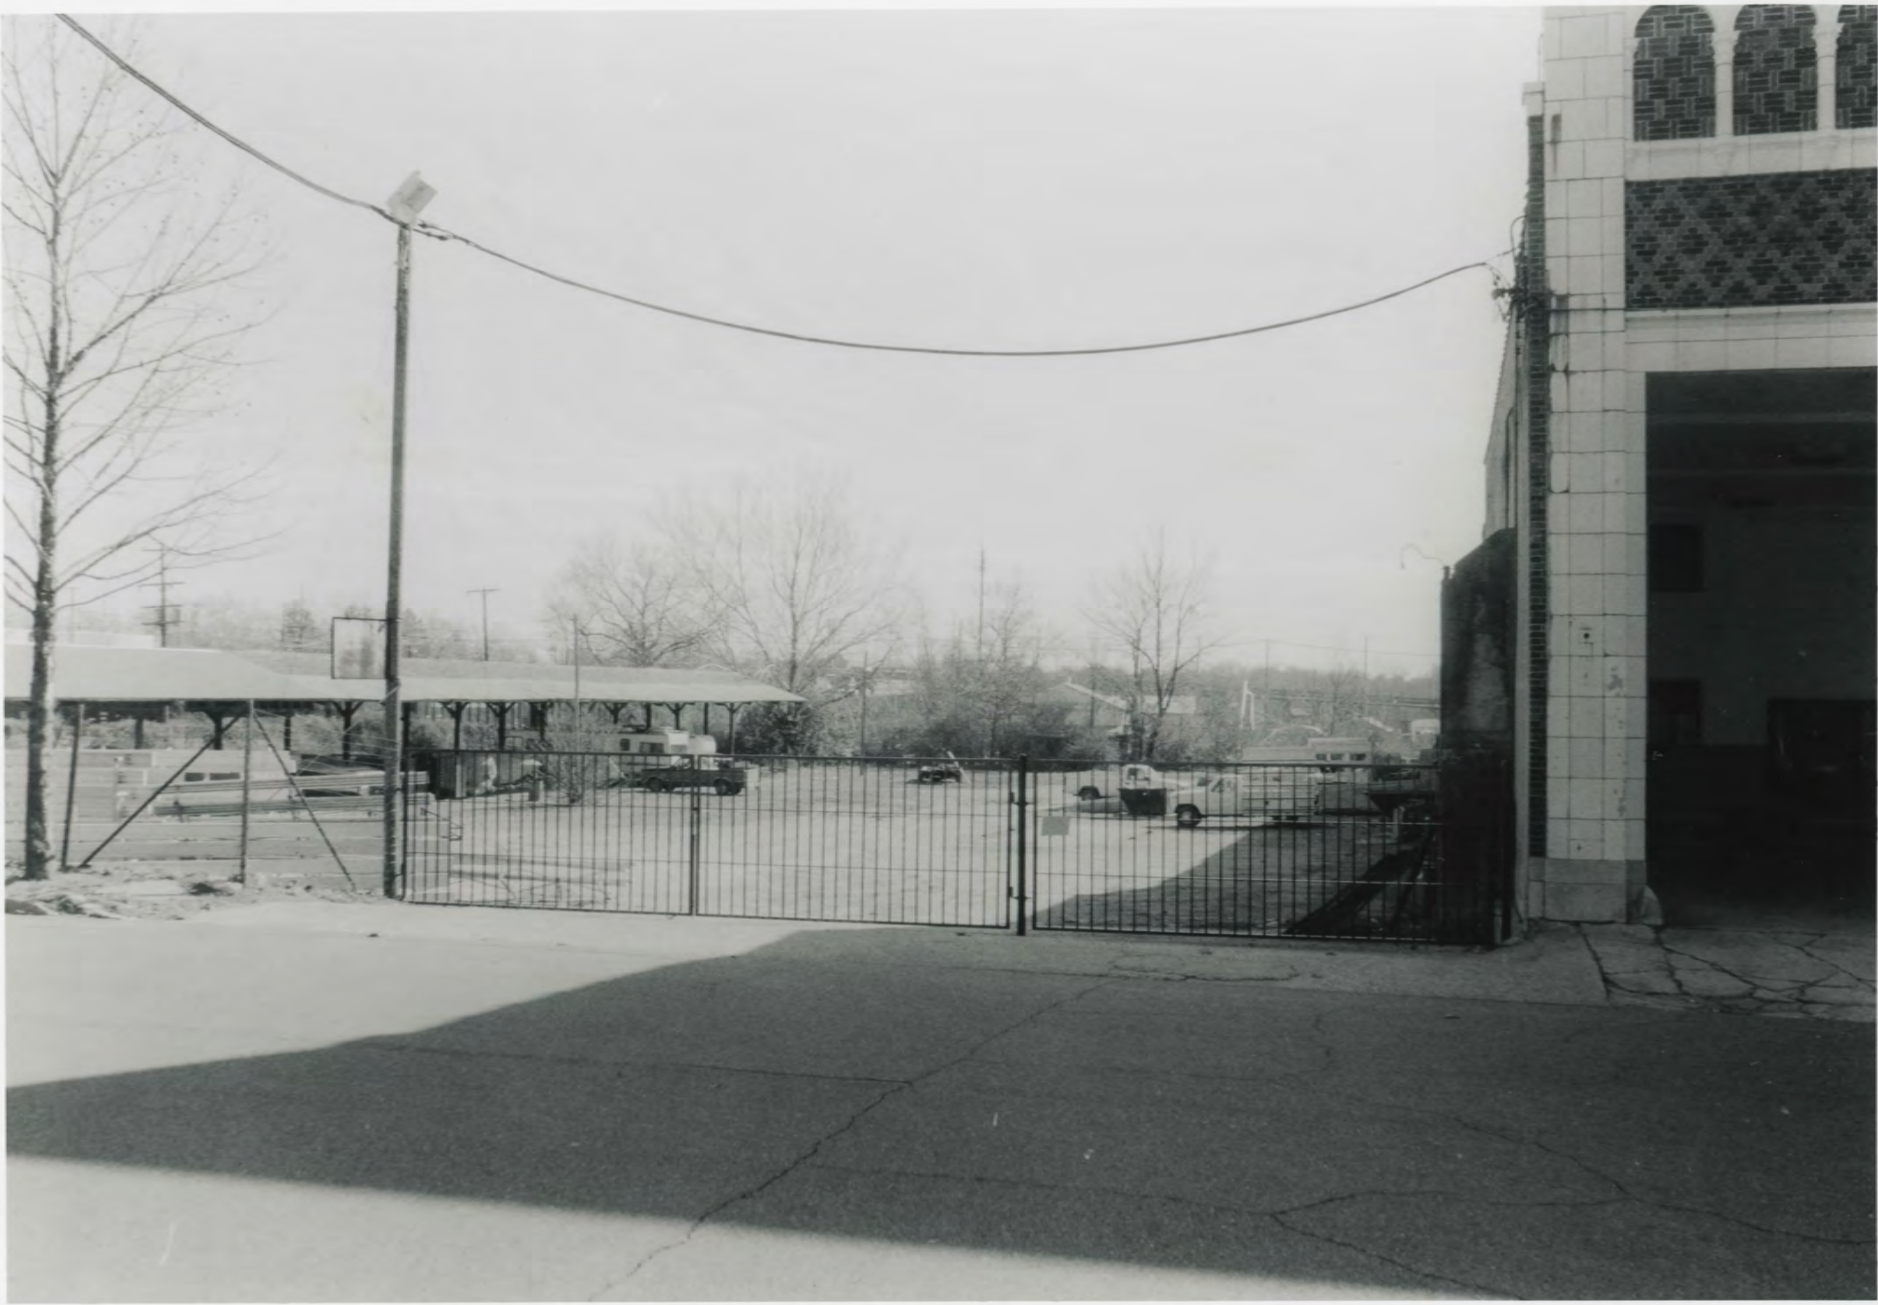
View of non-contribution ancillary
and used car lot and new gates
looking Southeast.

East of the main building is an 8,000 square foot lot that once held a horse stable and riding. The 1929 Sandborn map shows a large gable roof horse stable sitting in the middle of the lot with a circular riding pen directly to the east. An aerial photograph from circa 1945 also shows the roof horse stable and circular riding pen. By the time another aerial photograph was taken circa 1950, the ancillary structure has been removed and the space is filled by used vehicles and a small shed-roofed building. Since 1985 a large gable metal roofed open -sided structure has been used to store recreational vehicles and other equipment. This structure is non-contributing to this nomination.

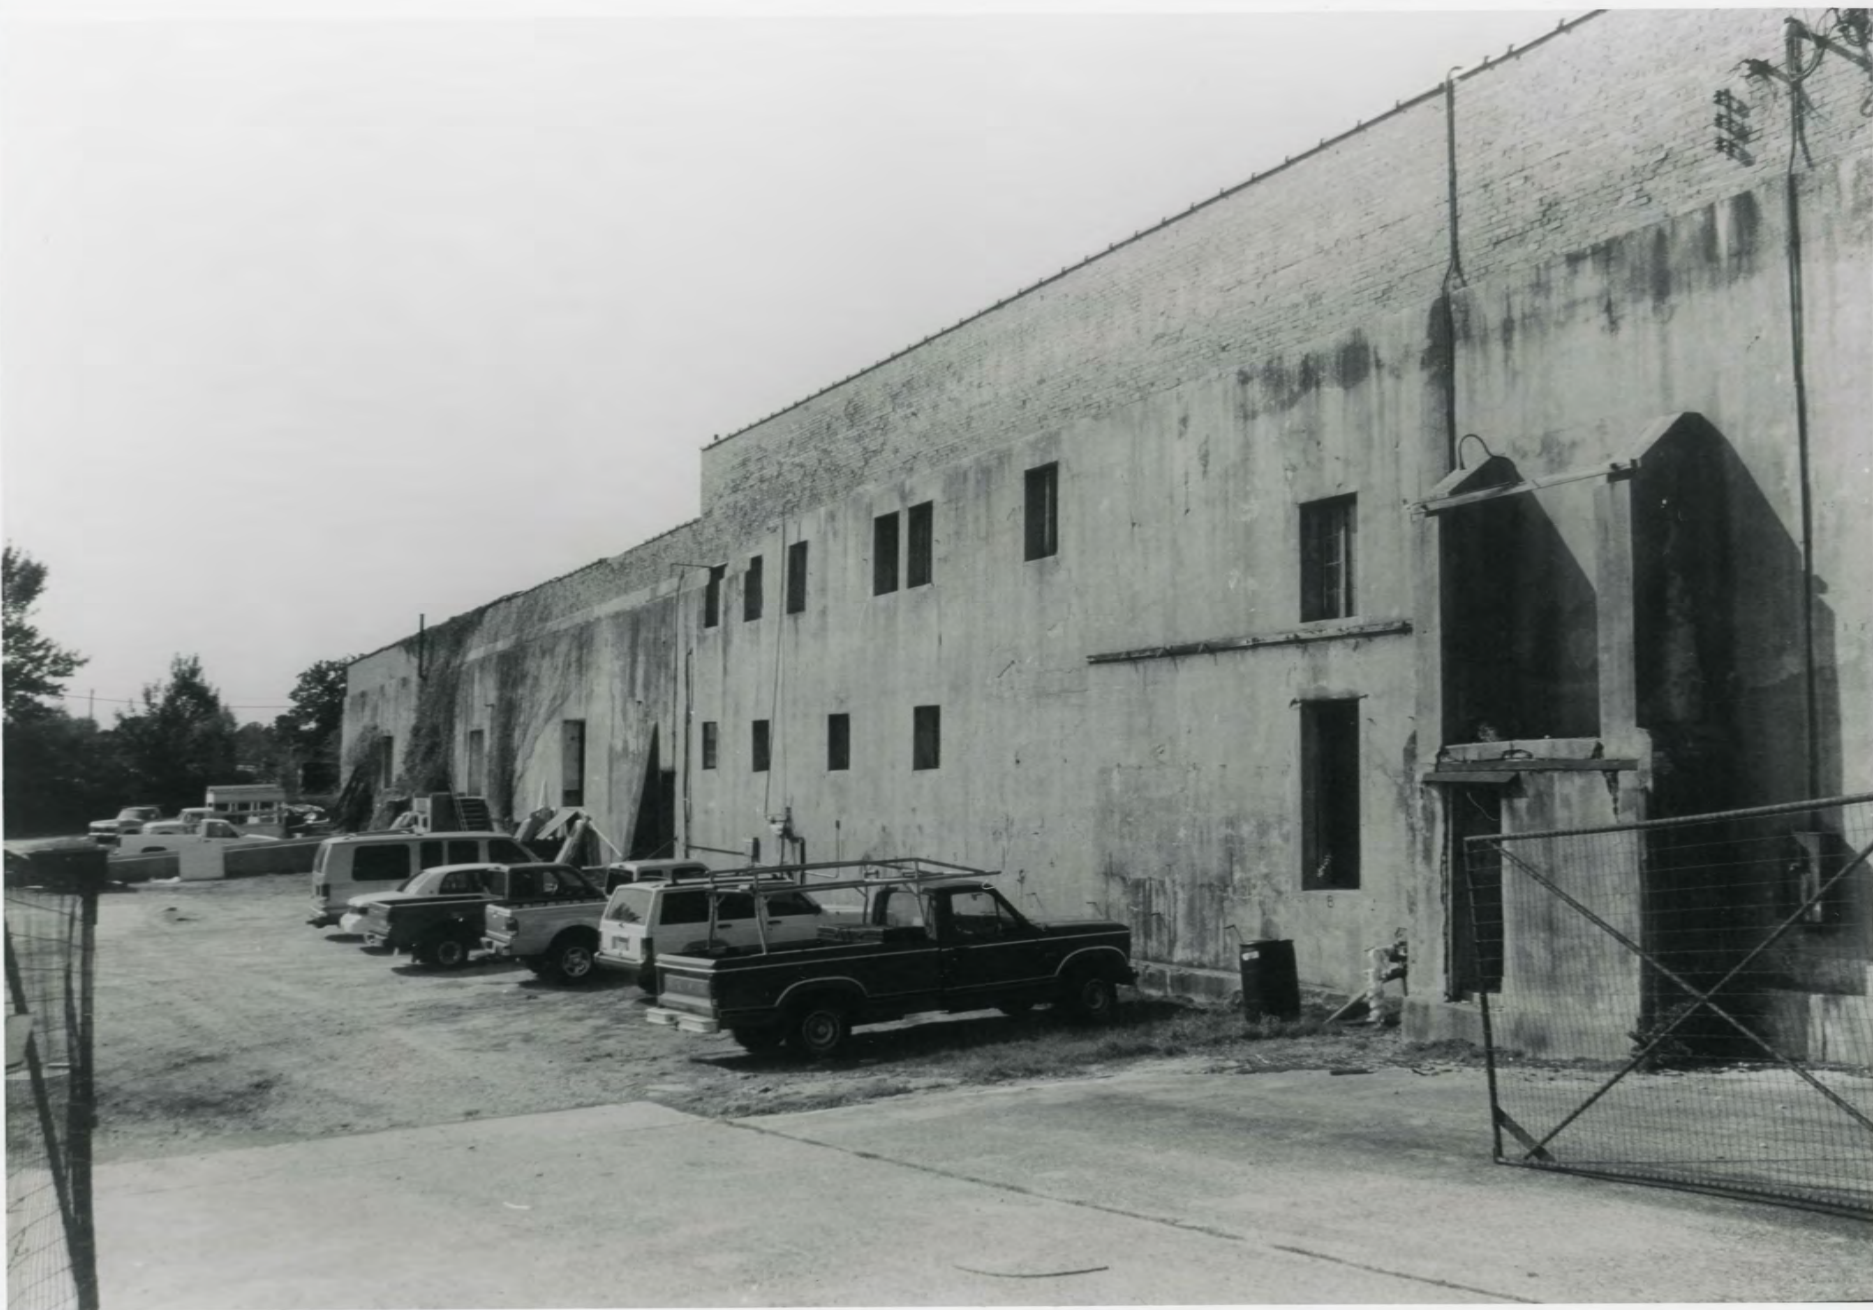
View of Eastern elevation looking
southwest. (Note gates were older
and were replaced shortly after photo
was taken)

The east wall runs the entire length of the building. The wall is stuccoed except for the portion that rises above the roofline to form a parapet. On the parapet a ghost sign indicates the words "Griffin Auto Co." The fenestration on this elevation is composed of six-beside-six and eight-beside-eight casement windows with obscured wire glass panes. A small projection near the northeast corner accommodated an exterior restroom that now lacks both a door and a roof. Entry into the interior is gained by a flight of stairs leading to a double-leaf metal door. Heavy equipment and vehicles can be loaded into the service area by way of three large garage doors located along the south portion of this elevation.

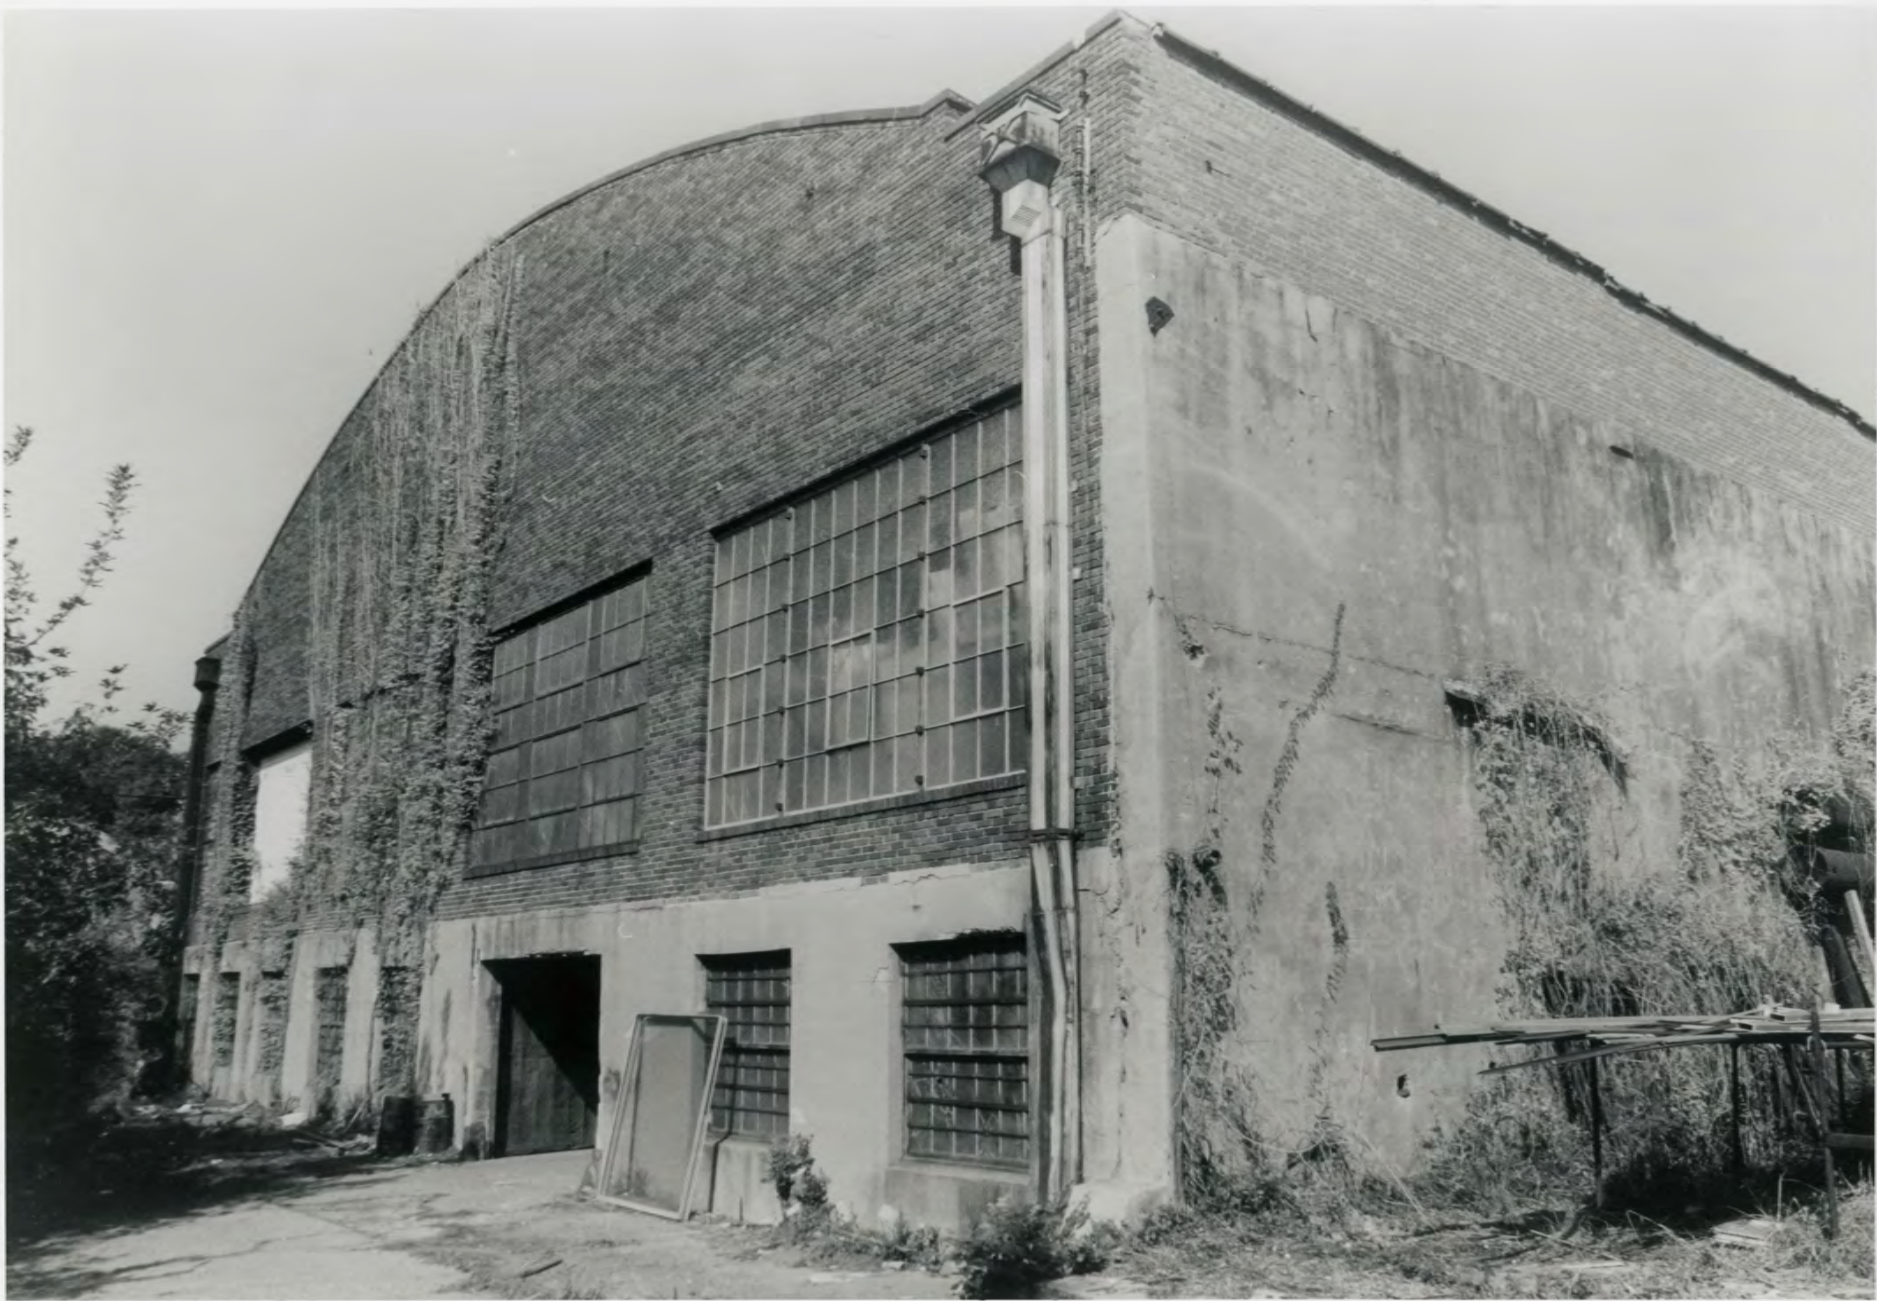
View of rear (south) elevation looking
northwest.

The rear façade parallels the railroad tracks. The wall constructed of red brick, and a coating of stucco denotes the raised basement. The elevation is fenestrated on the first floor by four eighty-four-light metal windows with panes in the center that crank outward to allow for ventilation. One window has been infilled, but the rest are in relatively good condition. Below, the fenestration of the raised basement is composed of seven twenty-four-light metal windows. A large opening near the southeast corner of the basement provided easy access for railroad shipments of

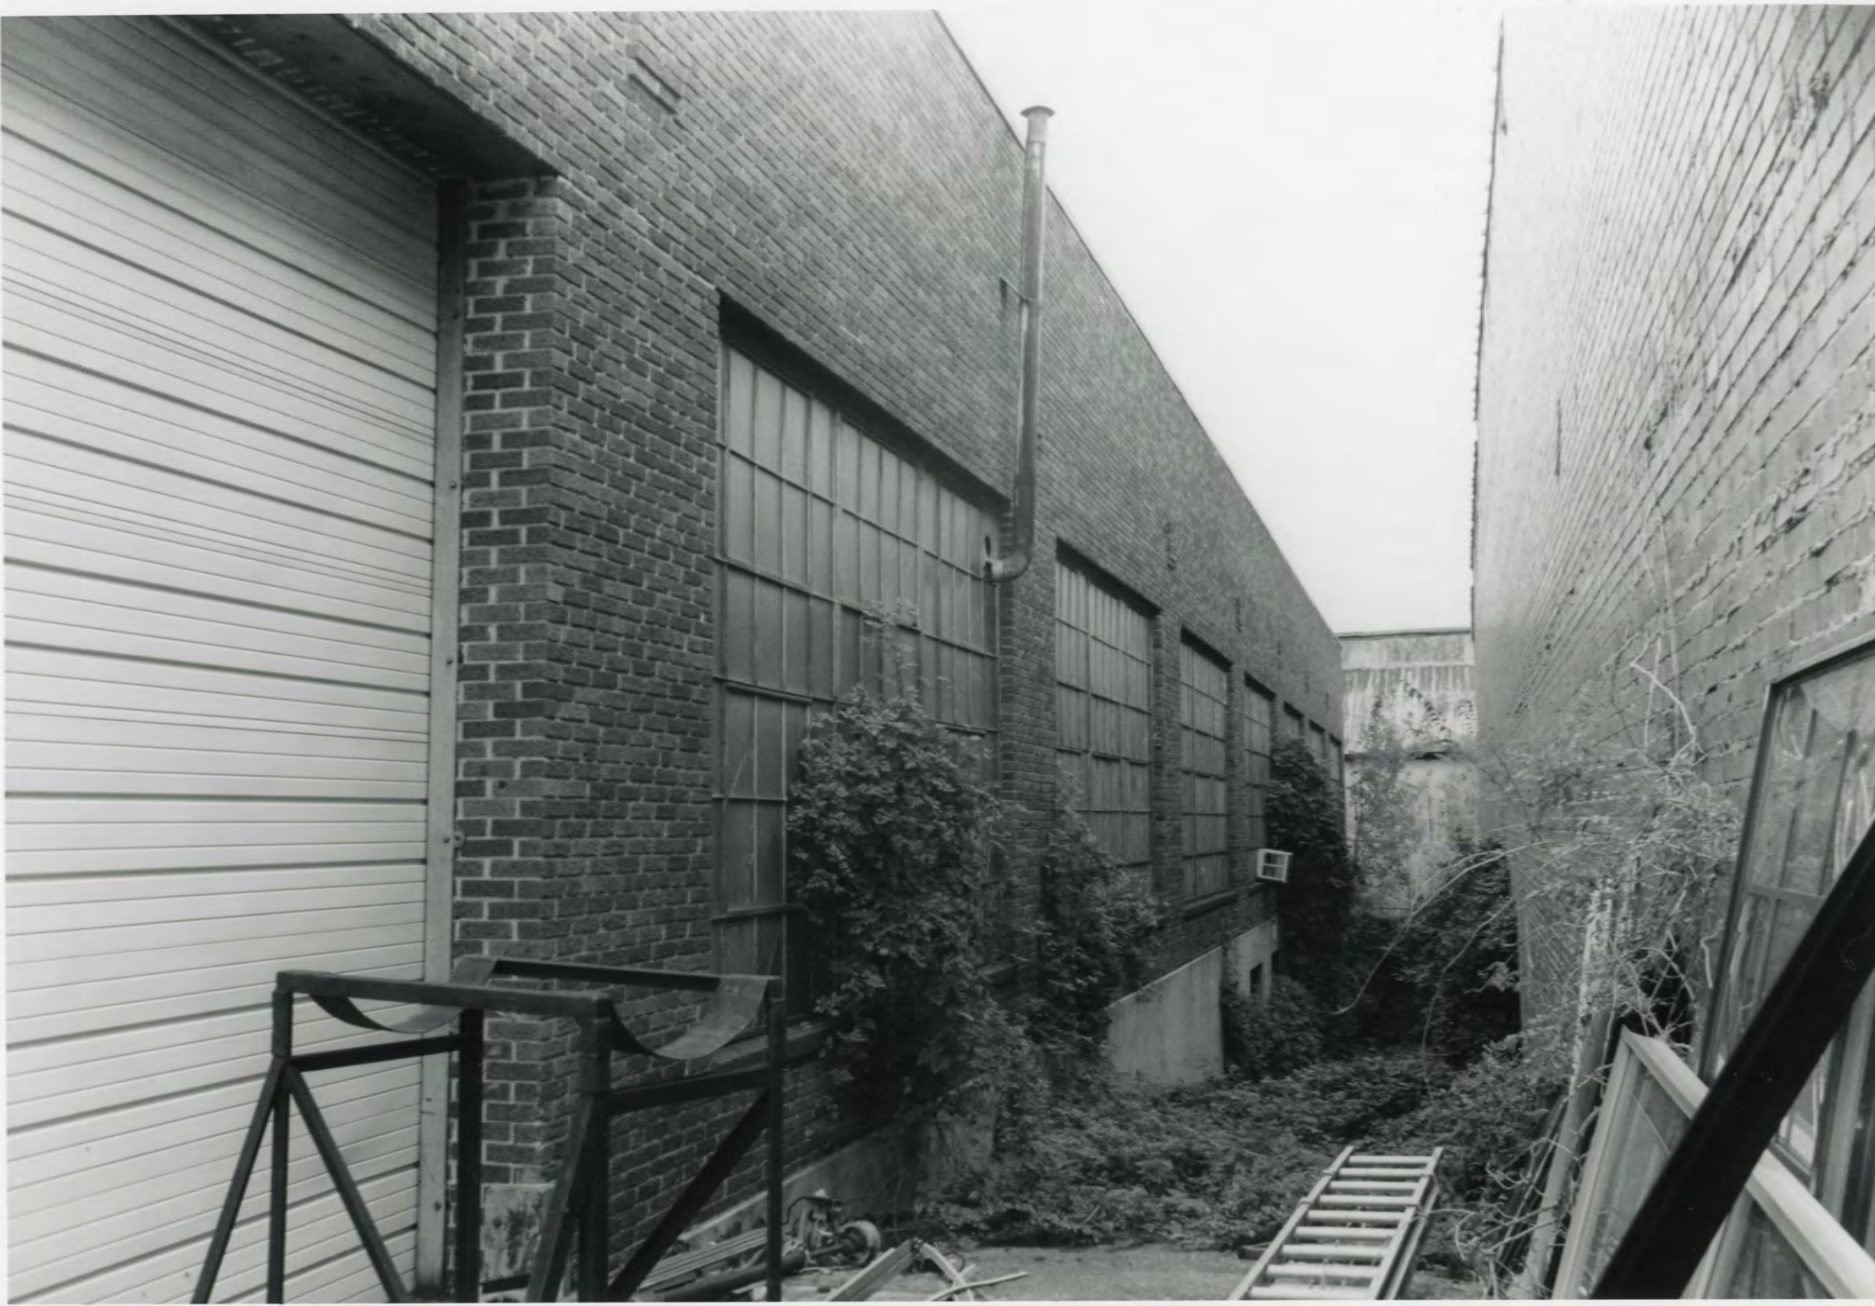
View of west elevation of service area
looking south east.

The barrel vault that covers the service department is hidden from view by a small raised parapet. A wood paneled garage door decorated by a pair of collonettes and three brick arches visually links this portion with the filling station. Inside a metal truss ceiling allows for an interior clear of supporting posts. Large multi-paned metal windows and skylights help light the enormous space.

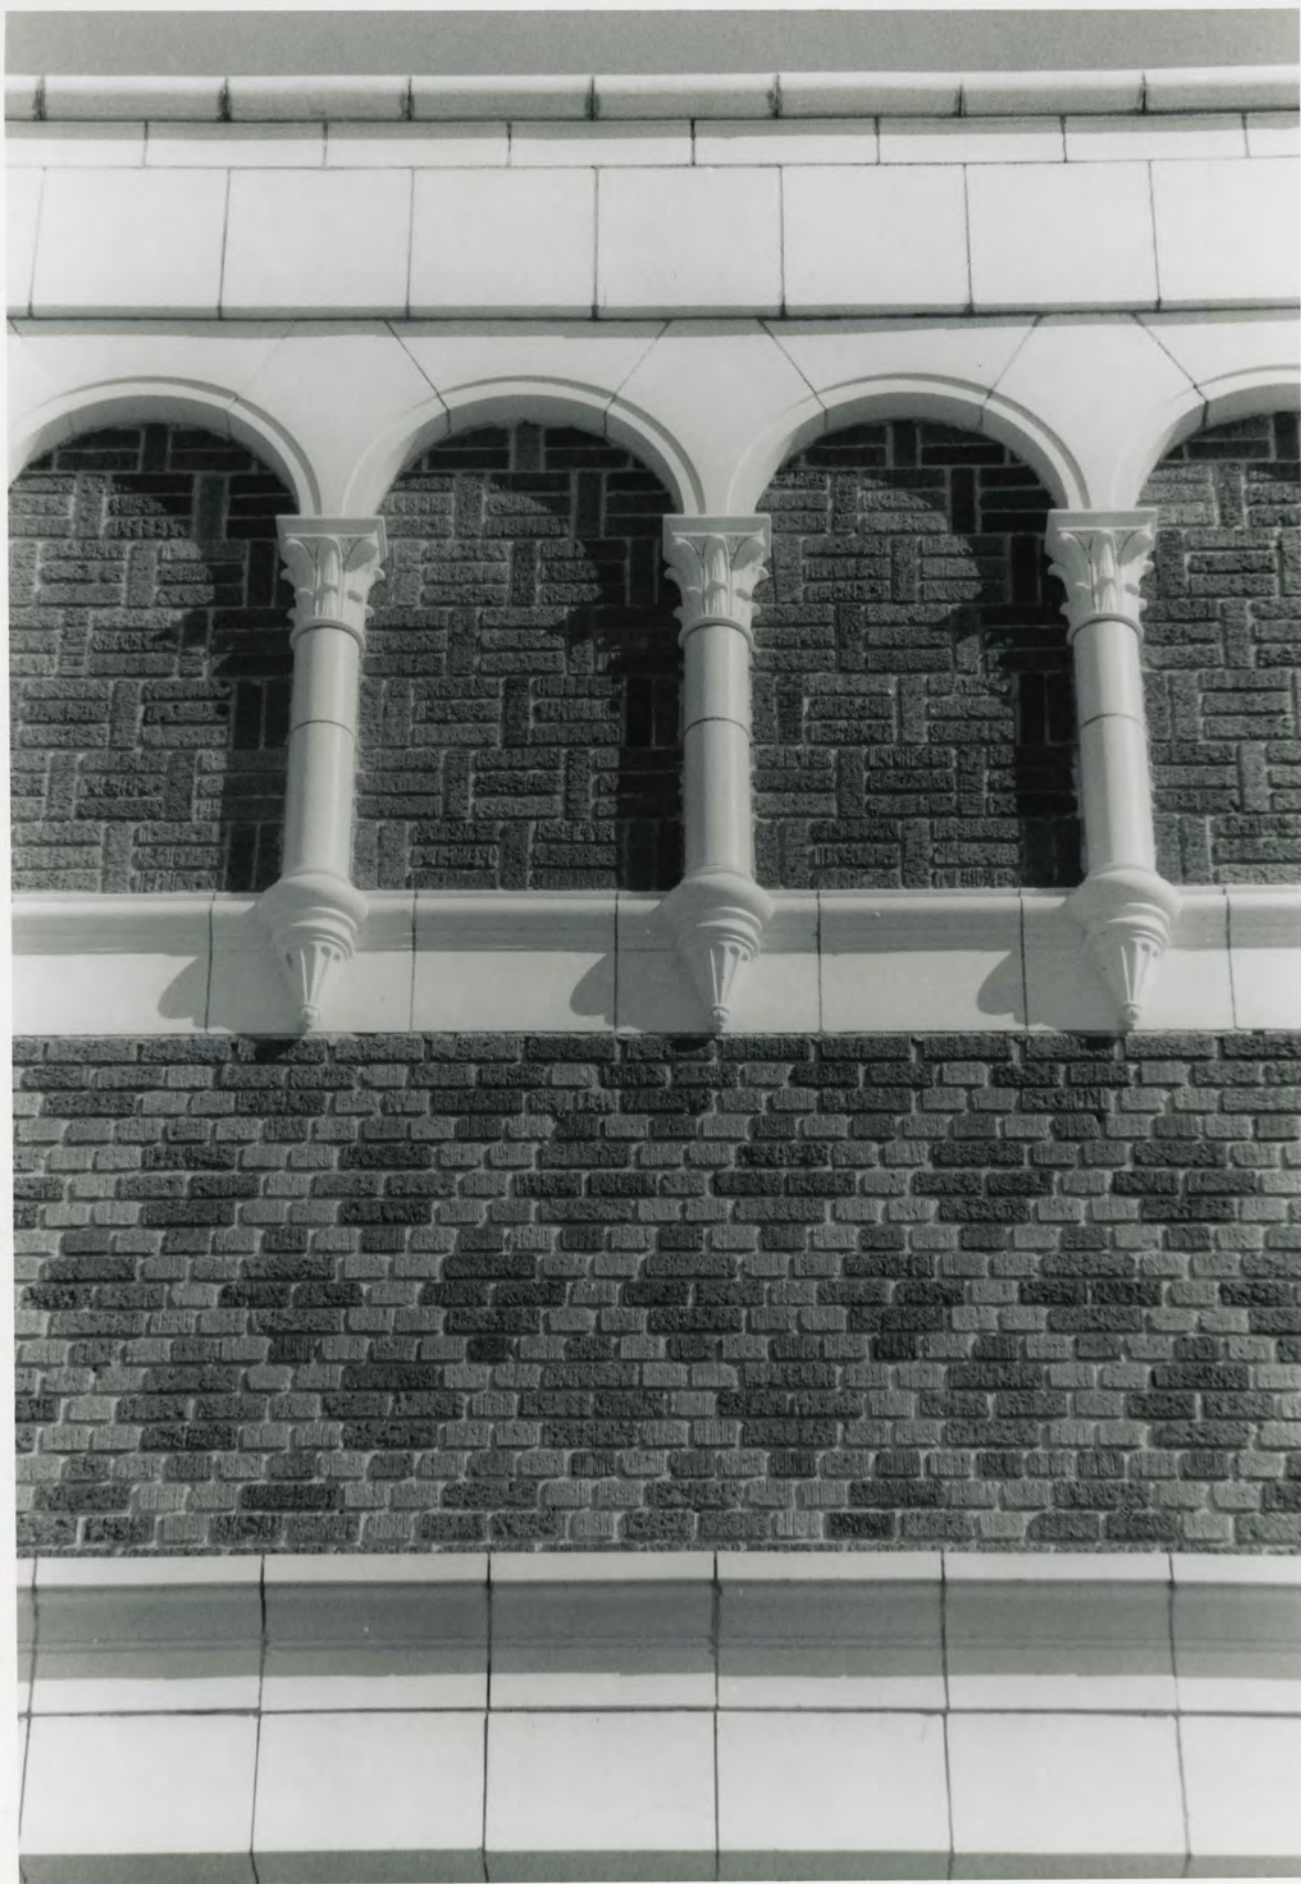
January 2001
Close up of blind arcade on west
elevation looking east.

Despite its utilitarian usage, and reinforced concrete construction, the Griffin Auto Company Building makes use of a variety of surface ornamentation on its prominent elevations. The filling station portion contains the most decorative details including a glazed terra cotta blind arcade that wraps around two sides of the building, and buff/brown tapestry brick. Glazed white terra cotta blocks decorate the square columns that support the large openings for the car shelter. The area above the shelter is broken up into decorative horizontal bands that utilize tapestry brick, cornices of white terra cotta, and a blind arcade of Corinthian colonnettes.

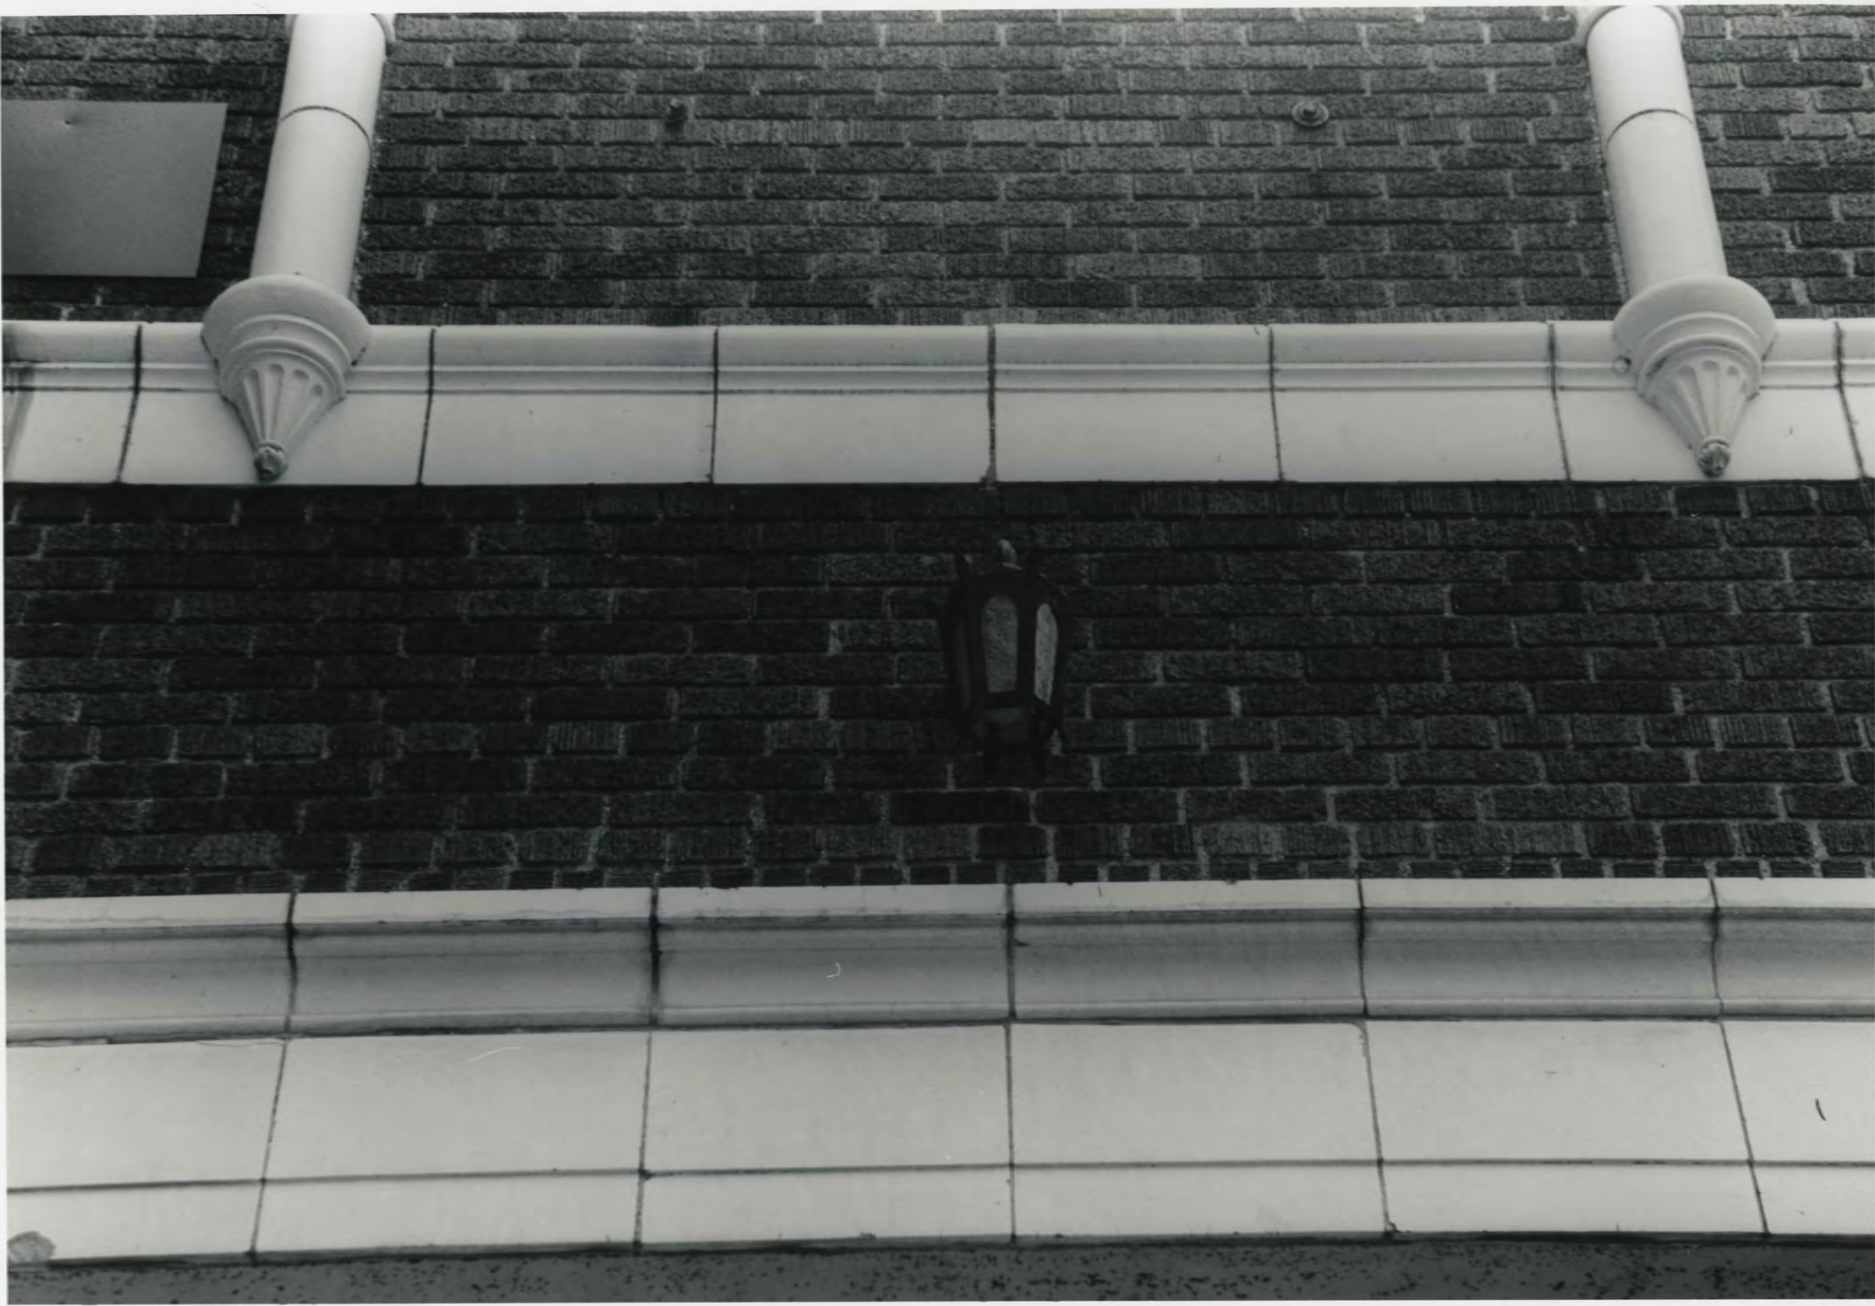
Detail of lamp above north elevation
service area garage door.

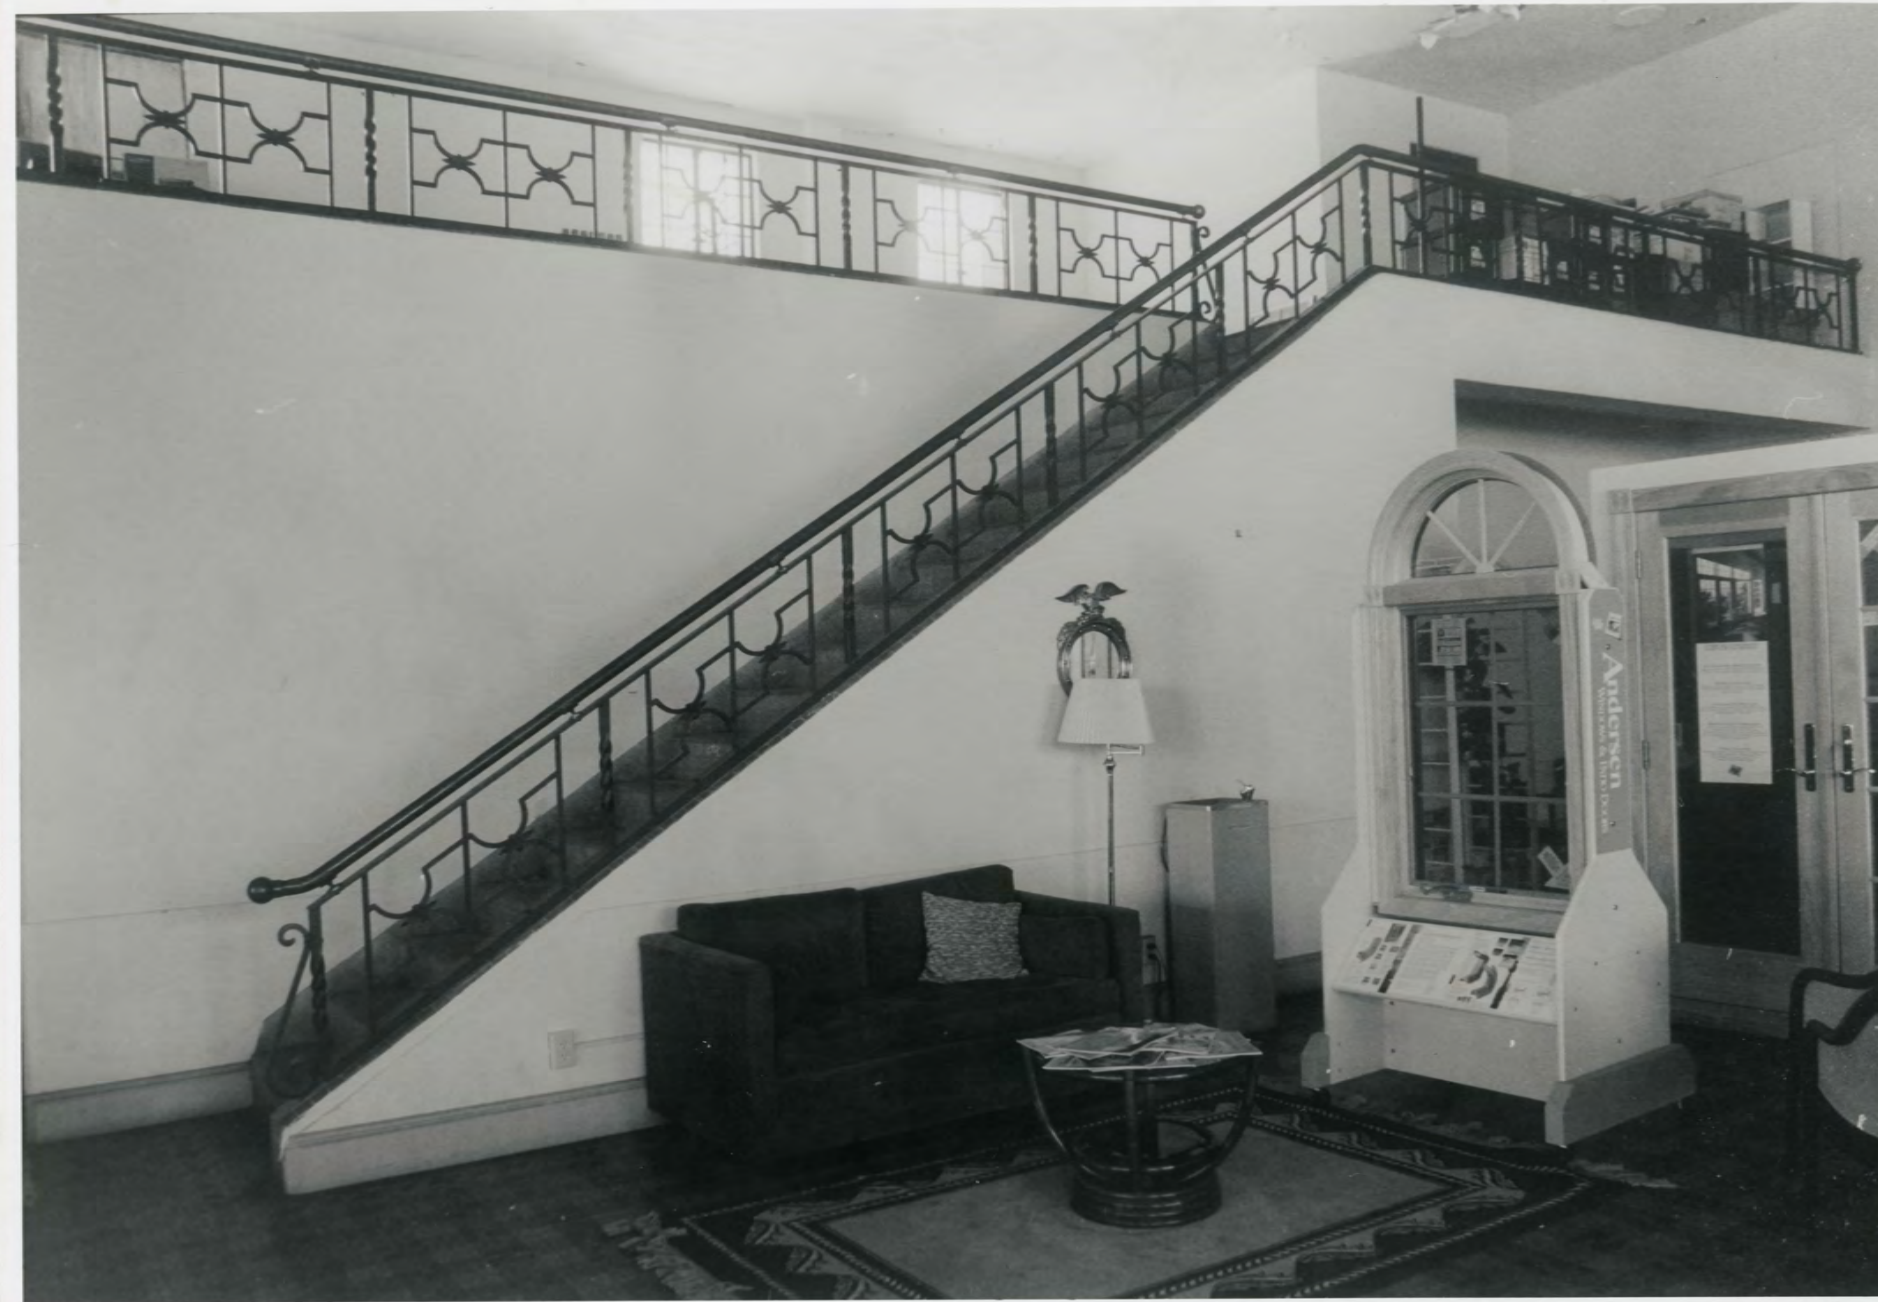
View of interior of showroom showing
mezzanine and stairs, looking east.

The interior of the showroom offers high ceilings with a mezzanine on the east side. The tiled floors are peppered with motifs (oak leaf, fleur-de-lis, and flower just to name a few) that are very similar to the tile that graces the third floor of the Union County Courthouse. A wrought iron balustrade with brass rail makes an impressive outline for

mezzanine and stairs. Originally, the mezzanine housed offices and a large safe. Paperwork was transferred from one part of the building to the other through a pneumatic tube system. Currently, the mezzanine is used for storage and the rear of the showroom space is sub-divided by office partitions that do not reach ceiling height. Hanging from the ceiling are six operable Emerson ceiling fans that have consecutive engine numbers.
