National Register of Historic Places
Registration Form

historic name Griffin Auto Company Building

street & number 117 E. Locust Street

city or town El Dorado

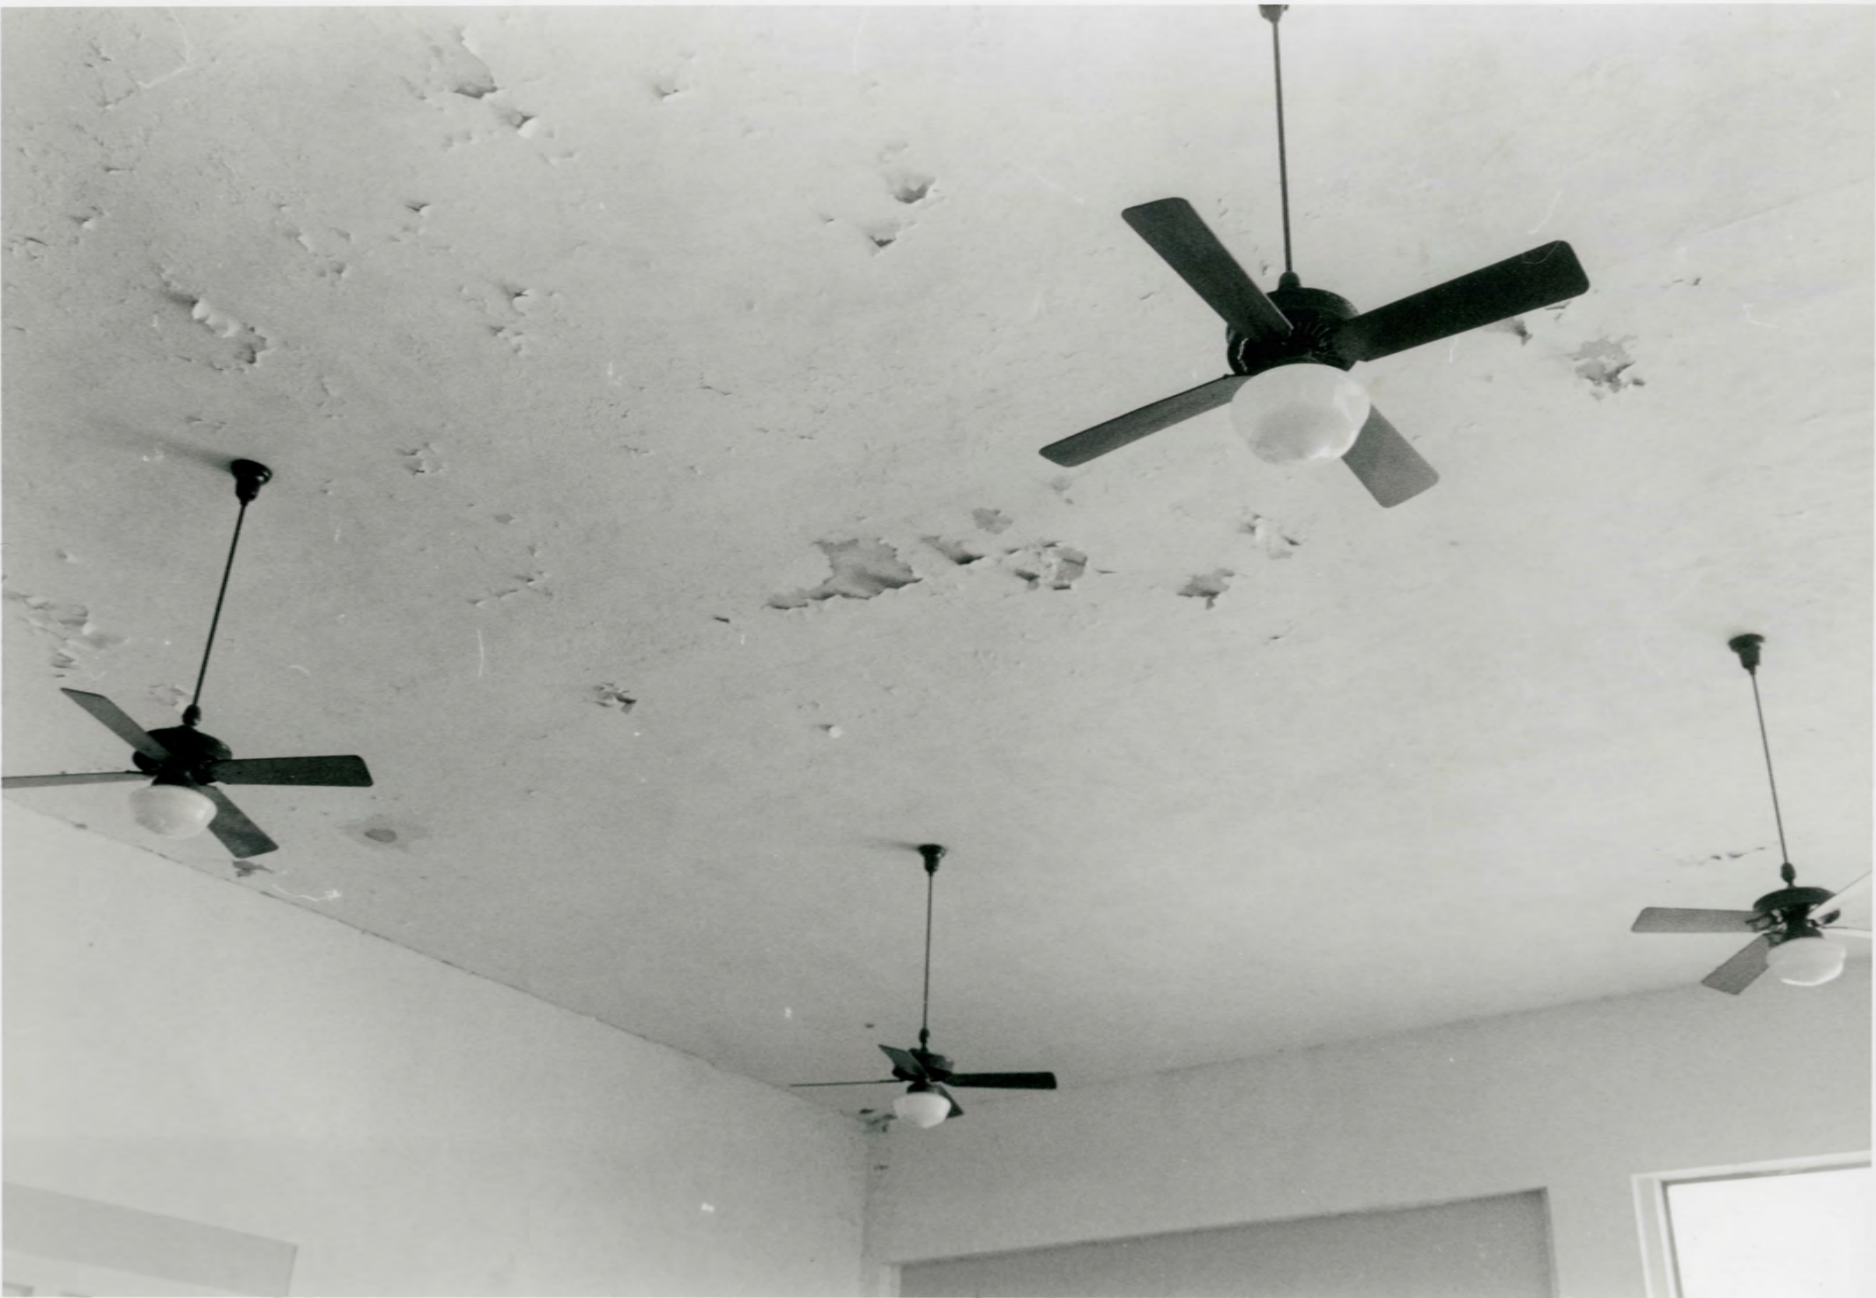
Interior detail of ceiling fans
(infilled window center background)
Looking west,

mezzanine and stairs. Originally, the mezzanine housed offices and a large safe. Paperwork was transferred from one part of the building to the other through a pneumatic tube system. Currently, the mezzanine is used for storage and the rear of the showroom space is sub-divided by office partitions that do not reach ceiling height. Hanging from the ceiling are six operable Emerson ceiling fans that have consecutive engine numbers.

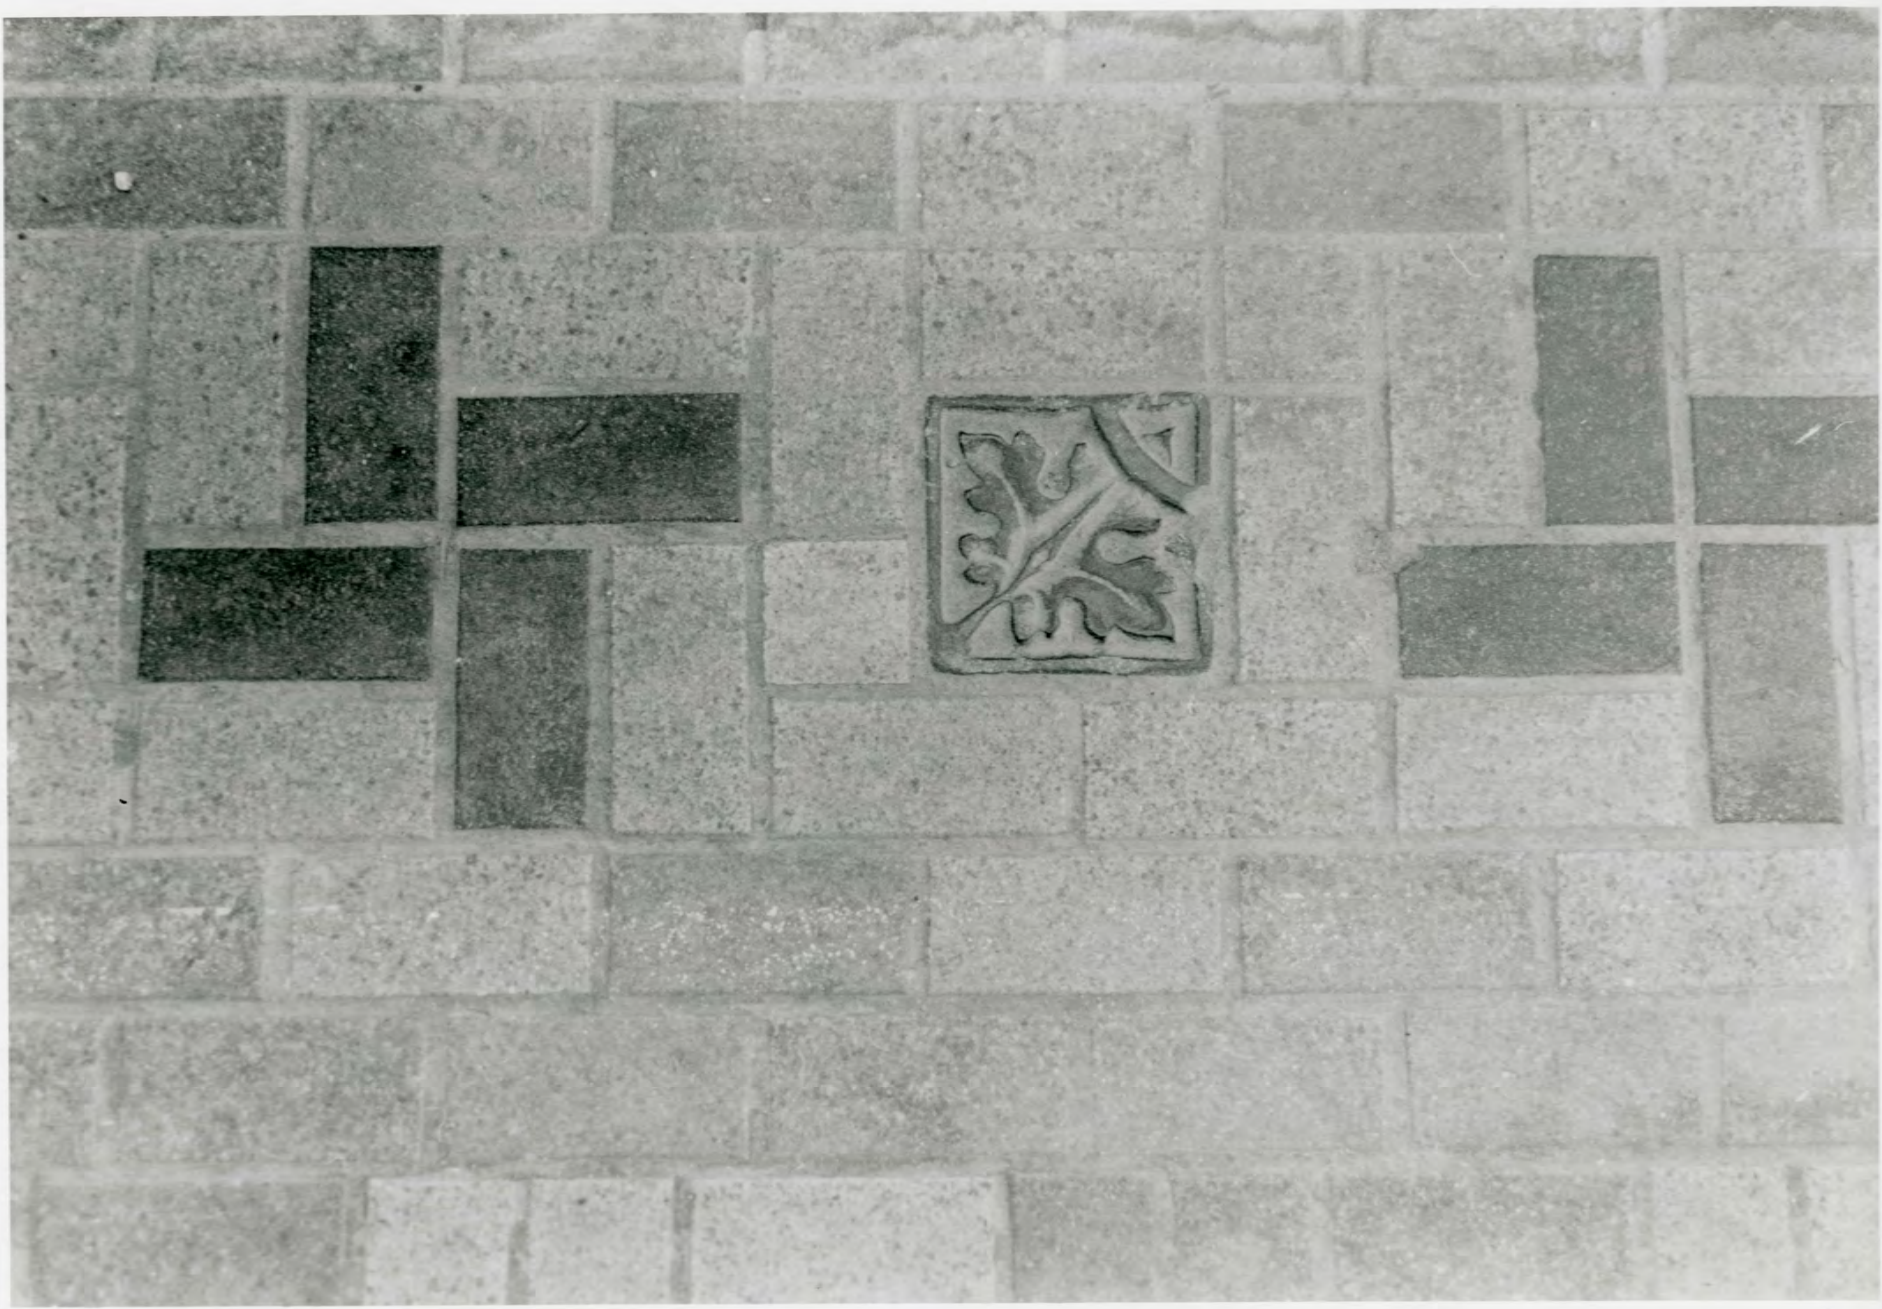
Detail of showroom floor tile
near west elevation looking west.

The interior of the showroom offers high ceilings with a mezzanine on the east side. The tiled floors are peppered with motifs (oak leaf, fleur-de-lis, and flower just to name a few) that are very similar to the tile that graces the third floor of the Union County Courthouse. A wrought iron balustrade with brass rail makes an impressive outline for

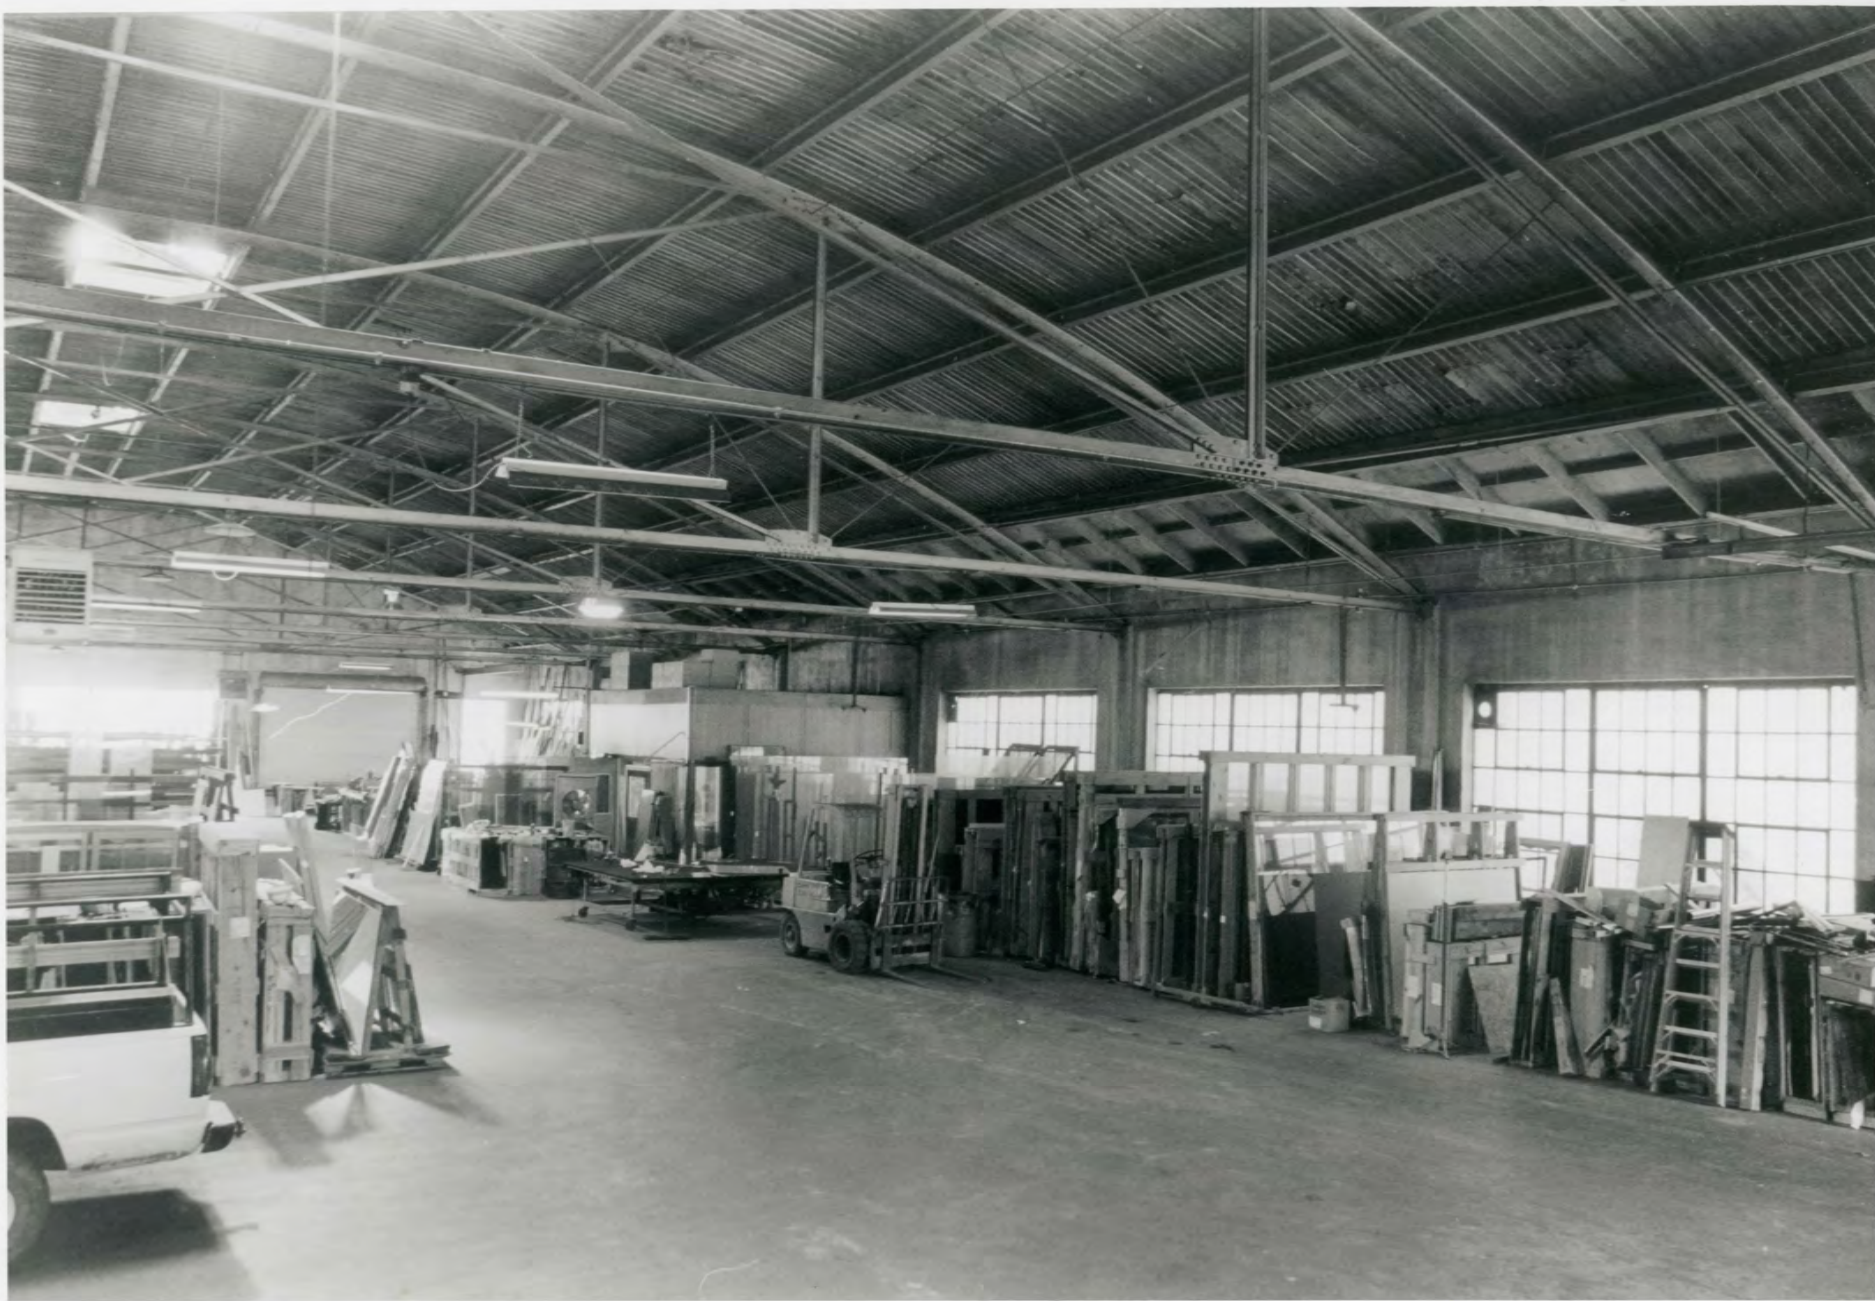
Interior of service area looking
South west.

The large floor space of the service department is unbroken by structural supports, because of metal trusses and a barrel vaulted roof. The space is lighted by electric lights, several large metal frame windows on the south, east and west elevations and three skylights.

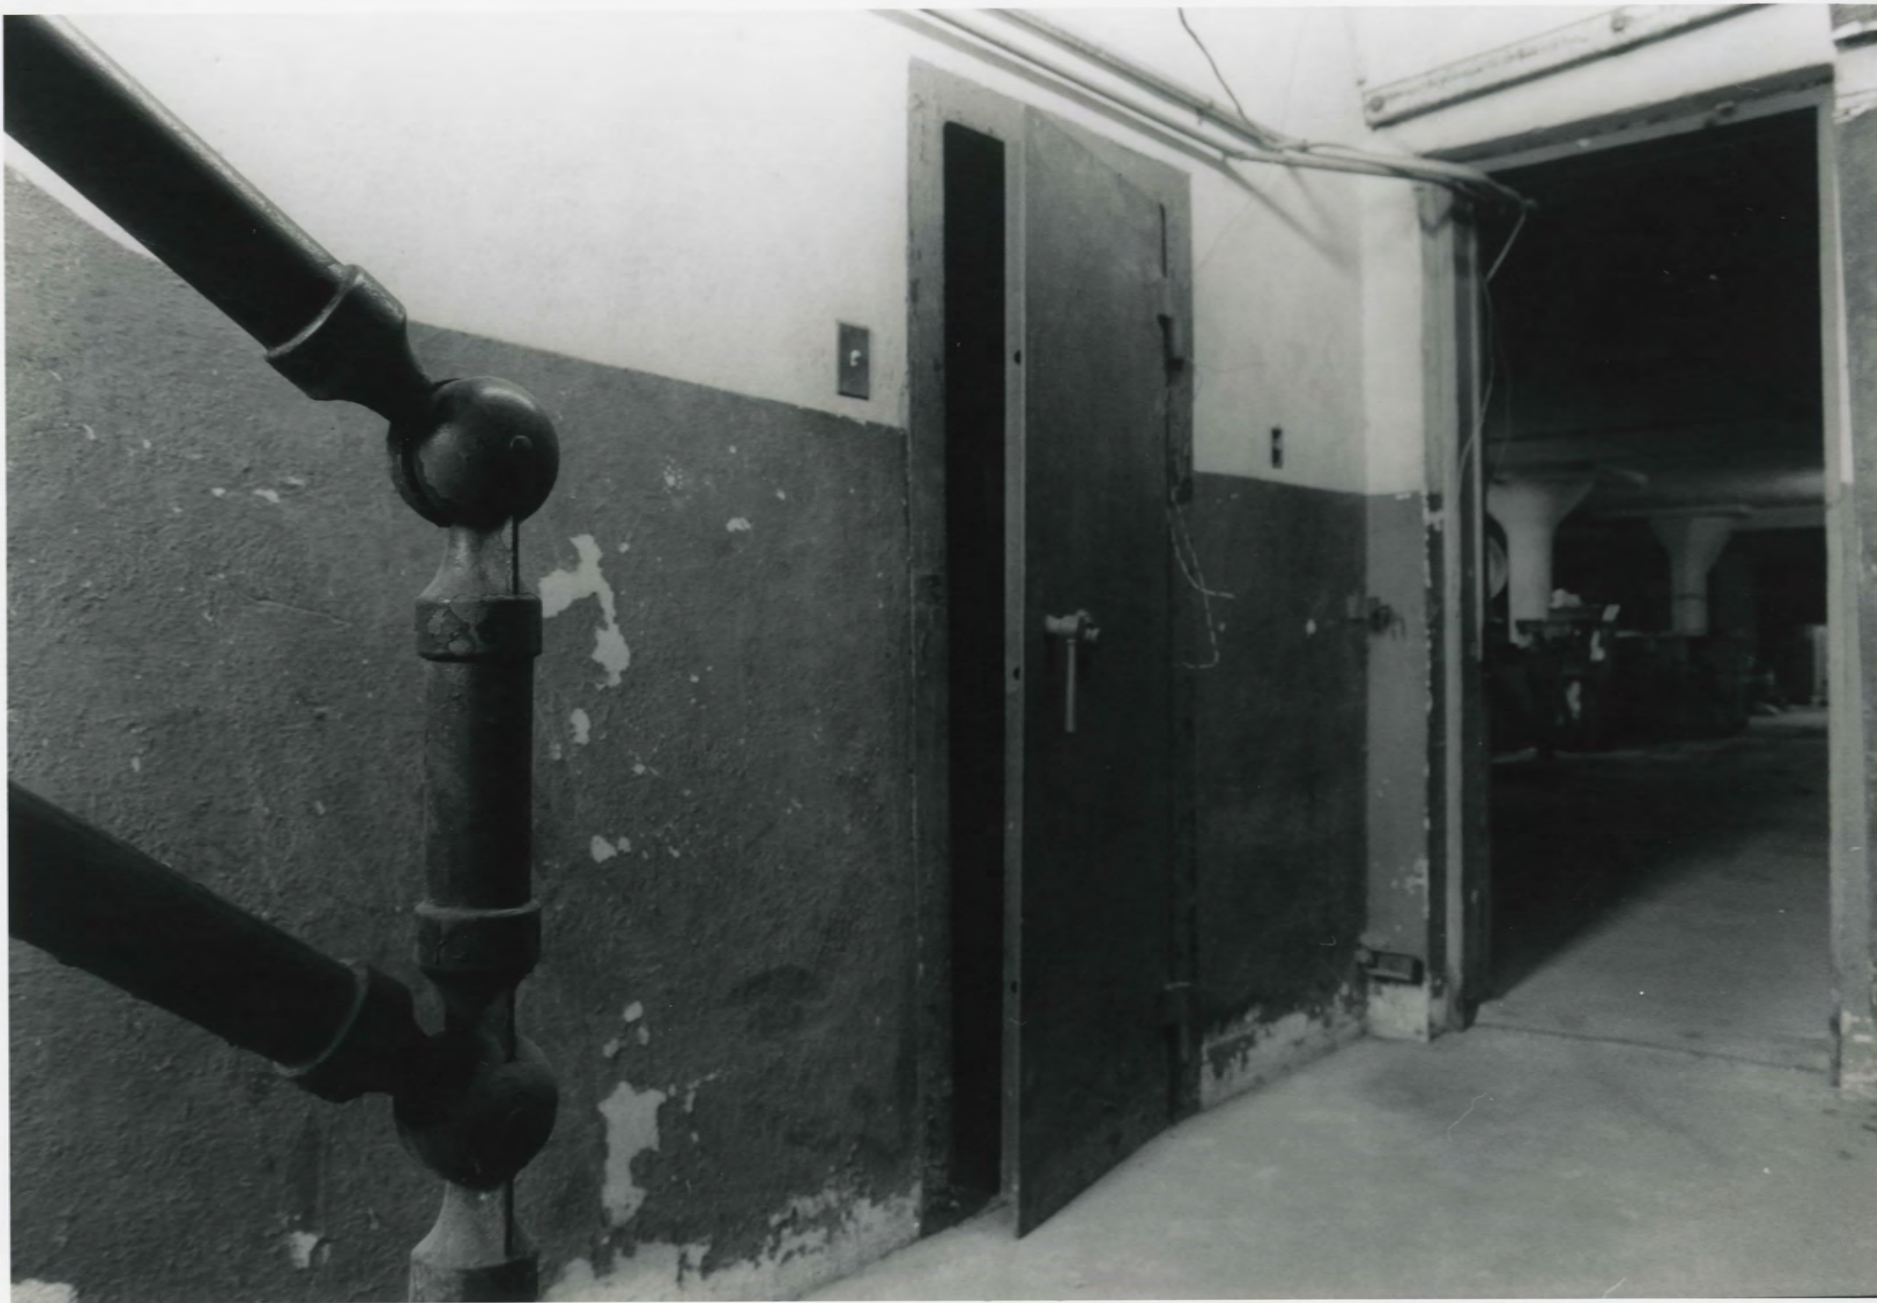
View of basement from stairwell
on east elevation looking west
(note vault)

The basement area matches the dimensions of the service department. The majority of the space is open storage; however, part of the area is divided into three large vaults. According to oral tradition, one vault was designated for each of the three Griffin brothers.
