NATIONAL REGISTER OF HISTORIC PLACES
REGISTRATION FORM

historic name Ellis, William and Amanda J., Farmstead Historic District

Ellis, William and Amanda J., Farmstead Historic District
Montgomery County, Iowa

DESCRIPTION

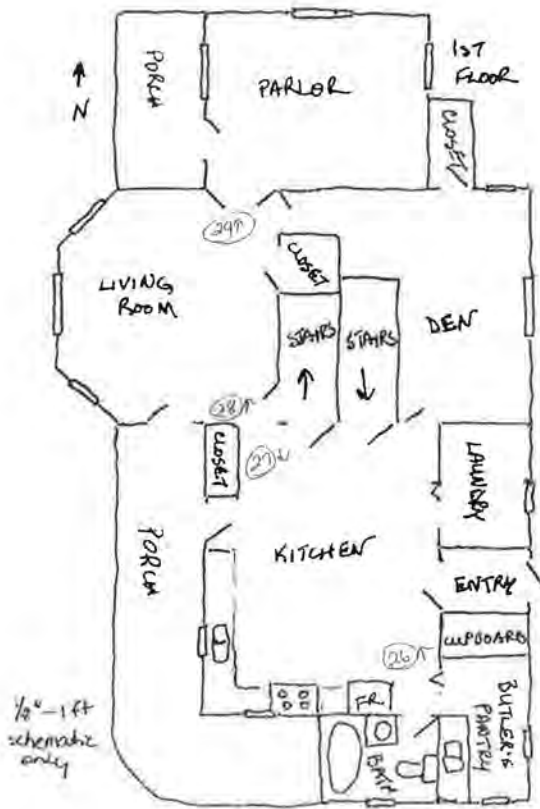
Sherri Mecker
Ca. 2014

Interior Photo Key
