National Register of Historic Places Registration Form

historic name Glenville District-No. 5 Schoolhouse

Glenville District No. 5 Schoolhouse

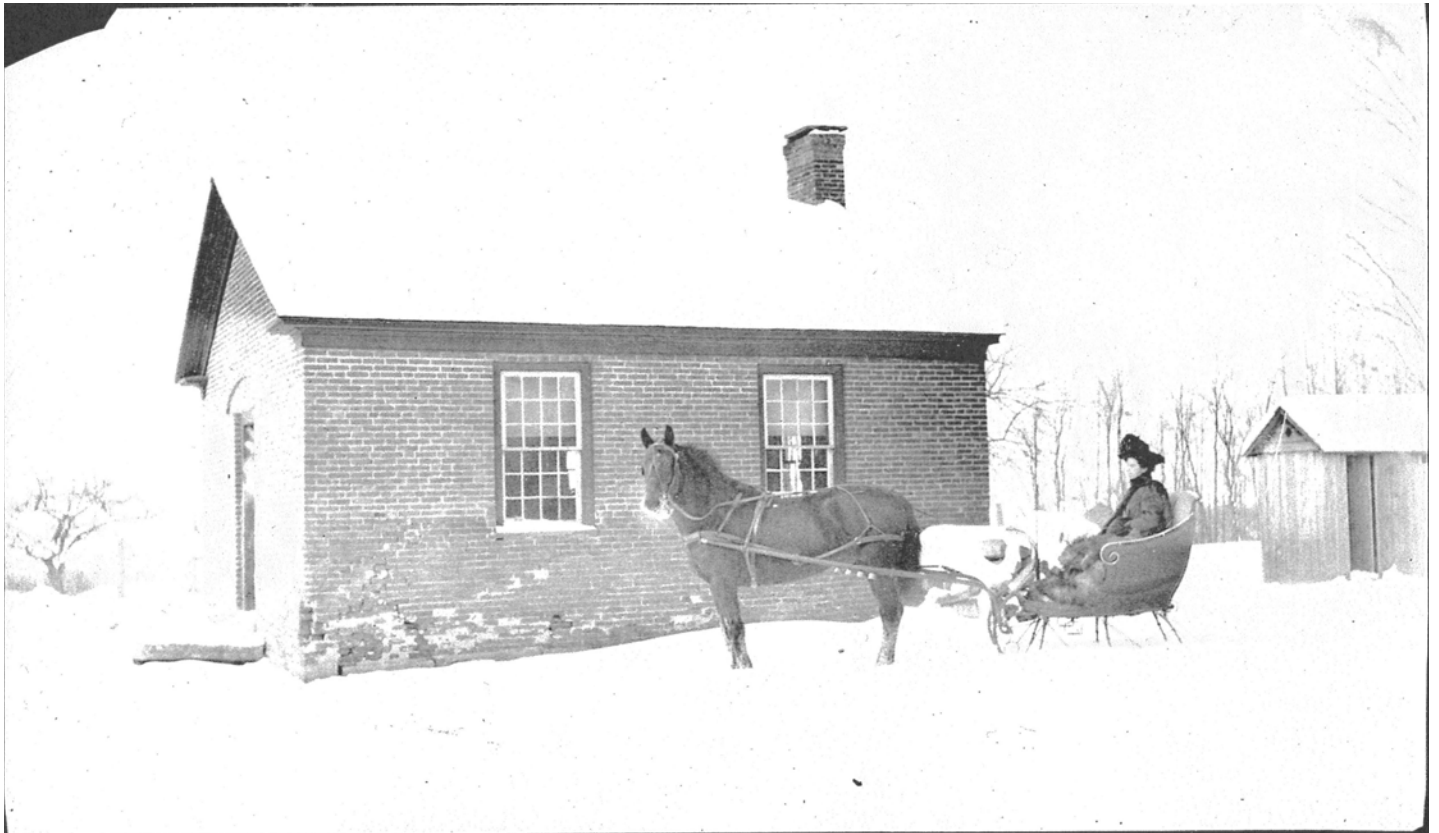
Figure 4: Glenville District No. 5 Schoolhouse - Photograph taken by Clarence Van der Veer in 1910

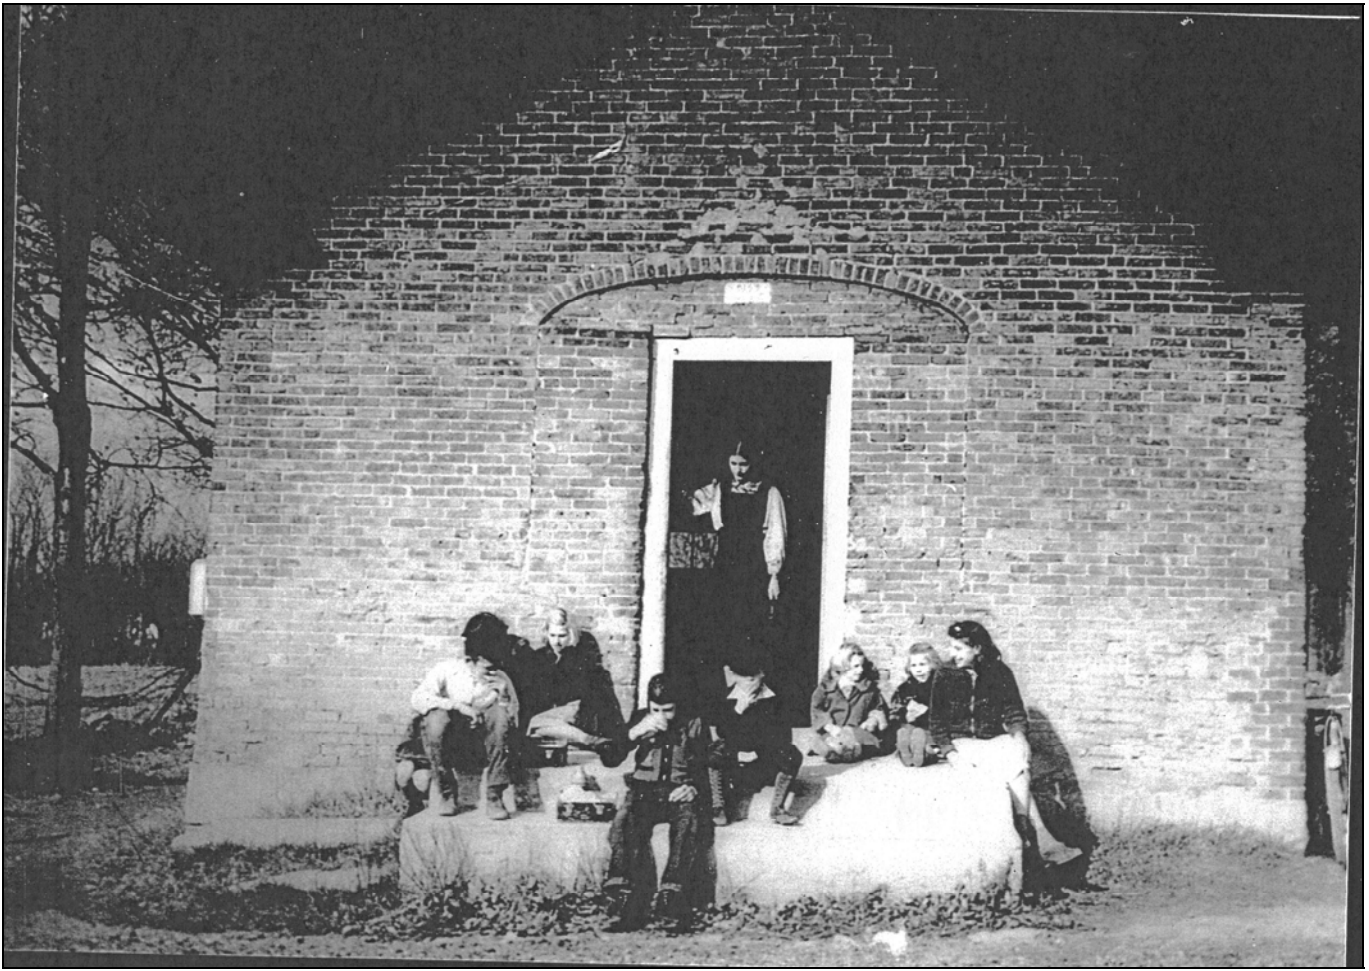
Figure 5: Glenville District No. 5 Schoolhouse, early 1940s

Entrance into the open schoolroom is through a four-panel wood door with a fixed four-light transom surrounded by simple wood casing that was installed during a 1976 restoration. The entry, which is approached by three wood tiered steps covering two large blocks of stone, is accented by a segmental arch above and a projecting wood sign engraved with the name "Green Corners Schoolhouse." The current entrance represents an early twentieth century alteration. The earliest photograph obtained that depicts the façade dates to circa. 1900-1902 (see continuation sheet 11-1) and shows a modest Greek Revival entry that is flanked by pilasters and capped with a simple entablature and fixed transom light. Photos from the early 1940s show the current configuration (continuation sheet 11-3)

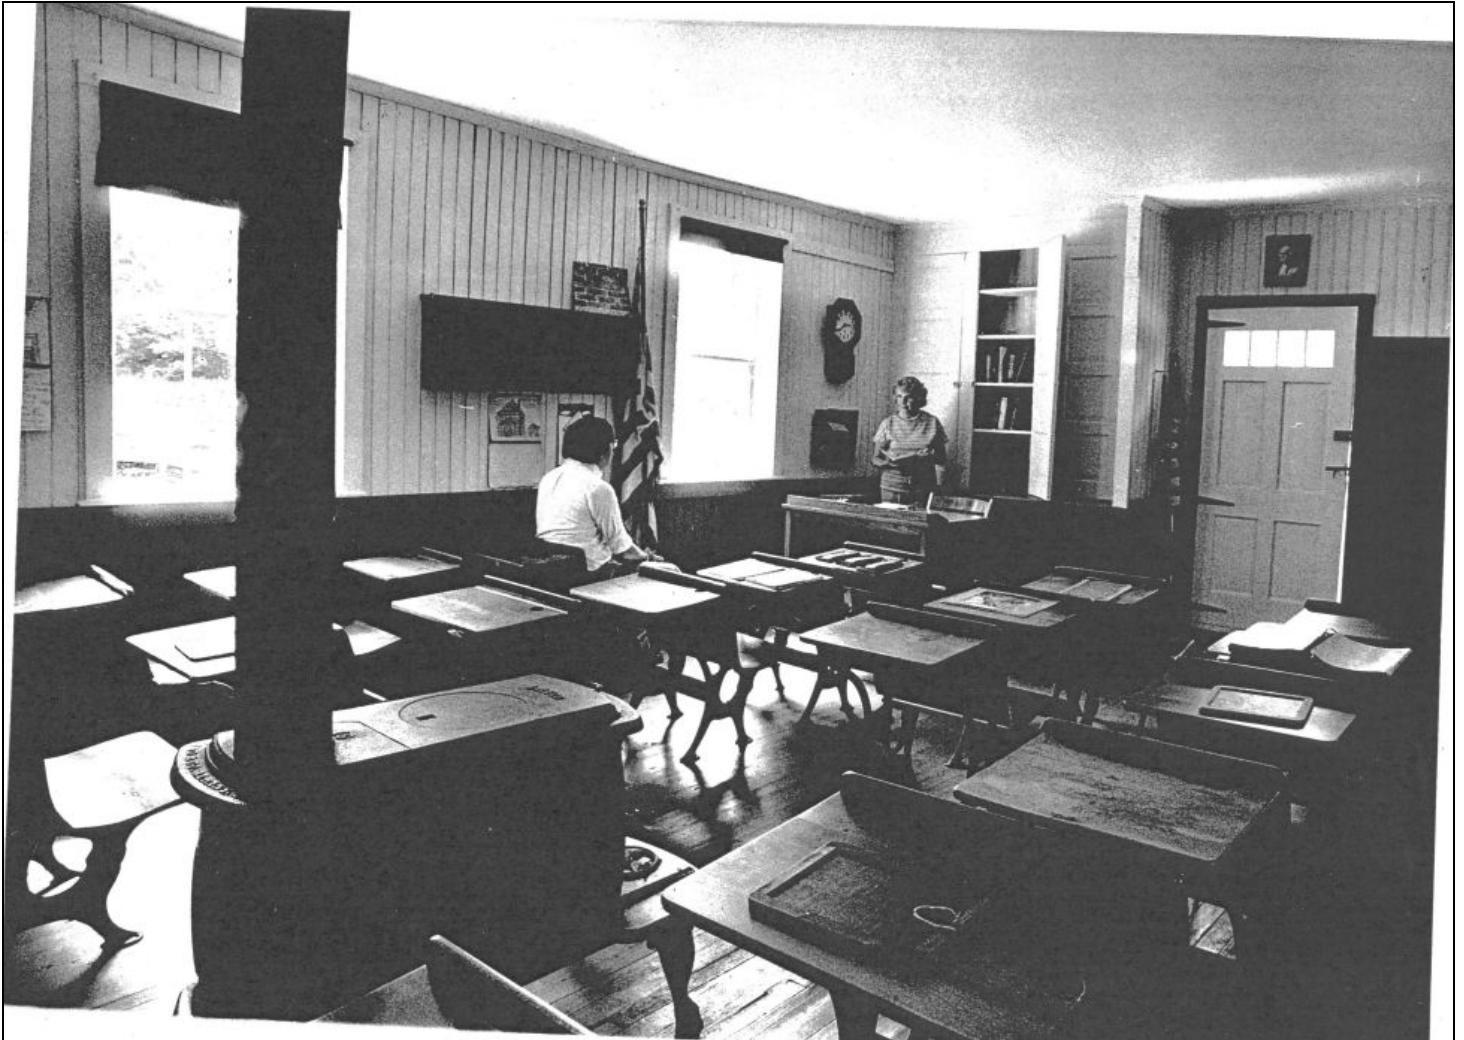
Figure 6: Glenville District No. 5 Schoolhouse, interior, July 1983 (photograph by Sid Brown)

While electricity was installed in the late 1930s, the wiring was removed in the 1970s because it was in poor condition. The school was originally heated by a wood stove that was centrally located near the entrance but relocated to the rear of the schoolroom during the 1970s renovations as shown in photographs dating to 1983 (continuation sheet 11-4). There is no indoor plumbing.

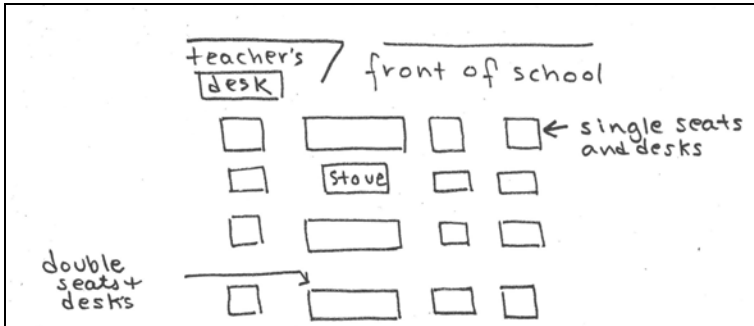
Figure 7: Seating arrangement in the early 1930s, drawn by former student Mr. Paul Dybas
