**NATIONAL REGISTER OF HISTORIC PLACES
INVENTORY -- NOMINATION FORM**

HISTORIC
Northeast Entrance Station
AND/OR COMMON

CITY, TOWN
Yellowstone National Park
STATE
Montana

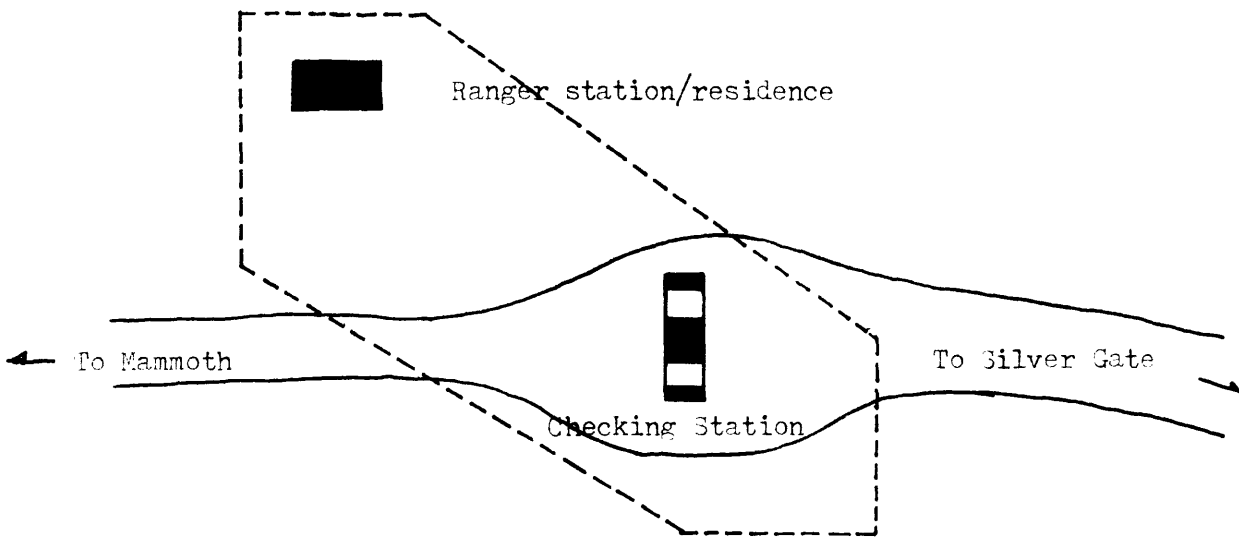
Northeast Entrance Station
Yellowstone National Park

The boundary begins at a point in the center of the entrance road 100 feet east-northeast of the exact center of the checking station building, then proceeds south-southeast 100 feet, then west-southwest 125 feet, then west-northwest 275 feet, then north-northwest 125 feet running parallel to and 25 feet west of the west wall of the ranger station, then 100 feet east-northeast running parallel to and 25 feet north of the north wall of the ranger station, then 250 feet south-southwest to the starting point, as shown on the enclosed sketch map.
