1. Name of Property		
historic name Vanness-Linen House		
other names/site number _Glenburn		
2. Location		
street & number 211 Hamburg Tumpike		not for publication
city or town Riverdale Borough		vicinity
state <u>New Jersey</u> code <u>NJ</u> county _	Morris code 02	zip code _07457

National Register of Historic Places Continuation Sheet

Vanness-Linen House Riverdale, Morris County, NJ

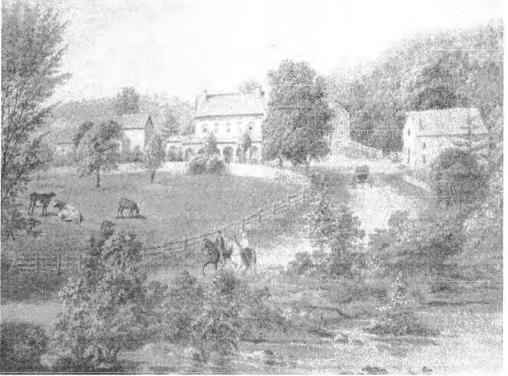
The third contributing outbuilding dates to at least 1887 (Figure 3) but could be older. It has been heavily modified making assessment difficult. The framing of the building is hand-hewn and pegged. The joists are 4x4. It now has asphalt roofing. It is L-shaped with an east west, one-and-one-half story section and a one story north south section. What is presumed to be the original section—the east west part—has a gable roof, hewn framing and pegged six-over-six windows. It is one-room deep and one-and-one-half stories. There is some thought that it could pre-date the house or could be an original out kitchen (Photo 21).

The north south section of this outbuilding is also frame with a gable roof and a deep stone basement. Its windows are multilight wood (Photo 22). While the date of construction for both sections is unknown, at least part of it had been constructed by 1887 (Figure 3). The original use of the building is also unknown.

It is difficult to state definitely when the existing outbuildings were constructed. Two appear in George Linen's painting and also seem to be indicated on the 1887 map (Figure 3). The fact that they do not appear on the earlier maps does not mean that they weren't extant but rather that the maps lacked sufficient detailing. The barn is certainly of the nineteenth century and could be contemporary with the ca. 1816 construction of the house.

The other L-shaped outbuilding dates to at least 1887 (Figure 3) but could be older. There is some thought that it could have been an out kitchen for the site. The proportions are a bit grand for the original three-bay house, the foundation of which seems to point to a small kitchen to the west of the side hall. However, because no evidence was found of a fireplace base in this area, this outbuilding could have been the kitchen.

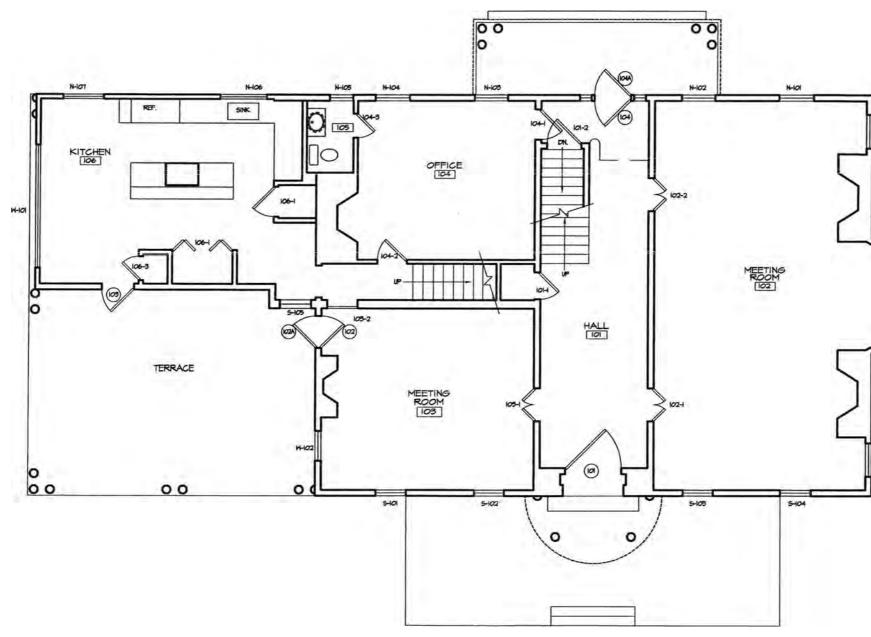
SCALE: 1/8" = 1'-0" DRAWN BY: KL DATE: 9/15/09 EX-2 HOLT MORGAN RUSSELL ARCHITECTS, PA 350 Alexander Street, Princeton, NJ 08540 T 609.924.1358 F 609.924.5985 FIRST FLOOR PLAN E-106 HMR Architects 5-104 E-105 E-102 E-IOI VANNESS-LINEN HOUSE RIVERDALE, NEW JERGEY N

The center hall runs the full depth of the house. It has wood floors and paneled wainscot topped by wallpaper. The stairs to the second floor run against the west wall. While the stairs and the north exterior door likely are original, the other features are from the ca. 1912 Colonial Revival upgrades including the south exterior door, the interior doors and the wainscot. They are quintessentially Colonial Revival. The oversized exterior Dutch door has heavy wrought iron strap hinges and bubble-glass transom. The wainscot and doors, both paneled, similarly evoke the eighteenth century but with Colonial Revival profiles (Photos 11-14).

To the east is the original ca. 1816 double parlor that was made into one room ca. 1912, during the first Colonial Revival remodeling of the house, Room 102. It has a bay window in the center of the east wall flanked by fireplaces. There are wood floors, a broad base board, panels under the windows, molded window and door casings and run plaster crown molding. The

To the west of the hall are the stacked rooms built in 1868; their size and shape are original but their finishes are from the ca. 1912 Colonial Revival upgrades. The south Room 103 has an 1868 fireplace with a Colonial Revival mantle. The wood floors and crown molding match those found in the large east room and date to ca. 1912 as does the tongue and groove wainscot and paneled doors. All are nice examples of the Colonial Revival (Photo 9).

Ca. 1912 and 1949, the north Room 104 was remodeled to resemble an early eighteenth century kitchen. It has pine flooring, paneled and textured plaster walls, paneled doors with cross bracing, plaster ceiling with faux exposed beams and large "cooking" fireplace along the west wall. This room, or den as it likely was known when it was created, is more obviously a Colonial Revival interpretation of an eighteenth century interior. It is overtly twentieth century whereas the other Colonial Revival additions are more simply integrated into the nineteenth century fabric (Photo 10).

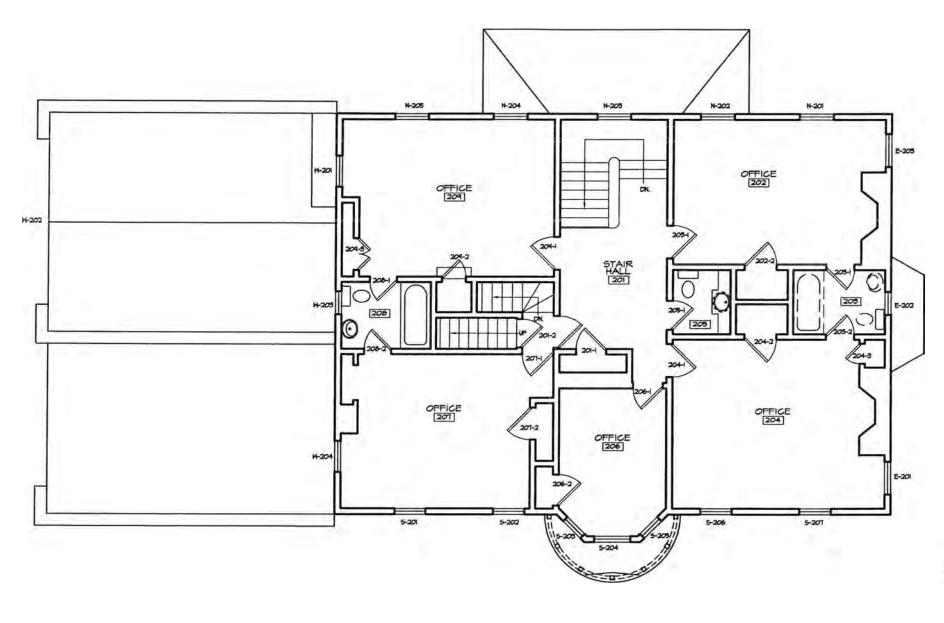
NATIONAL DEGLETED NOVINATION	11161	HOLT MORGAN RUSSELL ARCHITECTS. PA	SCALE: 1/8" = 1'-C
	H V K ARCHITECTS	350 Nexander Street, Princeton, NJ 08540	DRAWN BY: KL
		T 009.924.1338 F 609.924.5985	DATE: 4/15/09
	ロマノムン		1 2 2
RIVERDALE, NEW JERGEY	NECOND	DECOND FLOOR FLAN

The second floor of the main block has five bedrooms: two on each side and one centered at the southern end of the hall. These are divided by bathrooms. A third bathroom is off the hall (Photo 13). The side bedrooms are smaller than they were originally (both ca. 1816 eastern rooms and ca. 1868 western rooms) because of the addition of closets and bathrooms. The floors are wood, the walls plaster with simple baseboards. Generally, the doors are four-panel with simple molded casings. The window casings are also simple. For the most part, their detailing dates to the ca. 1912 Colonial Revival renovation although some of the doors may be nineteenth century. The eastern bedrooms retain their original fireplace openings but their detailing dates to the Colonial Revival upgrades of ca. 1912 (Photos 15 and 16). Nineteenth century trim can be found in two locations. The attic has been altered with the addition of several rooms and modern finishes at the walls and ceiling.
