National Register of Historic Places Registration Form

Name of Property		
historic name Smith/Friskey Ranch		
other names/site number 5CF.2879		
2. Location		
street & number County Road 339 (0.5 miles west of r	oad)	N/A not for publication
city or town Buena Vista	oudy	X vicinity
state Colorado code CO county	Chaffee code 015

Smith/Friskey Ranch, Resource 1, Site, Contributing, Photographs 1 through 32

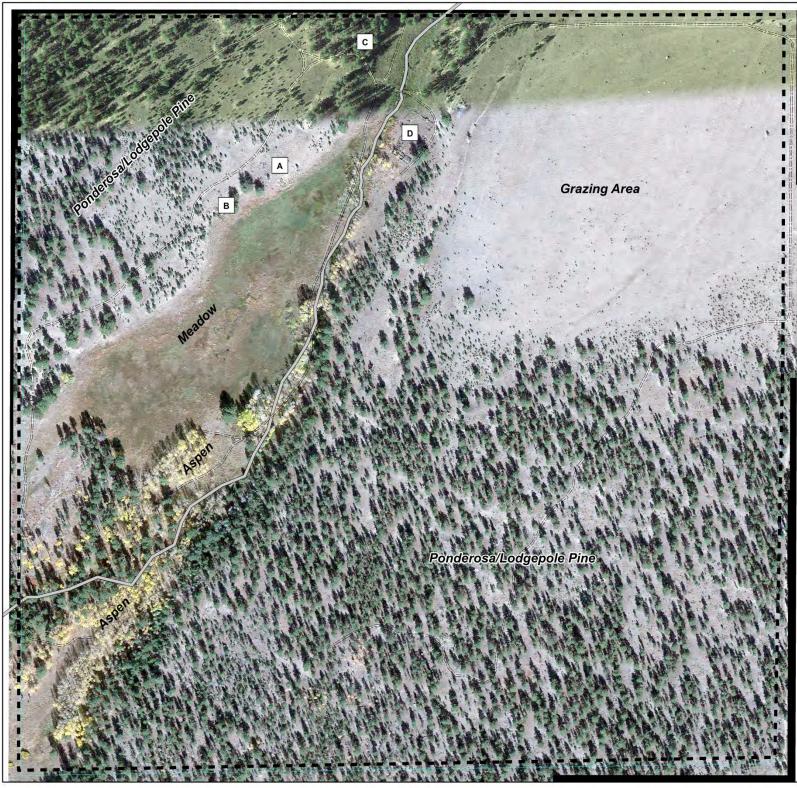
SMITH/FRISKEY RANCH SKETCH MAP-OVERVIEW

This section describes the resources of the Smith/Friskey Ranch organized by the following areas: Smith/Ernie Friskey Cabin; root cellar and building ruins; Gus Friskey House; and corral, barn, and shed ruins. Where applicable, archaeological components are discussed in association with any standing buildings. Ruins, small-scale objects, fences, roads, and artifact concentrations are considered features of the ranch site and are not included in the count of resources; they are labeled as features on the sketch maps. The resources are also listed in Table 1 at the end of this section and shown on three sketch maps.

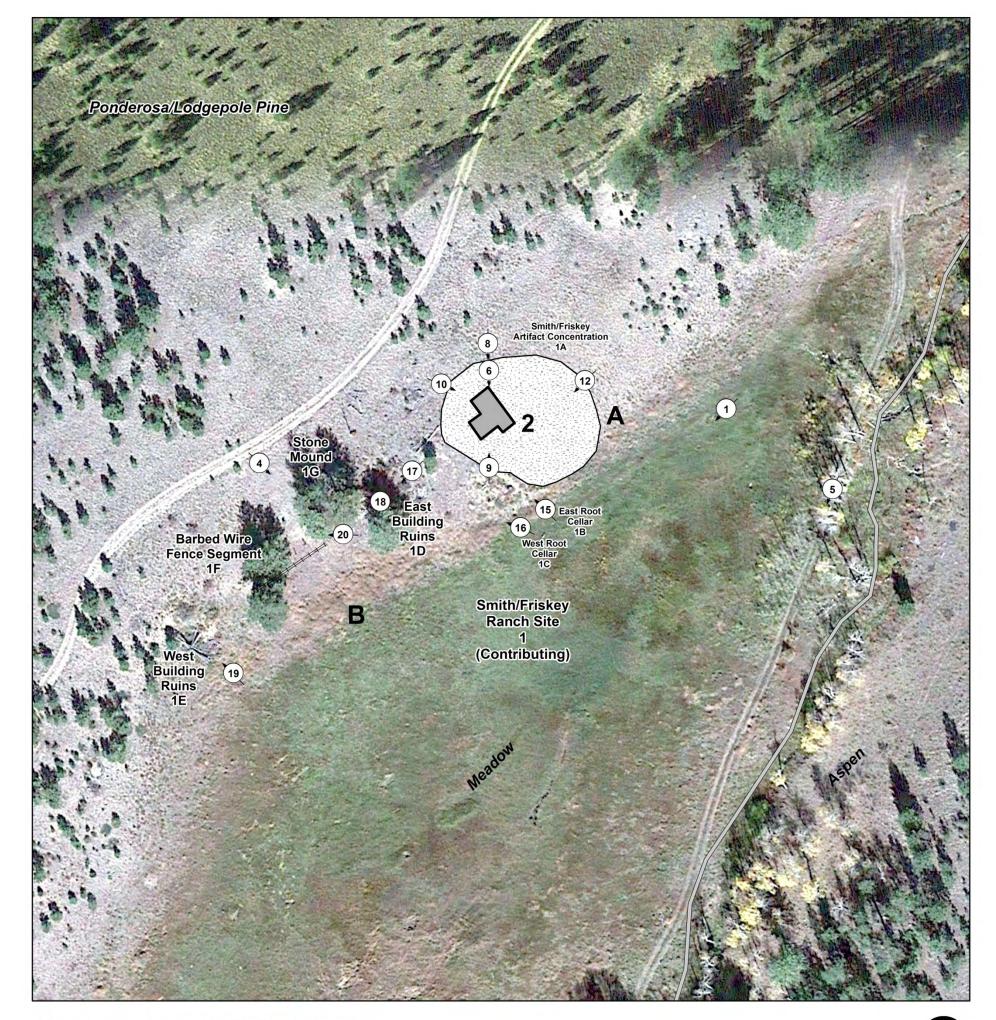
SMITH/FRISKEY RANCH SKETCH MAP-SOUTH DETAIL

This area (area B on the sketch maps) extends from about 30' south of the Smith/Ernie Friskey Cabin southwest along the western edge of the meadow for about 260'; the area is about 8' to 10' above the level of the meadow. Included are what appear to be the ruins of two root cellars, two buildings, a section of barbed wire fence, and a mound of stones. There is no documentary or oral history evidence as to the date of construction of these resources. Local ranchers Bryce Kelly and Joe Cogan both recalled the root cellars and buildings in this area as being in ruins during visits in the mid-1950s. Construction techniques and artifacts are not definitive for dating; a few round nails were observed during fieldwork. The resources could date from the Smith tenure or the early years of the Friskey ownership (ca. 1888-1920). These ruins likely contain buried archaeological deposits. At the current time, duff (partly decayed organic matter on the forest floor), dense vegetation, and roof/wall fall inhibit examination of the sediments within each root cellar or building ruin.

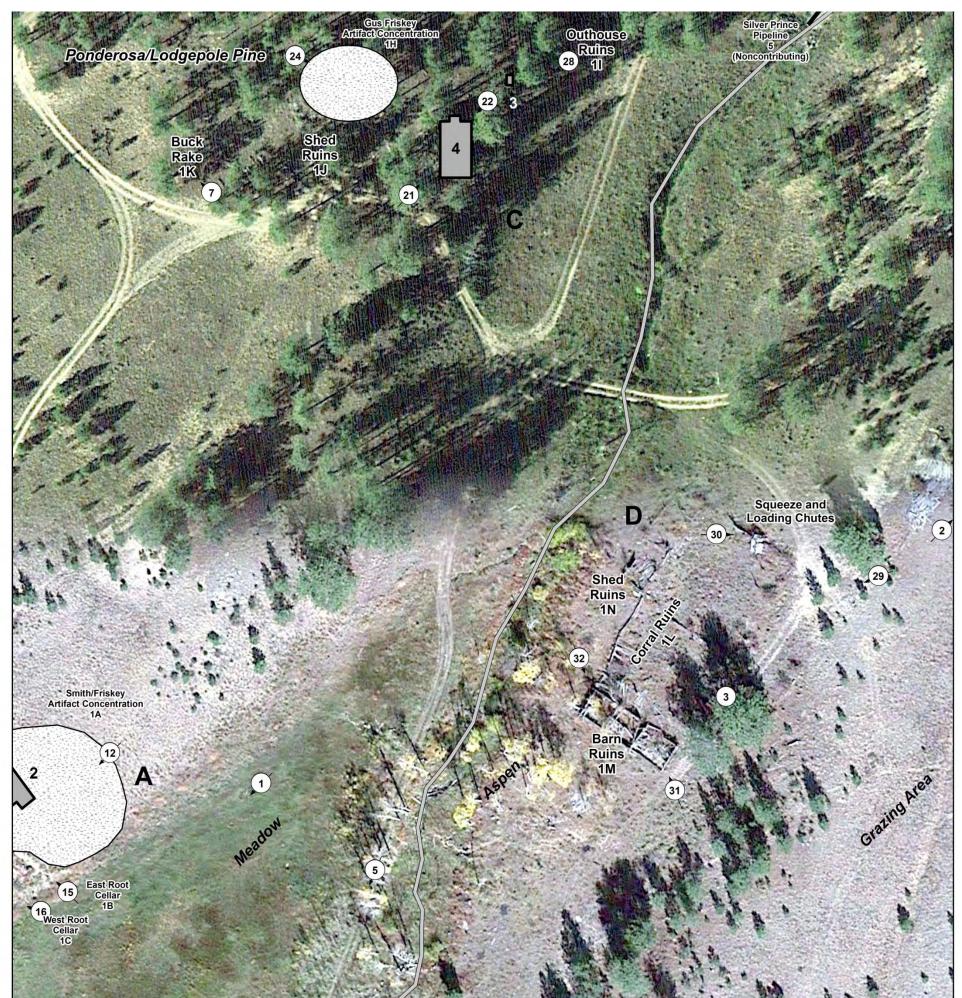
SMITH/FRISKEY RANCH SKETCH MAP-NORTH DETAIL

This area (area C on the sketch maps) is located on the west side of the Silver Prince Creek drainage on the north side of the access road from County Road 339. The house stands on a rise about 20' above the creek drainage and overlooks the corral area to the southeast. This section of the ranch includes the Gus Friskey house, a chicken coop, ruins of an outhouse and shed, and an extensive artifact concentration.

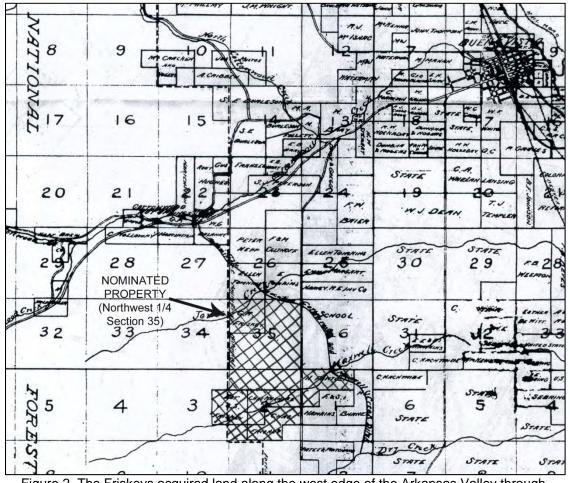
Figure 2. The Friskeys acquired land along the west edge of the Arkansas Valley through outright purchase and acquisition of government patents. The arrow points to the nominated area. The crosshatched area is the maximum extent of the family's holdings, including the lands of Johanna C.S., Otto, Charles, Gustave, and Ernest Friskey. Buena Vista is in the upper right of the map, while the Leadville National Forest extends along the left edge. Courtesy of Shaputis, *Where the Bodies Are in Central Chaffee County*, Some Land Owners and Old Roads in Northern Chaffee County, ca. 1900-10, map.
