1187
CLASSIFIED STRUCTURE FIELD INVENTORY REPORT
(Attach 4" x 5" Black and White Photograph)

STRUCTURE NAME "Cowboy Cave" STRUCTURE NUMBER NEED - 2

Cave Springs Cowboy Camp Complex(ranching theme):

STRUCTURE NAME Cave Springs Corral STRUCTURE NUMBER NEED - 1

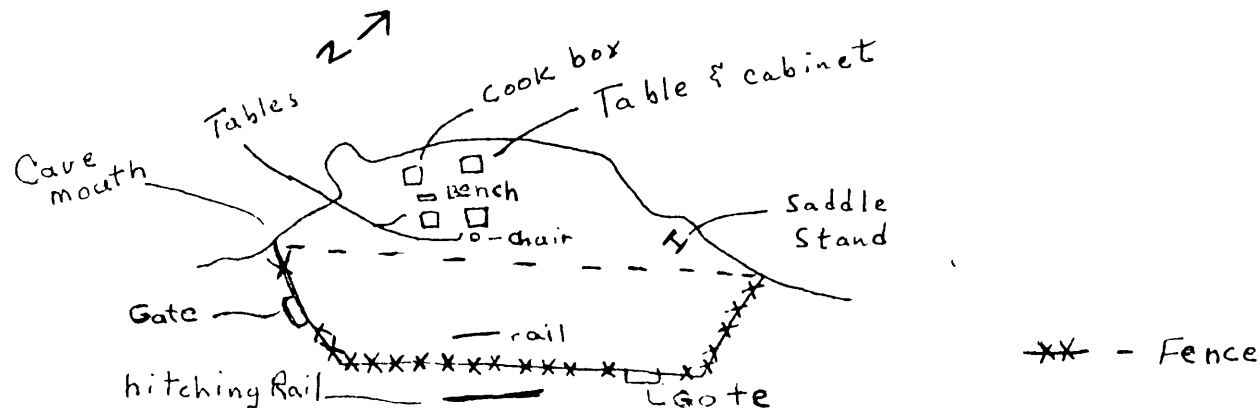
Type: OT (Cave) and FE
 Material: ST/WD
 Dimensions: 75'+ (widest) x 38'+ (deepest)

The site is a natural rock shelter that had been occupied by cowboys as a line camp in the area. Fence is mostly of juniper poles, some wire.

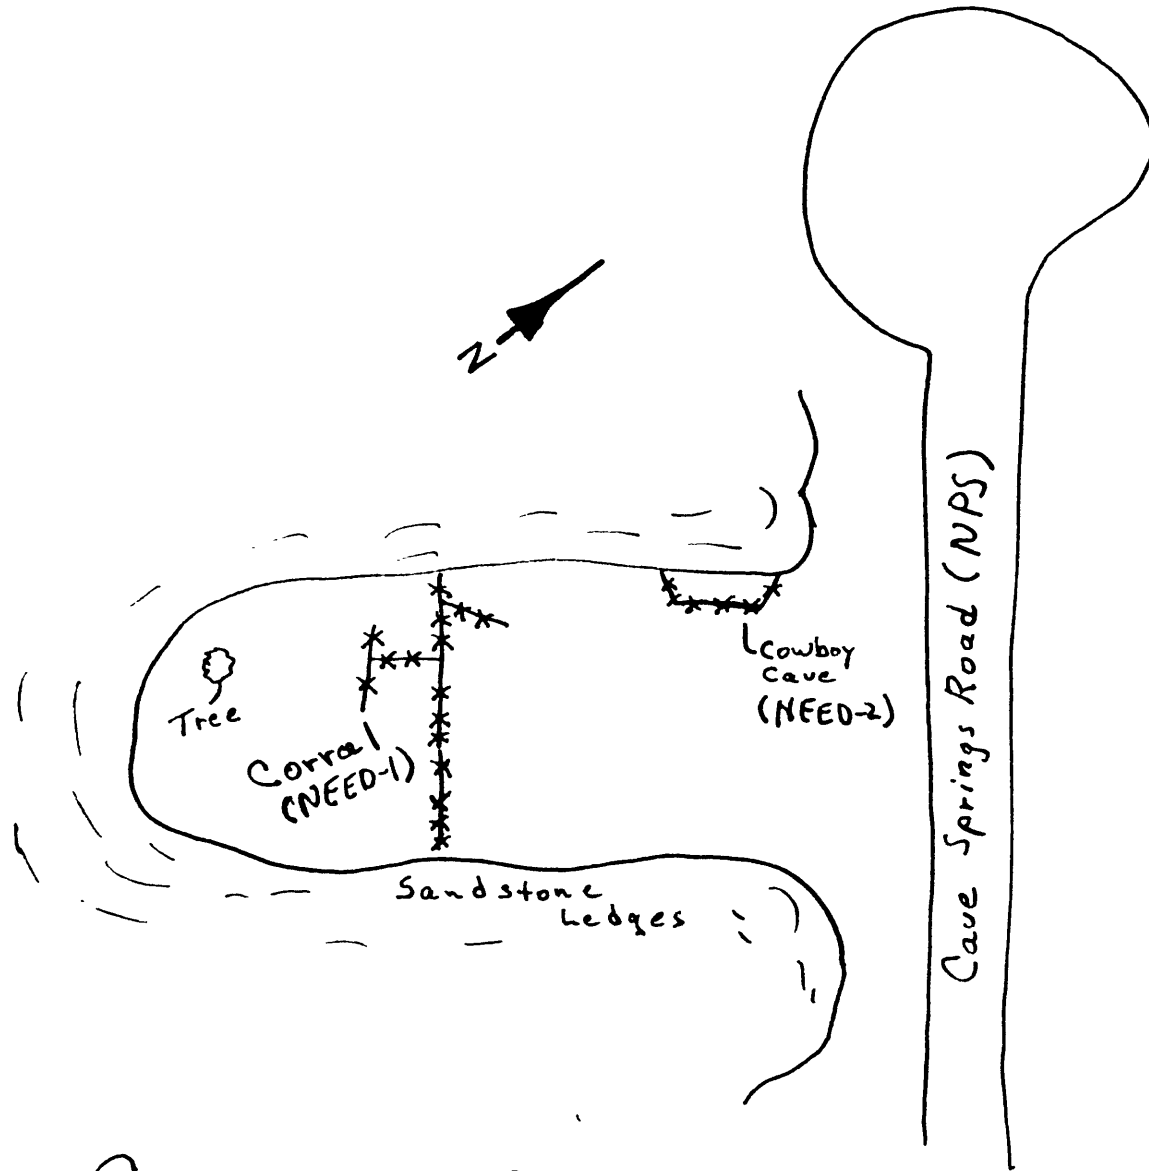
Cave Springs Cowboy Camp
Canyonlands National Park

1" = 100'

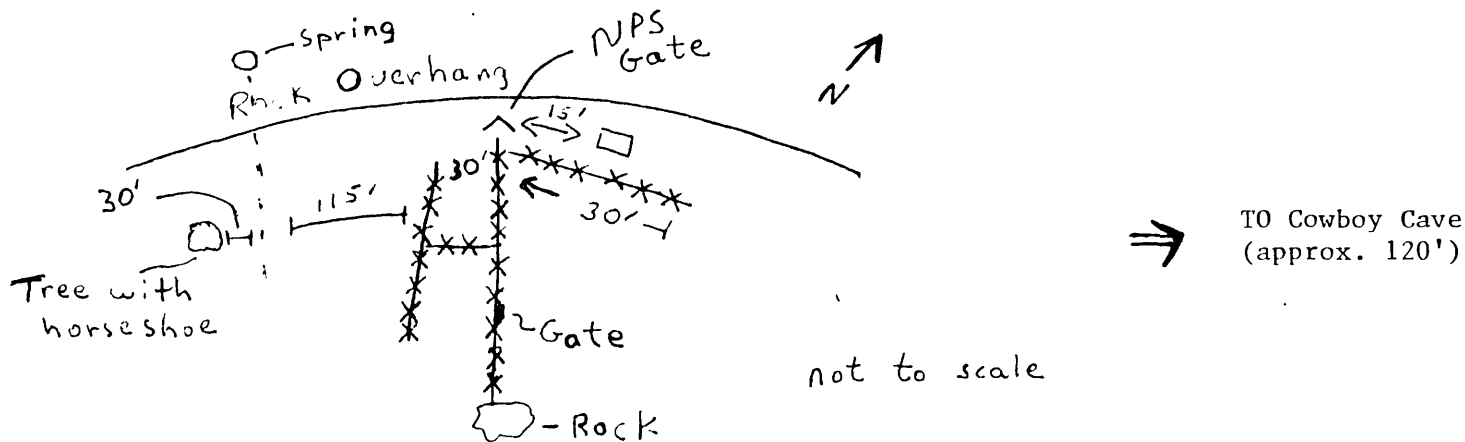
Type: FE

Materials: WD, MT

Major Feature: feed box (wood with metal hinges and metal cansom seams/ wire/nails & horse-shoe nails) box is 7'x3'9" x 5'4" max. height with salt-box type lid.
