National Register of Historic Places Registration Form

historic name Miller, Washington, House

other names/site number Cedar Winds

state Tennessee code TN county Maury code 053 zip code 38401

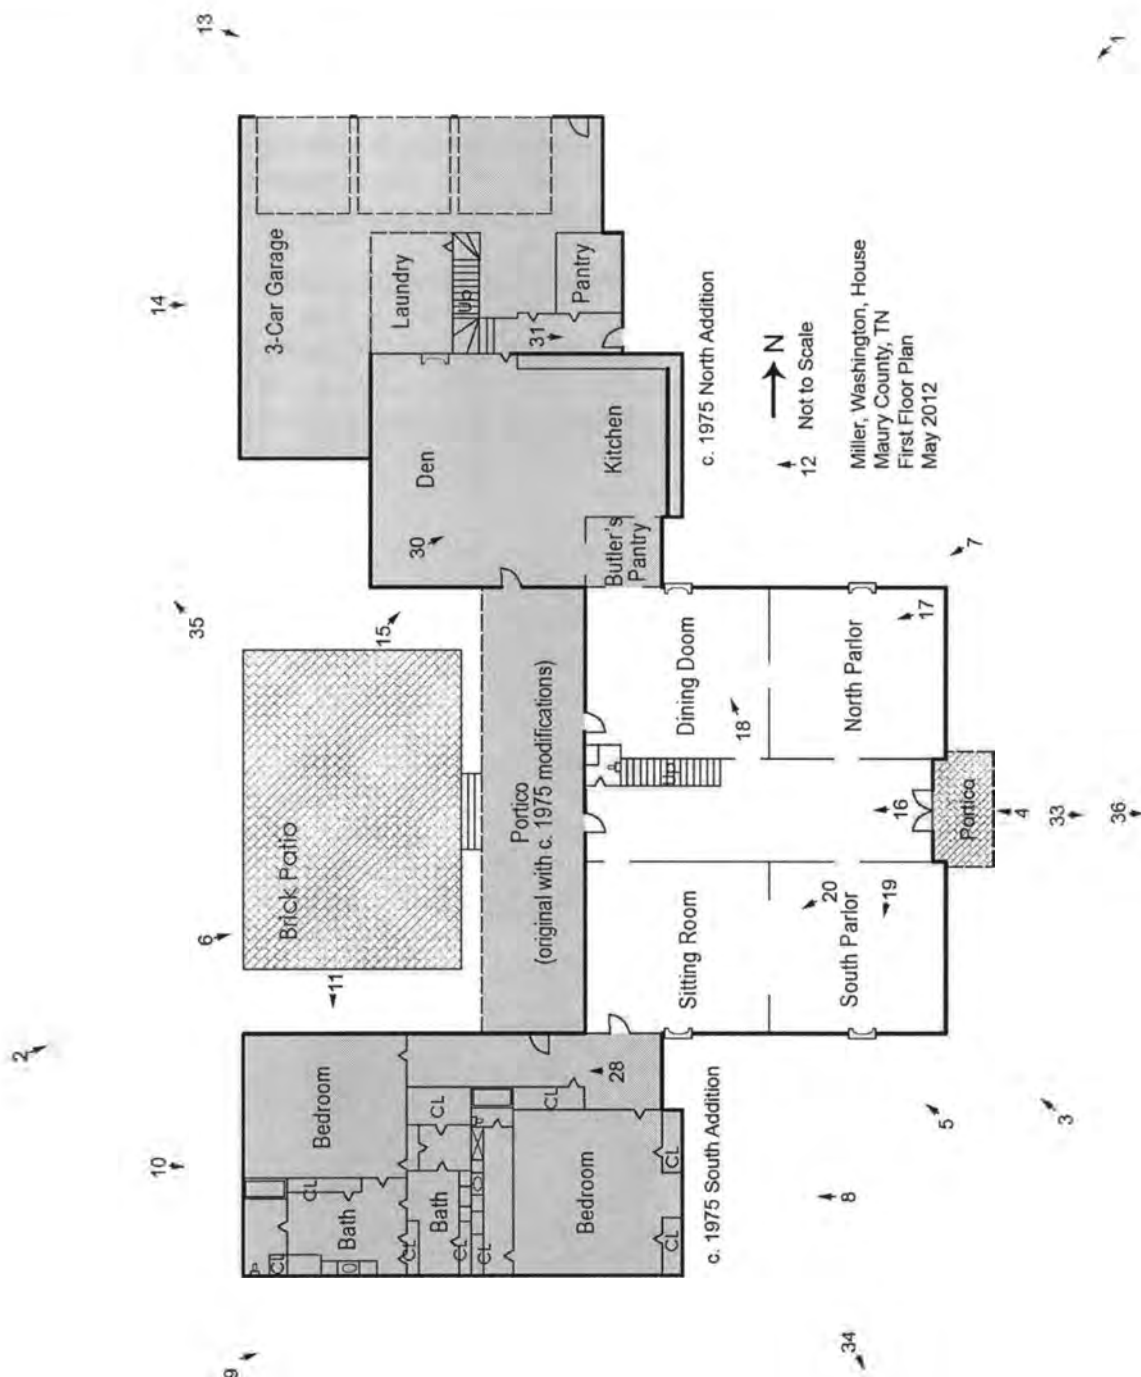
Washington Miller House. First Floor Plan and Photo Key.

The interior of the historic main block features a four-over-four, central hall plan, and unfinished attic. The original interior floor plan remains substantially intact. The front-to-back central hallway divides the first floor rooms, and corresponding spaces on the second floor are used as bedrooms (Photo #16). Rooms on the

first and second floors measure approximately 19 feet x 20 feet. Historic trim, wood flooring, stair railings, doors, windows, and chair rails remain intact throughout the historic main block of the house. Floors throughout the main block are wide poplar boards.

The central hall extends the width of the main block (Photo #16). The halfspace stairwell is located at the west end of the hall along the north wall. The stair appears to be original, and no physical or documented evidence exists to the contrary. The stairs feature a round wood handrail and a plain square newel post with a molded square cap. Plain, square balusters are located beneath the handrail. The halfspace stair extends west along the north wall of the hall to a halfspace landing along the west wall of the hall. From the landing, the stairwell turns east along the south wall to the second floor (Photo #21). Trim features of the hall include wide molded baseboards, shouldered surrounds around doors and windows, and crown molding. The central hall retains original wood floors, plaster walls, and plaster ceiling; however, the plastered walls have been covered in wallpaper. Although the wallpaper is not original, it is thought to be similar to wallpaper that would have historically been in this space. Two, two-panel wood doors on the north wall of the central hall lead into the north parlor at the northeast corner of the main block and the dining room is situated at the northwest corner. Opposite these rooms, two, two-panel wood doors on the south wall lead into the south parlor and sitting room, respectively. At the rear of the hall is a c.1975 ten-light, single-leaf door leading onto the rear porch. Although the door is a replacement, the opening and surround appear original. However, the surround is not shouldered like those found throughout the house. A small, half-bath is located beneath the stairs in the central hall and is accessed by a six-panel wood door with molded wood surround in the undercarriage of the stair. This bath was likely added c.1975. The rooms on either side of the central hall each contain original wood floors, plaster walls, and plaster ceiling. They each feature original simple molded baseboards, crown molding, and shouldered surrounds.

The north parlor, currently used as a study, is situated at the northeast corner of the main block (Photo #17). The fireplace, centered on the north wall, consists of a brick firebox with a marble surround and marble hearth. The fireplace has a modest classical wood mantel with fluted pilasters flanking either side of the firebox. The entablature consists of corner medallions and a fluted rectangular panel. The mantel shelf is slightly inset at the center leaving the appearance of column capitals at the mantel corners above the pilasters. Built-in cabinet shelves occupy the entire wall space on either side of the fireplace and were added c. 1975. The east wall of the north parlor contains two windows. The west wall has a centered opening leading into the dining room that is articulated with shouldered trim. This opening is the same width as the doorways leading to the rooms from the central hall.

The dining room is located at the northwest corner of the house and contains a molded chair rail (Photo #18). On the north wall of the dining room is a centered fireplace. Flanking the fireplace is a single window on the east side, and on the west side, a swinging, two-panel wood door that leads into the kitchen of the north wing addition. On the west wall is an off-centered window and a ten-light wood door that accesses the back porch. The door opening was added c. 1975; however, the surround matches the shouldered wood surrounds found throughout the historic main block of the house. The window was likely moved off-center to accommodate the door at that time. A small bump-out at the southwest corner of the room accommodates the half-bath installed under the stairwell and accessed through the central hall.

The south parlor, or formal living room, is situated at the southeast corner of the first floor (Photo #19). The fireplace and mantel are also identical to those in the north rooms with the exception of the sunburst panels centered under the mantel shelf. The fireplace is centered on the south wall and two windows are located on the east wall. A wide opening is located on the west wall that provides access into the sitting room. The sitting room has a central fireplace and mantel on the south wall that is identical to that in the south parlor (Photo #20). Flanking the fireplace is a single window on its east side, and on its west side, a two-panel wood door leading into the south wing addition. The west wall contains a single, centered window.

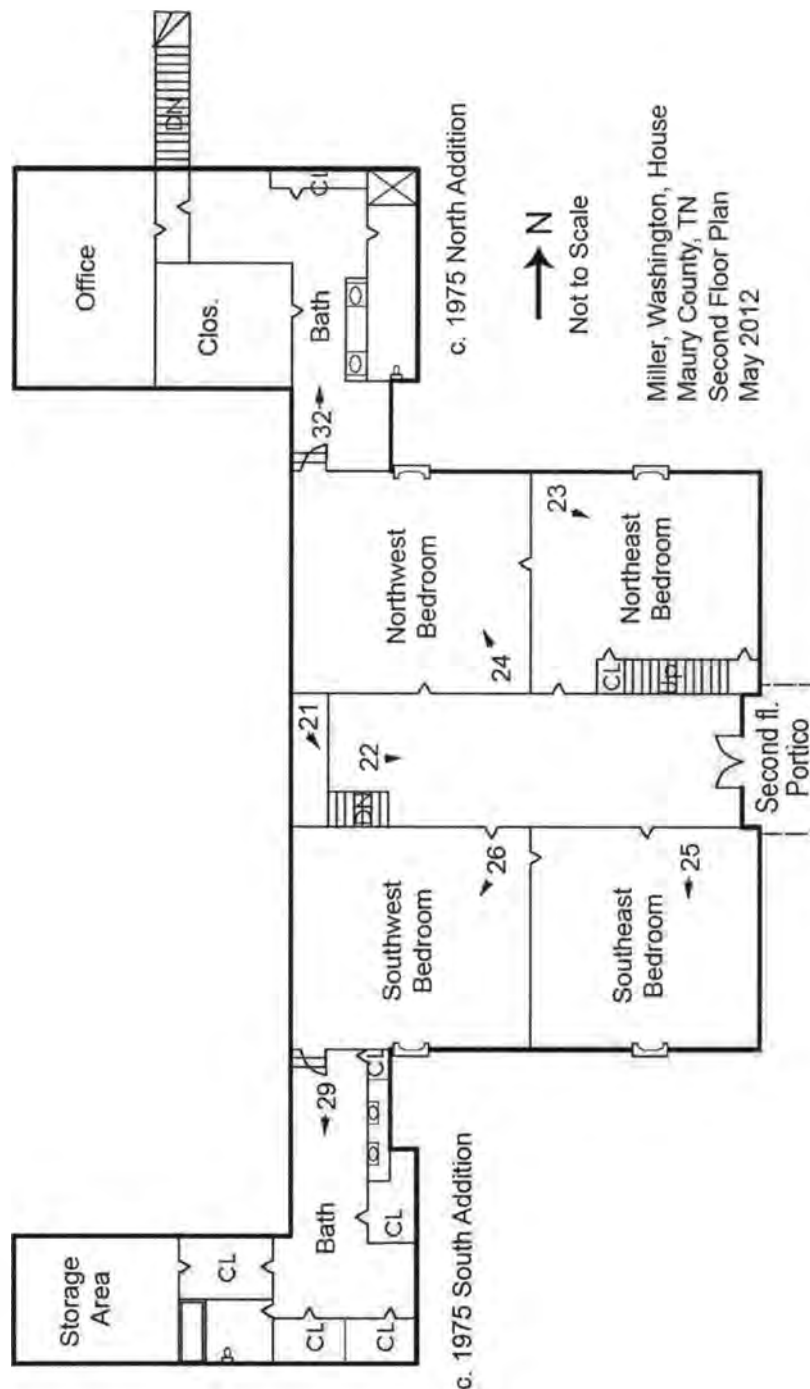
Washington Miller House. Second Floor Plan and Photo Key.

On the second floor, the stairs lead to the west end of a central hall similar to that of the first floor. A double-leaf door leading to the second floor of the front portico is centered on the east wall of the central hall (Photo #22). The door and transom reach the ceiling of the hall and occupy the majority of the west wall. The upstairs hall retains original wide molded baseboards, crown molding, and shouldered surrounds matching those seen in the downstairs hall. It also retains its original wood floors, plaster walls, and plaster ceiling. Like the downstairs hall, walls are covered with wallpaper thought to be similar to original wallpapering. Two, two-panel wood doors are located on the north and south walls providing access to the four bedrooms. A single window is centered on the west wall above the stair. The four bedrooms each retain original wide baseboards, crown molding, wood floors, plaster walls, and plaster ceiling. The shouldered surrounds in these bedrooms match that of the first floor, but the baseboards and crown molding are simpler than that of the downstairs.

The northeast bedroom has a fireplace and mantel centered on the north wall (Photo #23). The fireplace is brick and has a marble hearth, and surround like those of the downstairs rooms. The mantel is simpler than those of the downstairs room and consists of a plain shouldered surround with a plain wood panel beneath the mantel shelf. Two windows are located on the east wall and a centered, two-panel wood door on the west wall leads into the northwest bedroom. Along the south wall is an enclosed stairway leading to the unfinished one-room attic. The enclosure for the stair runs almost the length of the wall, ending just before the doorway at the western end of the wall. The stair is accessed at the east end of the wall through a four-panel wood door.

Centered on the north wall of the northwest bedroom is a fireplace identical to that of the northeast bedroom (Photo #24). Flanking the fireplace is a window on the east side and a six-panel wood door on the west side leading into the north addition. A single window is centered on the west wall of the bedroom.

The southeast bedroom has a fireplace identical to those of the north bedrooms centered on the south wall (Photo #25). Two windows are located on the east wall and a six-panel wood door is on the north end of the west wall that leads into the southwest bedroom.

The southwest bedroom has a fireplace identical to those of the other three bedrooms centered on the south wall (Photo #26). Flanking the fireplace is a single window on the east side and a six-panel wood door on the west side that leads into the south wing addition. A single window is centered on the west wall of the room.
