# National Register of Historic Places Inventory—Nomination Form

historic Otis Company Mill #1

and/or common The Old Stone Mill

city, town Ware N/A vicinity of congressional district First

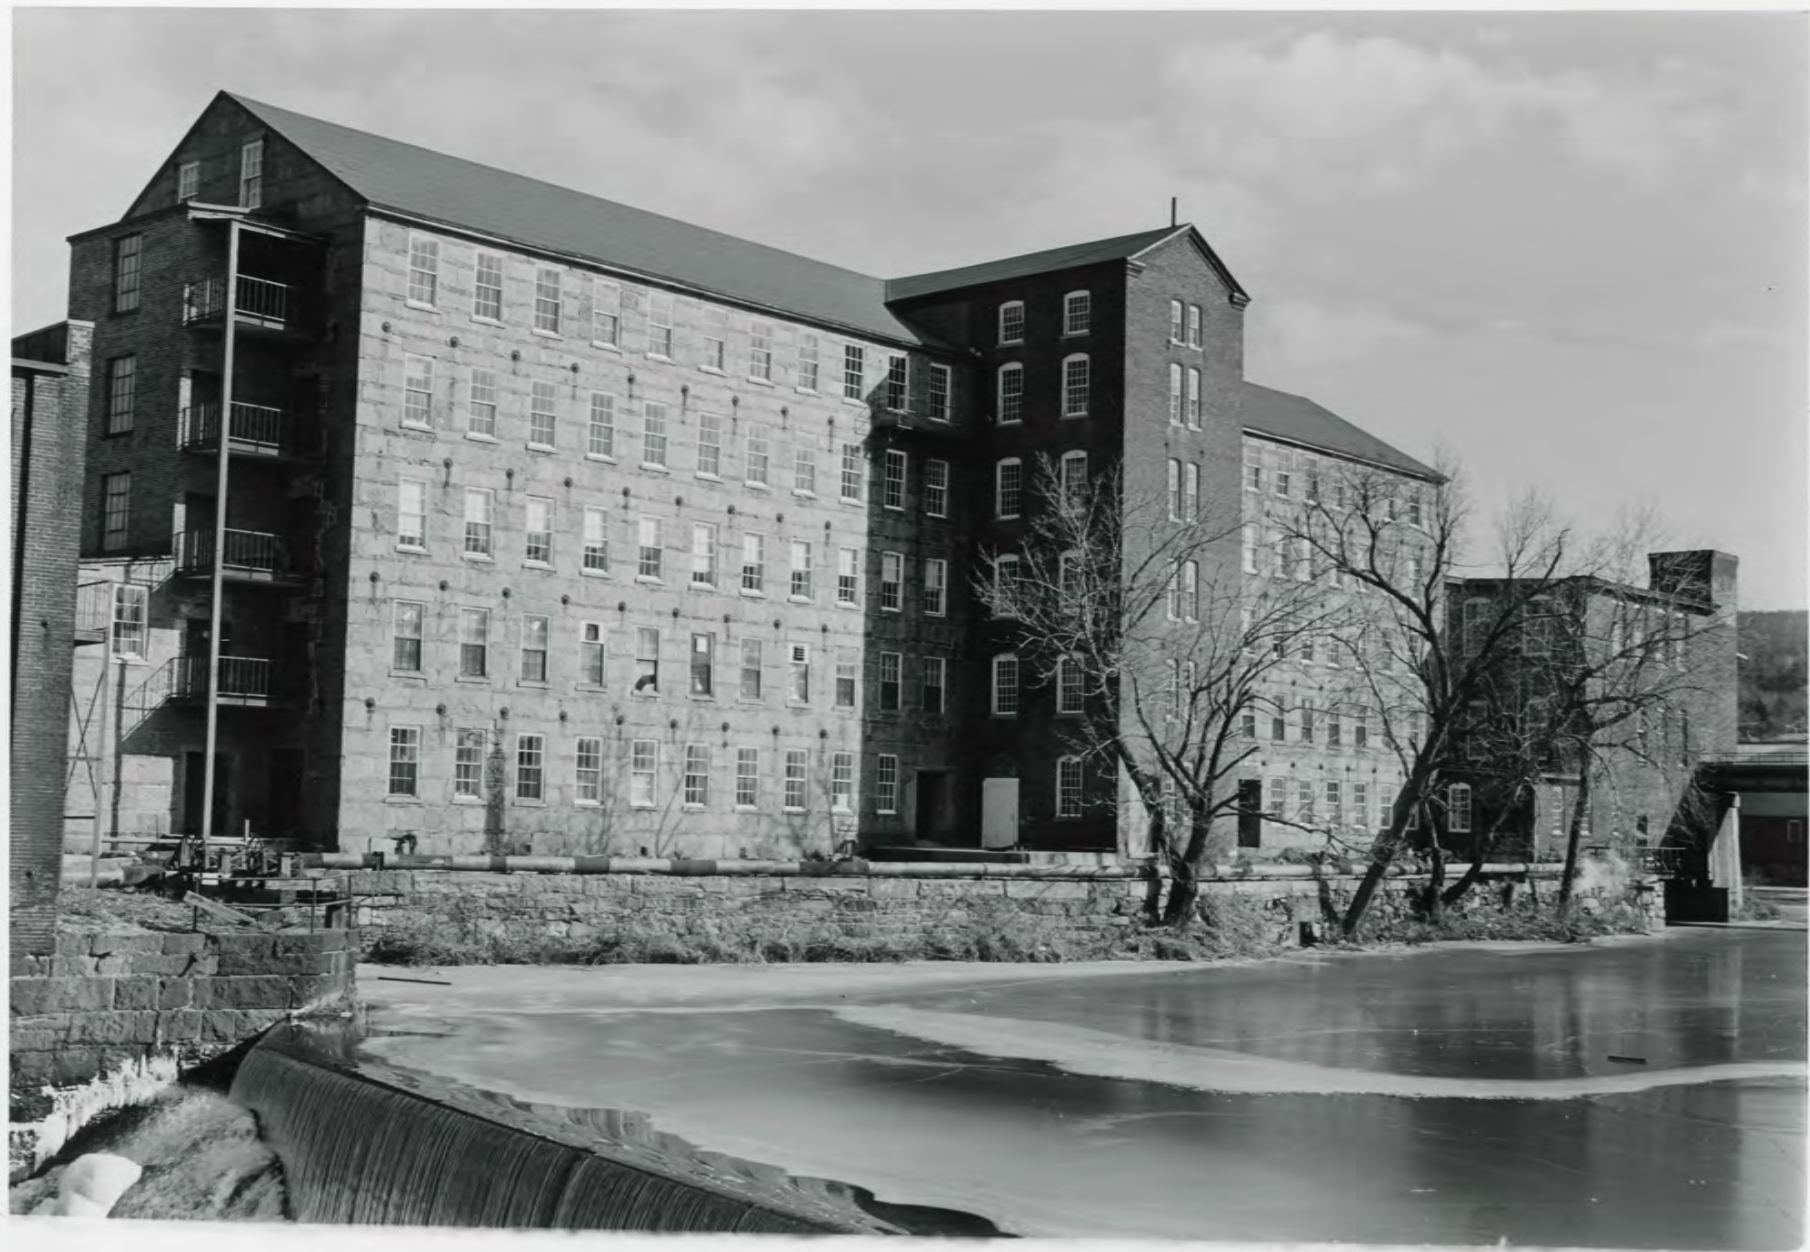
#1

Southern facade

Southern facade of the  
Otis Co. Mill #1,  
Massachusetts

The Old Stone Mill (Otis Company Mill #1) is a five story granite structure which sits amidst a cluster of nineteenth century red brick textile mills. It faces East Main Street to the north and abuts the Ware River along the building's entire southern facade. Due to a difference in ground elevation, only four of the five stories are visible from the street (north) side.

The five and a half story red brick tower on the south side was built to its present dimensions (20'x20') sometime between 1878 and 1886. The scale, the materials, and the 12 over 12 segmentally arched windows also complement the main structure quite nicely.
