National Register of Historic Places Registration Form

Historic name: **Albion River Bridge**
Other names/site number: **Caltrans number: 10.0136**
Name of related multiple property listing:

Historic Highway Bridges of California MPS 2004

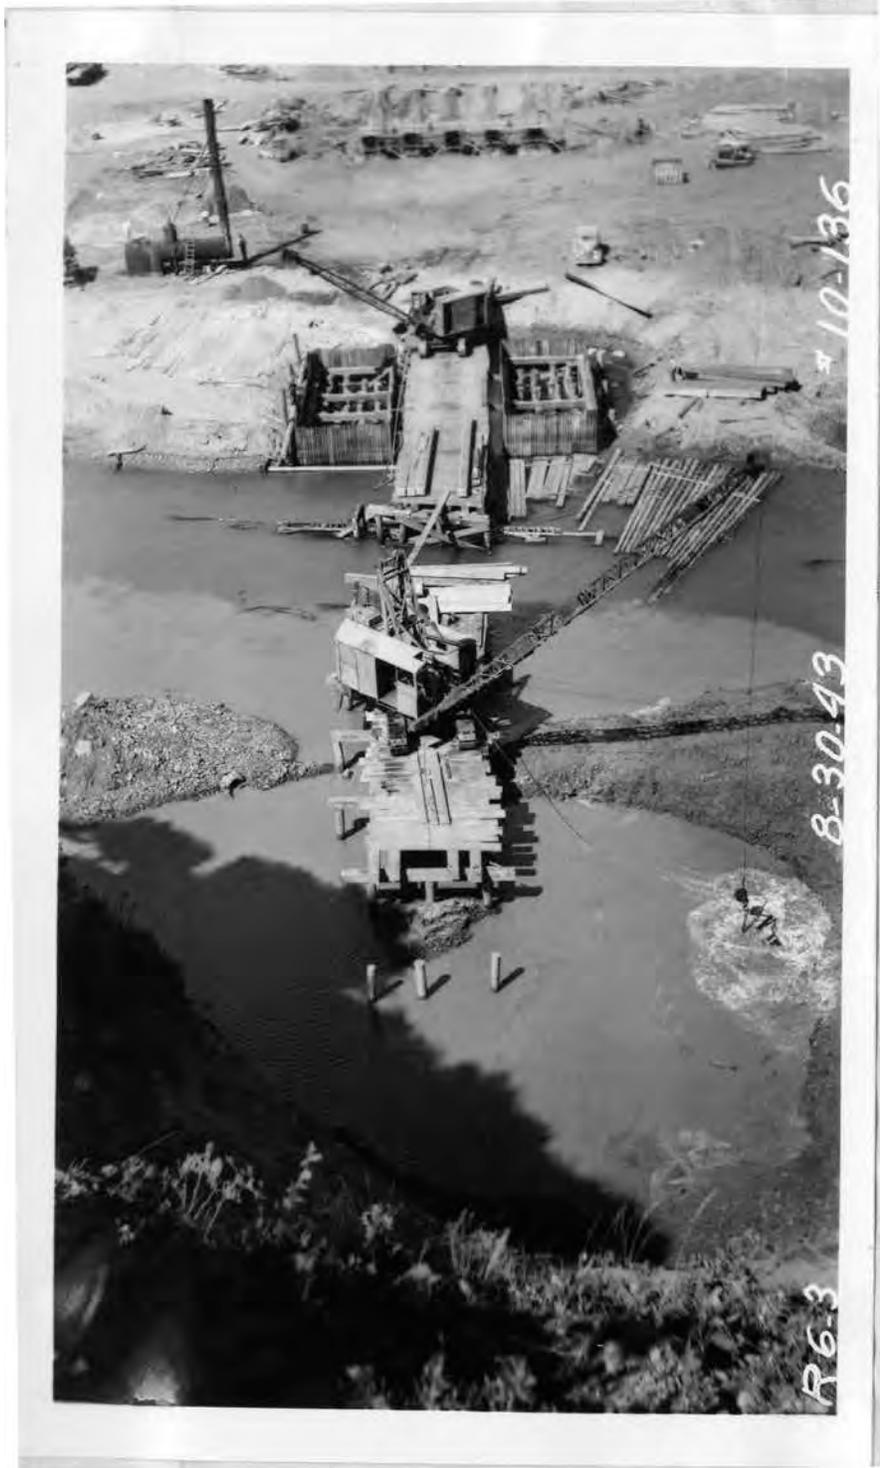
Figure 1: Albion River Bridge under construction, August 1943. California Department of Transportation archive.

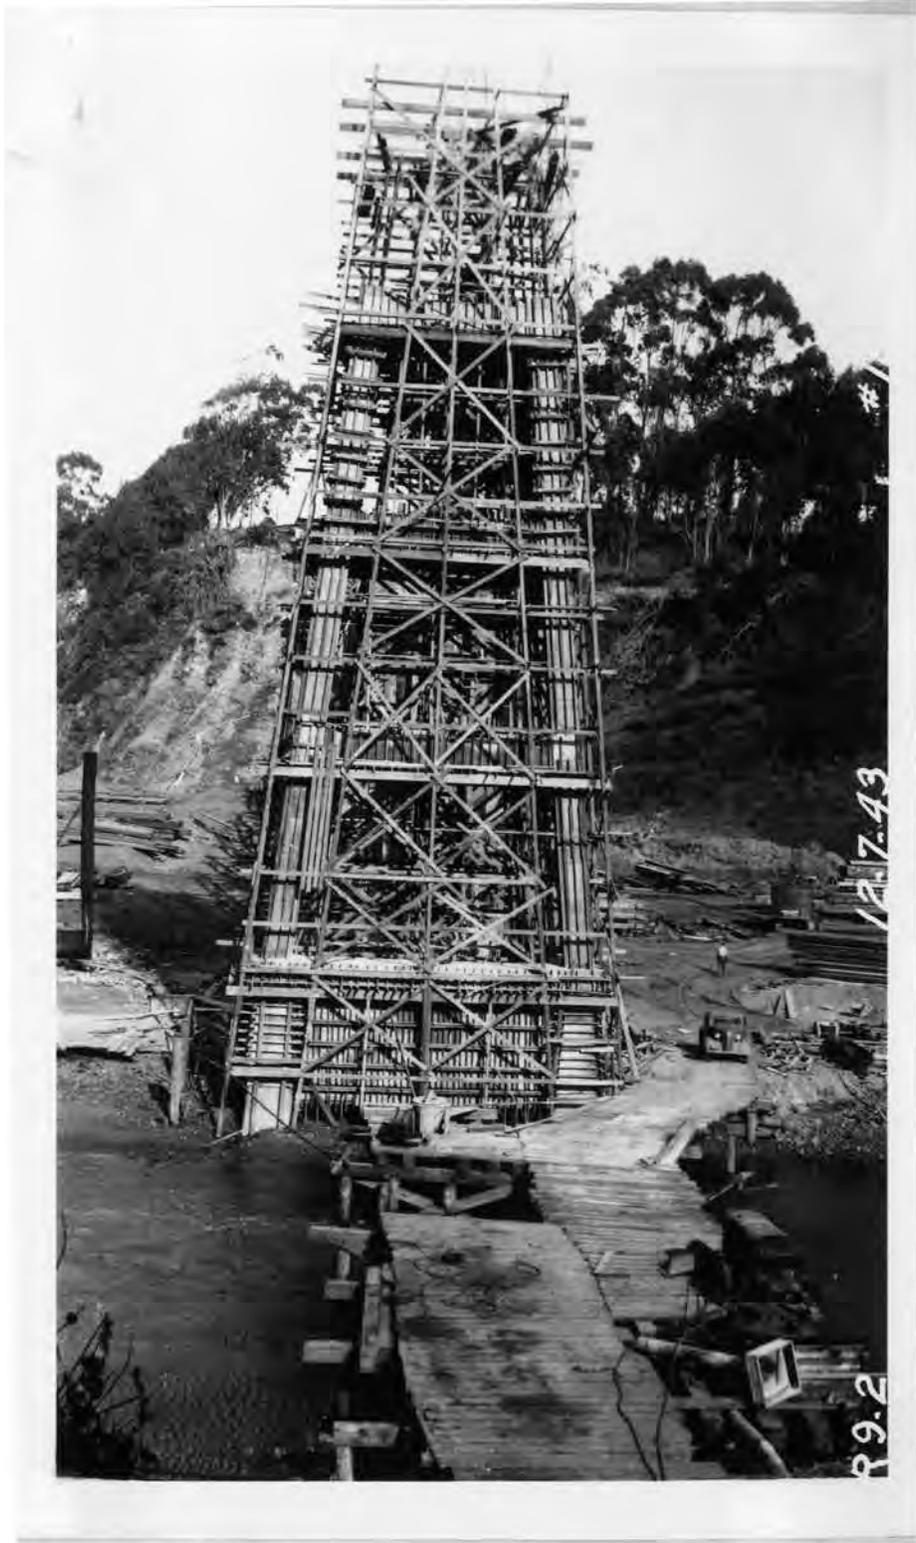
Figure 2: Albion River Bridge under construction, December 1943. California Department of Transportation archive.

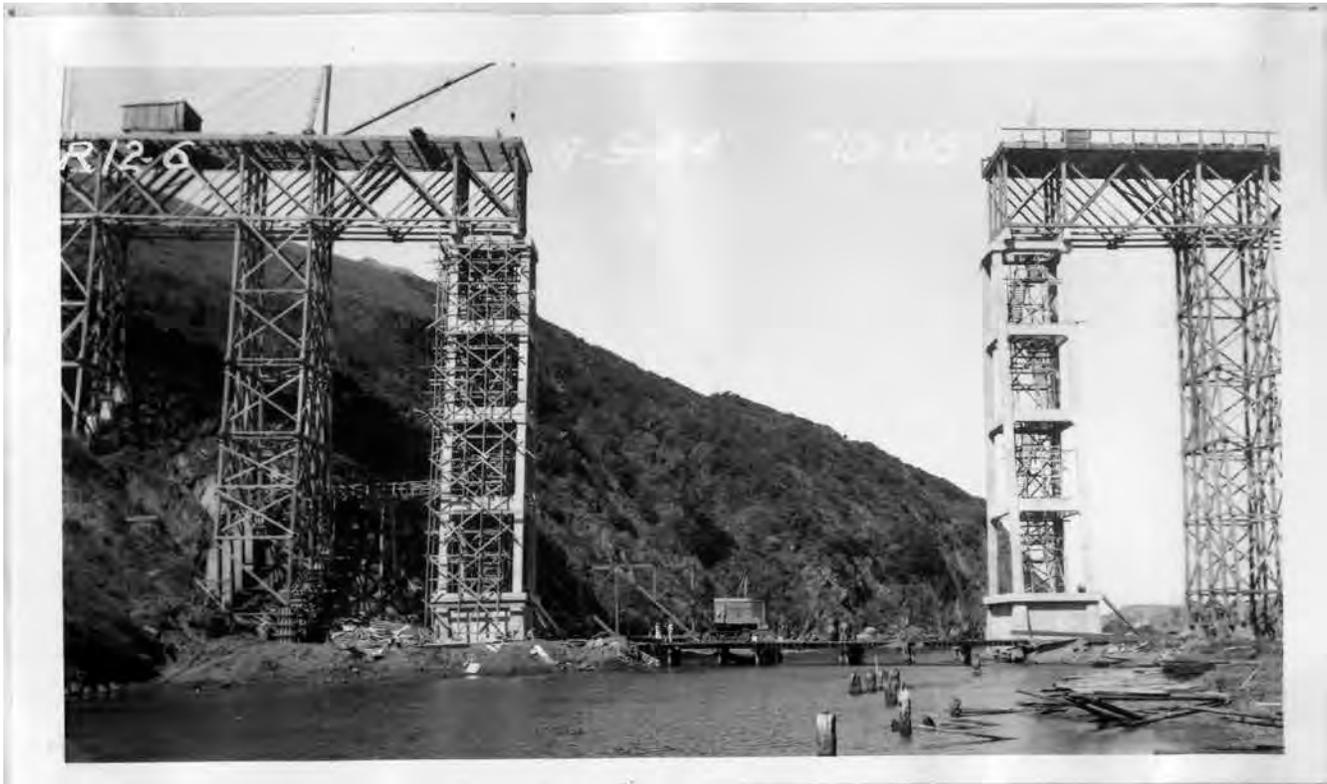
Figure 3: Albion River Bridge under construction, April 1944. California Department of Transportation archive.

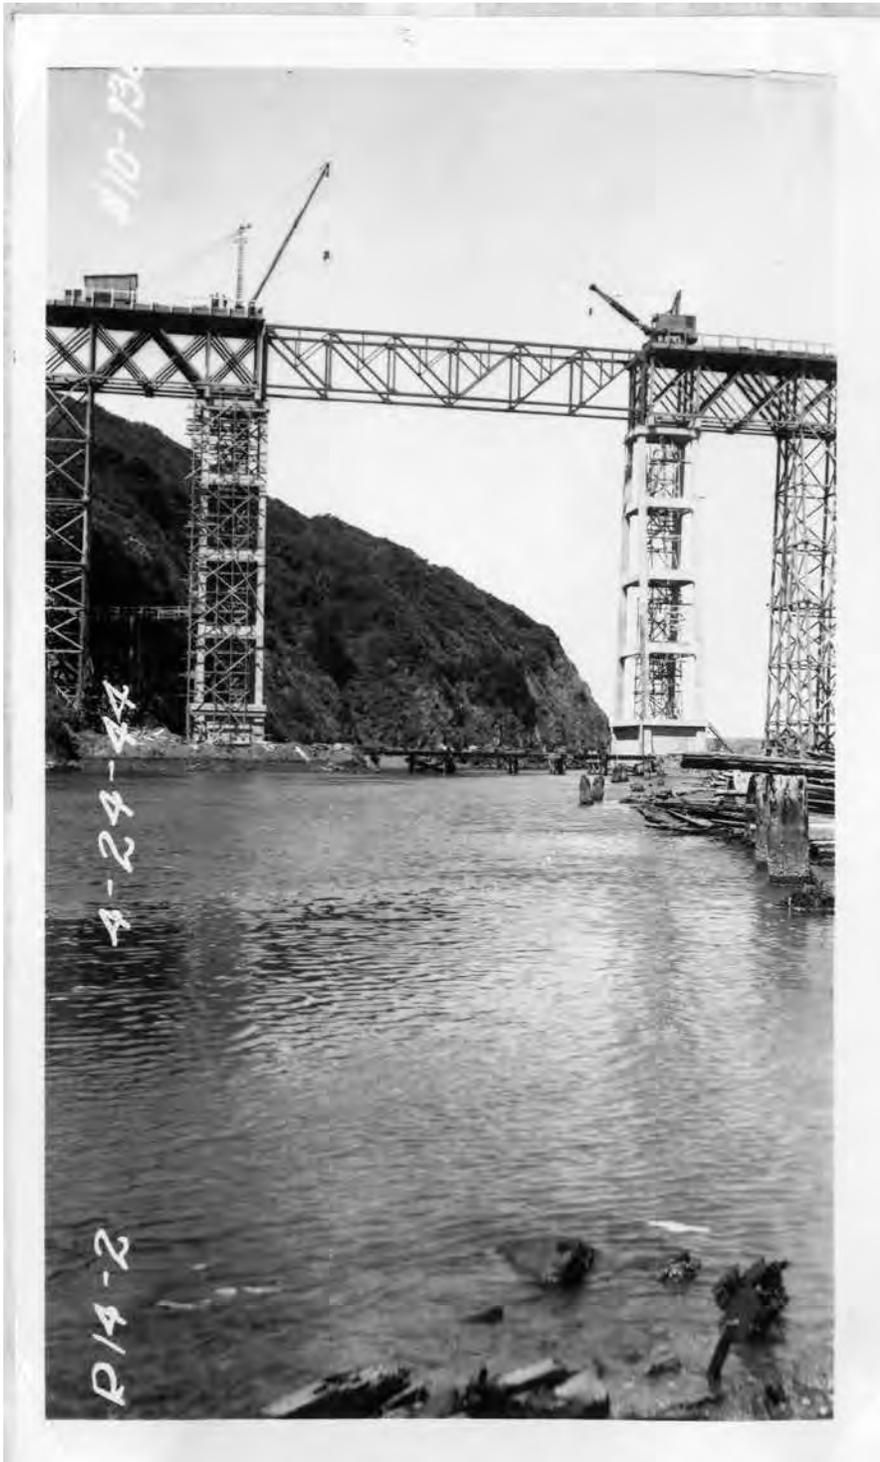
Figure 4: Albion River Bridge under construction, April 1944. California Department of Transportation archive.

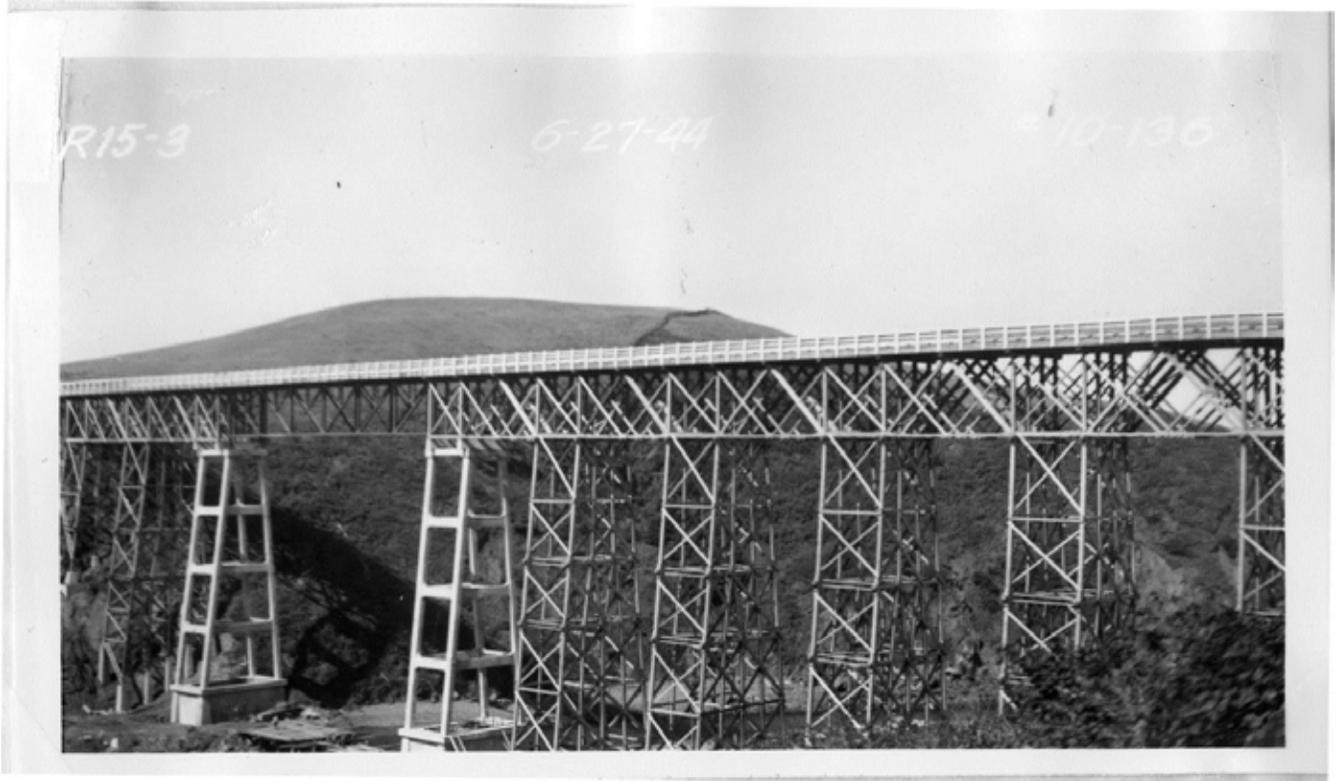
Figure 5: Albion River Bridge after completion, April, 1944. California Department of Transportation archive.

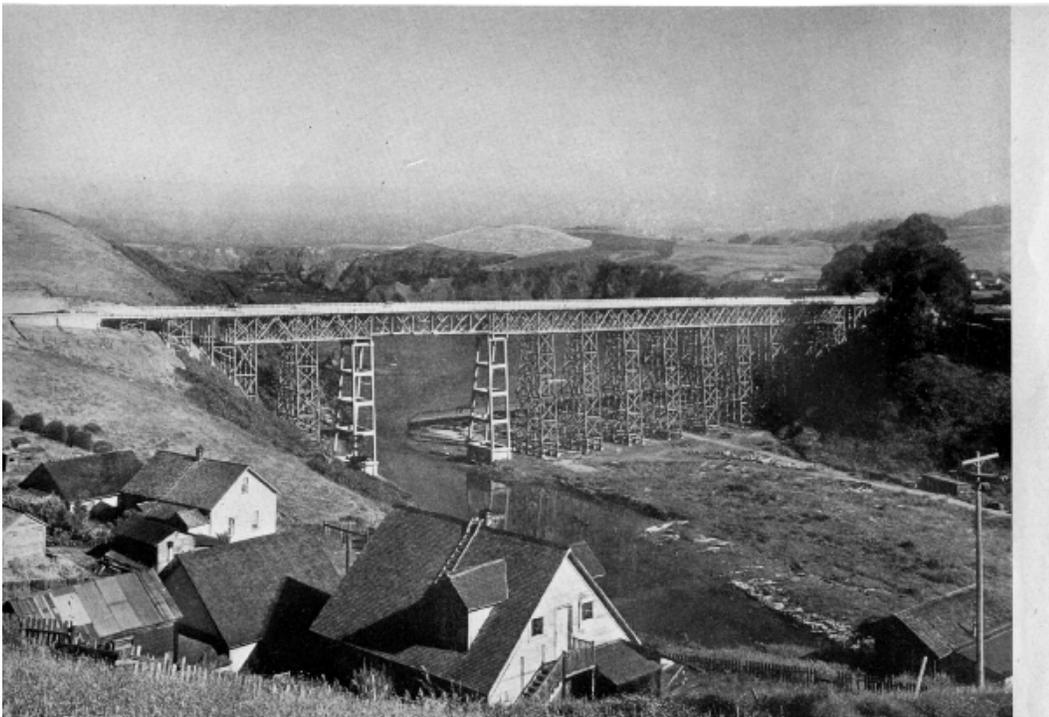
View of new \$350,000 Albion River bridge in Mendocino County. This is not the type of bridge the State would build under normal conditions but steel for reinforced concrete and structural steel could not be secured and much salvaged material had to be used

The amount of concrete was limited to foundations, abutments, and only 2 of the 13 bent piers. A steel truss was salvaged from an abandoned Swayne Lumber Company railroad bridge over the south fork of the Feather River near Oroville, 120 miles east of Albion. It was shipped to the Shrader Iron Works of San Francisco and refabricated into a 15 foot deep Pratt truss. This truss was installed onto 135' tall, poured-in-place concrete piers each side of the 130 foot wide river crossing section of the bridge. The remaining trusses are treated timber supported on treated timber trestle type bent piers of various heights on concrete foundations. Salvaged railroad rails were split and used to reinforce the new concrete elements of the bridge, in lieu of standard reinforcing steel.

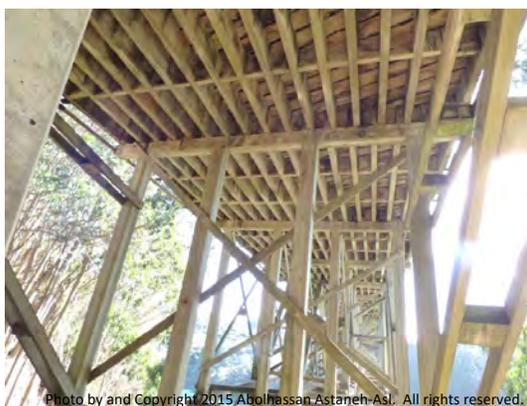
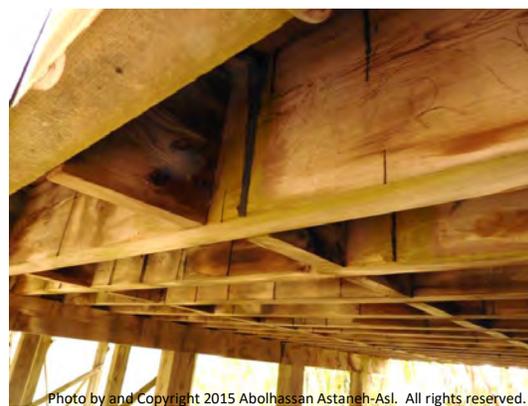
The existing timber members are in very good condition with no sign of rotting or crushing

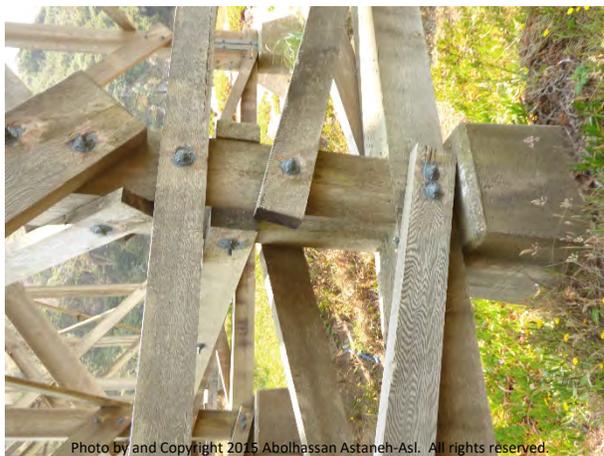
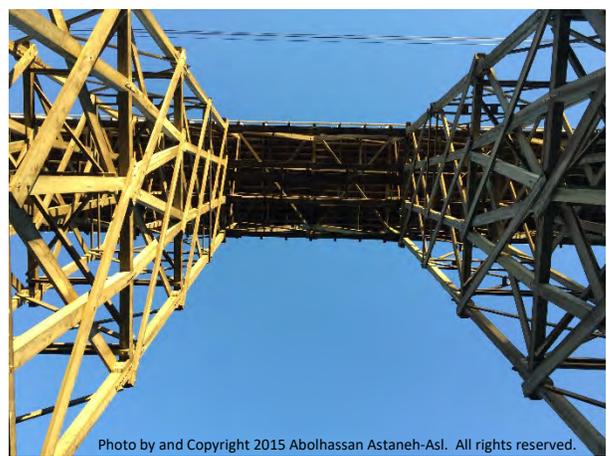
In 2013, the bridge underwent major painting and maintenance. The corroded bolts were replaced at the time and were coated to prevent corrosion; see the photographs below. Given that the bolts have been replaced, if the downgrading of the bridge was dependent on corroded bolts, those concerns should have been eliminated. Caltrans had not provided a rationale or documented any conditions that support the downgrading of the bridge, yet between 2013–2015 the bridge went from a rating of 7 to a 3, as attested to in the Routine Inspection Report and the Structure Inventory & Appraisal Reports submitted to the FHWA. I note that entering false data into a bridge inspection report submitted to the FHWA is prohibited by law.

The bolts connecting the timber members are in good condition in these 2015 photos
