HISTORIC RESOURCES INVENTORY BUILDING AND STRUCTURES

IDENTIFICATION	1. BUILDING NAME (Common) (Historic) Allyn Steele House	
	2. TOWN/CITY West Hartford	VILLAGE COUNTY Hartford
	3. STREET AND NUMBER (and/or location) 114 North Main Street approx. .2 acres Vol. 467, p. 797.

7. STYLE OF BUILDING Center chimney colonial DATE OF CONSTRUCTION c. 1775	
	8. MATERIAL(S) (Indicate use or location when appropriate) <input checked="" type="checkbox"/> Clapboard <input type="checkbox"/> Asbestos Siding <input checked="" type="checkbox"/> Brick fdn <input type="checkbox"/> Other (Specify) _____ <input type="checkbox"/> Wood Shingle <input type="checkbox"/> Asphalt Siding <input type="checkbox"/> Fieldstone <input type="checkbox"/> Board & Batten <input type="checkbox"/> Stucco <input type="checkbox"/> Cobblestone <input type="checkbox"/> Aluminum Siding <input type="checkbox"/> Concrete Type: _____ <input type="checkbox"/> Cut stone Type: _____

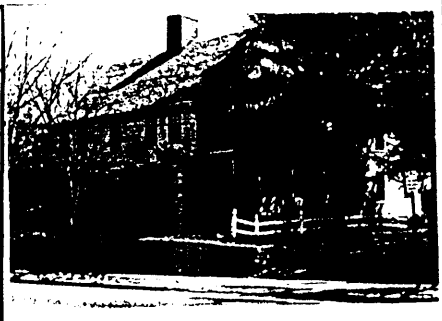
VIEW southwest NEGATIVE ON FILE CHC roll IV frame 11,13,1

This 5 bay center chimney gable roof, ridge to street, Colonial farmhouse has as its ornamental detailing pilasters and a modest entablature flanking the entry. Windows, which are obscured on the ground floor by shrubbery, are 19th century 2/2 sash. There is a 19th century veranda on one end of the house, and an added bay window.
