National Register of Historic Places Registration Form

Historic name U.S. Inspection Station—Fort Covington, New York
Other names/site number Fort Covington Border Station

*U.S. Inspection Station—Fort Covington
Franklin County, New York*

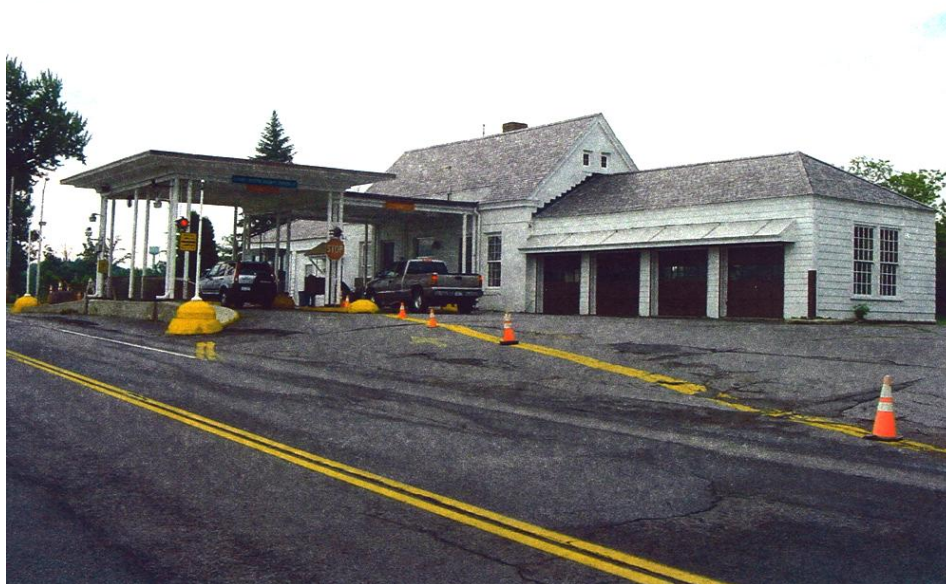
Photo number: NY_FranklinCounty_FortCovingtonBorderStation1.tiff

Description of view: front and side elevations, view: south

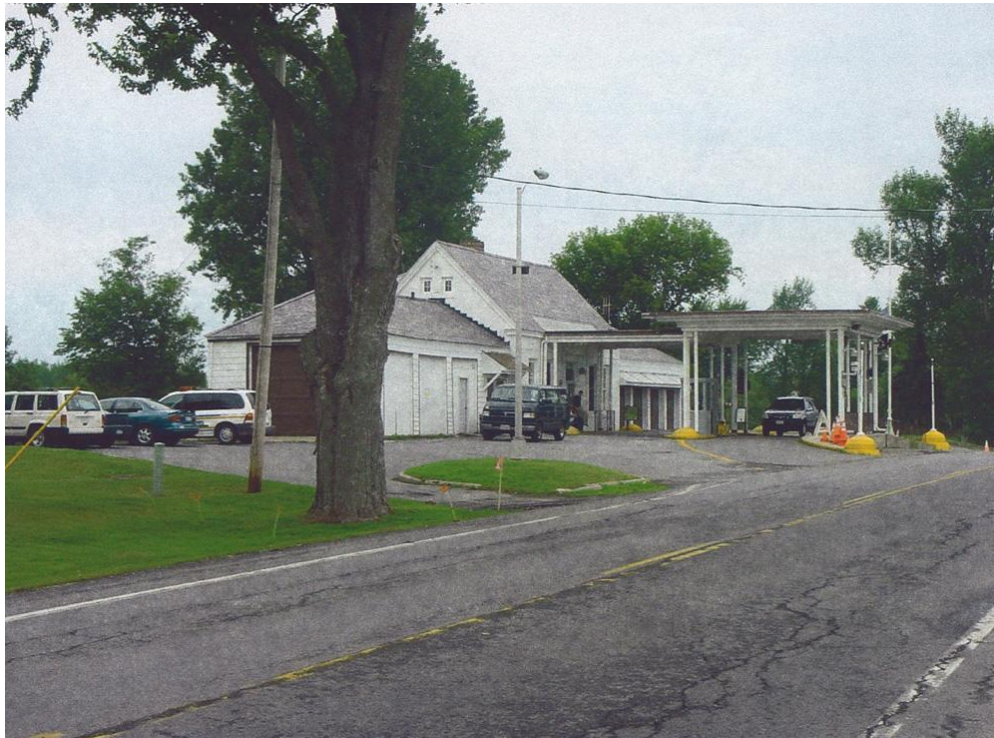
Photo number: NY_FranklinCounty_FortCovingtonBorderStation2.tiff

Description of view: front and side elevations, porte-cochere; view: northwest

Affixed to the front of the primary building is a flat roofed one-lane porte-cochere supported by a pair of metal columns at each inner corner. Affixed to its outer edge is an expansion to the porte-cochere that is similarly flat-roofed. This expansion, however, is taller and larger than the porte-cochere, and is supported by multiple metal columns at each of its corners. All of the porte-cochere columns rest not on the paved ground, but on elevated concrete islands. Two short, thin metal columned flagpoles with balloon finials are set in a thick, round concrete base outside of both outer corners of the added canopy.

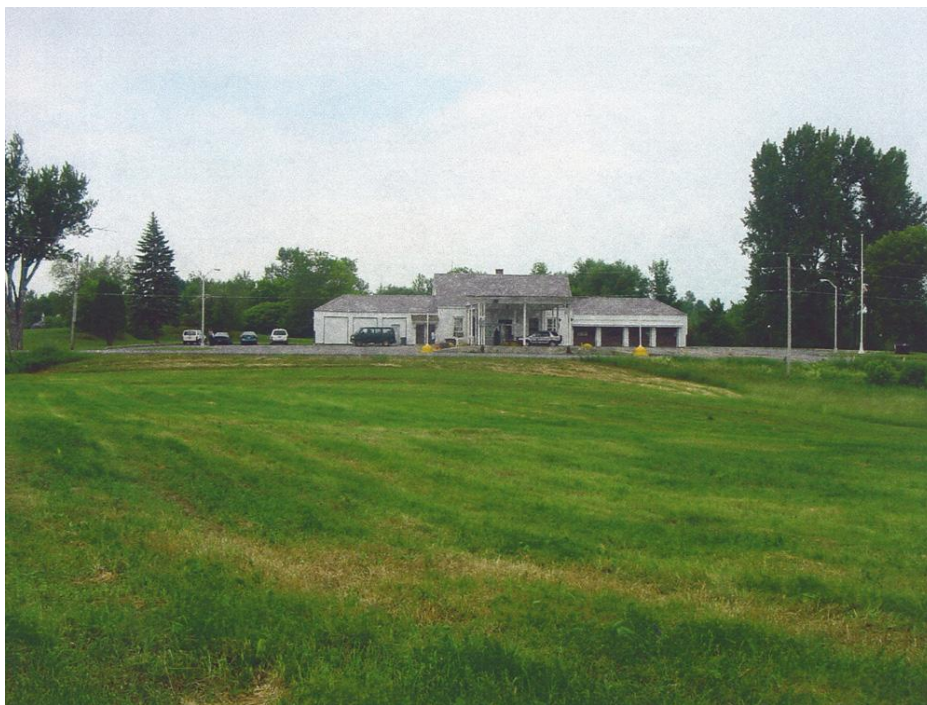
Photo number: NY_FranklinCounty_FortCovingtonBorderStation3.tiff

Description of view: front elevation from the distance, view: southwest

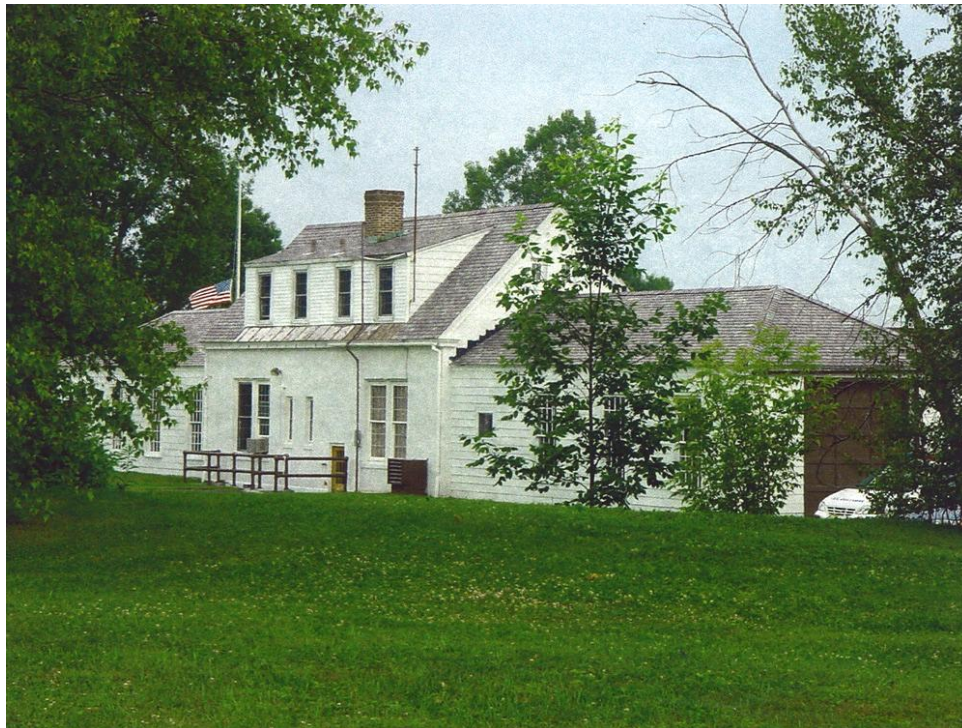
Photo number: NY_FranklinCounty_FortCovingtonBorderStation4.tiff

Description of view: rear elevation, view: north

Located at the outer bays on each side of its first level rear elevation are two symmetrically placed pairs of 12/12 woodframe double hung windows. Placed off-center due slightly north on the rear elevation are two adjacent 4/4 double hung windows of a very thin, vertical design. A rear entrance, presumably to the basement, is located below grade at the rear elevation. The rear elevation of the southern garage wing features three bays of 12/12 woodframe double hung windows with molded wood surrounds and wood sills. The innermost bay of this wing contains a small, square window. All four of the bays across the rear elevation of the northern garage wing feature 12/12 windows similarly detailed to those at the rear of the southern wing.

Centered in the roof above the rear elevation is a 4-bay shed dormer clad in wood clapboard. Each bay is well spaced from the next bay, and contains a double hung window. Centered in the roof directly above the rear dormer is a square shaped brick chimney with crown molding.

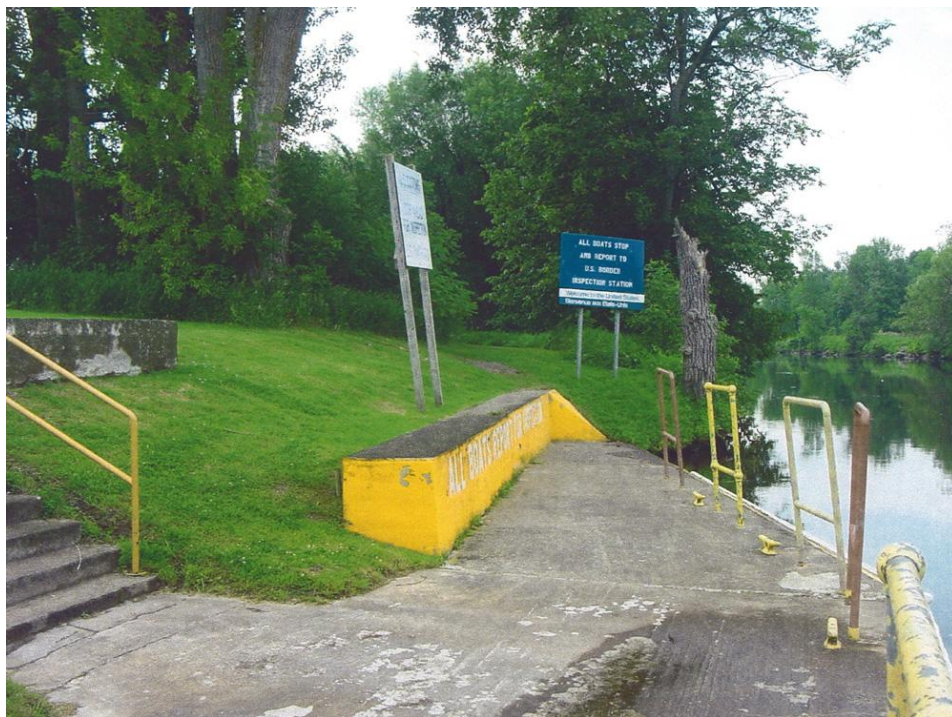
Photo number: NY_FranklinCounty_FortCovingtonBorderStation5.tiff

Description of view: boat landing, view: south

Travelers downstream on the Salmon River, located directly behind the inspection station property, are required to declare, so there is an original concrete landing and walkway, low retaining wall, and stair are all present near the riverbank. The edge of this landing features early if not original pipe rail guards. The stairs from the riverbank lead upslope, where the walkway to the primary building becomes a pathway through the rear yard. This path is lined with lightpoles, some of which are set into a flagstone and mortar base. The rest of the rear yard is largely covered with lawn, and includes an occasional tree specimen within it.

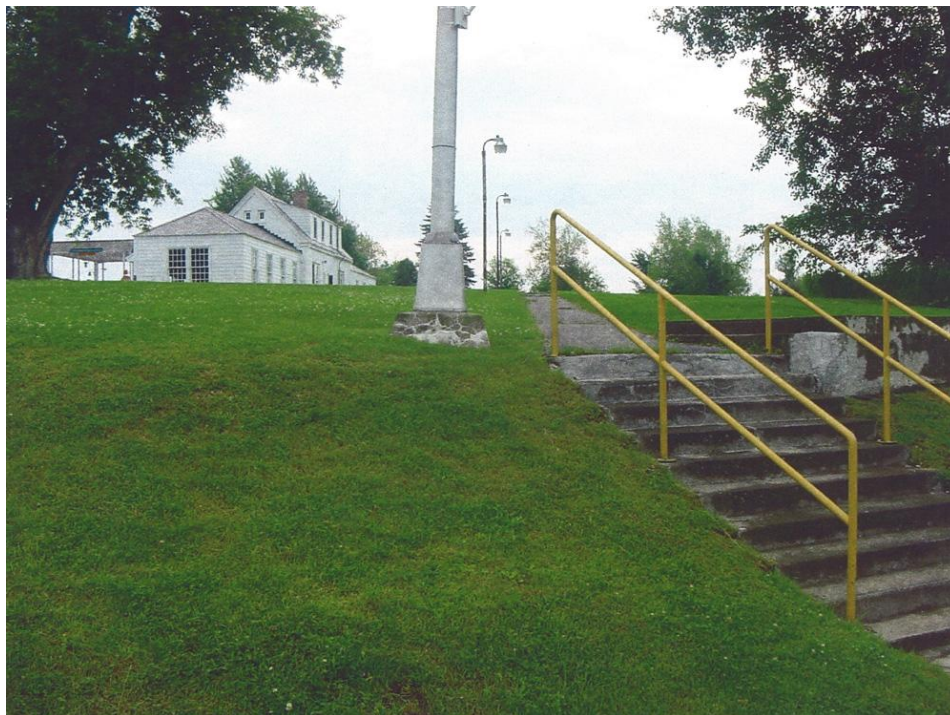
Photo number: NY_FranklinCounty_FortCovingtonBorderStation6.tiff

Description of view: stairs from the boat landing to the Inspection Station, view: southeast

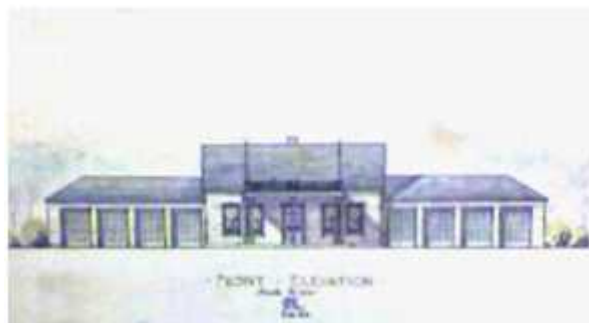
U.S. Inspection Station – Fort Covington
Franklin County, New York
Courtesy: National Archives and Records Administration
Date: 1932
Description of view: front elevation

The renderings for the Fort Covington Inspection Station can be found at the National Archives and Records Administration (NARA).⁴ Though some alterations have occurred, the inspection station as currently extant is true to the overall form of the original front elevation rendering. Original details still present include the presence of paired, wood frame, multi-glazed double hung windows, the hipped gabled symmetrically placed garage wings, and a centered chimney.

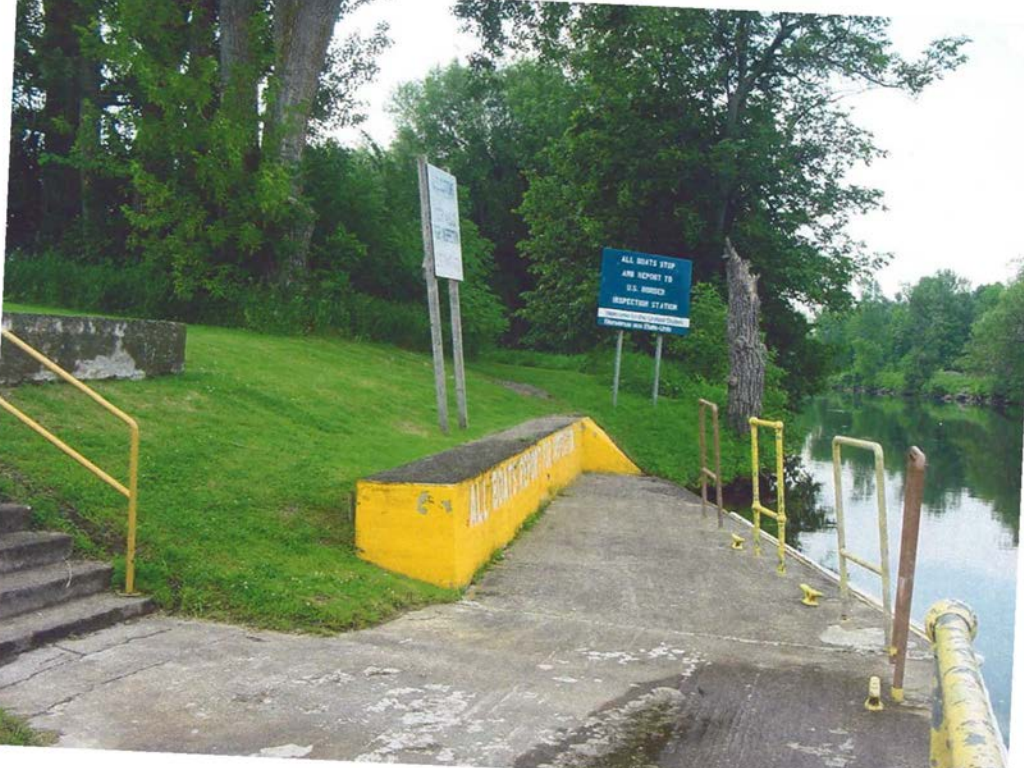
ALL BOATS STOP
AND REPORT TO
U.S. BORDER
INSPECTION STATION

White sign on wooden post
