NATIONAL REGISTER OF HISTORIC PLACES
REGISTRATION FORM

Historic Name: Mountain View FarmOther Name/Site Number: Tippy, Richard S. Farmstead YE0089

Street & Number: County Road 218, P.O. Box 85Not for Publication: N/ACity/Town: PlainviewVicinity: XState: AR County: Yell (149) Code: AR Zip Code: 72857

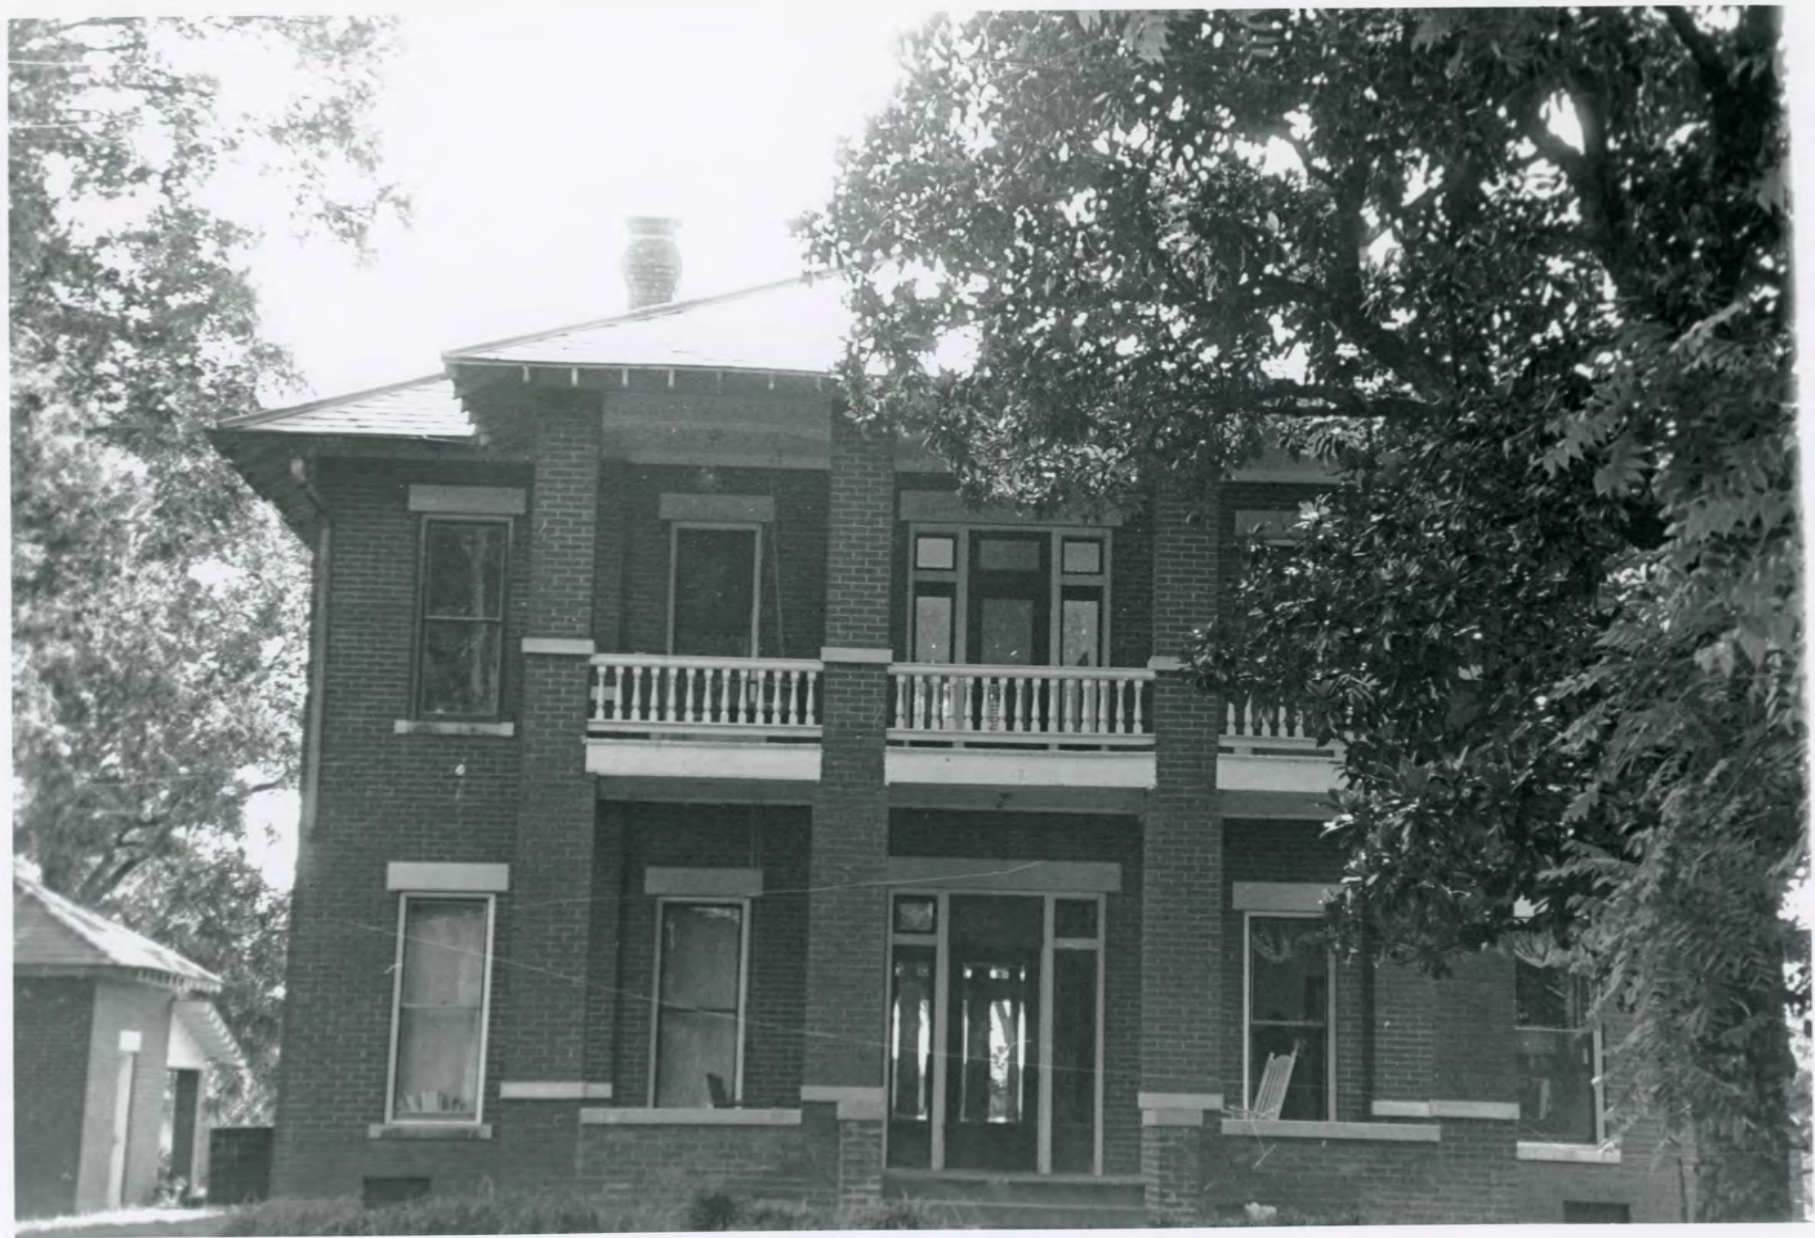
View of main house from east

The eastern elevation or facade of Mountain View Farm is five bays in length and fenestrated by four double-hung one over one pane windows accented with white stone lintels and sills. The pane door flanked by single pane sidelights, and a tripartite transom capped with a stone lintel. This same arrangement is repeated across the upper level of the facade and the same decoration is maintained in window and door design. A half hipped roof two tiered porch extends across three-fourths of the home's entrance. Four heavy squared piers built of brick support the projecting roof. Each vertical support is accented with two limestone slabs. The stone slabs extend over the piers to lend the illusion of a capitol and base found on columns. Pilasters, on the main building, align with each pier and contain the same brick and stone composition. The upper tier is built of tongue and groove wood planks and is enclosed with a wooden balustrade made of turned spindles. The porch is supported by a raised cement platform faced with brick and capped with stone slabs. Projecting eastward are a series of concrete steps located between the two inner piers. The steps are contained between two low stoops made of brick and capped with stone composition. The upper tier is built of tongue and groove wood planks and is enclosed with a wooden balustrade made of turned spindles. The porch is supported by a raised cement platform faced with brick and capped with stone slabs.

Projecting eastward are a series of concrete steps located between the two inner piers. The steps are contained between two low stoops made of brick and capped in stone. Due to rot, the balustrade is the only portion of the exterior which has been replaced since its construction. The replaced portion was copied from the original element. The two story height of this entrance porch is not commonly associated with either plan or style, as well as the use of turned wooden spindles.

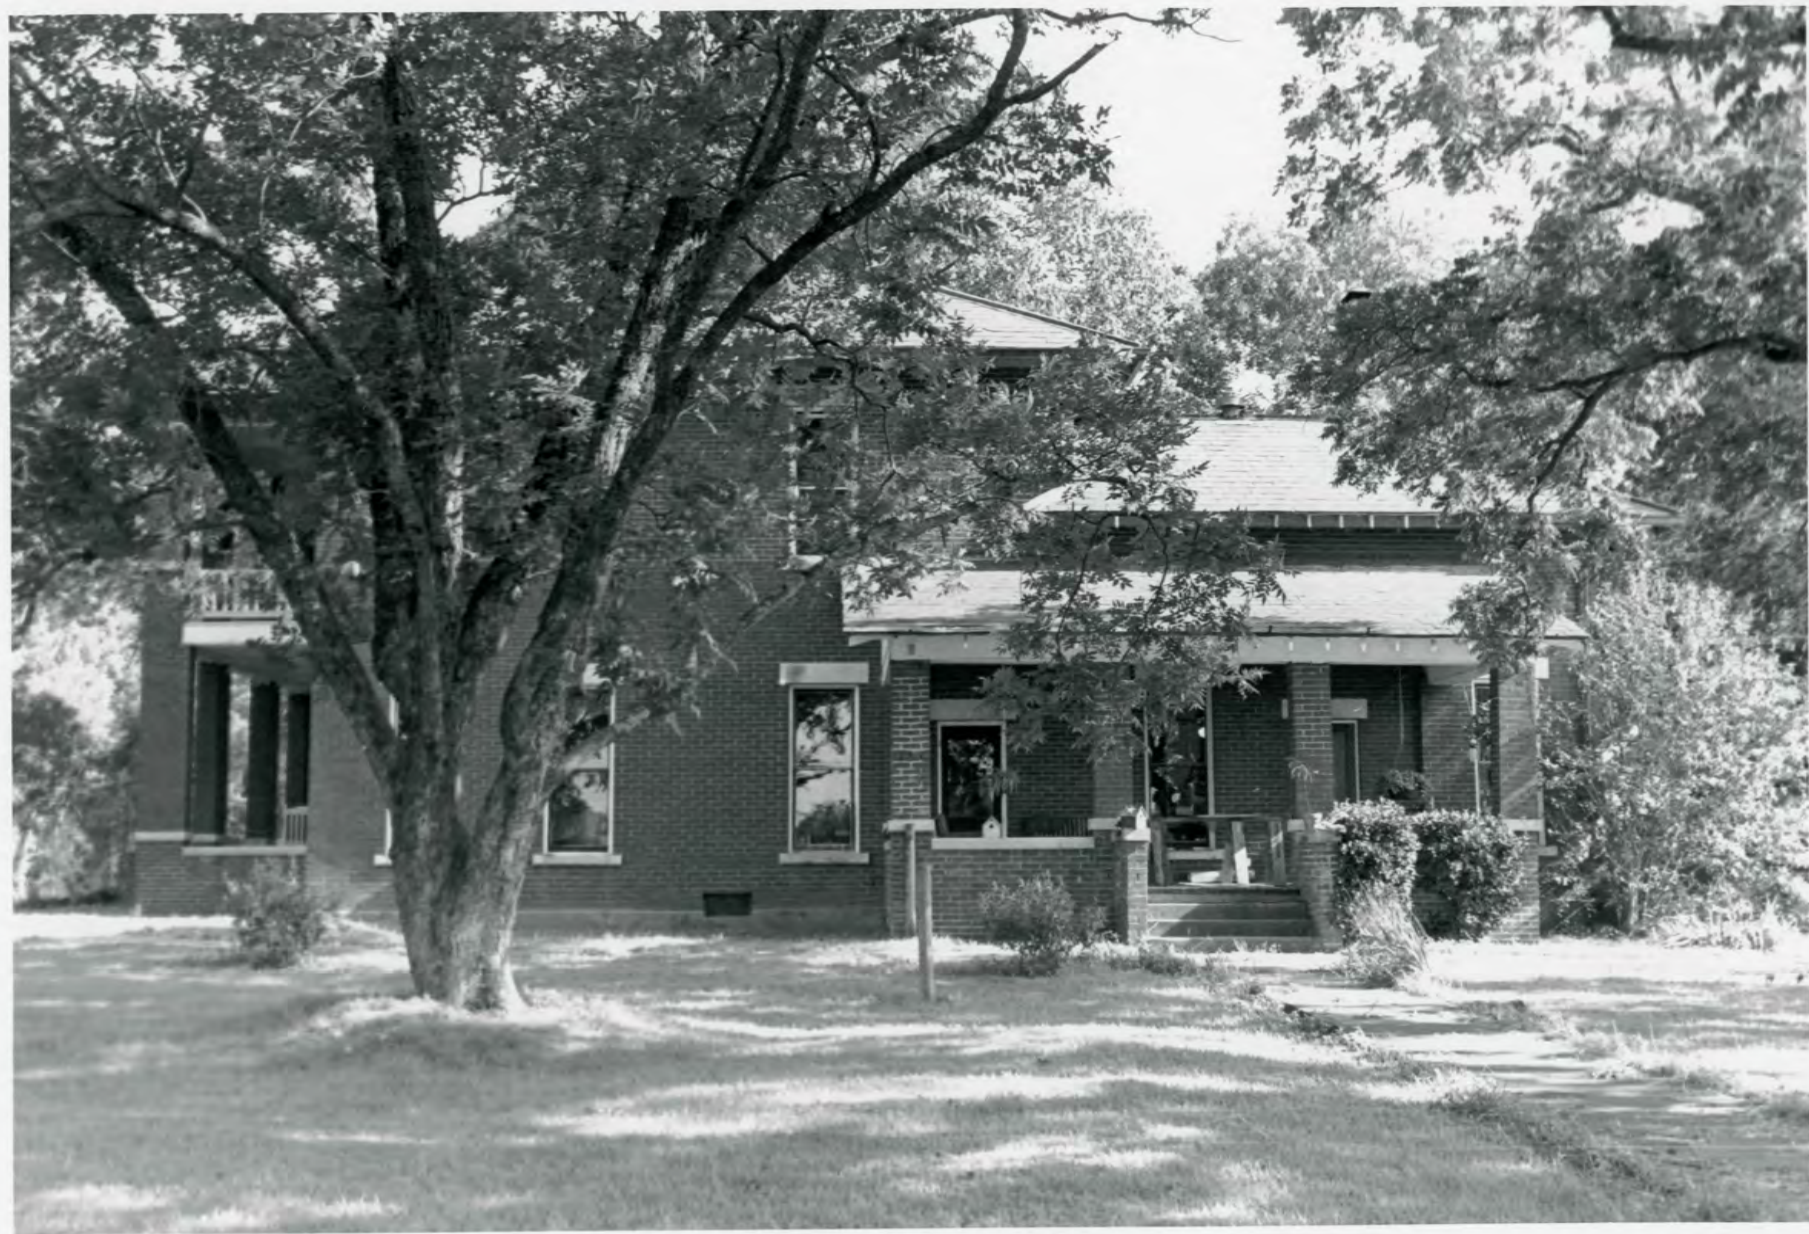
View of northern elevation of house

The northern elevation joins the primary body to the addition forming the longest continuous wall space. The main structure is divided into four bays while the addition contains three vertical divisions. Beginning at the third bay and extending westward to the beginning of the last bay on the addition, the shed covered porch visually joins the two sections. Designed like the eastern porch, with the exception of being one story, the roof is supported by four squared brick piers each containing an overextended stone slab forming a pseudo base. The piers are placed on a raised brick platform which is covered by a cement slab. Four concrete steps, contained between the two middle piers, extend northward and are contained between two brick and stone capped stoops. The fenestration pattern of the main mass is like the southern side, with one exception. The portion of the fourth bay located under the shed porch is a stone capped single glazed pane door. The pattern continues with the typical window and a second stone capped door. The third bay of the addition contains a window capped by a stone lintel and sill.

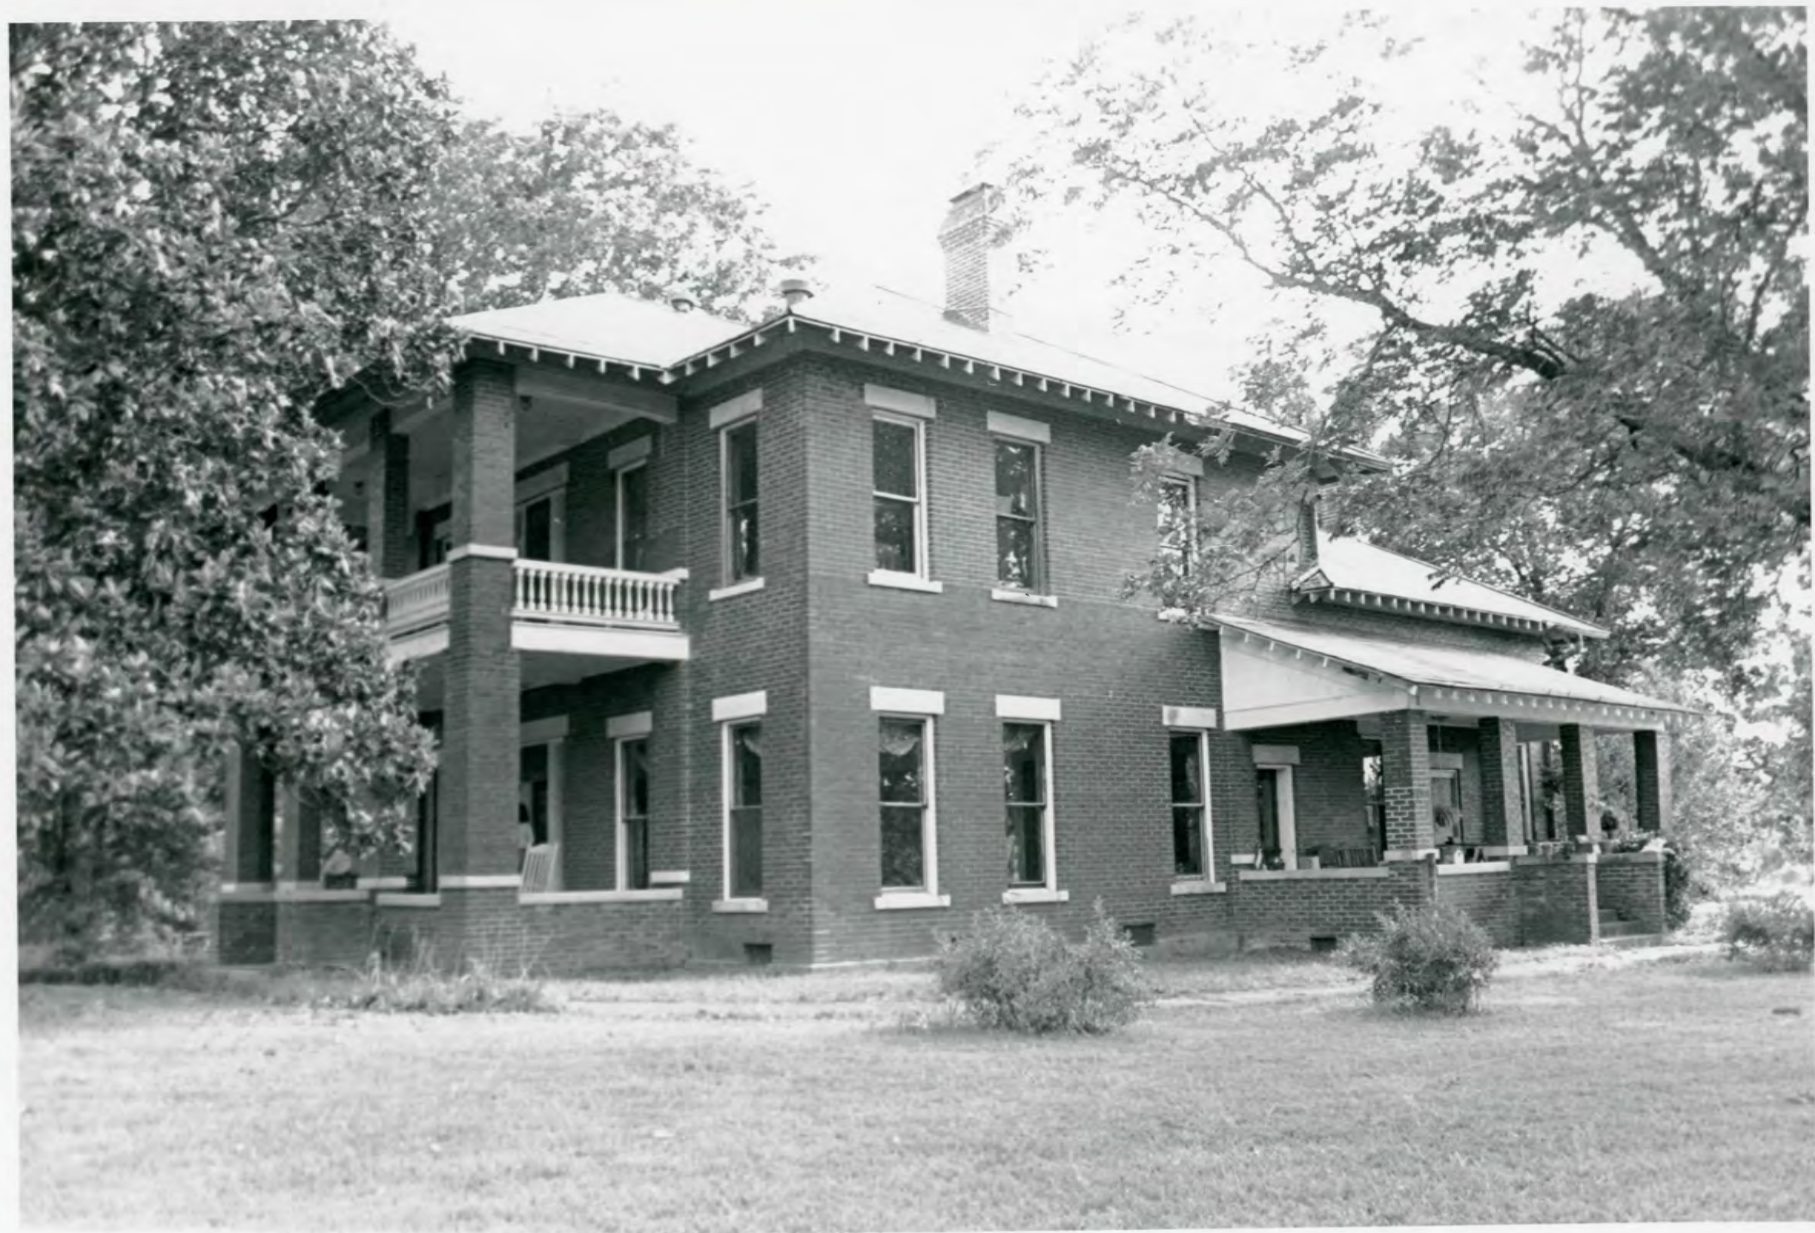
View of house from the northeast

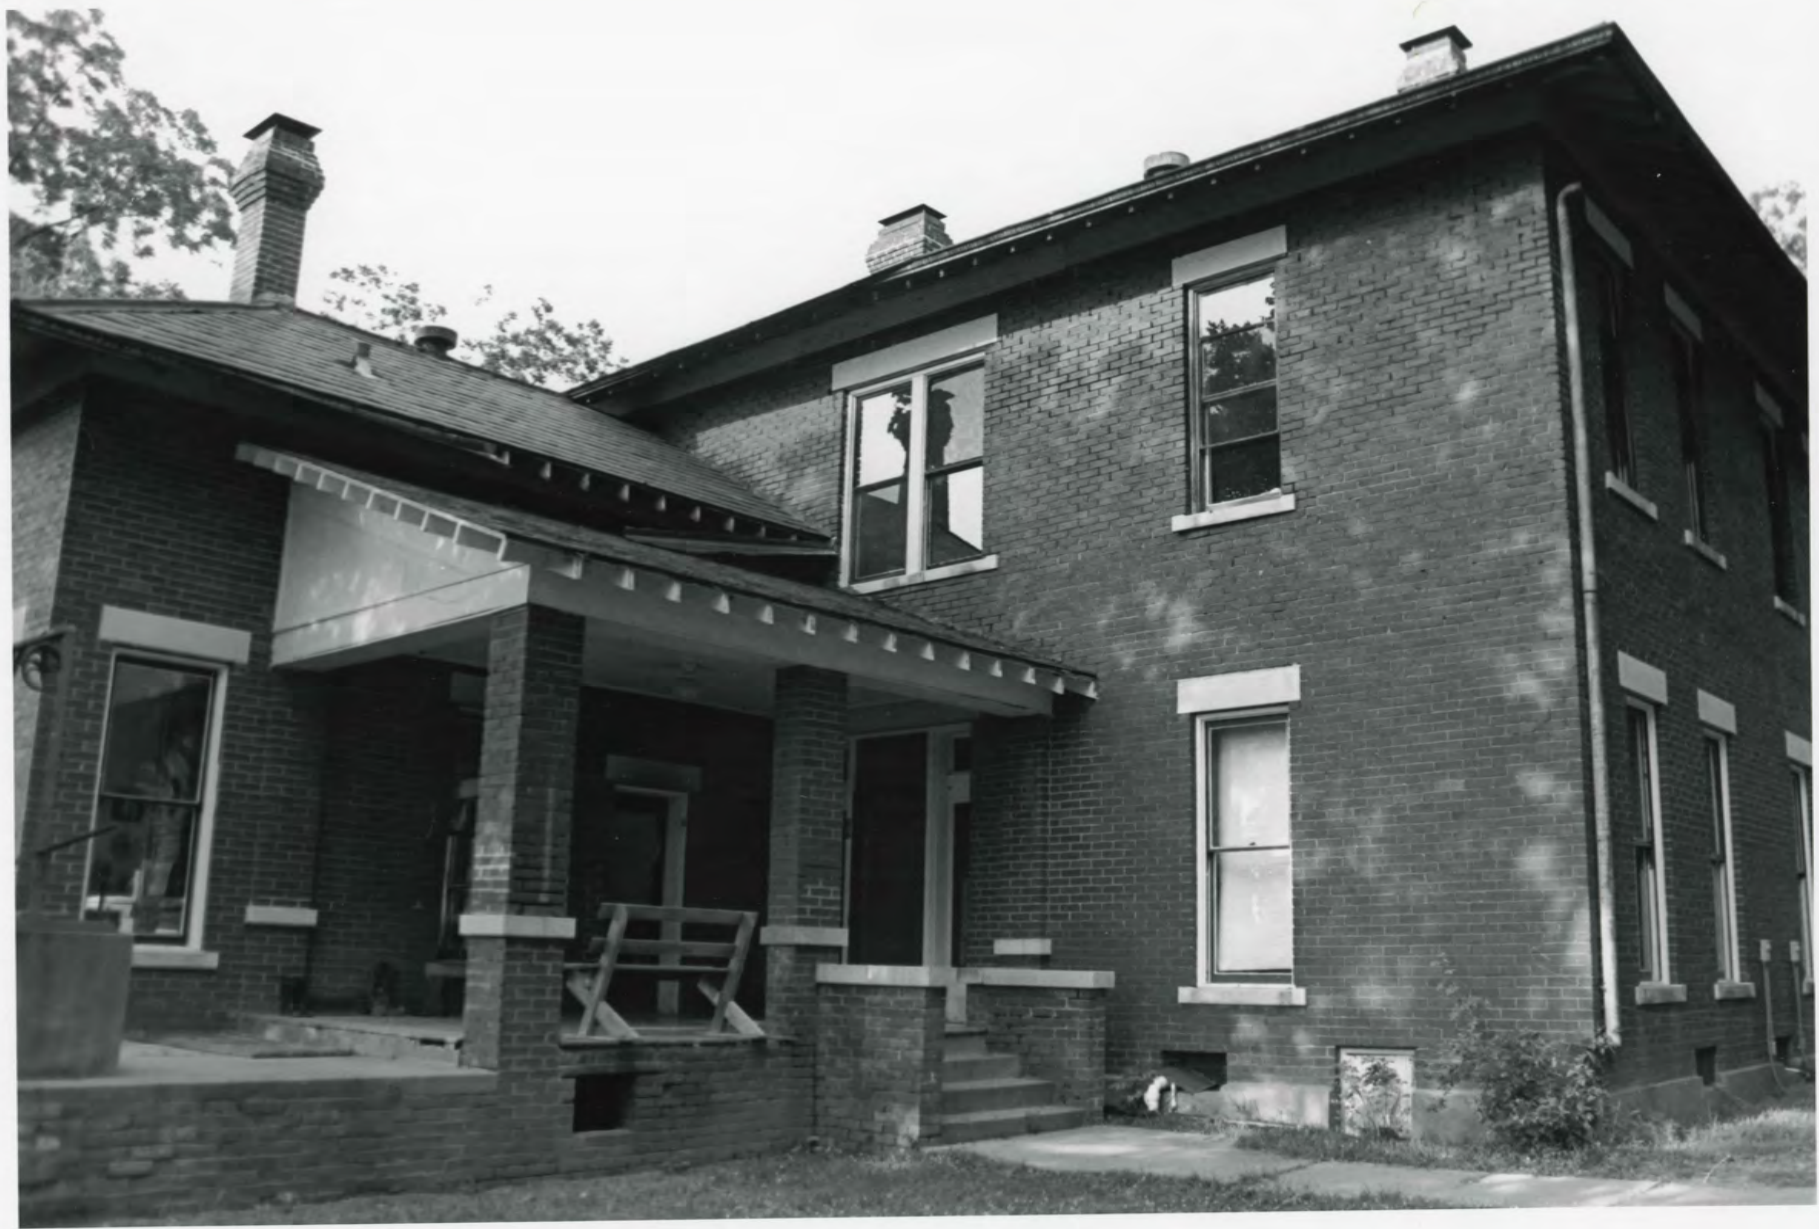
View of rear of house from the southwest

The western elevation is broken by an L-projection that extends outward by one room in length. From the southwest corner to the walls interruption by the south wall of the projection, piercing occurs twice. The first bay from the southwest corner features single one over one windows with the chosen

decorative treatment on both levels of the bay. Moving north, the second bay of the primary mass contains a door which is set back from the wall forming a small alcove. Framed in wood and covered by a transom, it is the only glazed single panel door not covered by a stone lintel. Directly above the door, two one-over-one pane windows are joined by a single stone lintel and sill.

The south wall of the projection has a shed covered porch supported by two brick piers which rest on a brick wall foundation covered by tongue and groove wooden planks. The shed roof joins the western wall and extends to a point midway between the uncapped door and the southwest window. An otherwise awkward junction is tied to the design by terminating in a pilaster which continues downward to the stone capped brick stair stoop. The stoop contains three cement steps which lead to the west. On the south wall of the projection, the porch covers three-fourths of the addition and connects to the wall with pilaster. This wall is broken with three vertical divisions. A glazed panel door capped with a stone lintel is located in the bay closest to the western elevation. The pattern continues across the projection with two windows one a cement slab joins the higher level wooden porch and extends past the southern side of the projection. A set of stairs leading westward are attached to the south wall. A concrete block well, now covered, sets at the southwest corner of this raised concrete platform.

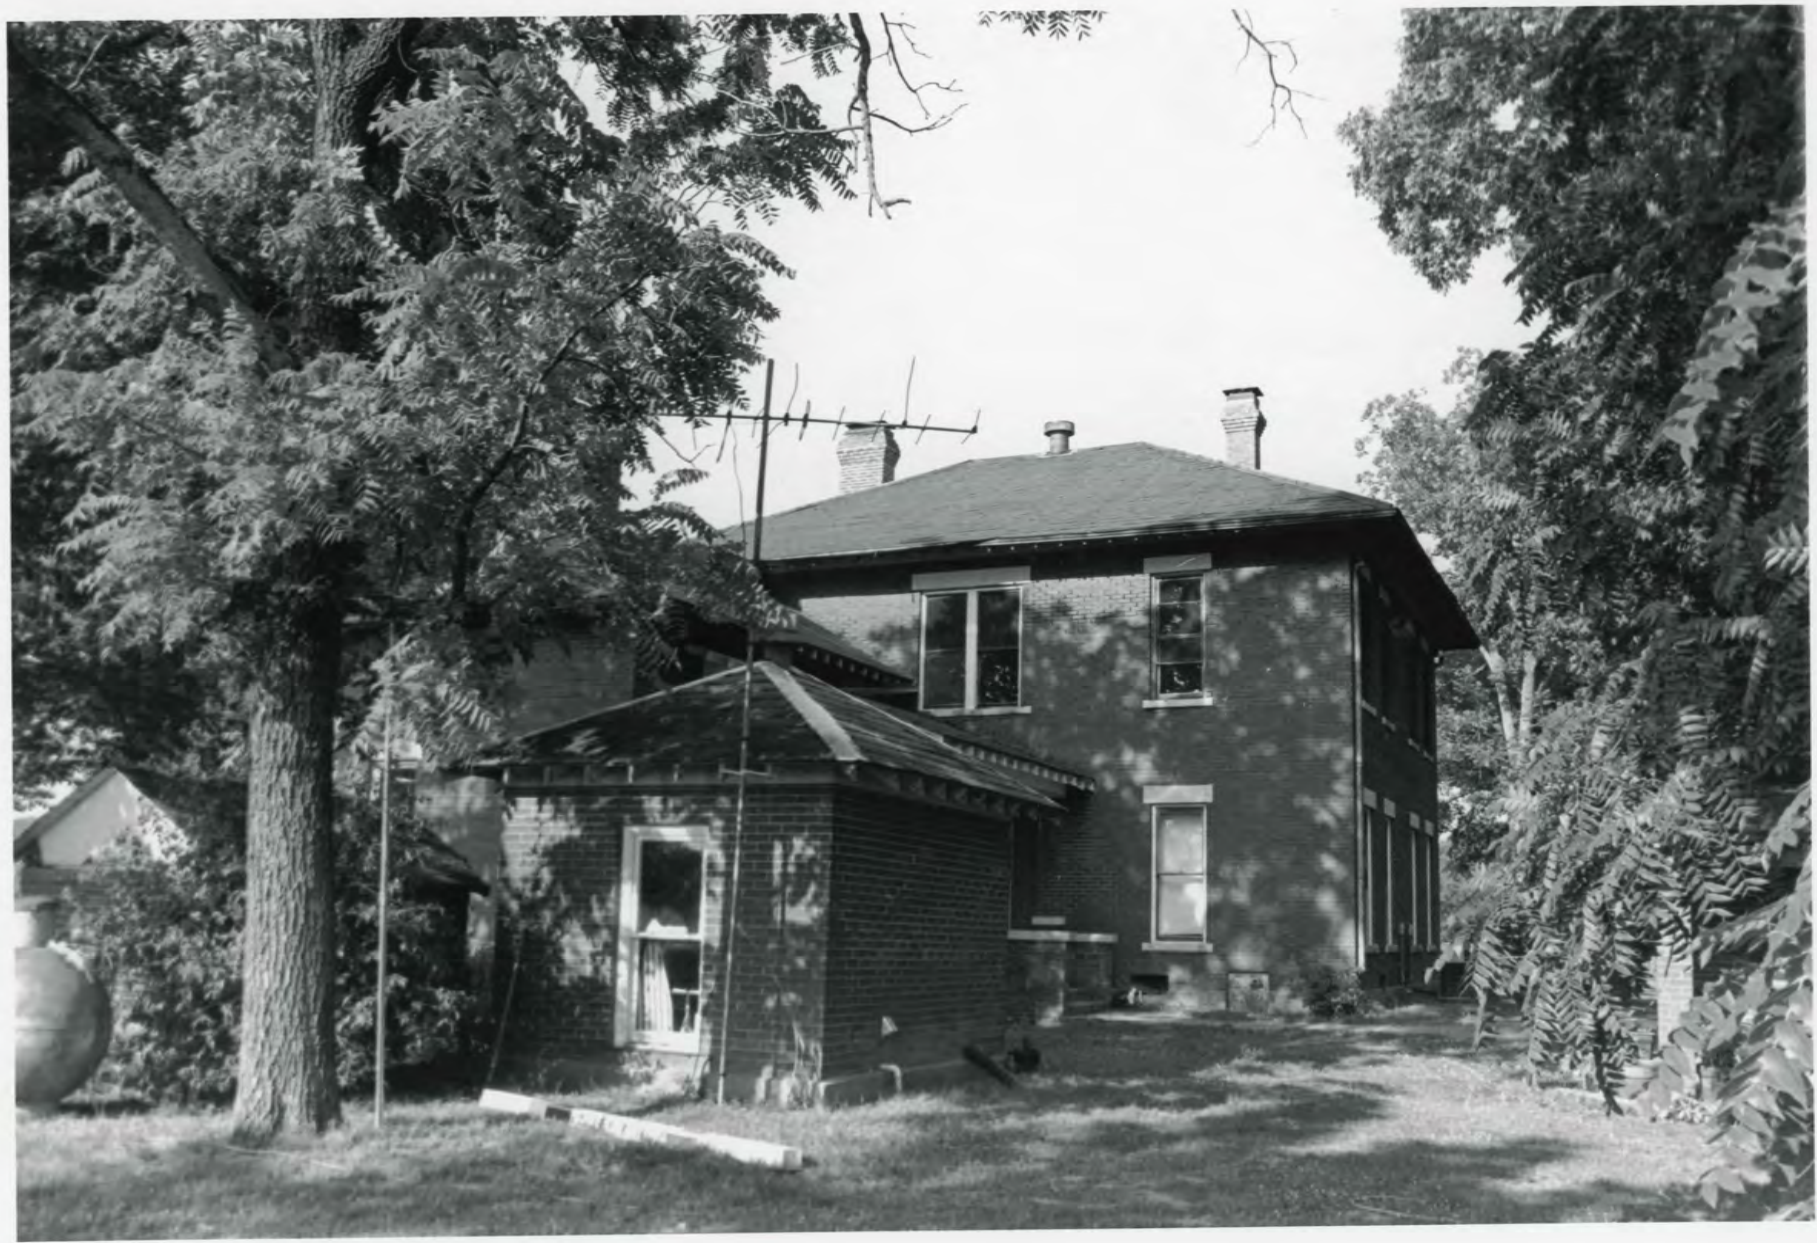
Negative located at Arkansas Historic Preservation Program
View of rear of house from the southwest, with delco
house in foreground

The brick framed delco house located west of the root cellar is square in plan and is covered with a slate hipped roof with exposed rafters. It sits on a concrete slab. A wooden frame and panel door is located on the eastern side and is placed to the left of center. One window, of the same type used on the home, is found on the west wall. The interior wall surface is covered with plaster. Today this structure is used as a laundry room which has caused the south hall to be pierced for outlets.

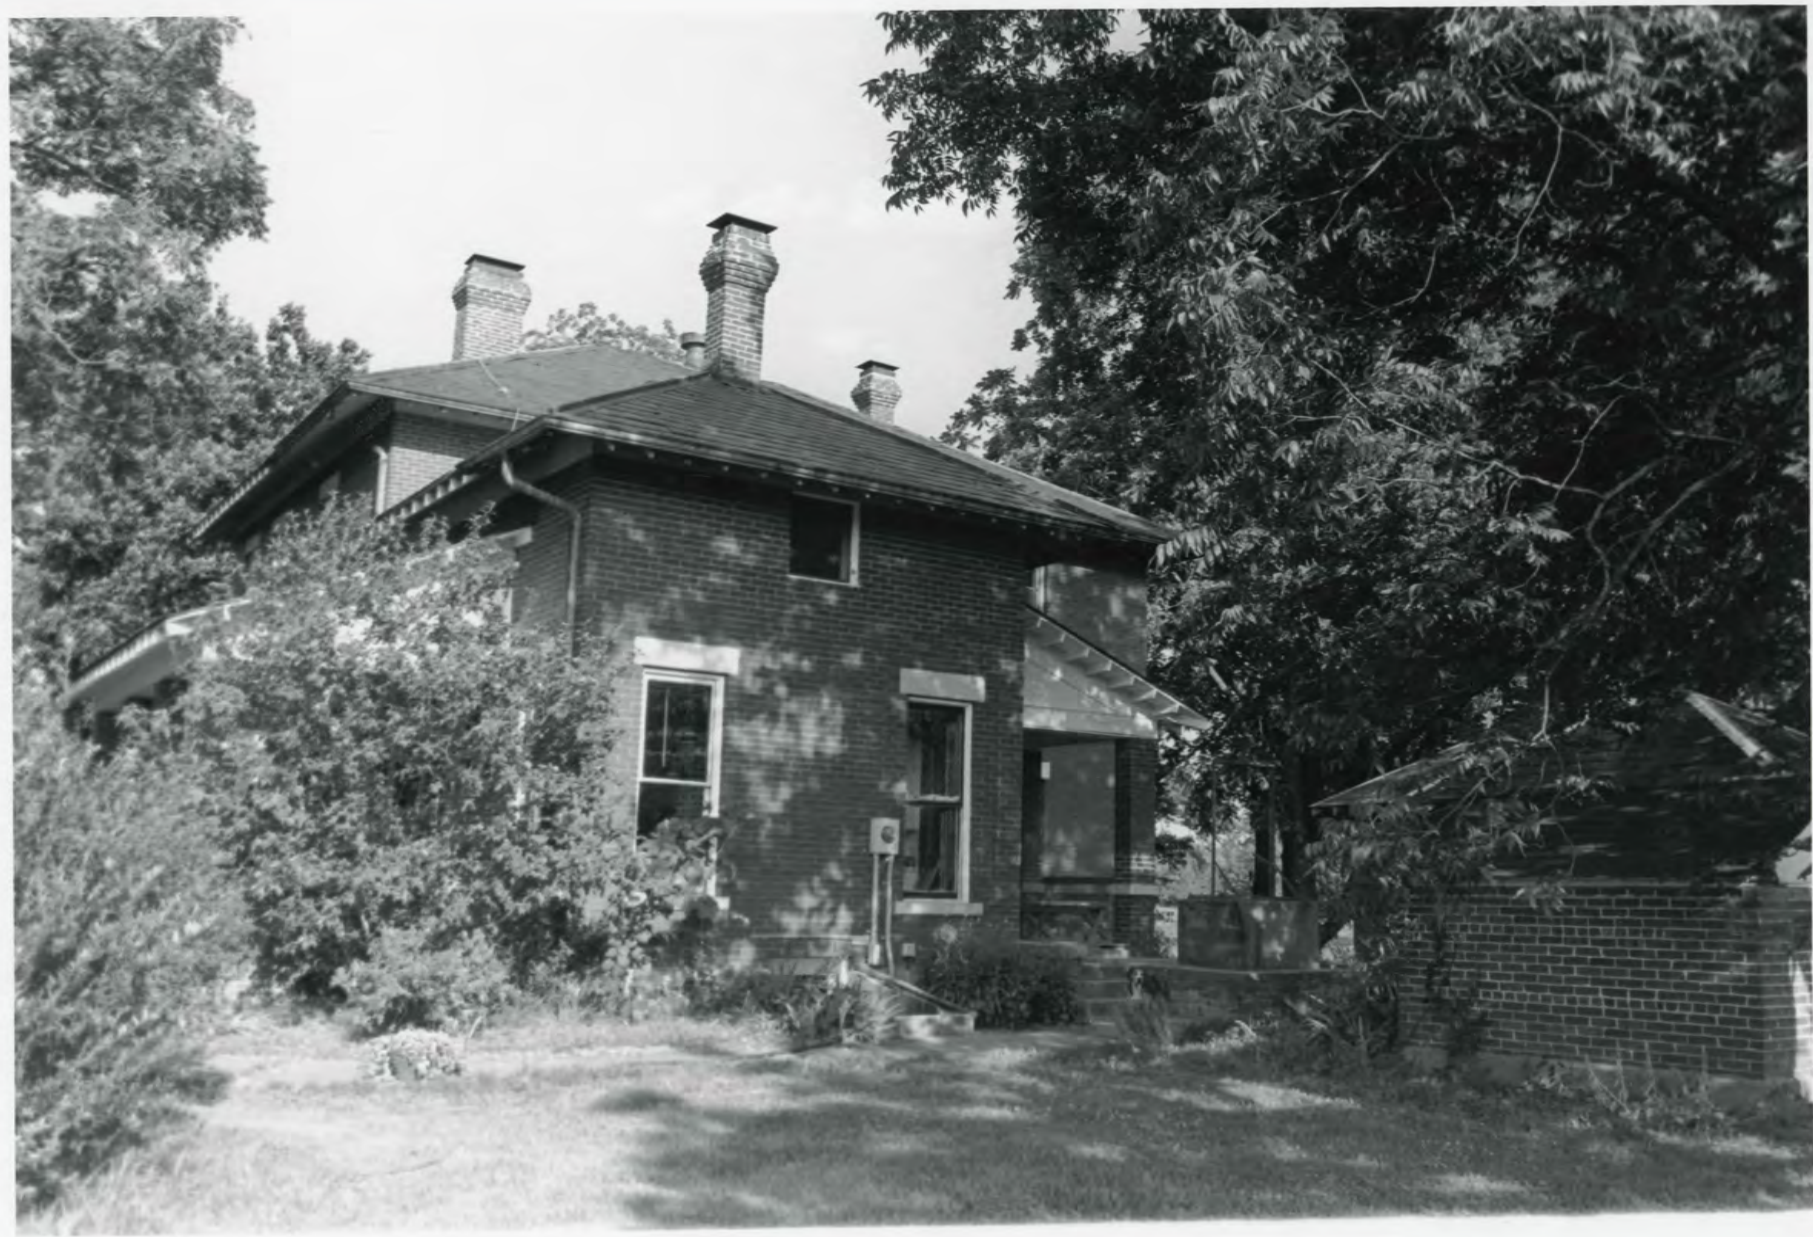
View of rear of house from the northwest

The eastern wall of the projection contains the centrally placed subterranean entrance to the partial basement, the basement if housed in its totality under the L-addition. Two one over one pane windows capped with stone lintels and sills are placed on the first level on either side of the basement entrance. A small single pane casement window is positioned in the middle of the wall and extends downward from the roof and wall junction.

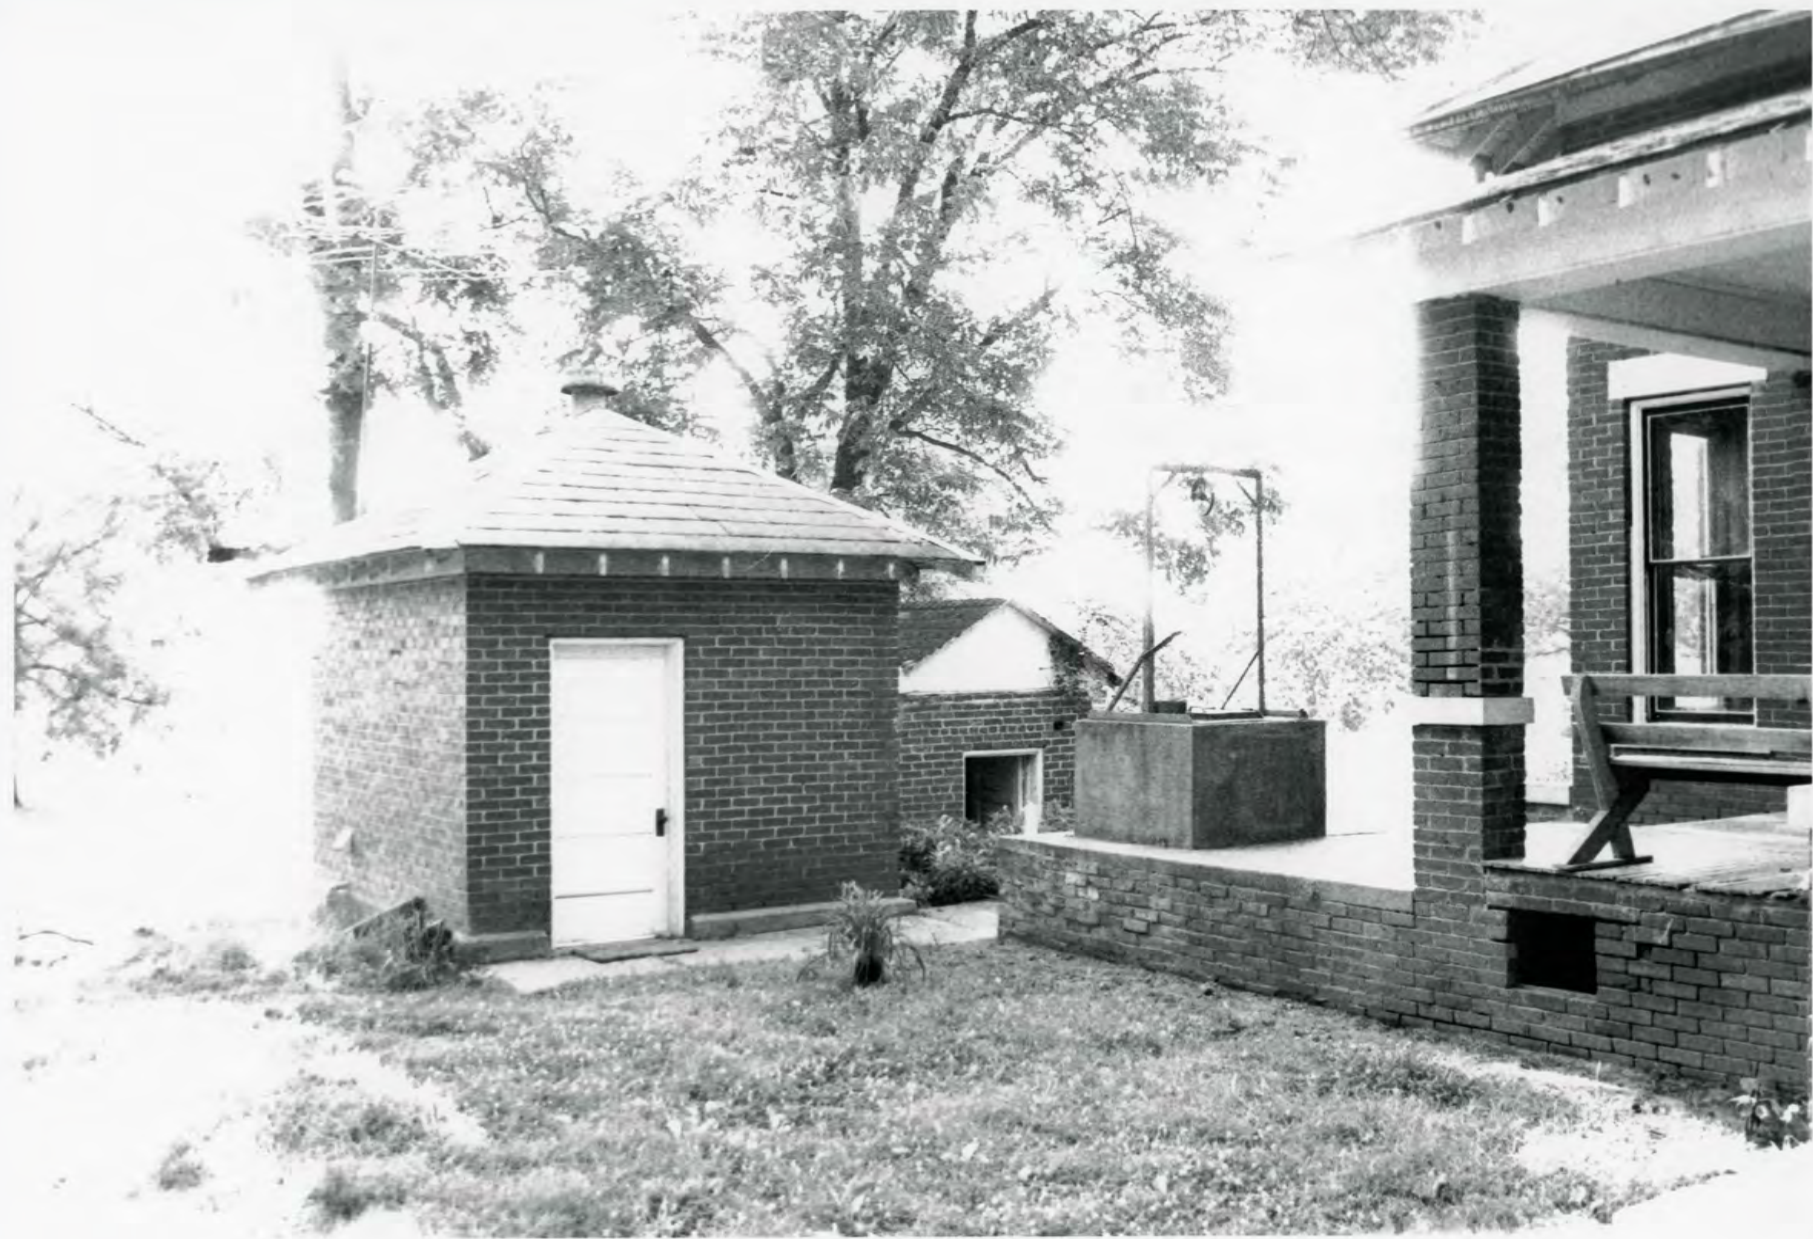
View of Delco House (with root cellar behind) and main house at right from
the Southeast.

The outbuildings located closest to the home reflect the simple elegance of the residence. Each shares in common continuous concrete slab foundations, brick framed walls and exposed rafters. A number of different features are found with each of these brick outbuildings. The root cellar is the only rectangular plan structure. Covered by a gable roof of asphalt shingles, the building sits on a concrete slab foundation which is located approximately three feet underground. The walls are solid red brick with the exception of one absent header, possibly left out for ventilation purposes. Cement steps are contained in a concrete block retaining wall and lead to a central gable entrance. The interior is lined with the original shelves and a drain system

more commonly associated with spring houses. Presently, this structure suffers the most deterioration due to the rotting roof and door. Replacing these two features would stabilize the building.

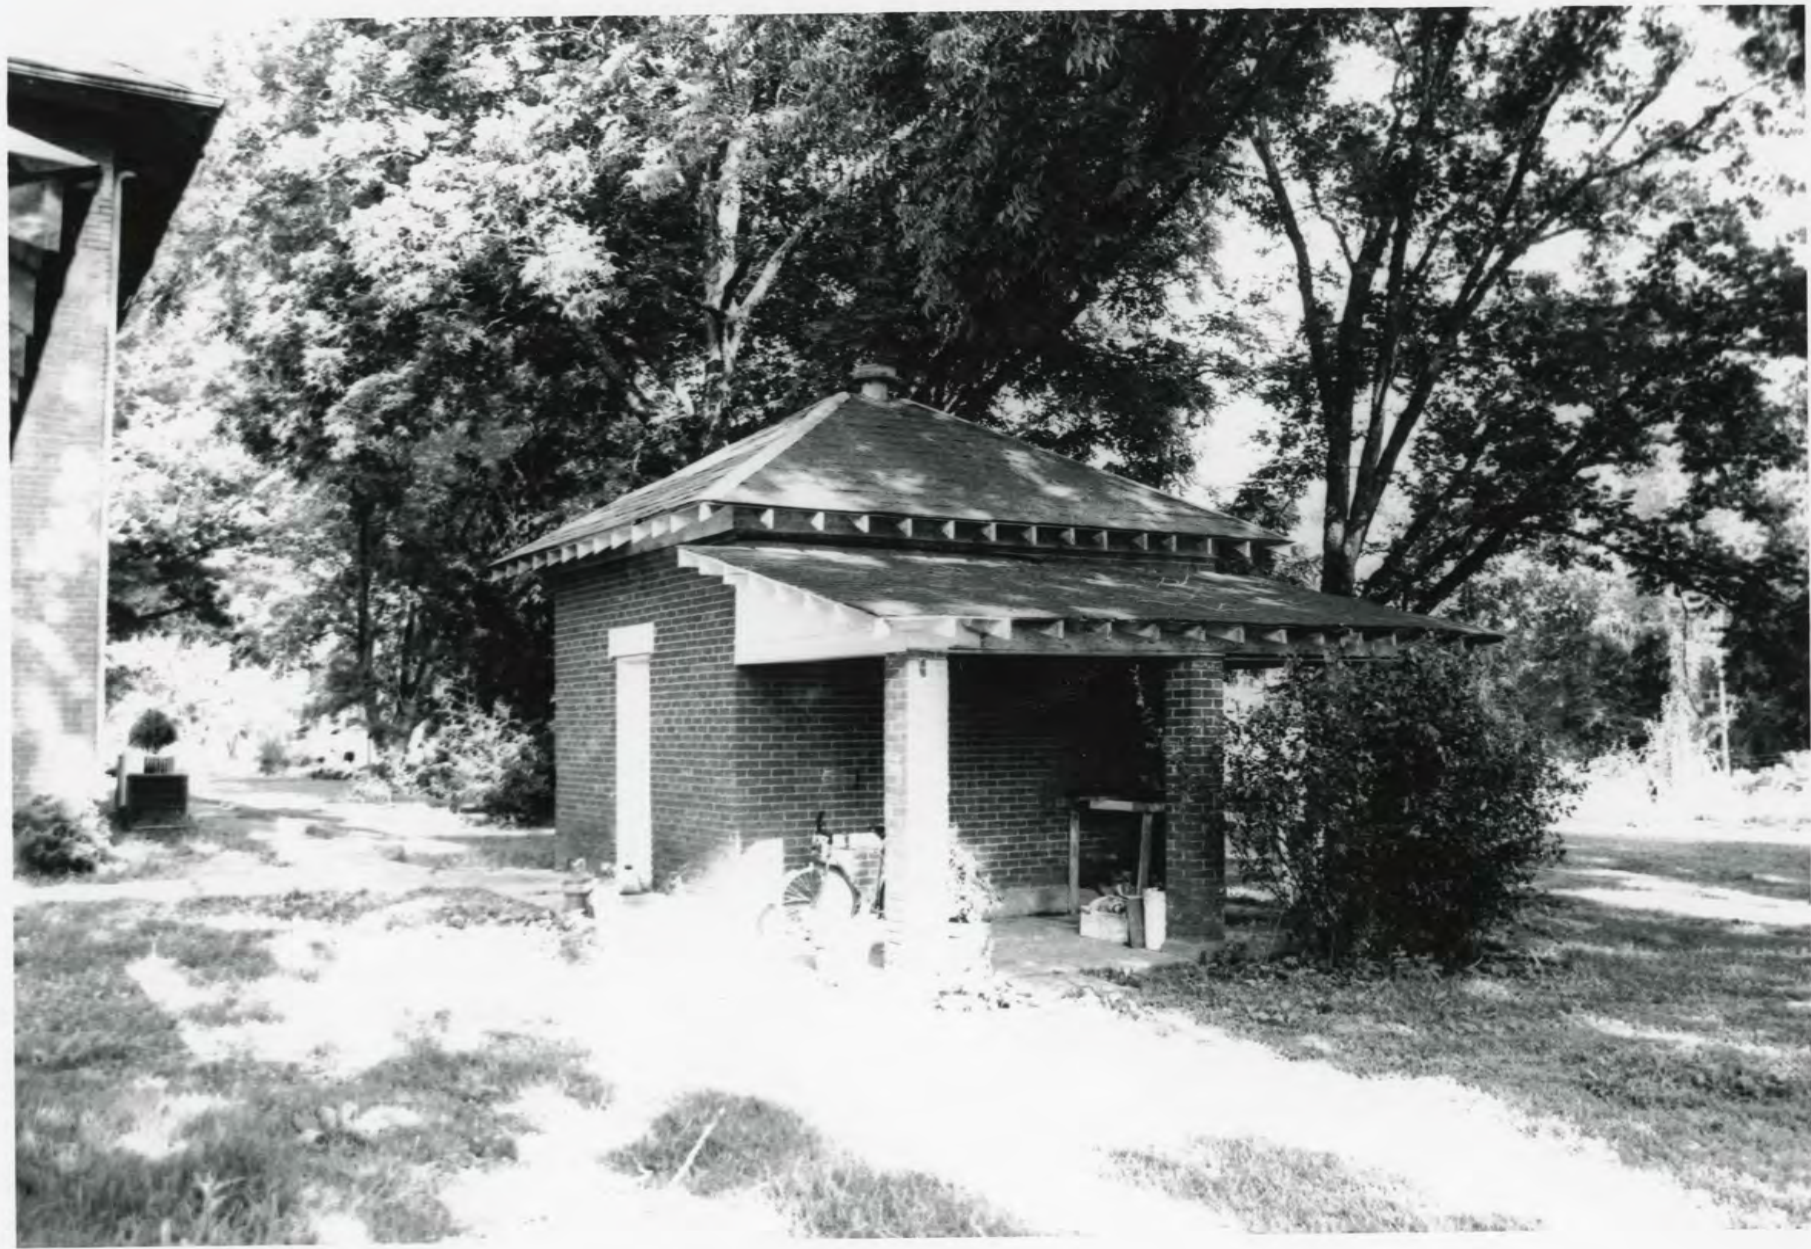
View of bunkhouse from the northwest

The third brick outbuilding is located to the south of the delco house. At one time used as a bunkhouse, this brick framed structure is square in plan and covered by a slate hipped roof. A shed porch extends from the western elevation and is supported by three square brick piers. The entire structure rests on a continuous concrete slab. The centrally placed wood panel door, on the north side, is capped with a stone lintel. A window is found on the southern wall. Today the building is being converted into an office.

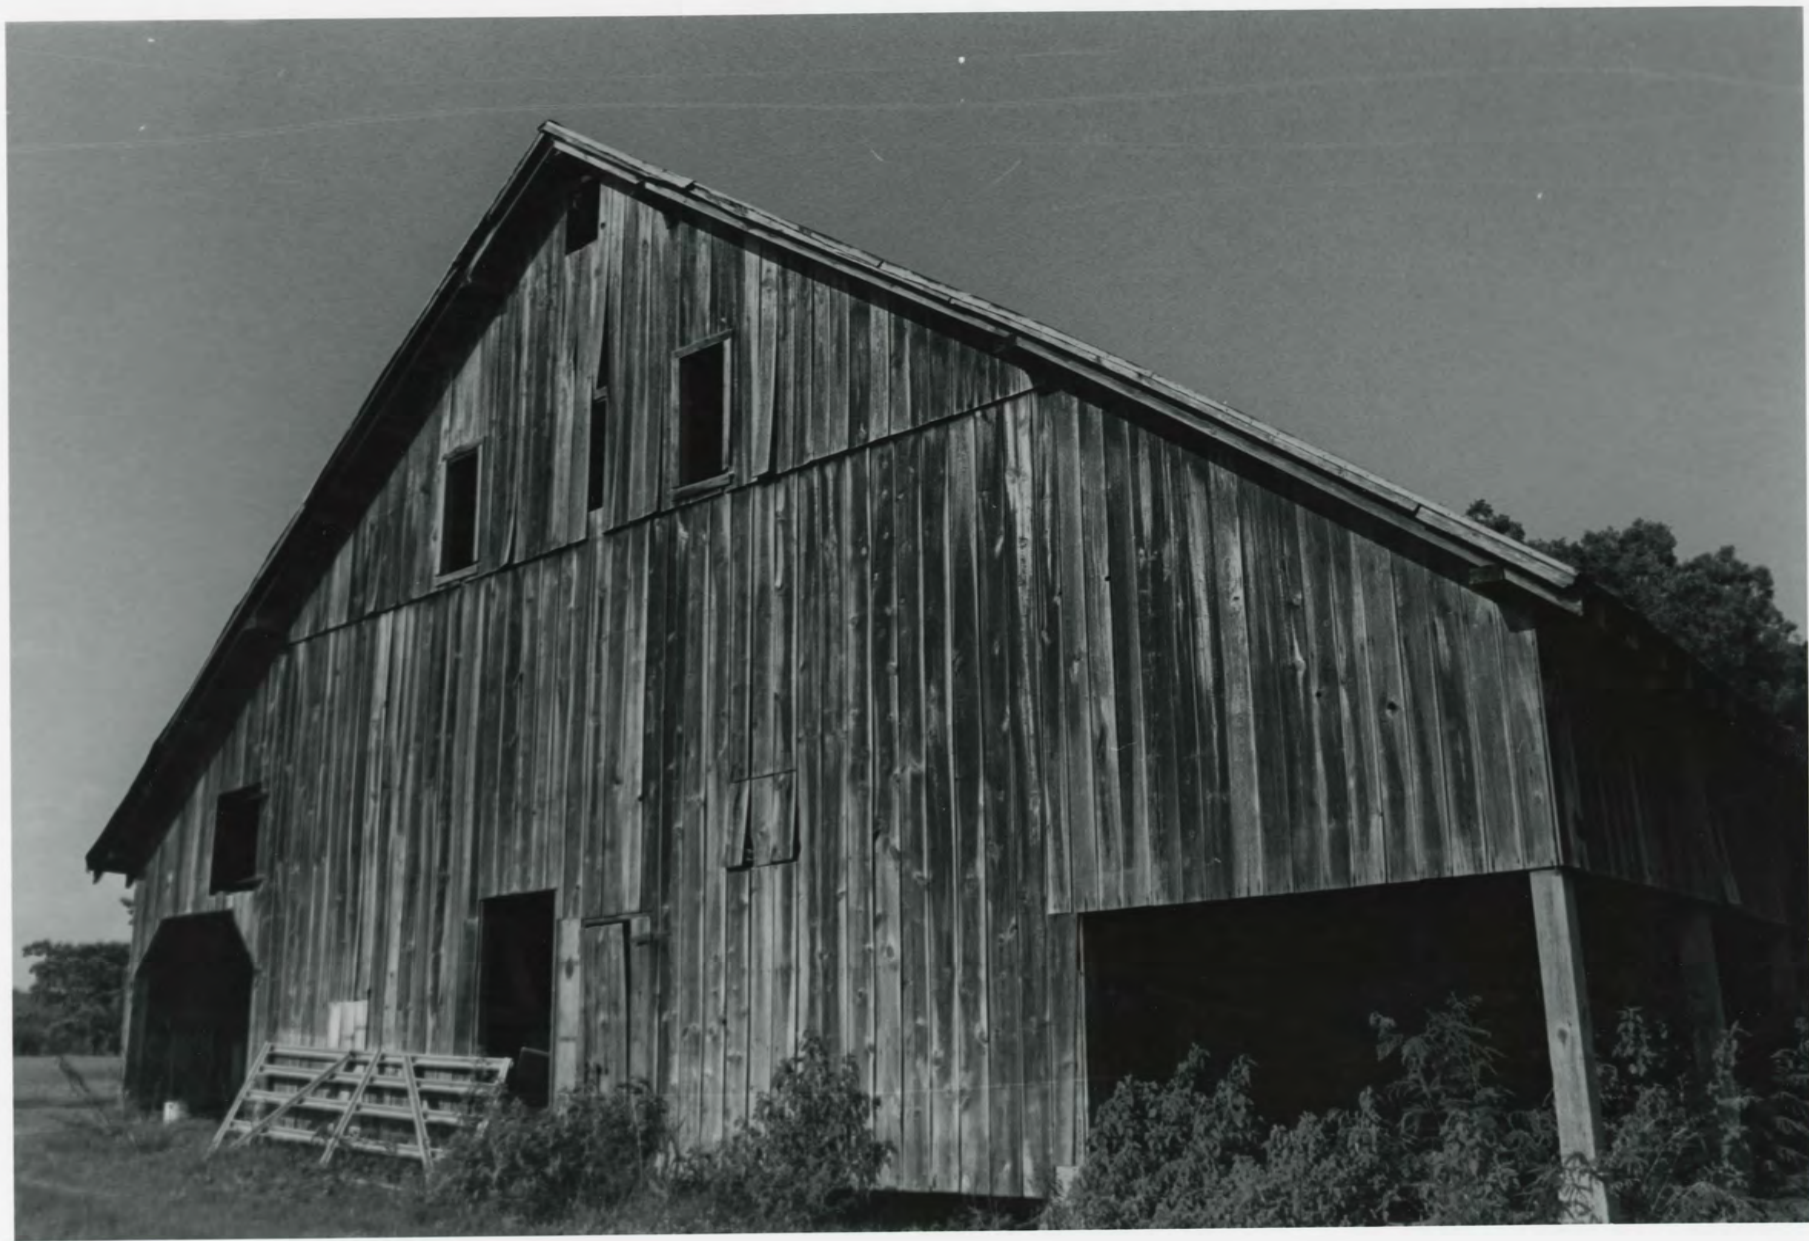
View of barn from the southwest

The large timber framed gabled roof barn is an outstanding example which maintains its original materials except for a small portion of the tin roof. Rising from concrete piers, the barn has two shed editions contained under one roof line. The north edition is covered by wood doors while the southern shed is open and supported by six timber posts resting on cement truncated piers. A central drive is placed on the eaves side and is an uncommon feature of barns in this area. The length of the external wood planks, which run vertically, are reminders of Plainview's past as a lumber town. The fenestration pattern of the eastern elevation, a central plank door with a small window to the south, two mid-level openings with hinged wood doors, two thin upper windows with four over four frames; absent of glass, is repeated on the western side. A hay hood located on the eastern wall is the exception to this repetition. The drive-through is the only piercing which occurs on the north and south side. The lower floor is broken into two separate pens with the eastern pen containing the stair to the hay loft. The hayloft has a feature that is unusual in barn design--Split in two, the western portion is built with a slant downward toward the northwestern mid level window.
