NATIONAL REGISTER OF HISTORIC PLACES
REGISTRATION FORM

Historic Name: Mountain View FarmOther Name/Site Number: Tippy, Richard S. Farmstead YE0089

Street & Number: County Road 218, P.O. Box 85Not for Publication: N/ACity/Town: PlainviewVicinity: XState: AR County: Yell (149) Code: AR Zip Code: 72857

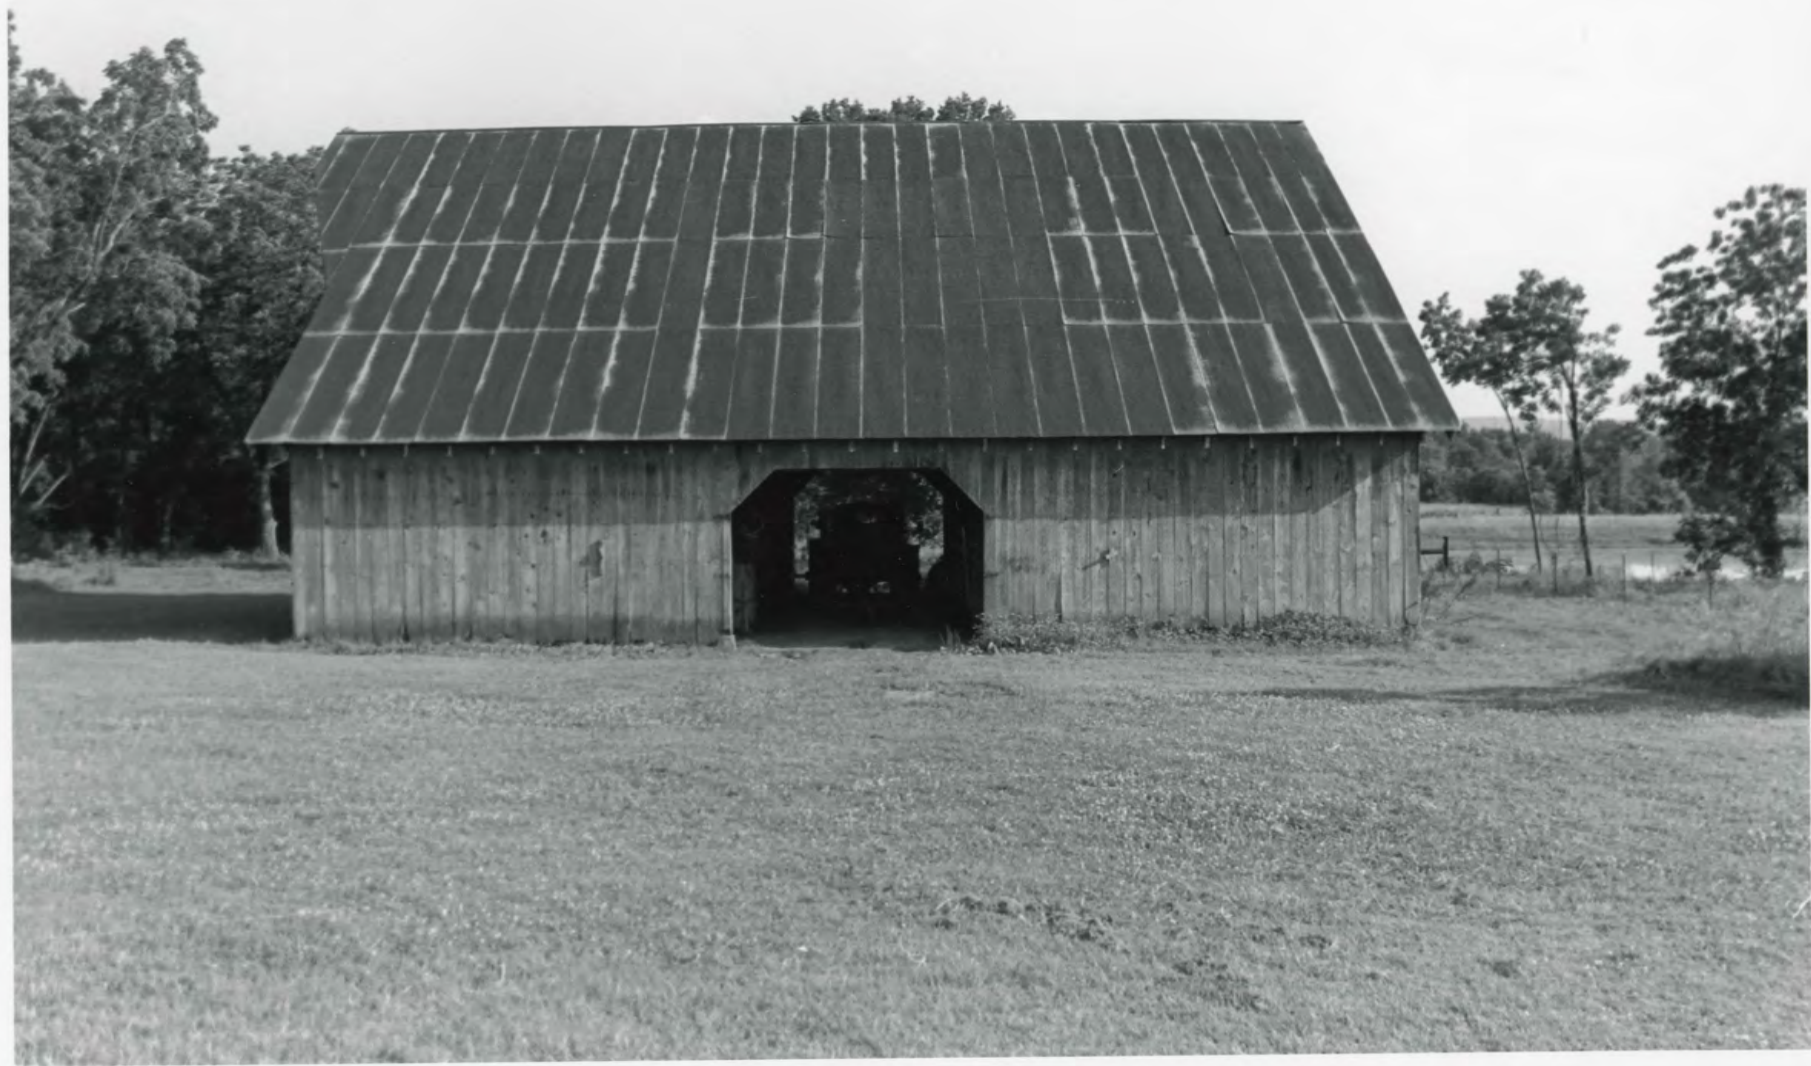
view of north elevation of barn

The large timber framed gabled roof barn is an outstanding example which maintains its original materials except for a small portion of the tin roof. Rising from concrete piers, the barn has two shed editions contained under one roof line. The north edition is covered by wood doors while the southern shed is open and supported by six timber posts resting on cement truncated piers. A central drive is placed on the eaves side and is an uncommon feature of barns in this area. The length of the external wood planks, which run vertically, are reminders of Plainview's past as a lumber town. The fenestration pattern of the eastern elevation, a central plank door with a small window to the south, two mid-level openings with hinged wood doors, two thin upper windows with four over four frames; absent of glass, is repeated on the western side. A hay hood located on the eastern wall is the exception to this repetition. The drive-through is the only piercing which occurs on the north and south side. The lower floor is broken into two separate pens with the eastern pen containing the stair to the hay loft. The hayloft has a feature that is unusual in barn design--Split in two, the western portion is built with a slant downward toward the northwestern mid level window.

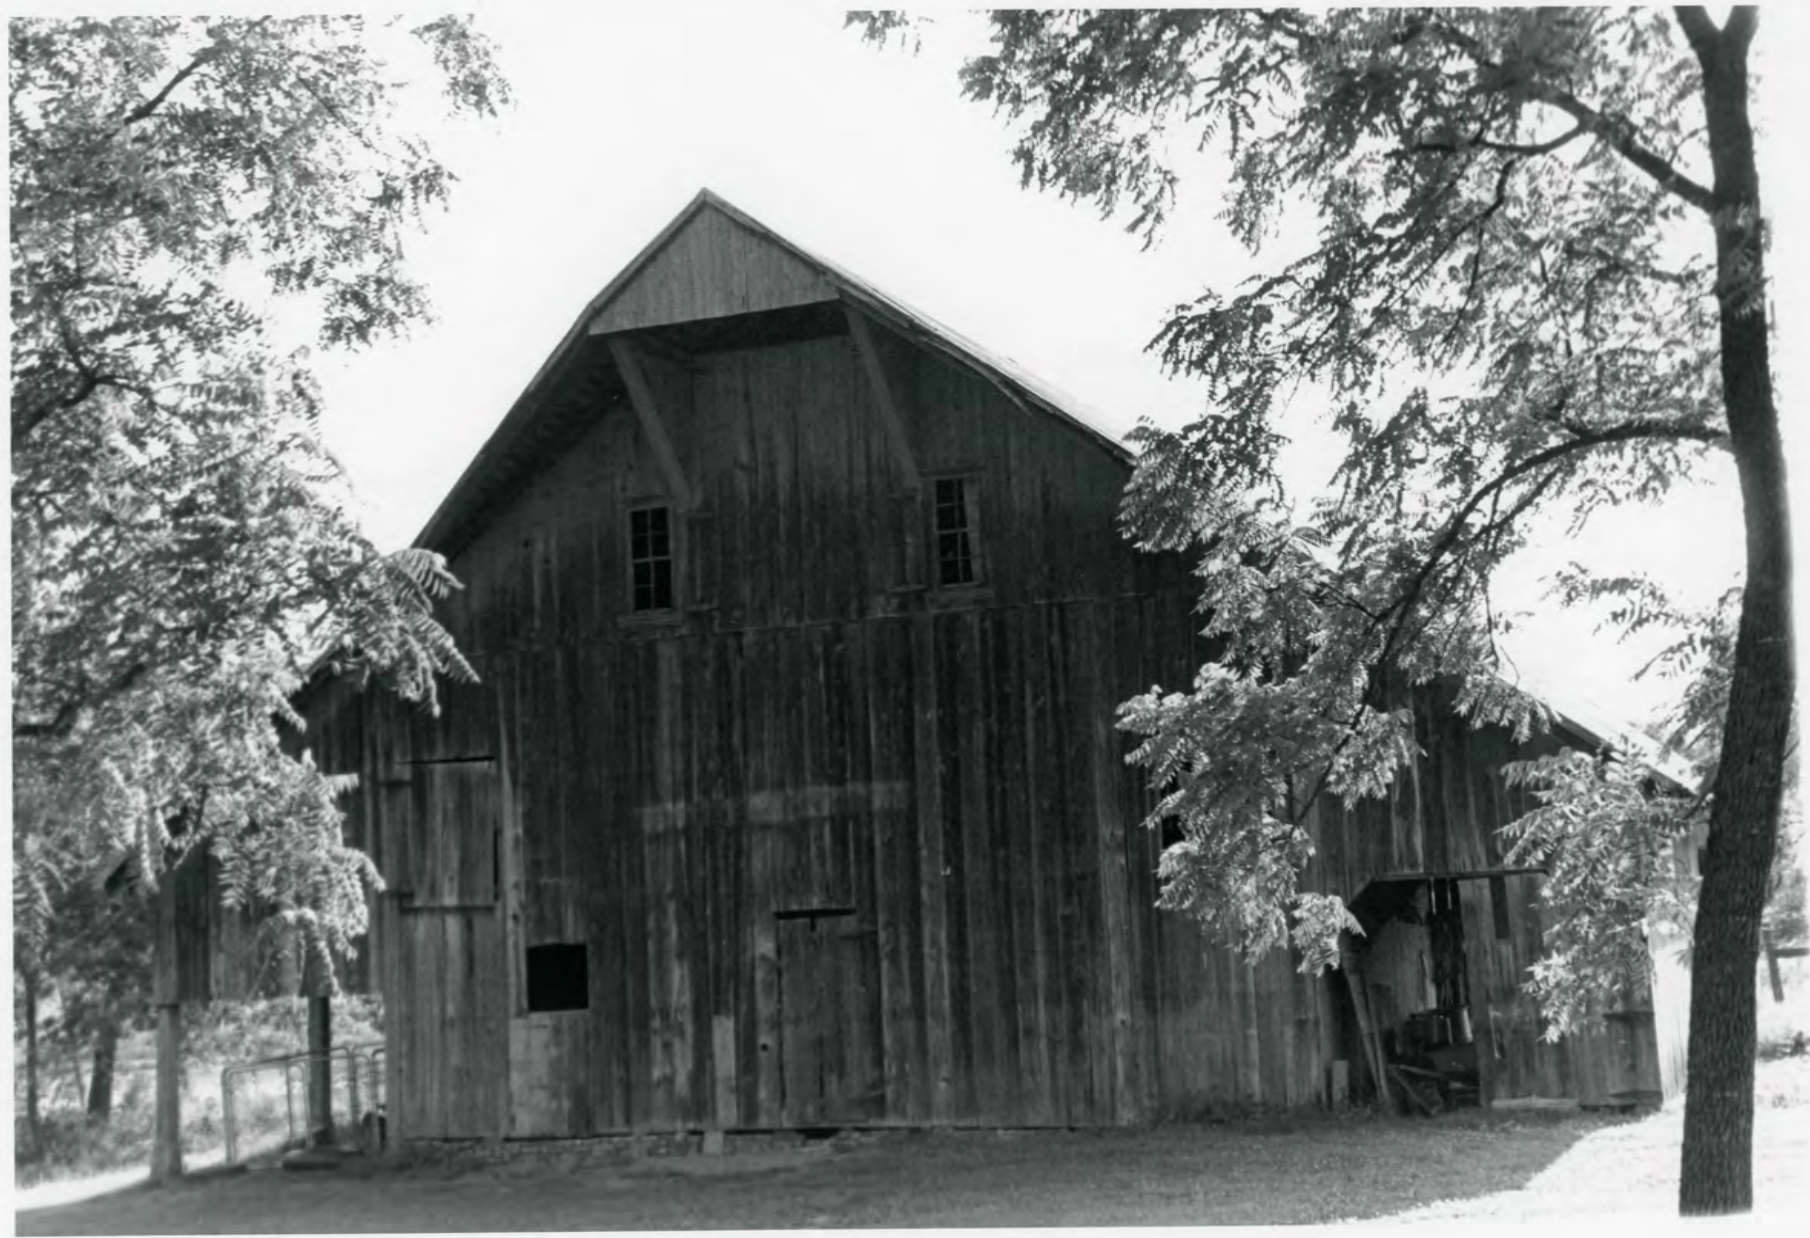
View of eastern elevation of barn

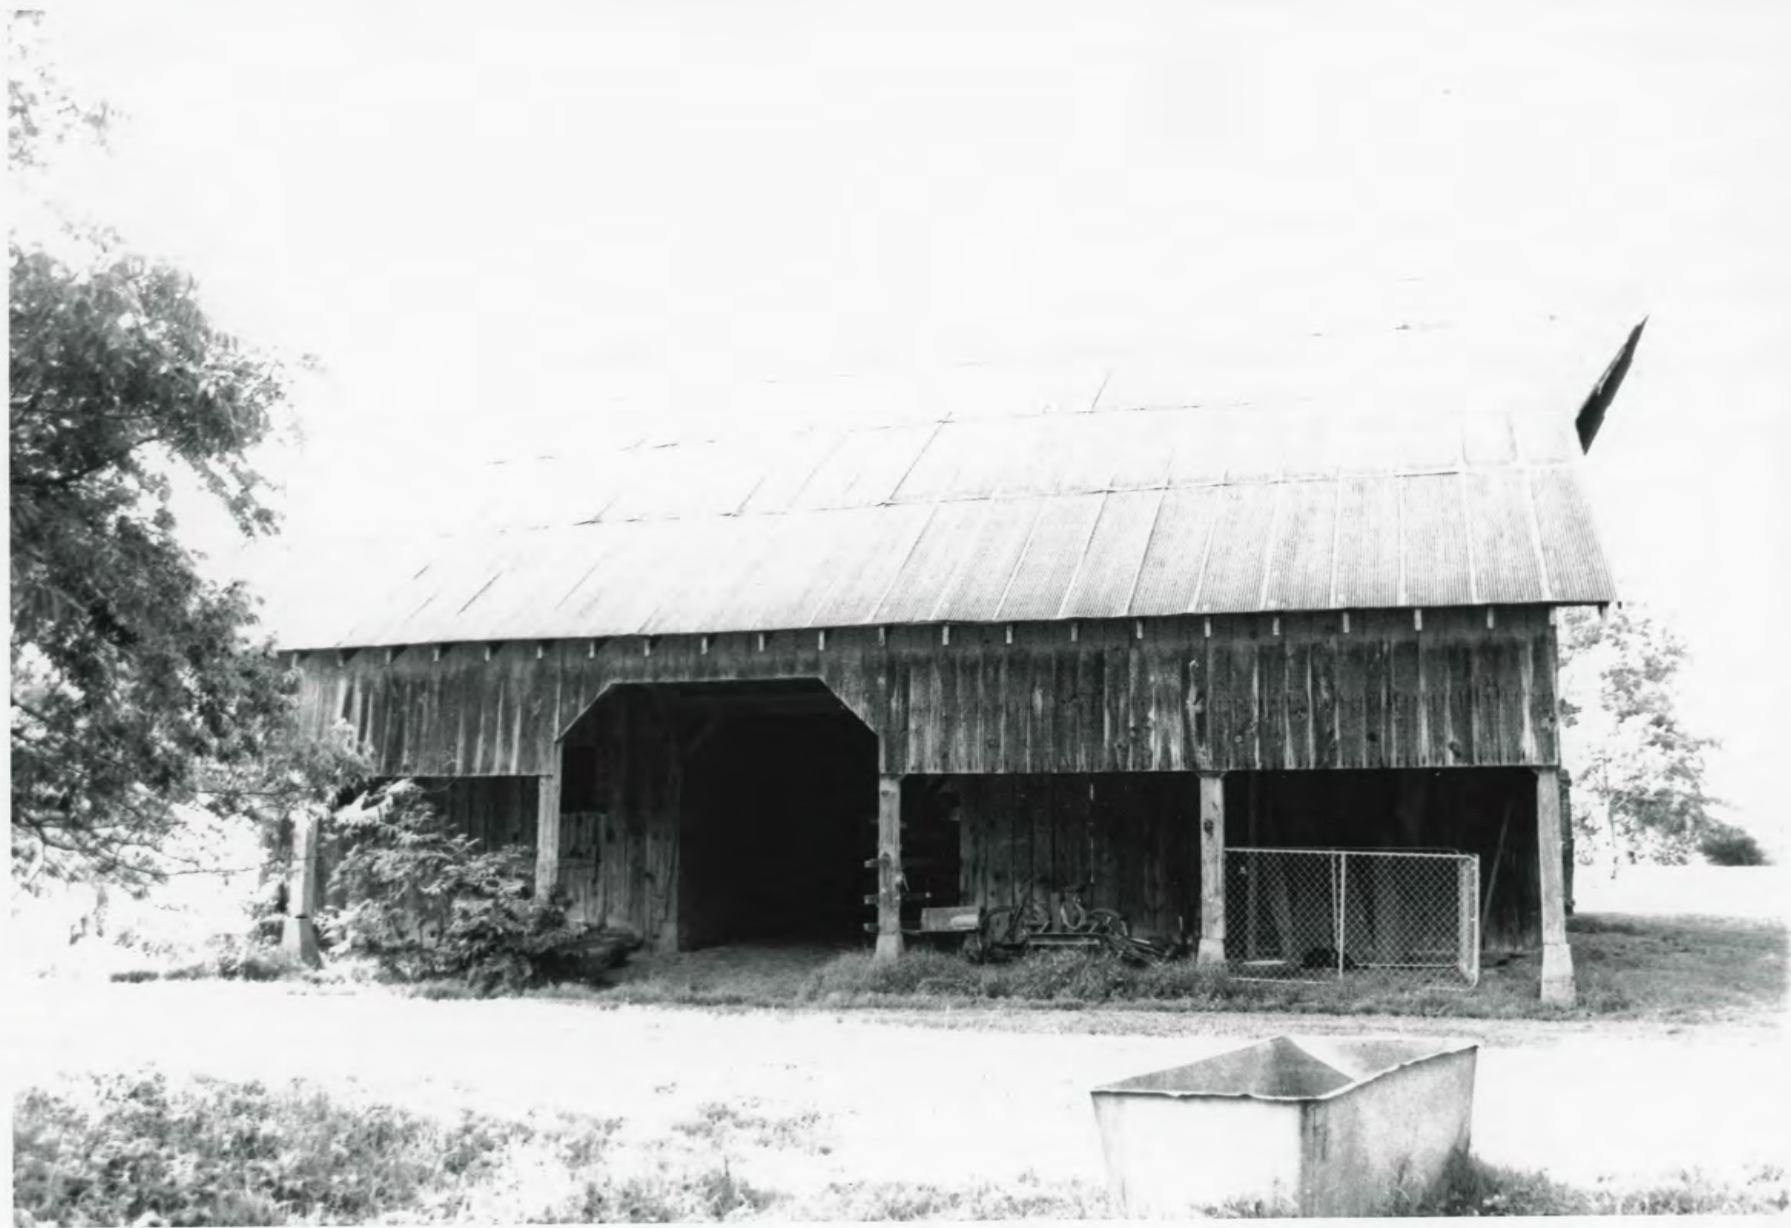
View of Barn from South

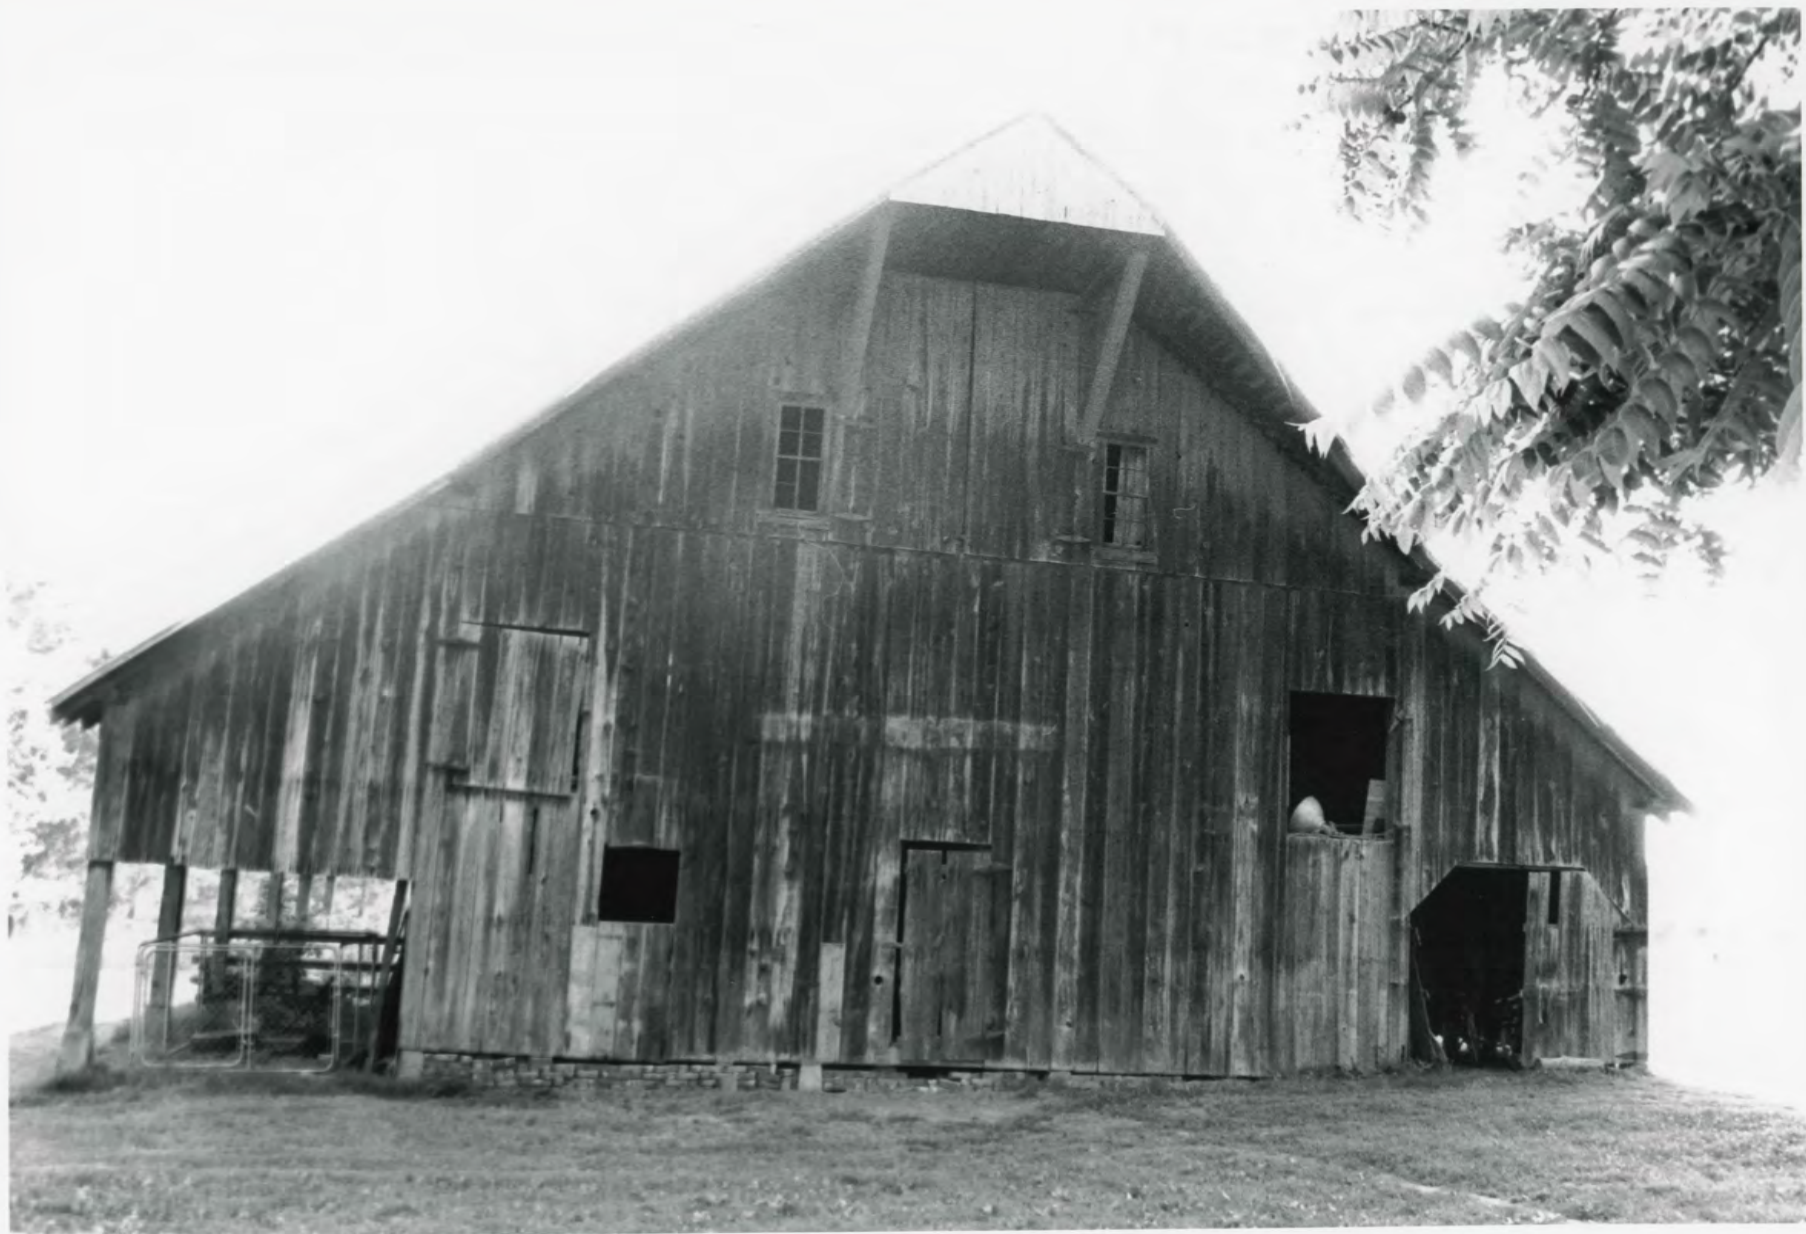
View of Barn from the east

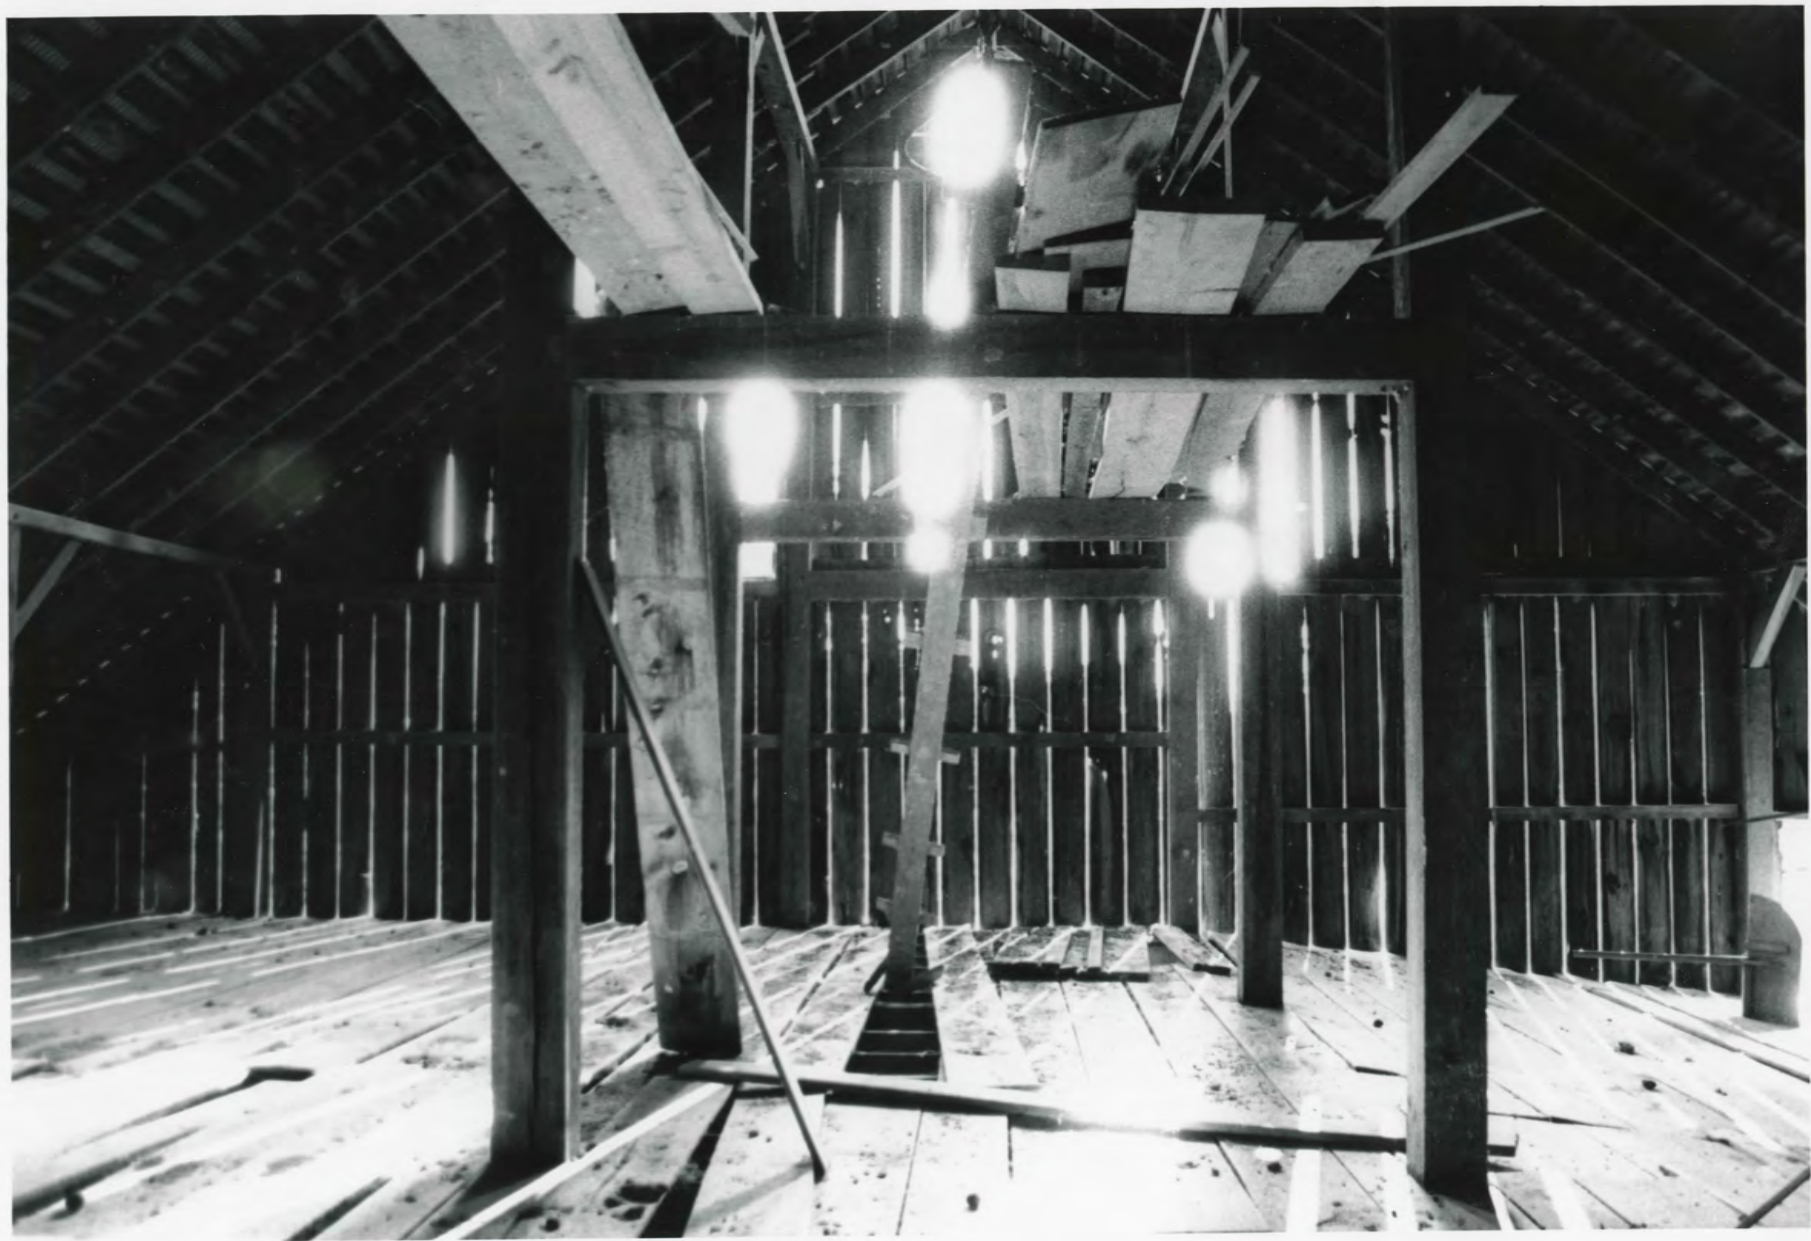
View of barn loft from the east
