NATIONAL REGISTER OF HISTORIC PLACES
REGISTRATION FORM

Historic Name: Munger House

State: AR County: Johnson Code: AR 071 Zip Code: 72846

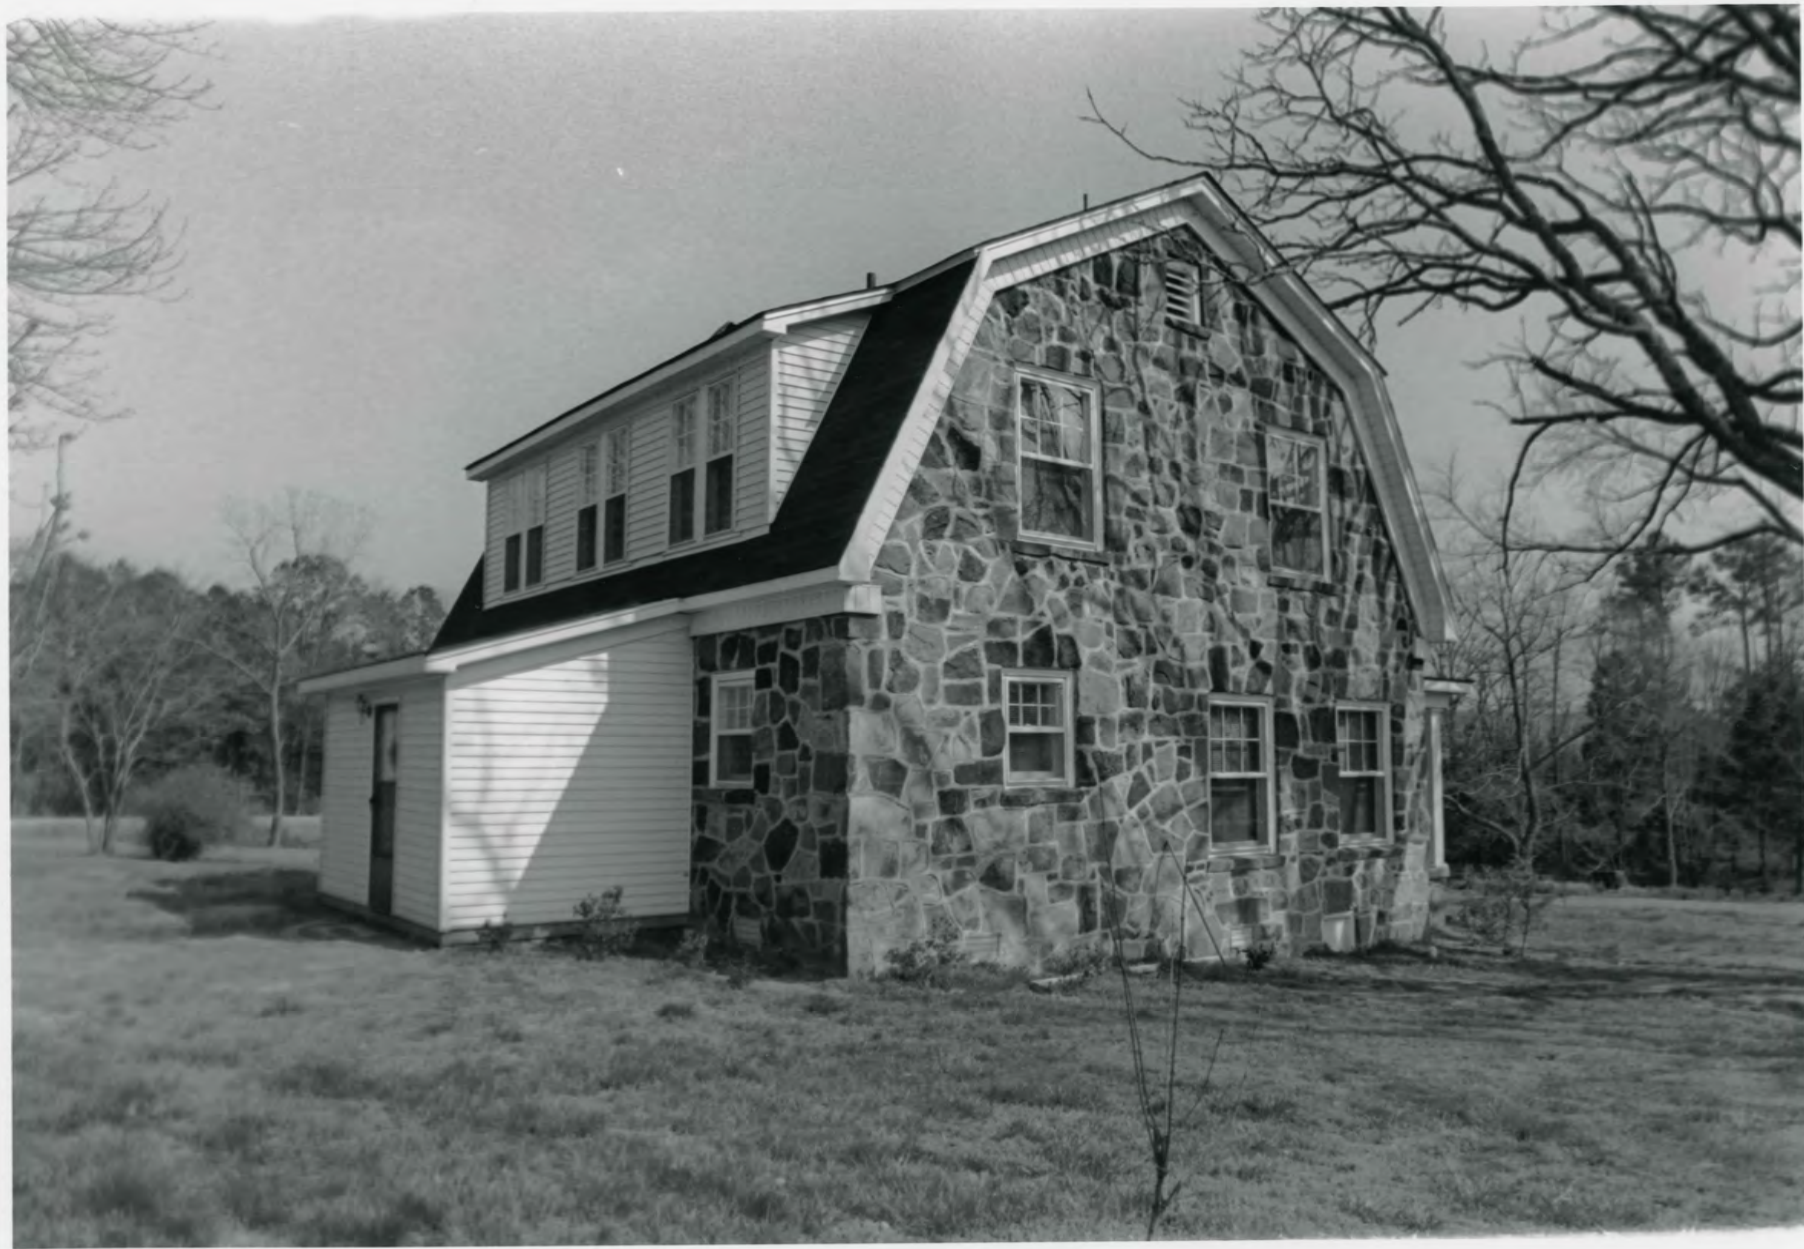
View from the northwest

The first story of the western elevation is asymmetrical in composition with three six-over-one windows. The two dining room windows near the front of the house are of identical, regular size while the rear kitchen window is much smaller and positioned higher on the wall. Upstairs, two regular six-over-one windows illuminate the bedrooms.

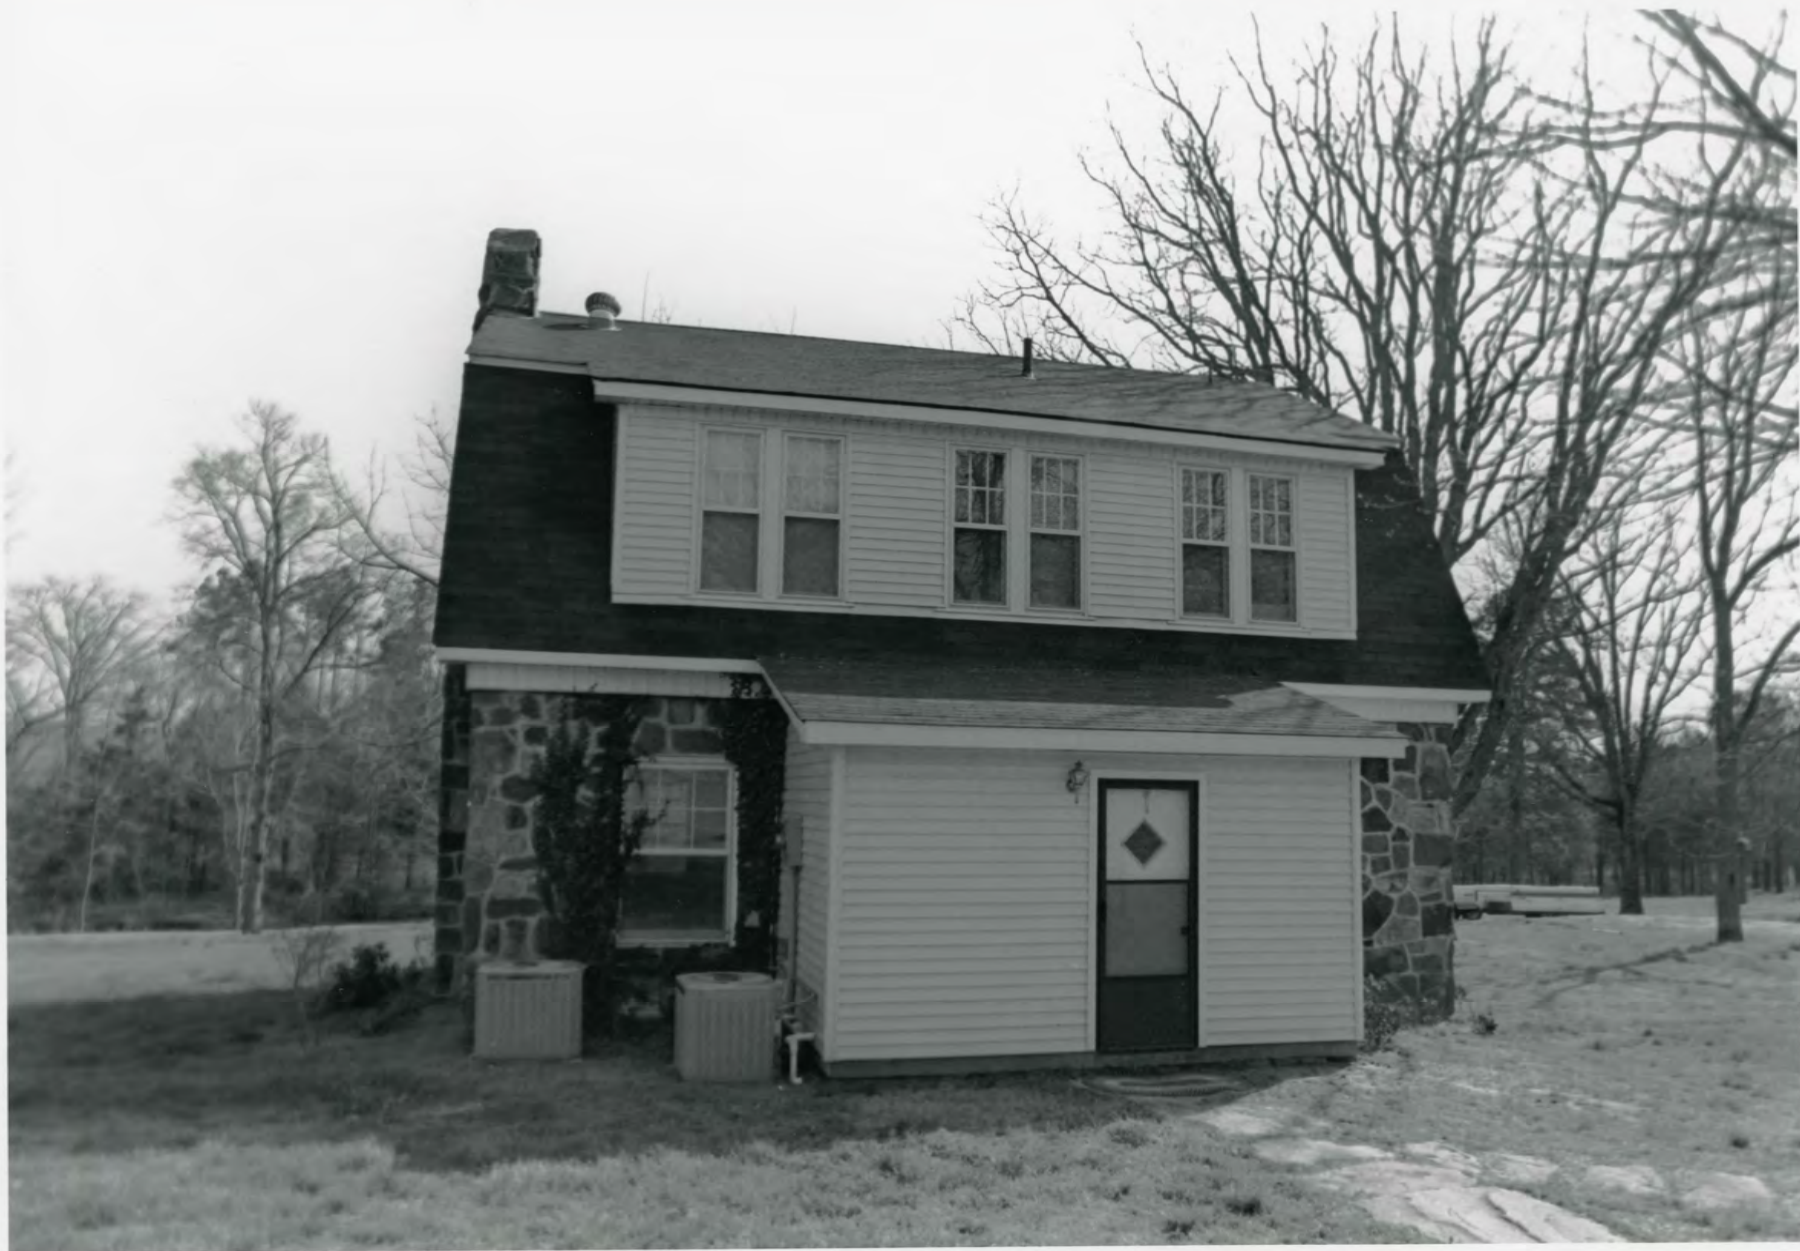
View from the north

The eastern elevation contains the central exterior stone chimney which is flanked by four six-over-one windows (two per floor). The rear, or northern, elevation consists of a central shed-roof porch that was originally a screened-in porch. It is now enclosed and covered with vinyl siding. A modern single-leaf door is positioned west of center. Otherwise, the first story is fenestrated by a large six-over-one window to the east of the porch while a much smaller window of the same sash configuration is placed to the west of the porch. Above, a shed-roof dormer deviates from its front elevation counterpart only by having full-length windows for the center pair.

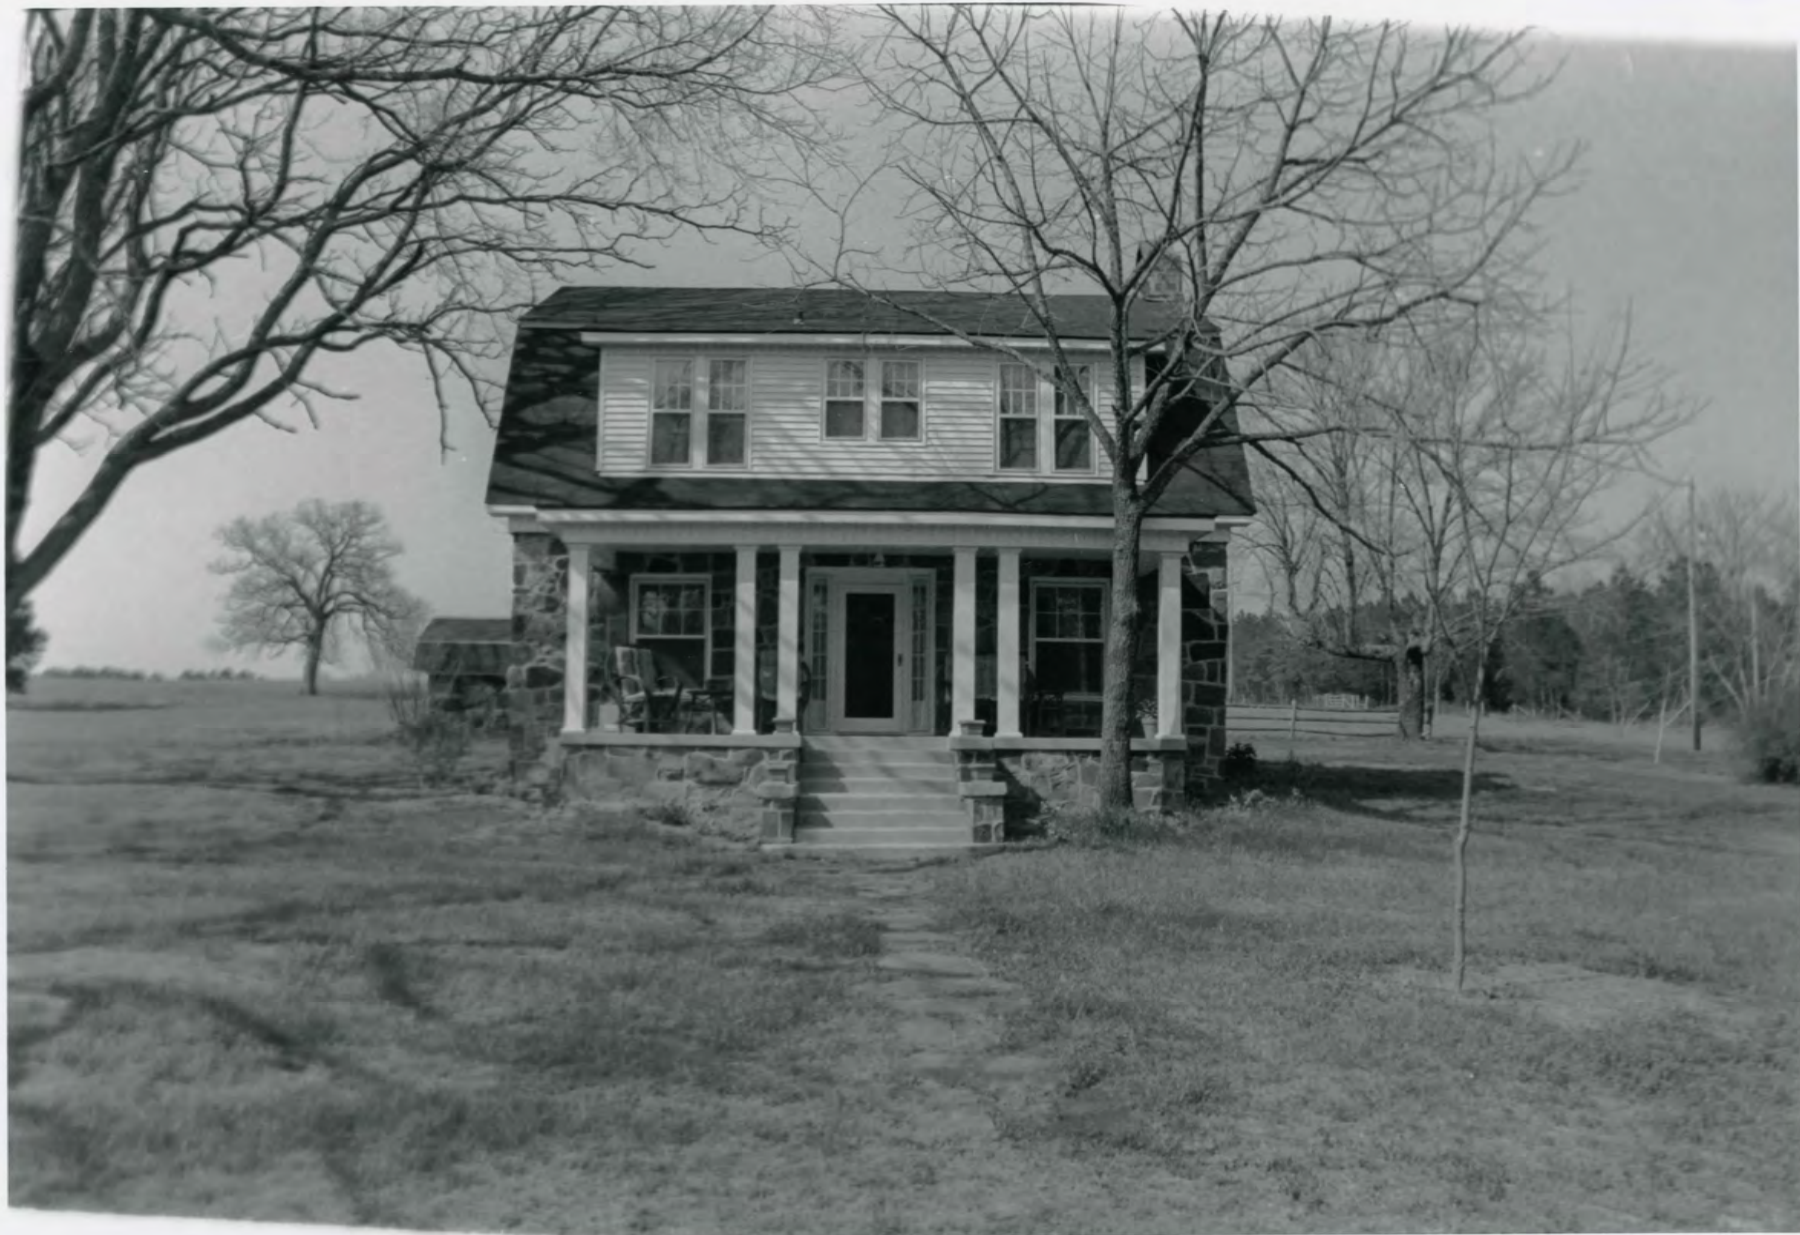
View of front elevation

from the south

The front, or southern, elevation consists of a full-length, shed-roof porch supported by six square columns. The raised, poured-concrete porch floor is accessed by a substantial seven-step stone-and-concrete stoop. The first-story wall underneath the porch roof is symmetrically arranged with two large six-over-one, double-hung, wood-frame windows and a central entrance. The single-leaf, fully-glazed, fifteen-pane door is flanked by ten-pane sidelights. Above the porch, the gambrel roofline is broken by a long shed dormer fenestrated by three pairs of six-over-one, double-hung, wood-frame windows. The two center windows provide light for the bathroom and are shorter in height than the end pairs. The dormer is currently clad with narrow-width vinyl siding.

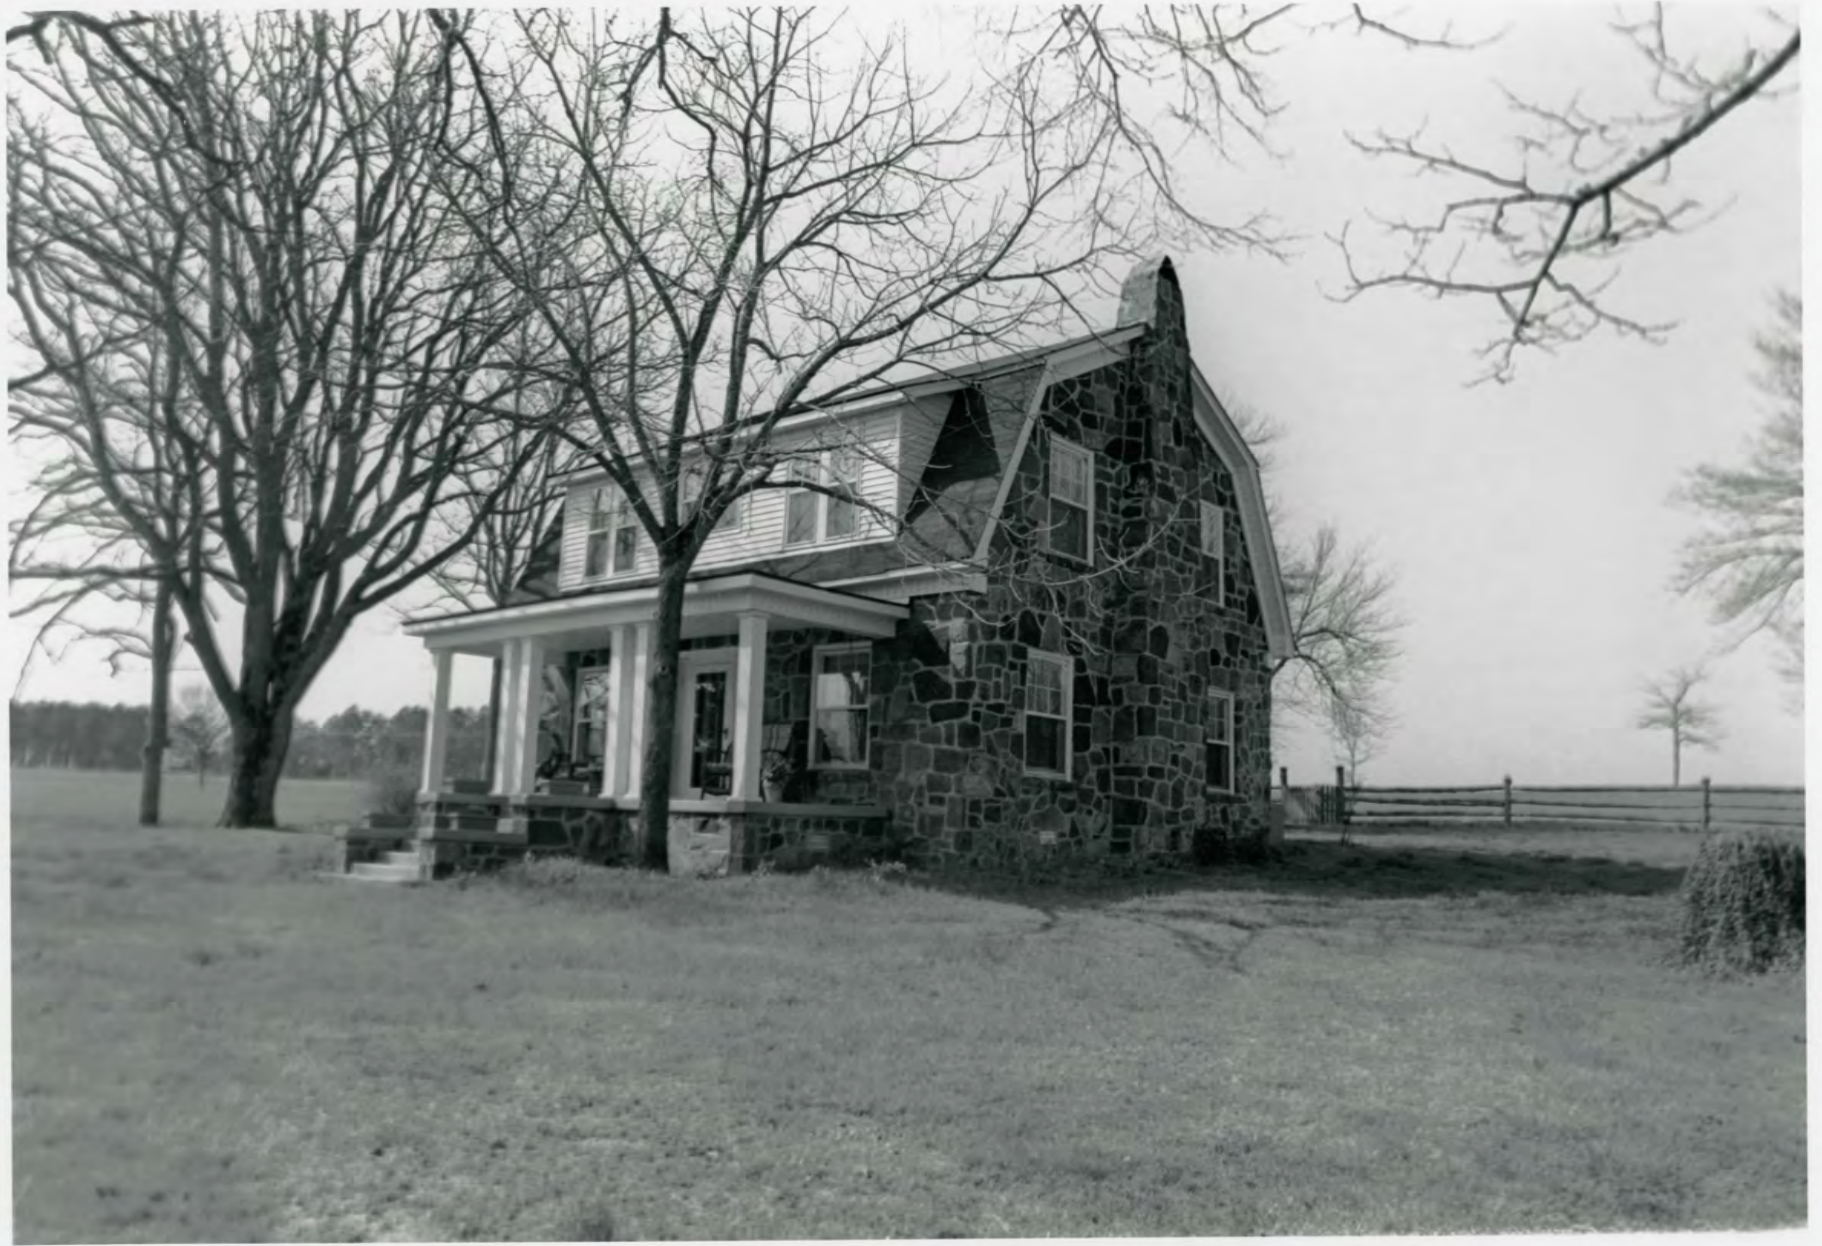
View from the southeast

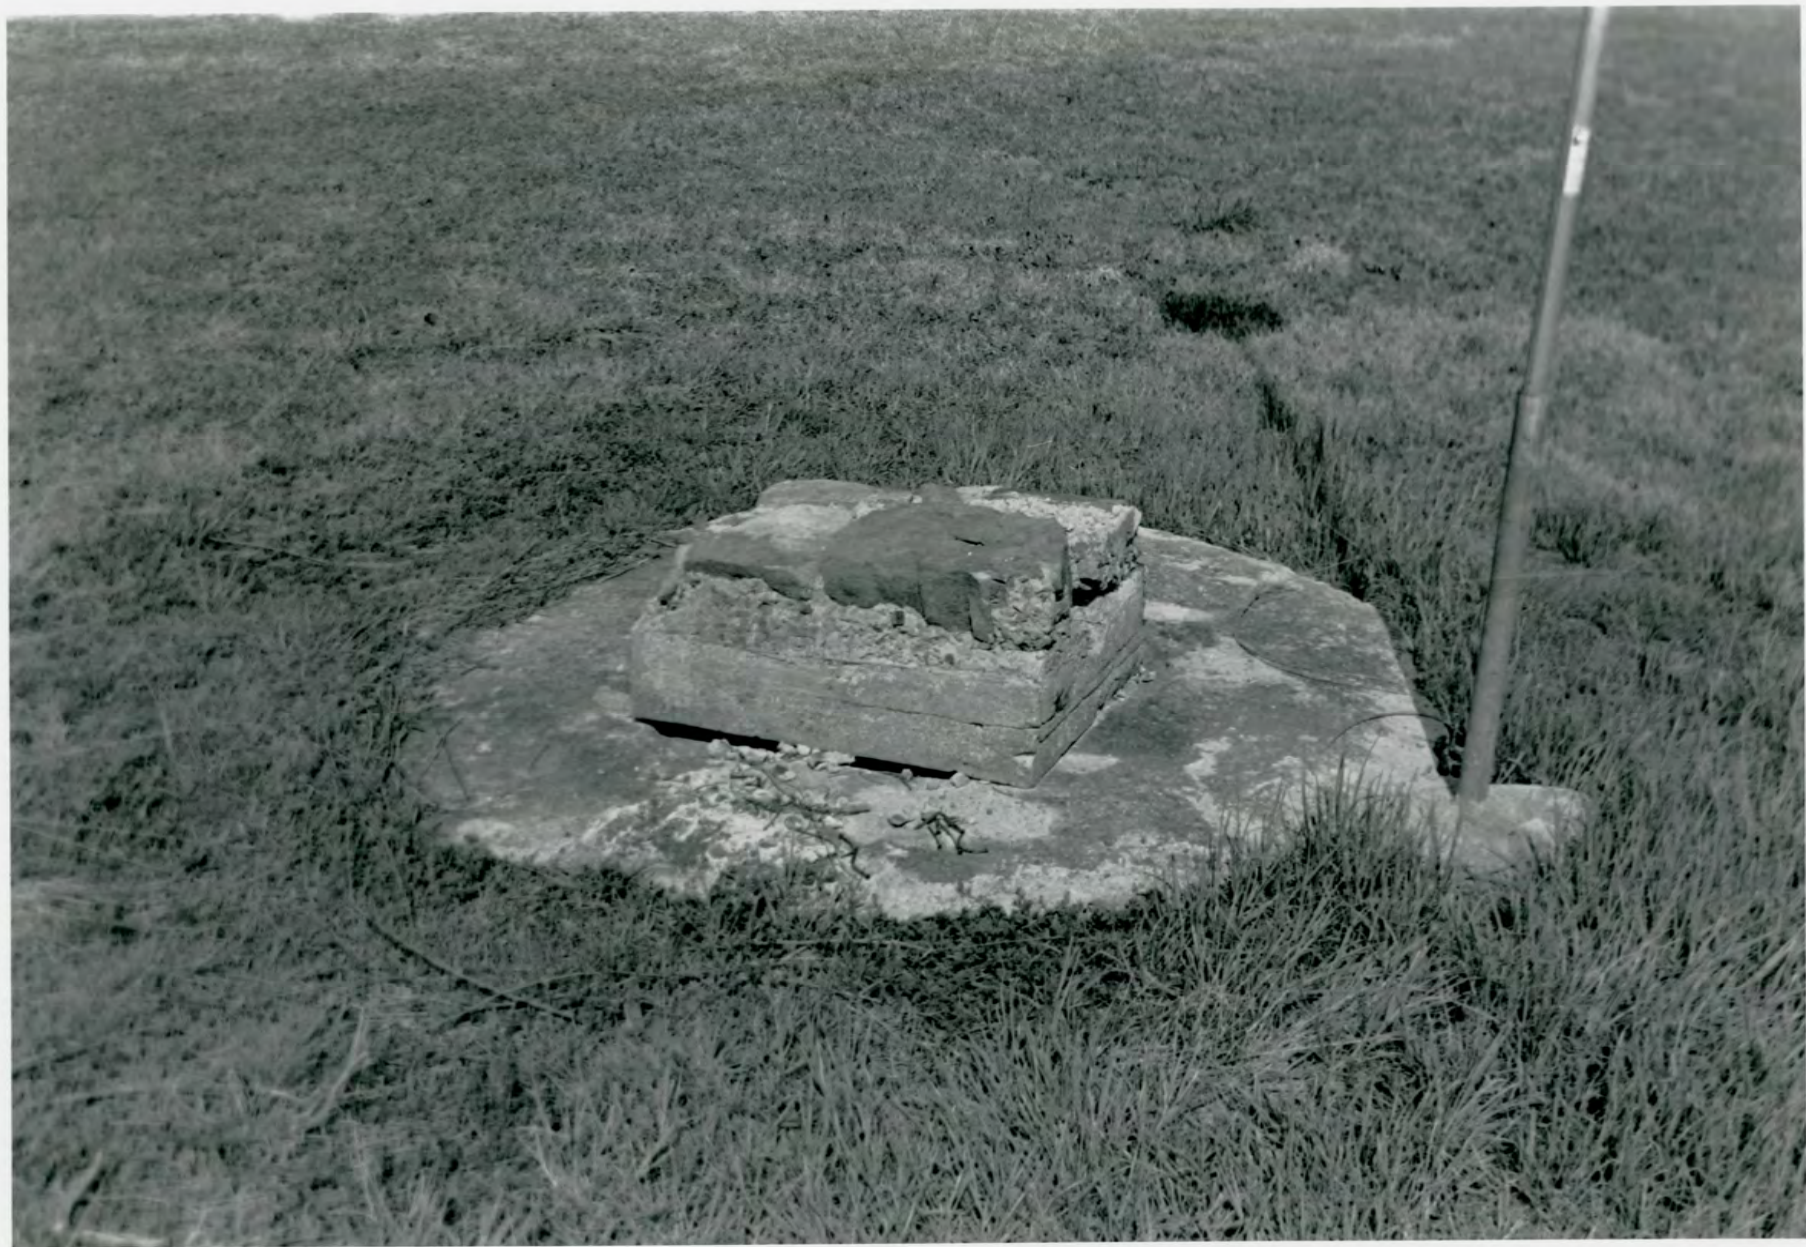
View of cistern from the southwest

Associated with the dam is a concrete cistern positioned on the slight hill to the north of the Munger House. Water was pumped from the lake via underground pipe to the cistern, which provided water pressure for the indoor plumbing, the first in the Lutherville community.

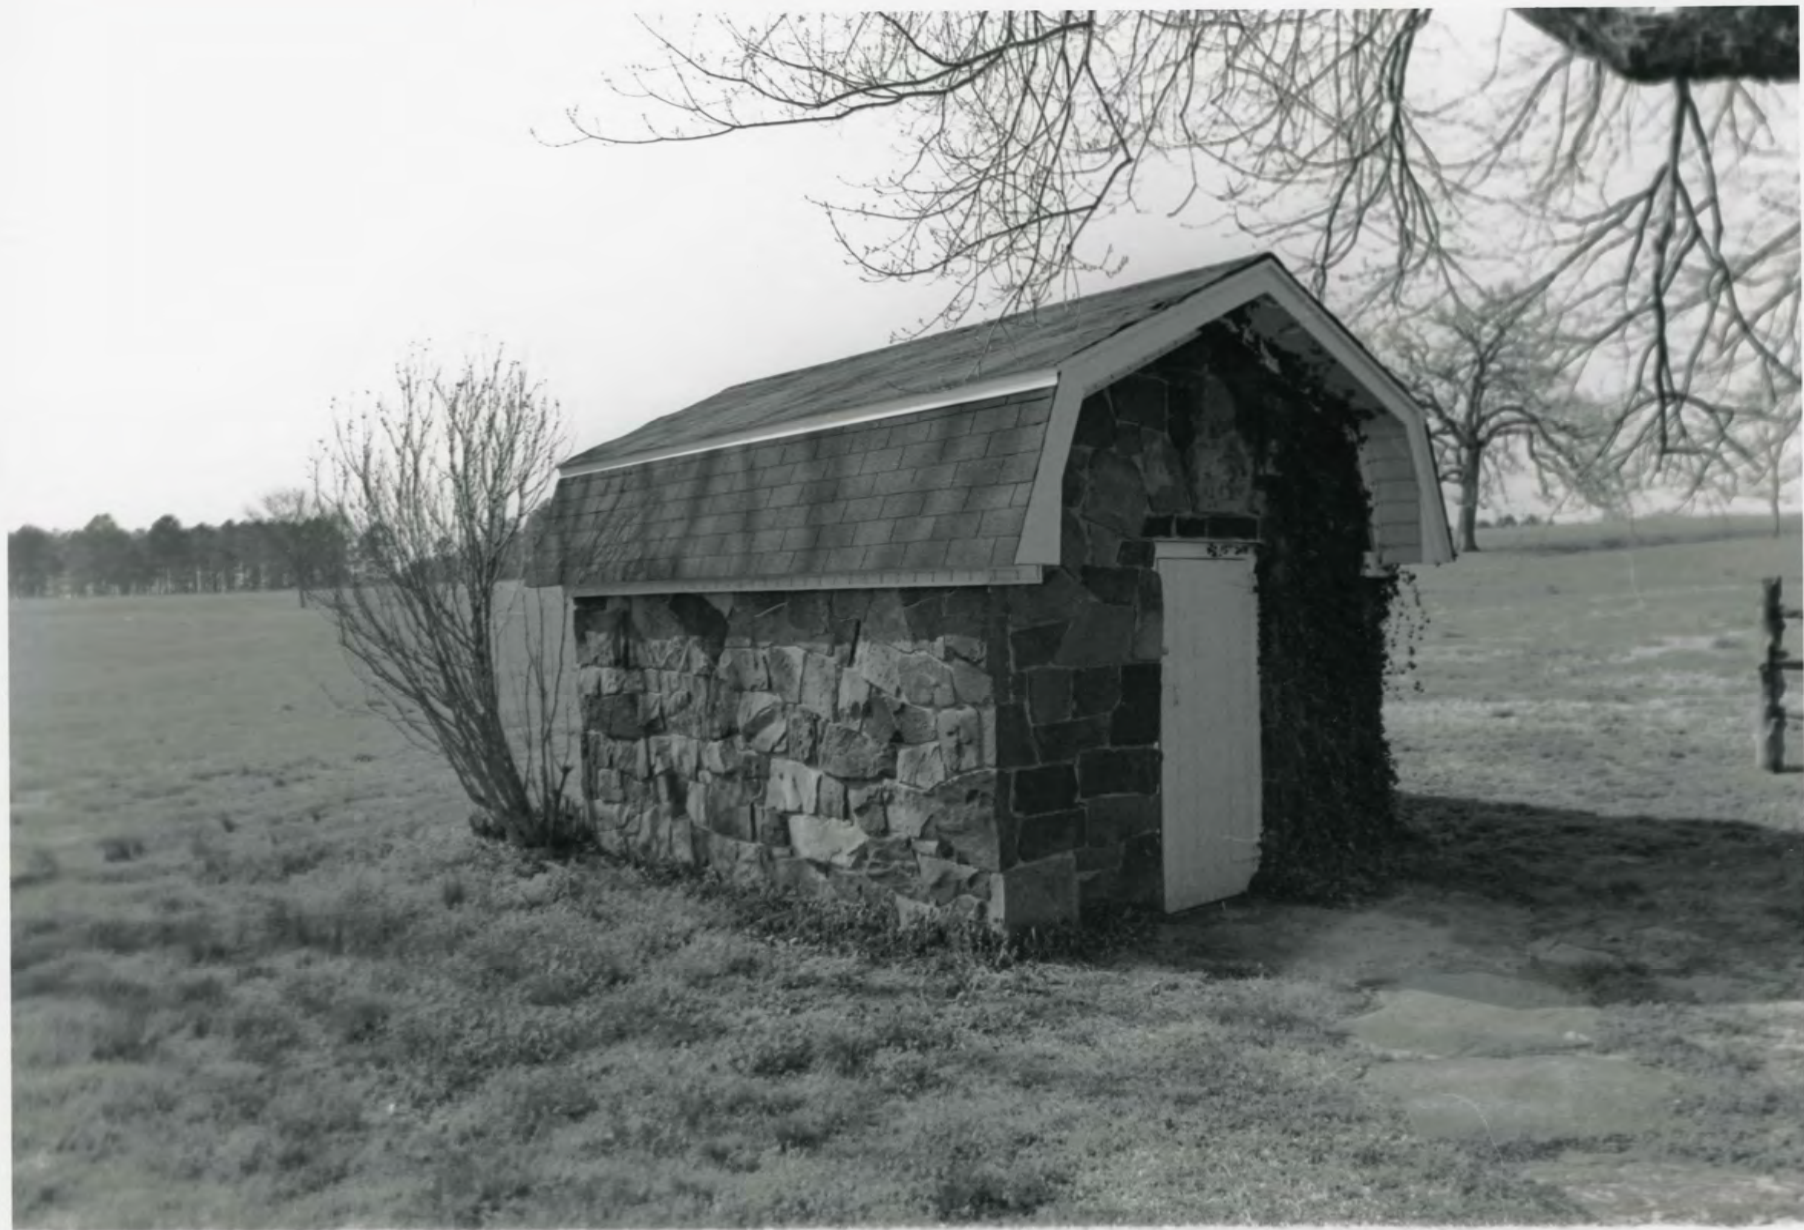
View of smokehouse from
the southeast

Also included in the nomination is a small stone smokehouse that features a matching gambrel roof and a single-leaf entrance to the east. More impressive is a large reinforced-concrete dam in front of the house that forms a sizable pool in the northern fork of Slover Creek. The dam now has

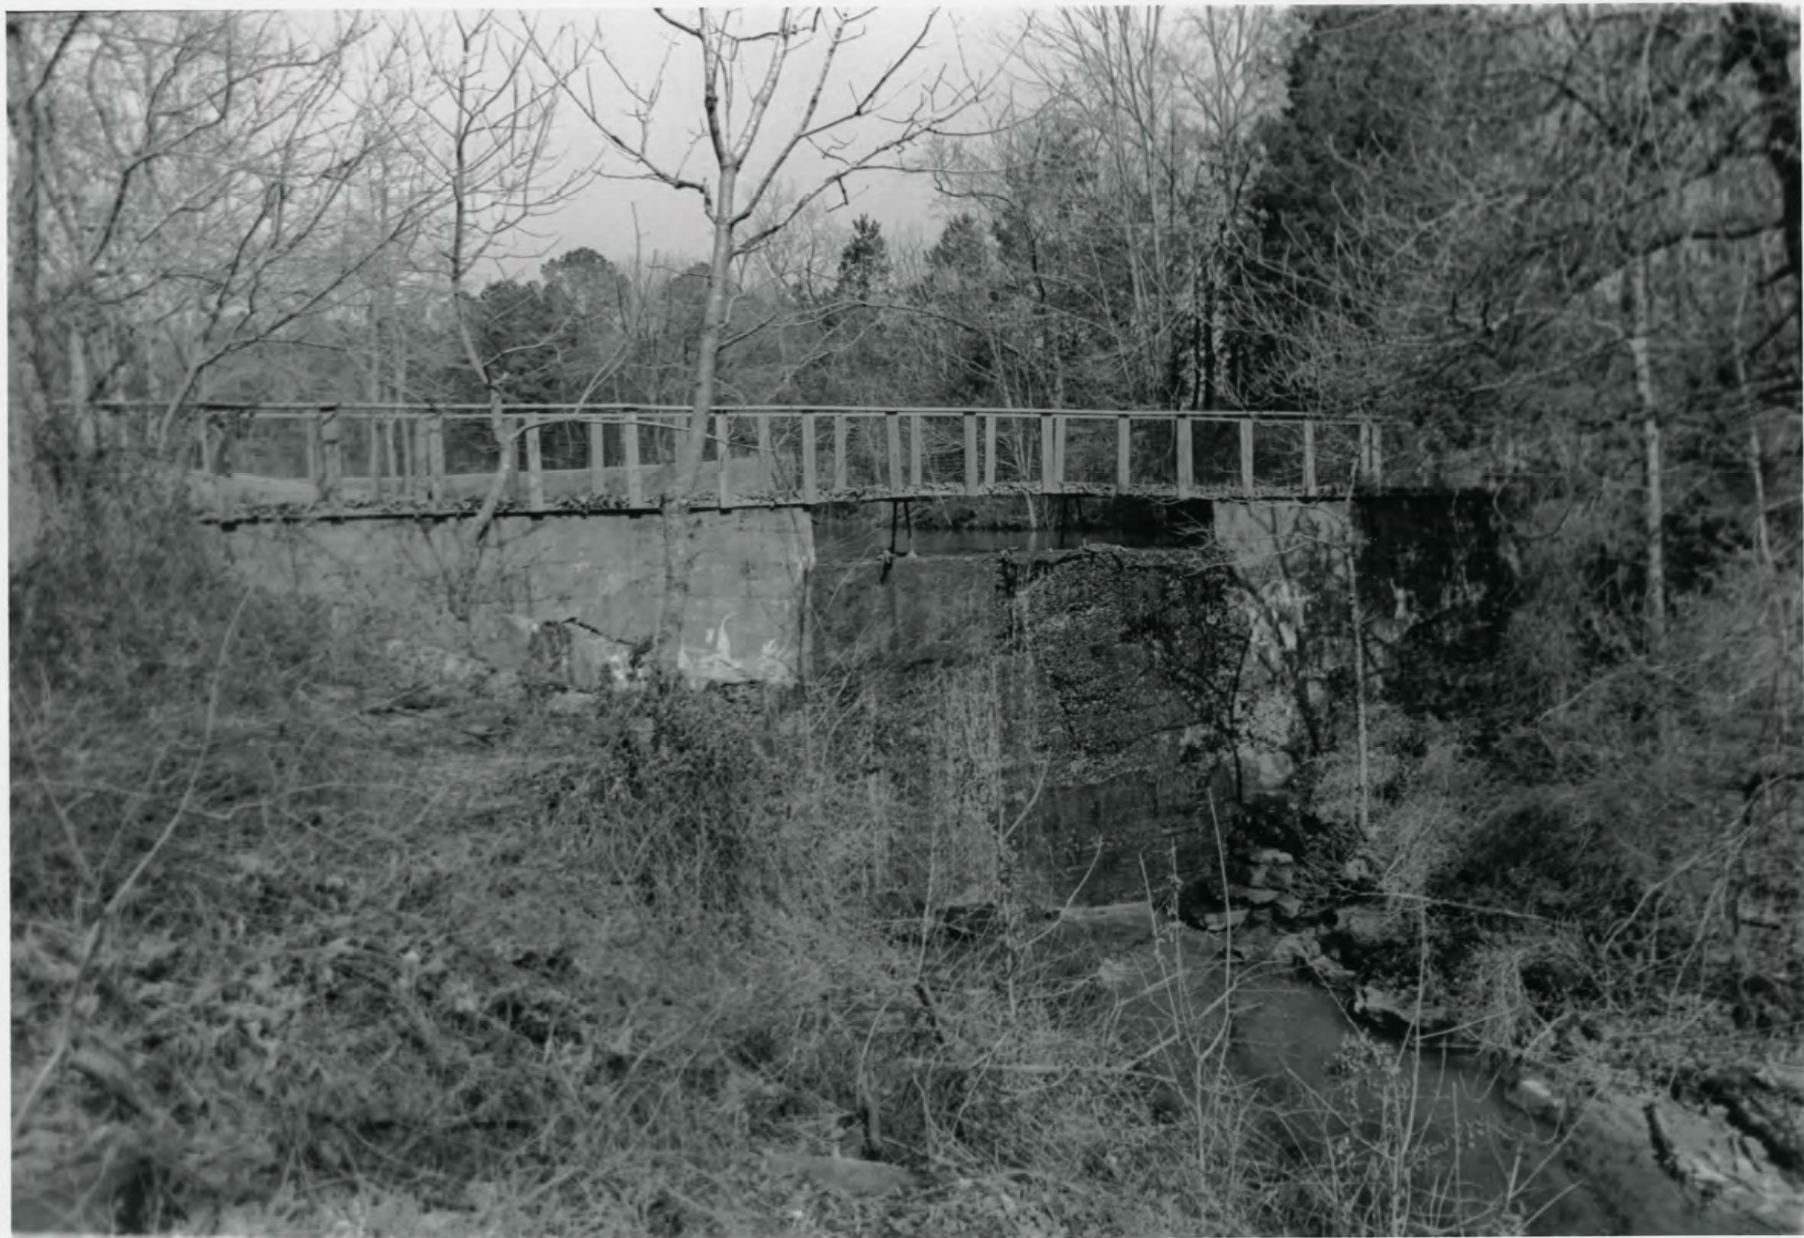
View of dam from the west

a wooden walkway across the top.

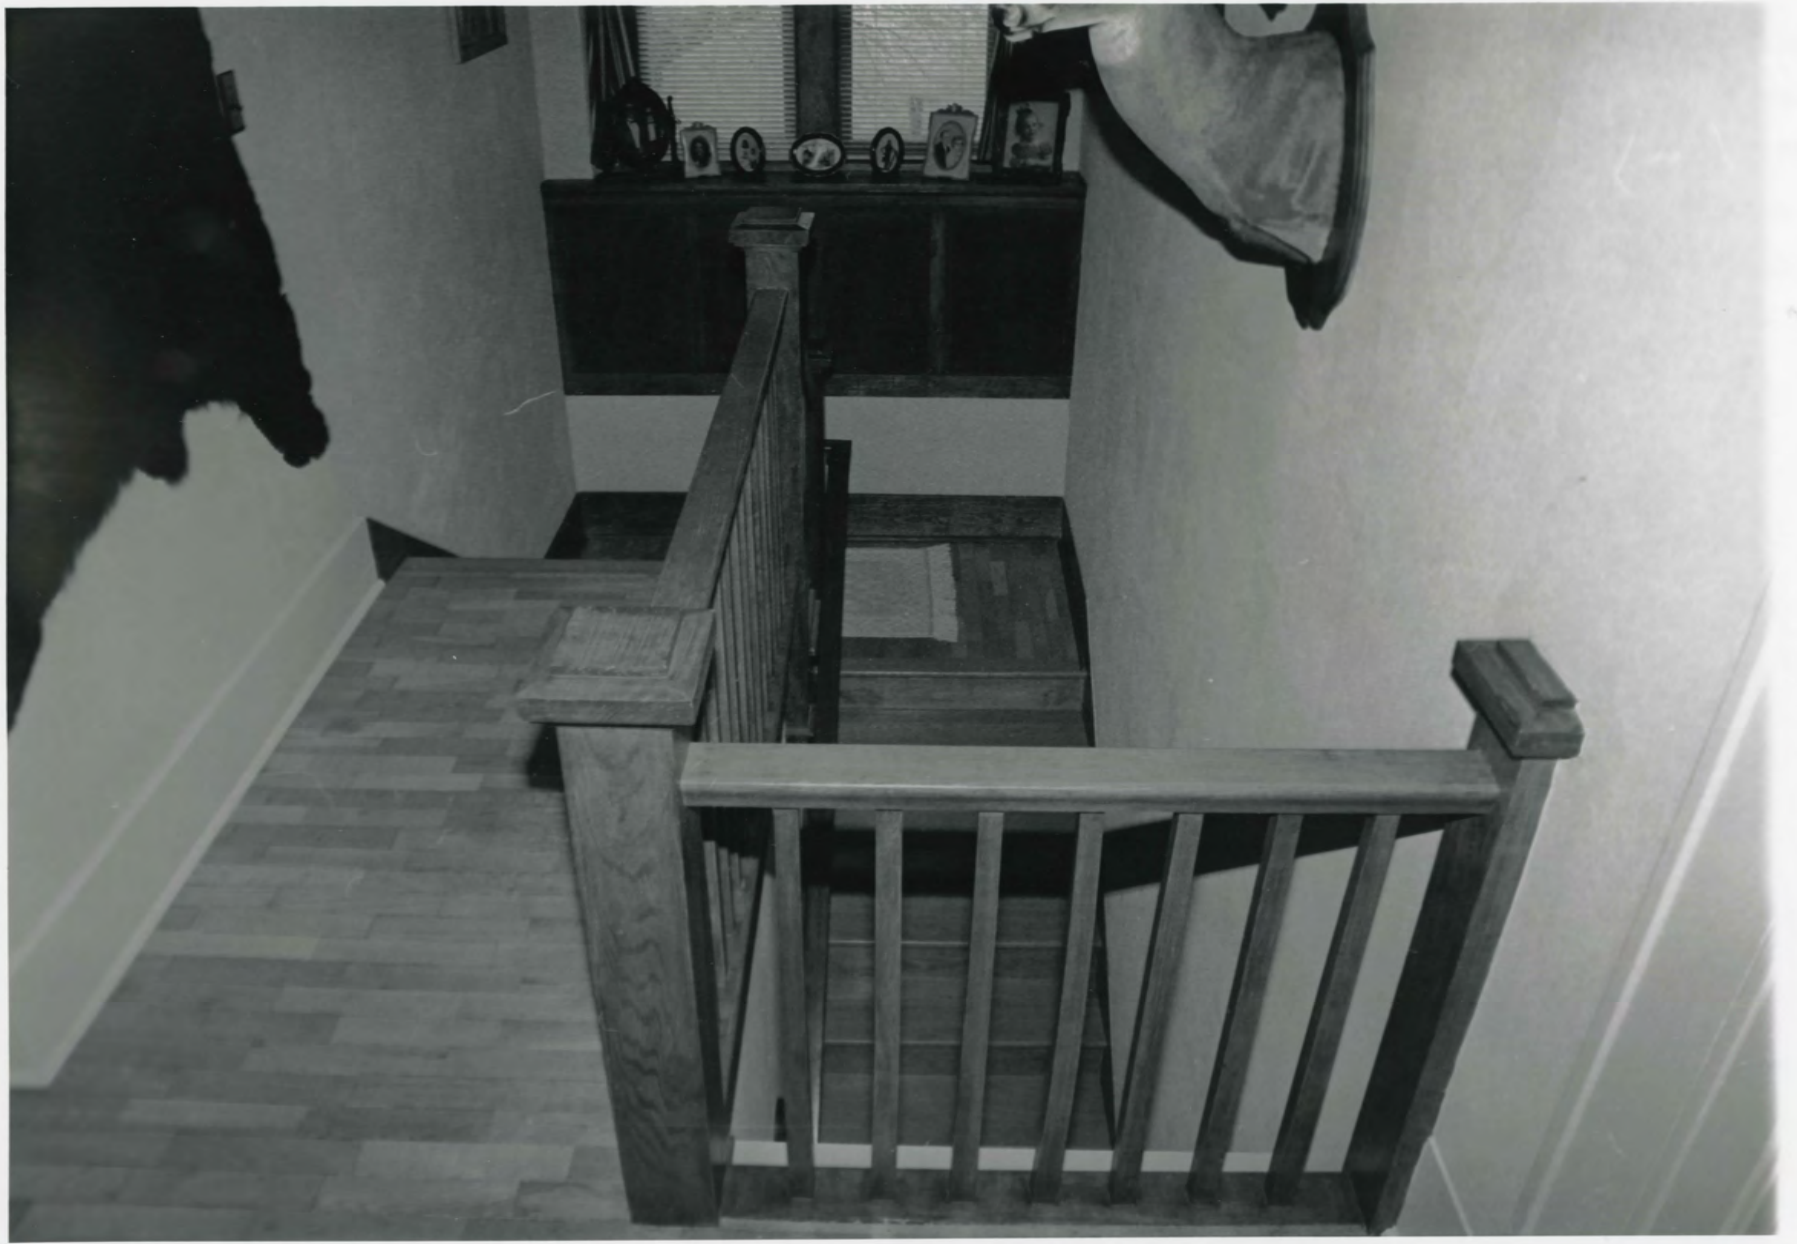
View of staircase from
second floor

The interior of the house features the original oak floors and an oak stairway with a stick balustrade that is entered from the central entrance hall through an arched opening. A brick fireplace surround with a simple wood mantel is located in the living room. Unusual original Art Nouveau light fixtures are found in the entrance hall, dining room, bathrooms, hallway, and one bedroom. The original tub, sinks, and medicine cabinets are still found in the bathrooms. Perhaps the most interesting interior feature, however, is a secret compartment behind an oak panel at the mid-level stairway landing. Alterations to the interior consist primarily of lowering the ceilings in the entrance hall, living room and dining room to allow for central heating and air conditioning. Sheetrock walls were also added in the entrance hall, living room, and dining room when insulation was installed, although the original plaster walls are still intact behind the sheetrock. The kitchen was completely remodeled with new appliances and cabinets.

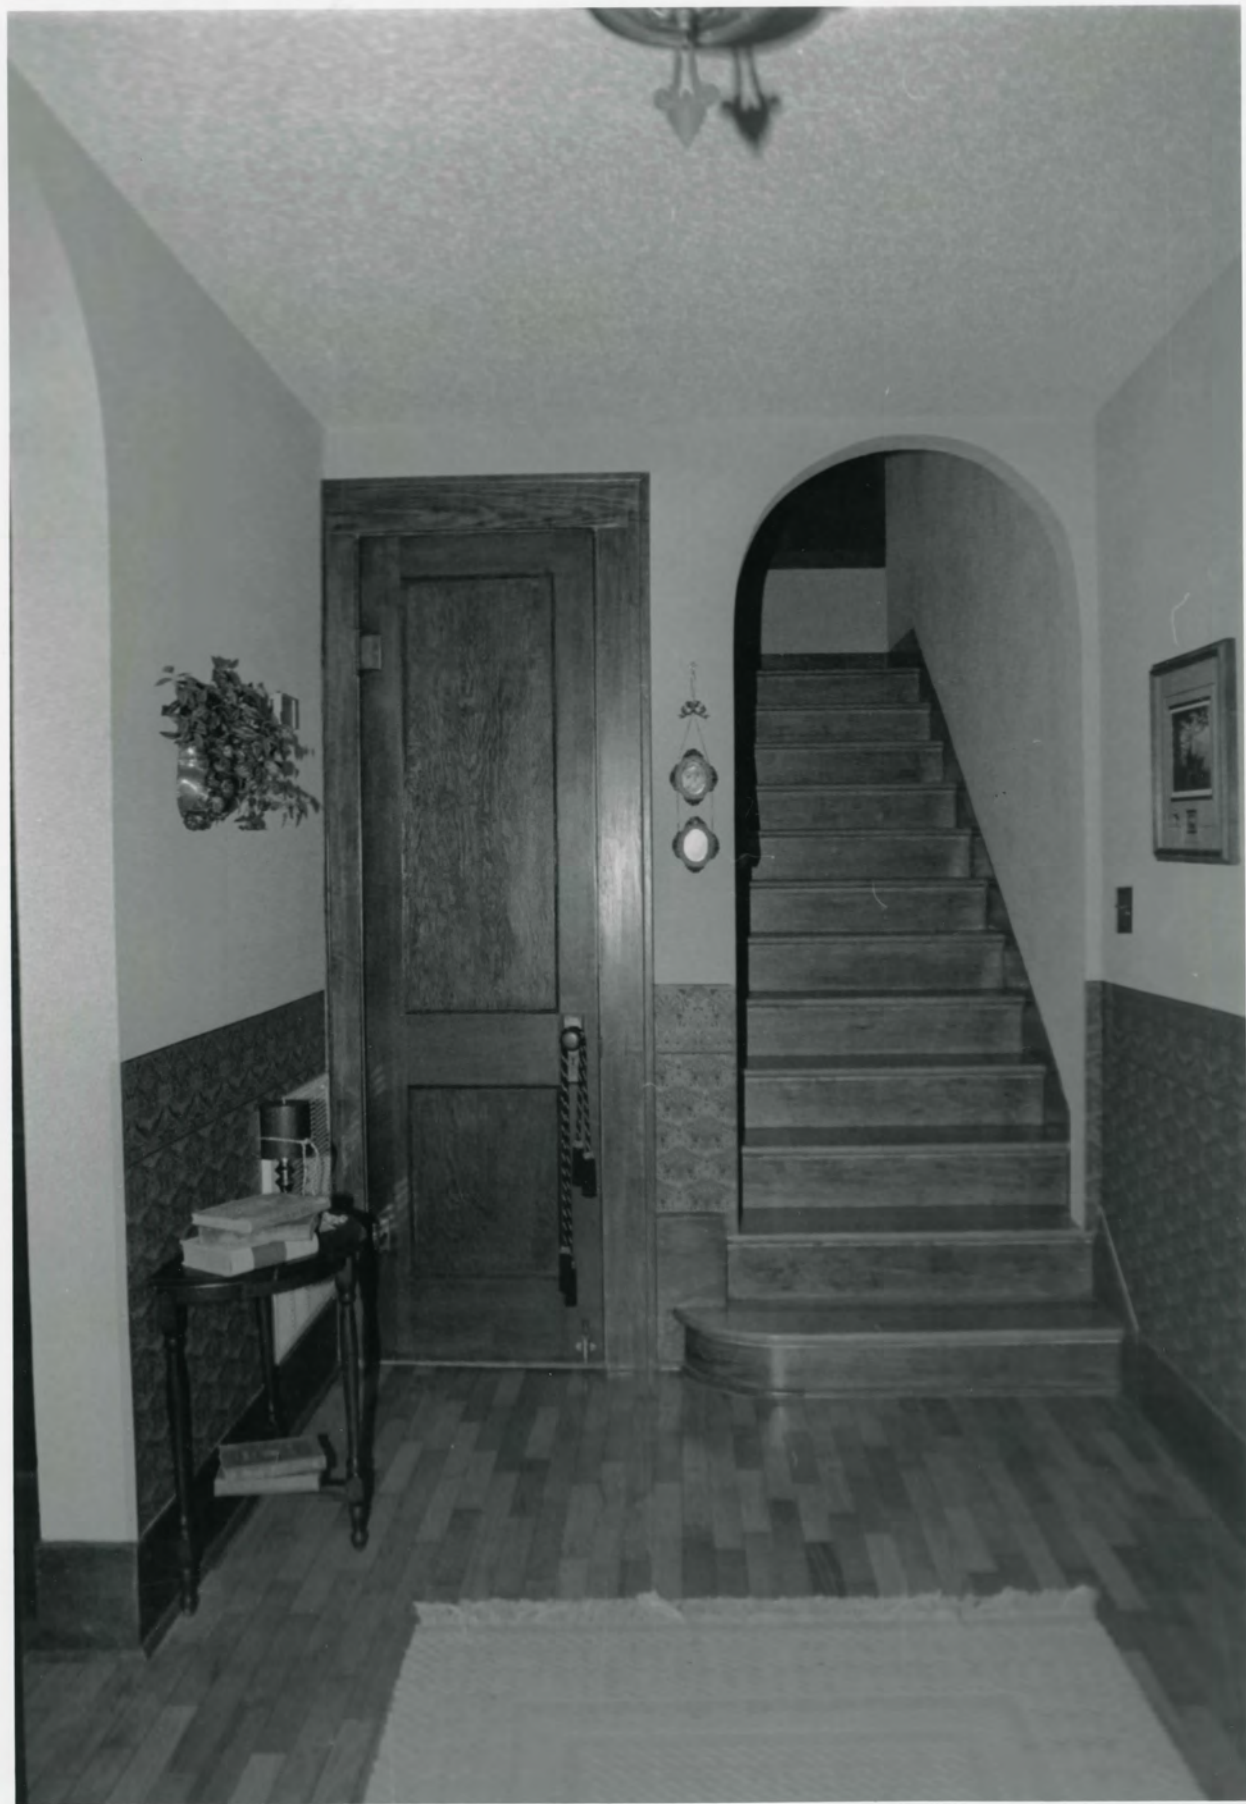
View of staircase landing compartment
from the south
