NATIONAL REGISTER OF HISTORIC PLACES
REGISTRATION FORM

Historic Name: Munger House

State: AR County: Johnson Code: AR 071 Zip Code: 72846

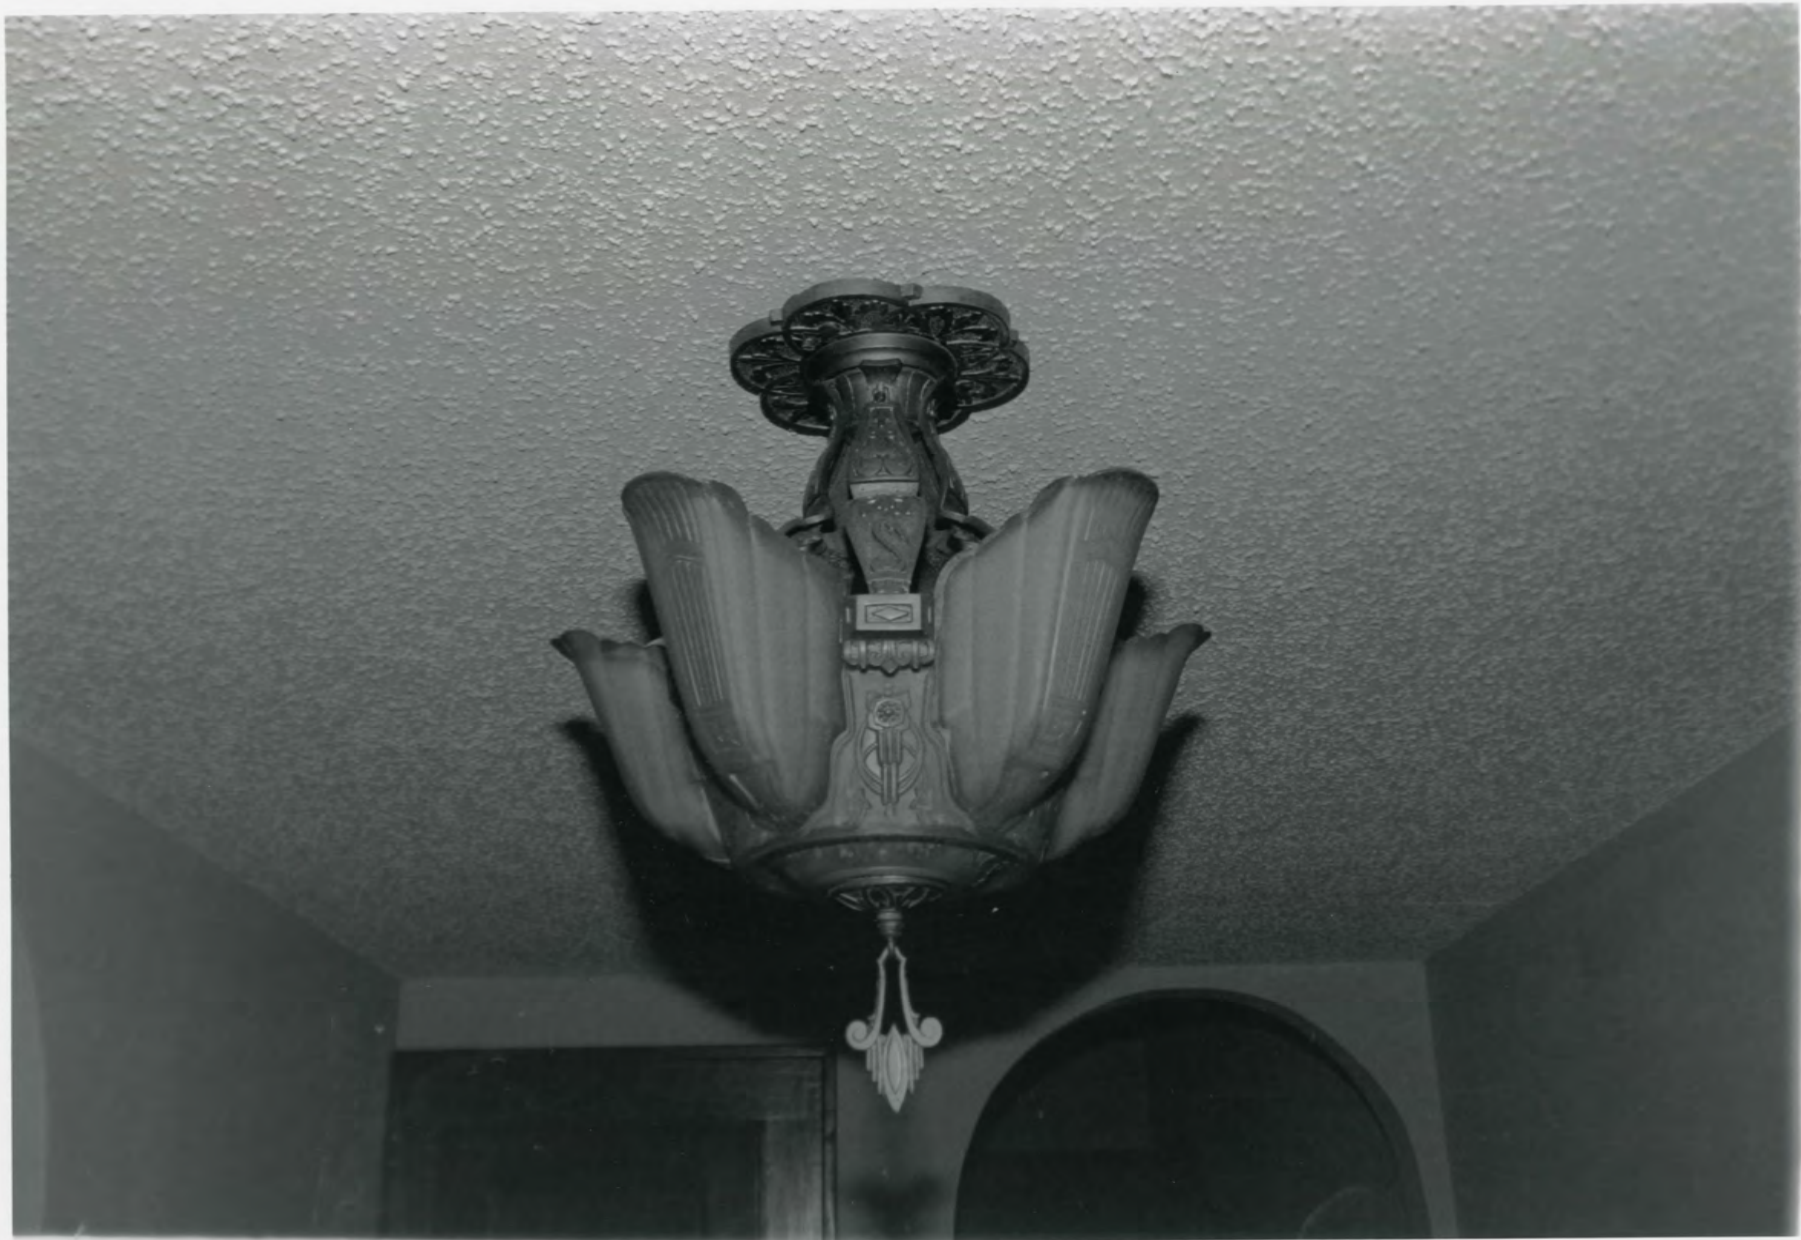
View of entrance hall lighting fixture
from the south

The interior of the house features the original oak floors and an oak stairway with a stick balustrade that is entered from the central entrance hall through an arched opening. A brick fireplace surround with a simple wood mantel is located in the living room. Unusual original Art Nouveau light fixtures are found in the entrance hall, dining room, bathrooms, hallway, and one bedroom. The original tub, sinks, and medicine cabinets are still found in the bathrooms. Perhaps the most interesting interior feature, however, is a secret compartment behind an oak panel at the mid-level stairway landing. Alterations to the interior consist primarily of lowering the ceilings in the entrance hall, living room and dining room to allow for central heating and air conditioning. Sheetrock walls were also added in the entrance hall, living room, and dining room when insulation was installed, although the original plaster walls are still intact behind the sheetrock. The kitchen was completely remodeled with new appliances and cabinets.
