NATIONAL REGISTER OF HISTORIC PLACES
CONTINUATION SHEET

Merced Lake Ranger Station
Property Name

National Register of Historic Places Registration Form

historic name Merced Lake Ranger Station
other names/site number Merced Lake Cabin, Merced Lake Snow Survey Cabin, Yosemite National Park Building No. 3400

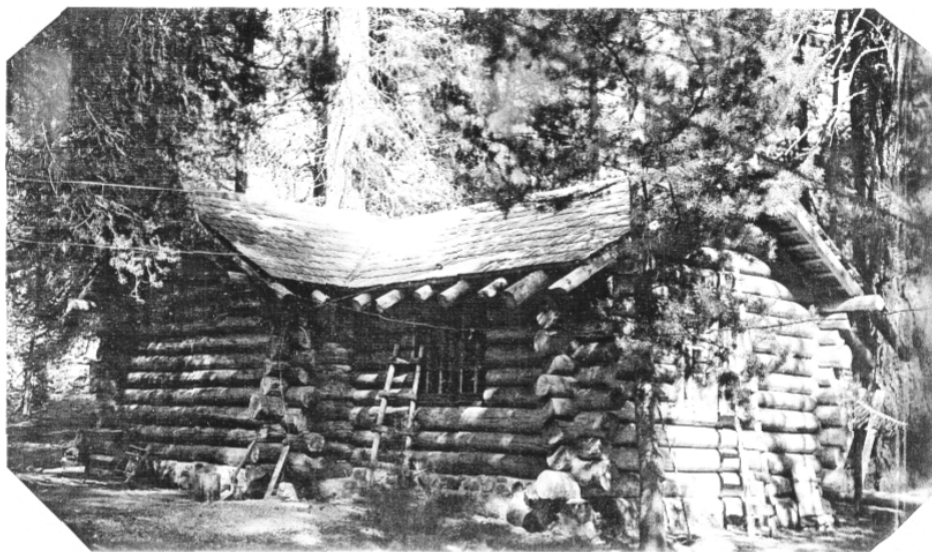
Historic Photo #2. West bedroom addition during construction. Photo is from final construction report, January 1935. Photographer unknown.
Photo: Yosemite National Park, Division of Resources Management and Science, Branch of History, Architecture and Landscapes, El Portal, CA.

The building was originally constructed as a two-room cabin, rectangular in plan measuring 16' by 22', and capped by a gable roof. In 1934, Yosemite's superintendent requested a bedroom addition be constructed onto the ranger station. The addition is approximately 13' by 15' and extends from the rear, or west, elevation forming a cross gable roofline. The tack room addition on the southwest corner of the building was constructed outside of the period of significance, sometime between 1972 and 1974. The overall form of the tack room addition is a lean-to structure capped by a shed roof that has been incorporated into the south facing roof slope of the bedroom addition.

- Bedroom addition and battered masonry chimney constructed in 1934; at this time an additional masonry chimney was removed from the south end of the building and replaced by a cylindrical metal flue

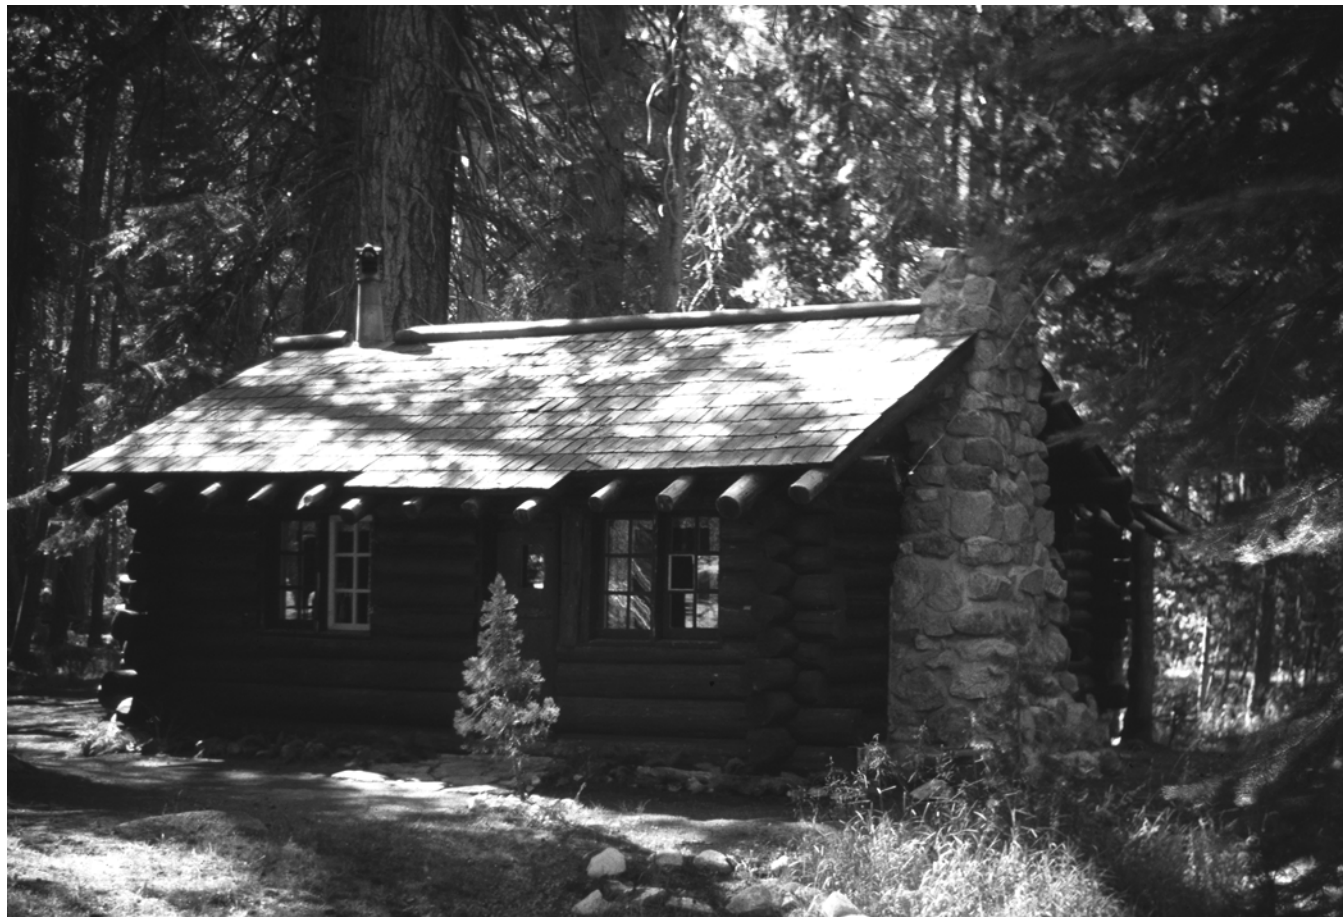
Historic Photo #3. Merced Lake Ranger Station, 1942.
Photographer unknown. Photo: Yosemite National Park Research Library.

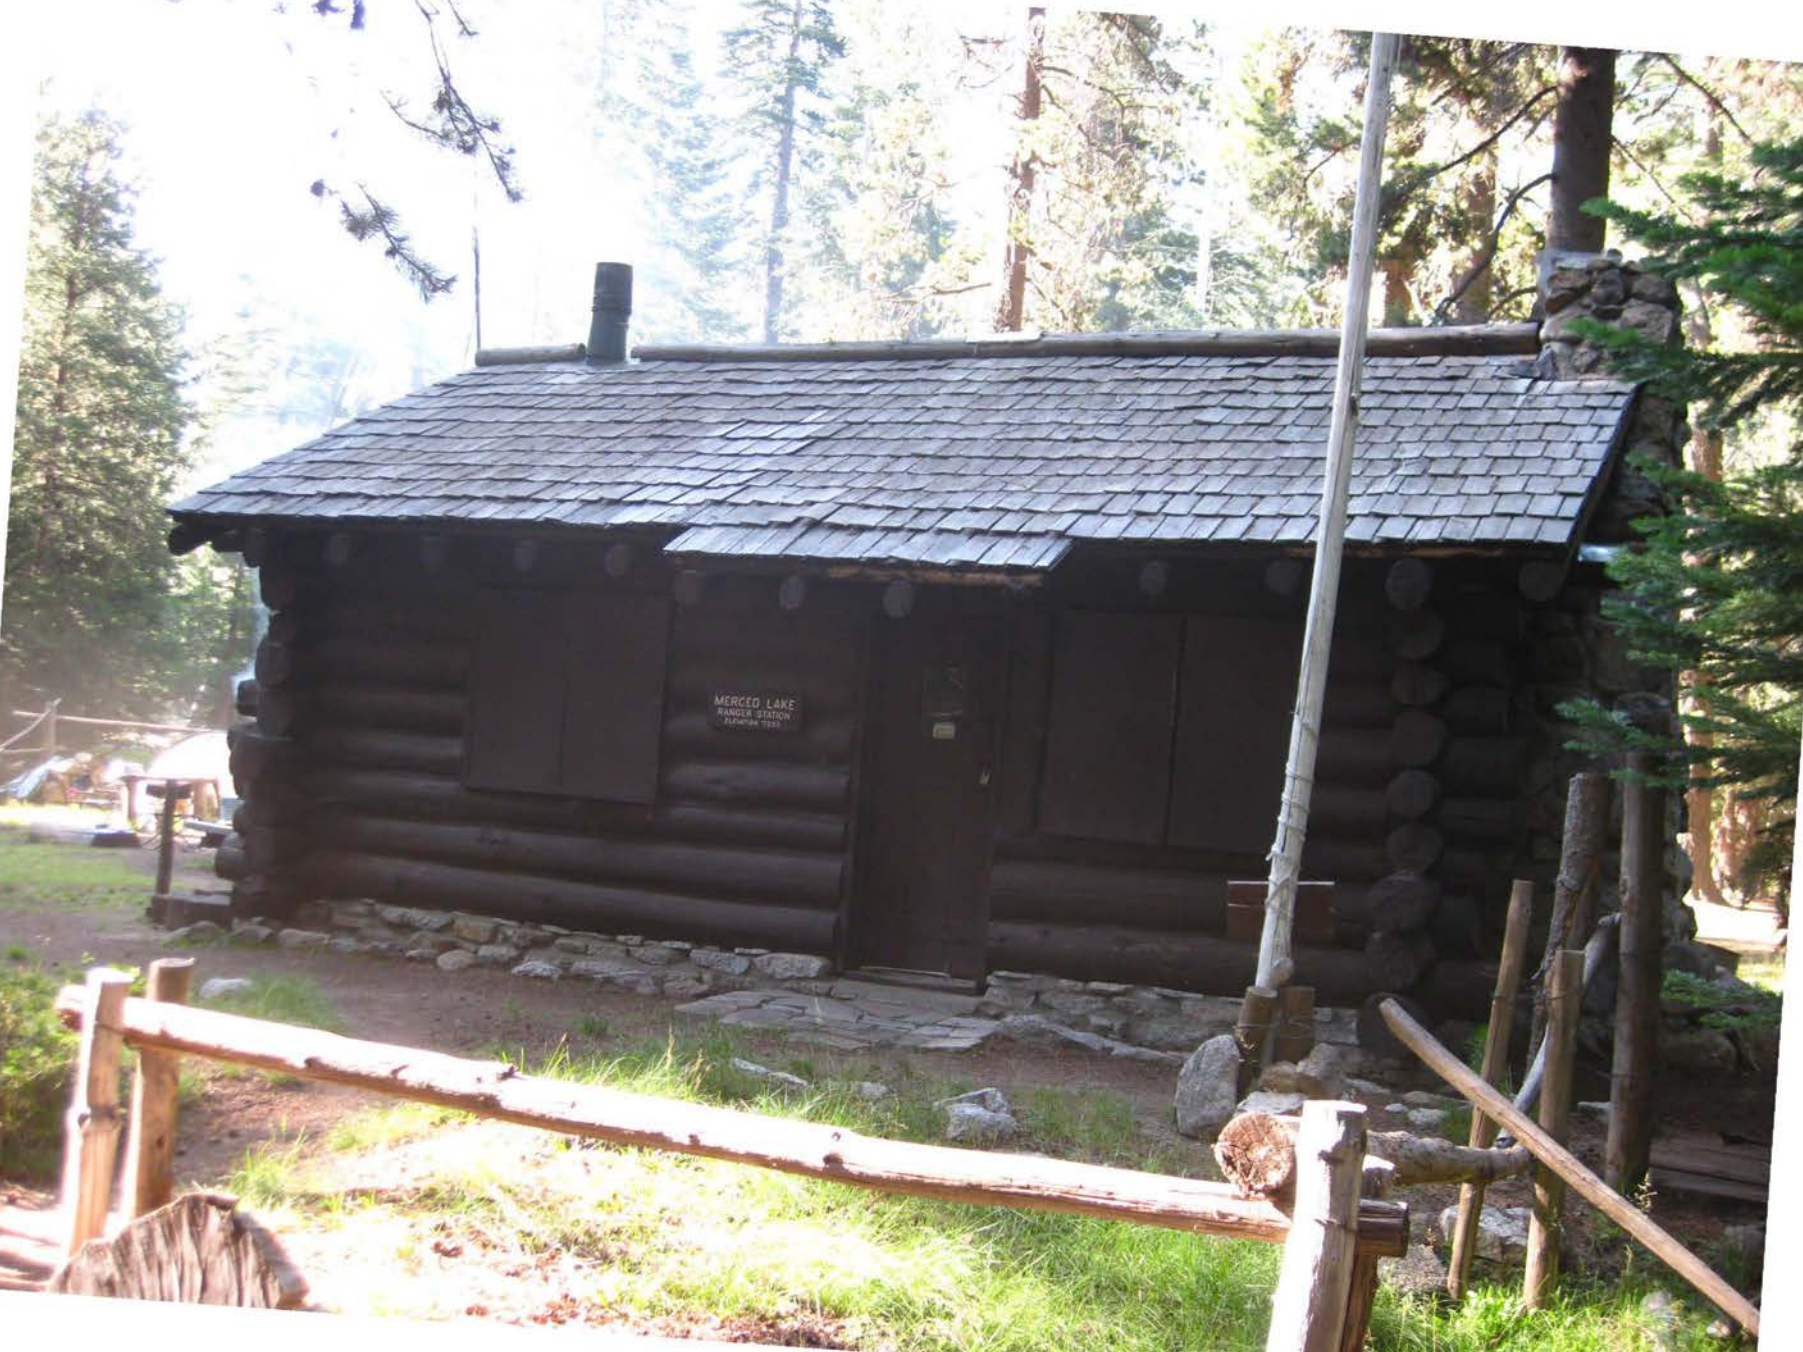
MERCED LAKE
RANGER STATION
BURNED 1939
