National Register of Historic Places
Registration Form

historic name Pitsenbarger, Ananias, Farm

state West Virginia code WV county Pendleton Code 071 zip code 26807

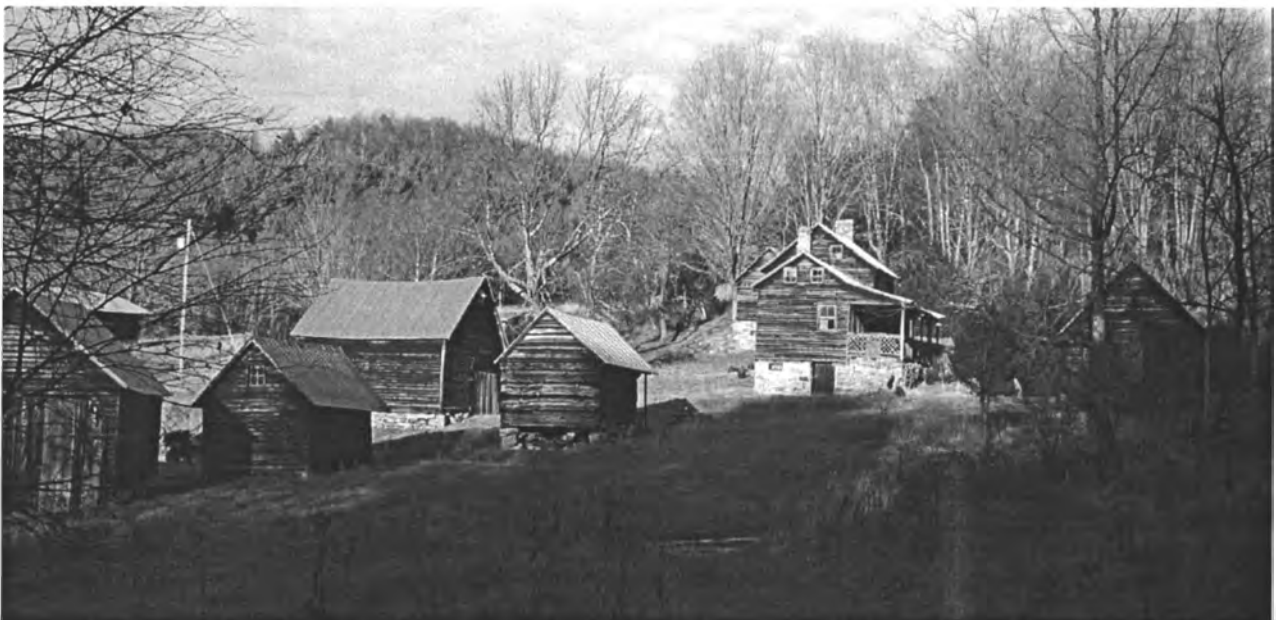
Photo 1 (see photo log)

Photographer:	Jeffrey Munn (unless noted otherwise)
Date:	winter/spring 2010 (unless noted otherwise)
Photo 1 of 20:	Pitsenbarger Farm; camera facing northeast
Photo 2 of 20:	Pitsenbarger Farm; camera facing east (photo by Aubrey Von Lindern, SHPO, April 2011)
Photo 3 of 20:	Pitsenbarger house (#1); camera facing north/northeast
Photo 4 of 20:	Pitsenbarger house (#1); camera facing east/northeast
Photo 5 of 20:	Interior, living room of original section of house
Photo 6 of 20:	Interior, staircase from second floor to third in house
Photo 7 of 20:	Springhouse (#5); camera facing west
Photo 8 of 20:	Springhouse interior (photo by Aubrey Von Lindern, SHPO, April 2011)
Photo 9 of 20:	Chicken coop (#3); camera facing south/southwest
Photo 10 of 20:	Granary (#4); camera facing southwest
Photo 11 of 20:	Cellar house (#6); camera facing east/northeast
Photo 12 of 20:	Horse stable (#6); camera facing northwest
Photo 13 of 20:	Carriage house (#7) next to chicken coop (#3); camera facing northwest

Historically, the property included 23 buildings (see Figures, Page 20). The house (photos 1-6), situated in a "bowl" near the main spring, and 15 log and frame outbuildings remain. The cellar house (photo 11), two hog pens, a stable (photo 12), woodworking shop (photo 14), carriage house (photo 13), chicken coop (photo 9), granary (photo 10), shed, WPA privy (photo 14), and spring house (photos 7-8) are clustered near the house with three small hay barns (photo 16) in adjacent fields and a large double-crib log hay barn (photo 15) situated a few hundred yards up the hill to the southwest of the house. A blacksmith shop, wash house, cider house, still house, cattle weigh scale house, corn crib and a small hay barn no longer exist. The foundation of the sugar shack and scale house (photo 17) remain. The only modern buildings on the property are a few hundred yards away from the old homestead. They include a log home built about 1986, and an open-air pole barn structure built in the 1990s next to the newer log home. Very little has changed to the property or buildings over the years. The most visible change has been the replacement of pole press roofs that were on some of the outbuildings. They were replaced with standing seam metal roofs due to their deteriorating condition.

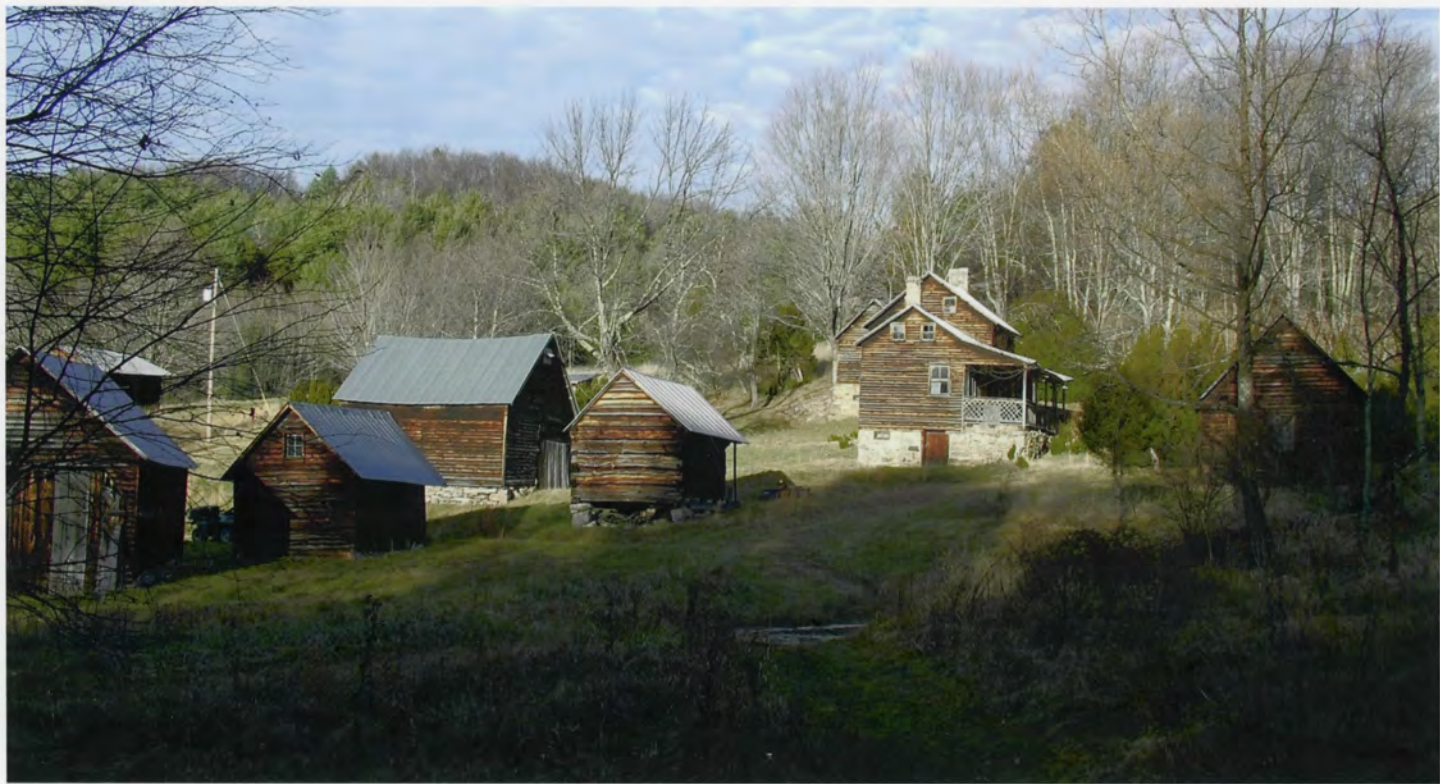
Pitsenbarger Farm
Pendleton Co., WV
Photo 1 of 20

The original section of the house, constructed in 1845, includes the two-and-one-half story section on the north end, which is slightly wider than the later one-and-one-half story c.1900 addition. The house rests on a foundation of coursed rubble stone and is clad in weatherboard siding. It has a gable roof of standing-seam metal. This original section is constructed of large hand-hewn logs measuring 10" to 11" wide.

The main (east) elevation of the original section has a centered door and a six-over-six, double-hung sash window to each side. Centered above the windows on the second story are two smaller, four-over-four, double-hung sash windows. There are two doors and one, six-over-six, double-hung sash window on this elevation of the addition. A shed-roof porch extends the length of the house.

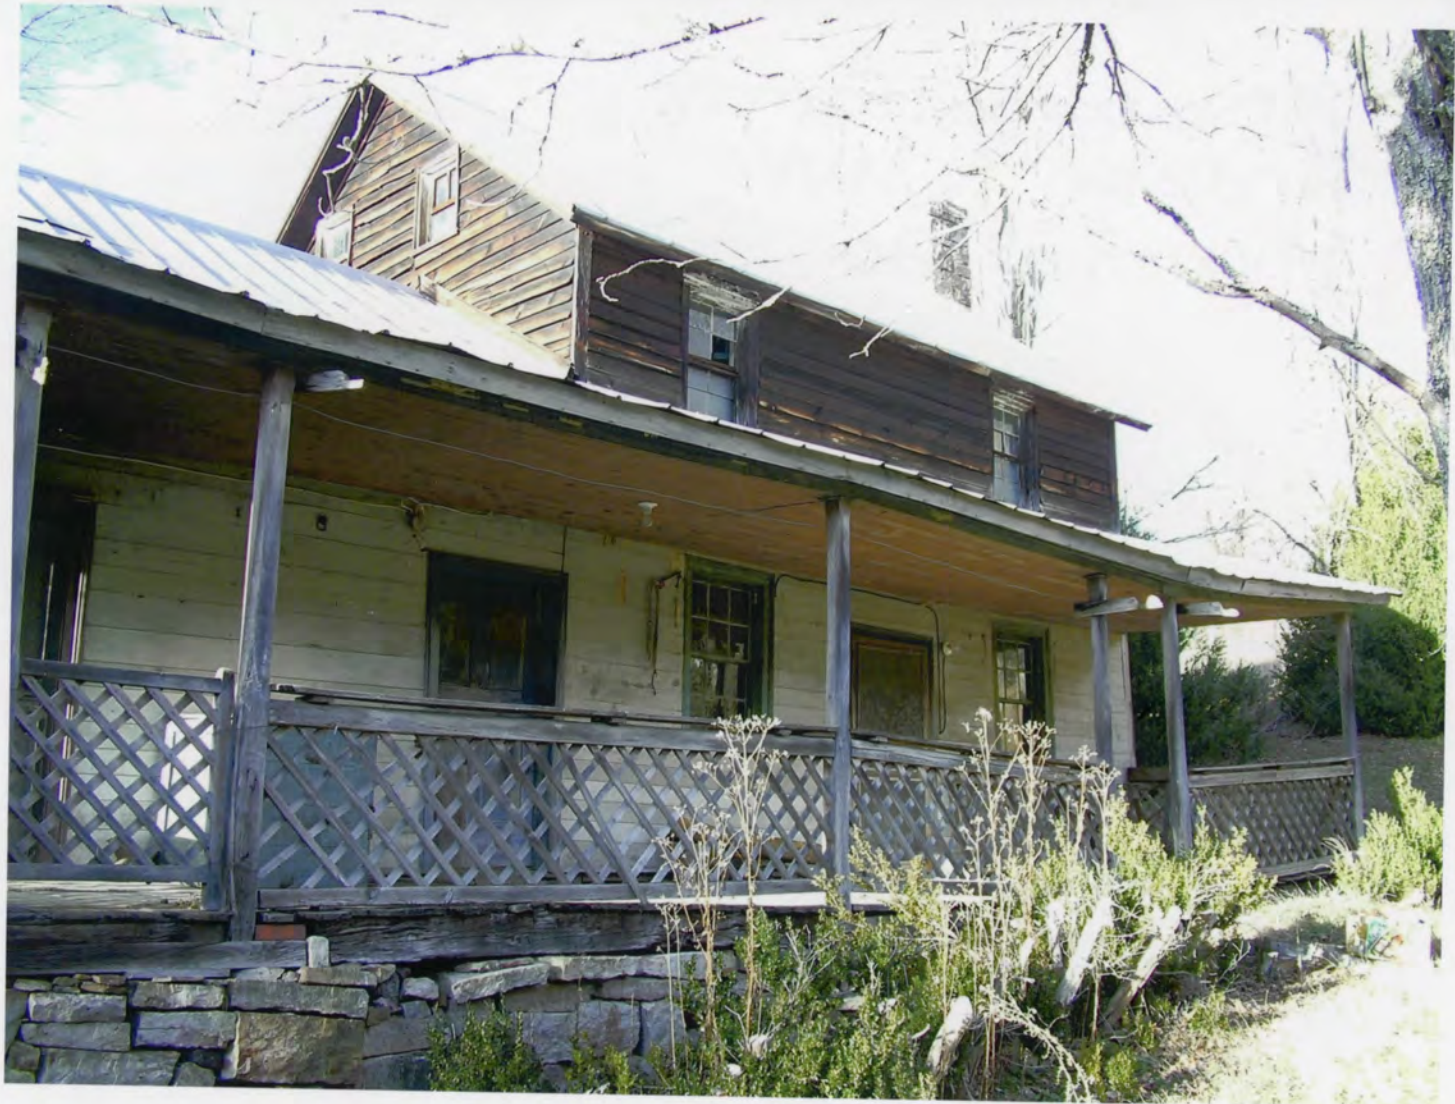
Pitsenbarger Farm
Pendleton Co., WV
Photo 3 of 20

The architecture is locally significant as an intact collection of Pendleton County farm buildings. The original section (photos 3, 5-6) of the farmhouse was constructed in 1845 during a period of extensive construction and prosperity associated with the general economic and agricultural conditions of the South Branch Valley just before the Civil War. It stood as a modest house with exposed logs for more than half a century until it was added on to (photo 4) and sided c.1900 by Ananias Pitsenbarger. Like many other farms of the South Branch Valley, the original settlement period home (Amick's house) no longer exists and the later house was added on to in order to meet the needs of the family. Ananias constructed several of the outbuildings and added to the house during the second period of major construction in the South Branch Valley.

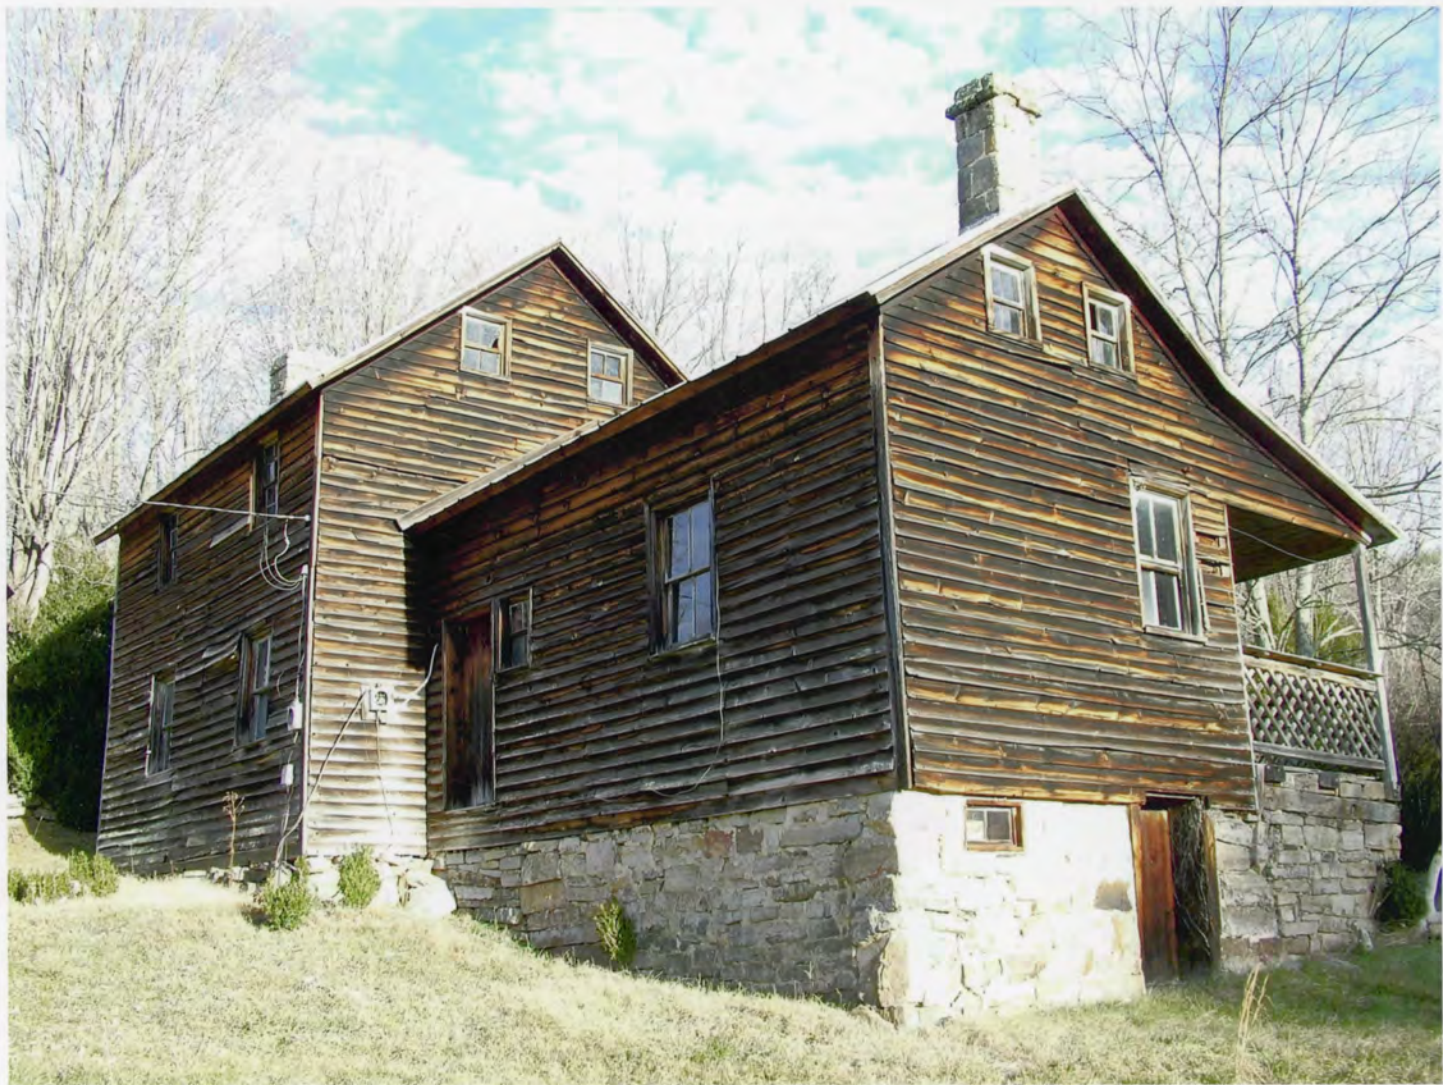
Pit\$enbarger Farm
Pendleton Co., WV
Photo 4 of 20

The rear (west) façade of the original section includes four windows similar to those on the main elevation. This façade of the addition includes a door with a small adjacent window and a two-over-two, double-hung sash window. The north elevation of the house has a squared and coursed rubble stone, exterior chimney. There are no windows on this elevation. The south elevation, within the c.1900 section of the house, has an interior stone chimney. There are two small, double-hung sash windows in the gable end of the addition as well as the south gable of the original section of the house.

Since the house was built on a small hillside, the c.1900 addition has an exposed basement level. It includes a door and a small fixed window.

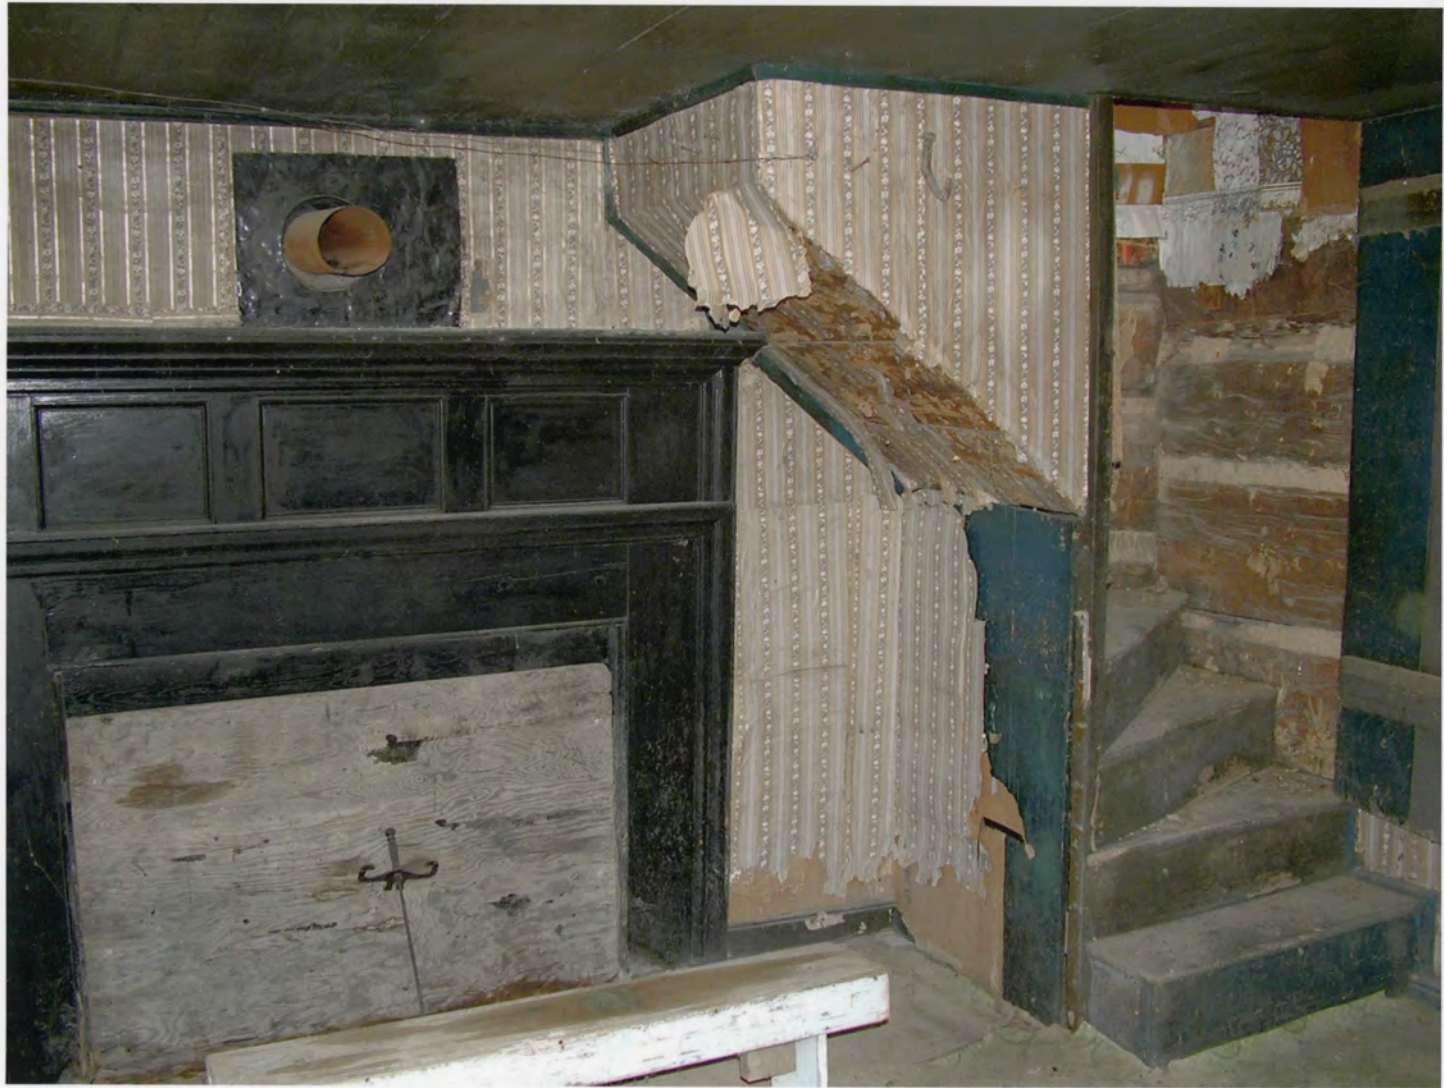
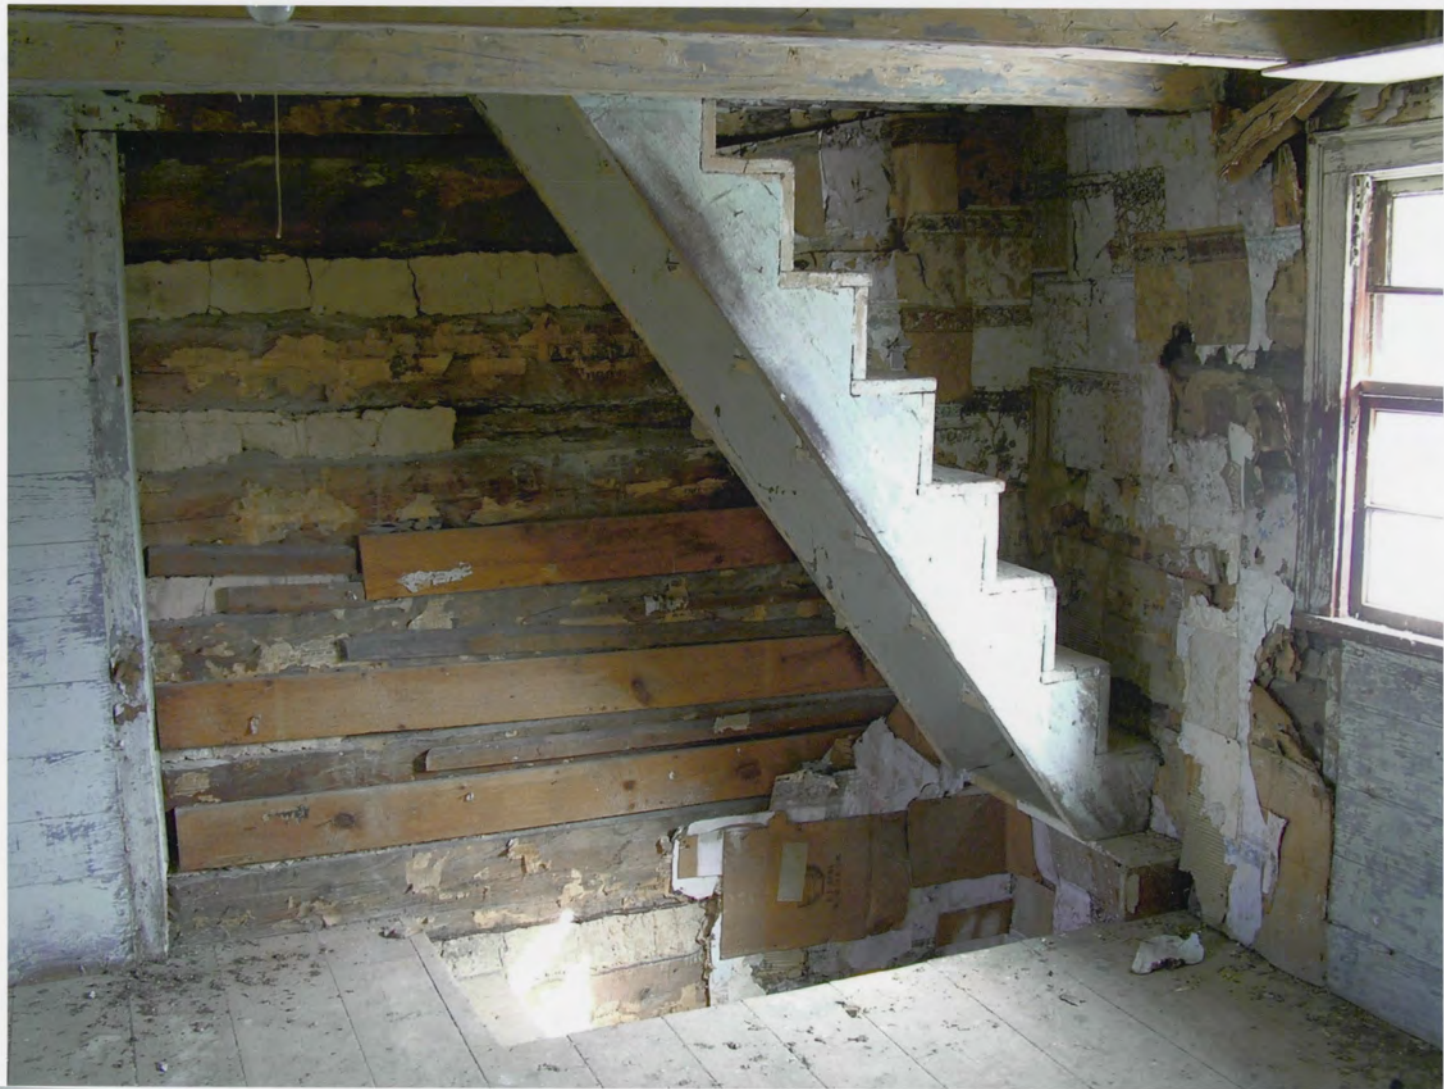
Pitsenbarger Farm
Pendleton Co., WV
Photo 5 of 20

The north end of the house (constructed in 1845) includes two rooms on the first floor, a stone fireplace on the north wall. The living room is 16' x 13' and the adjacent room is 16' x 8'. The partition wall between these rooms is not insulated and has no supporting studs. There is no door or pass through to the addition. From the living room, a staircase leads to the second floor which includes two rooms in the same configuration as the first. Another narrower staircase leads to the attic space at the attic level. The log construction is visible on the staircases. The attic level has wide-planked flooring and was never finished space. The attic reveals the roofing system of 5" round logs numbered with simple slash marks in order from one to nine.

staircase leading to the attic space. The kitchen includes a fireplace with adjacent built-in, floor-to-ceiling wall cupboard on one side and a wood stove with matching cabinet topped with a sink under the window to the opposite side.

The interior wood walls of the house were painted or whitewashed, and also covered with layers of newspapers and magazines for insulation. Layers of linoleum cover the wooden floors. The floors appear to be original planks underneath later coverings. The ceilings are wooden planks, as are the interior doors. There is old trim molding in the main rooms at the floor and ceiling. There are wooden shelves built inside the cellar, and a wooden cider barrel remains. The floor of the cellar was made from wooden planks.

With regard to alterations, the original roof was replaced with standing seam metal, likely in the mid-twentieth century. The original roof material is unknown, though wood shakes/shingles were common to the area and existed on many of the outbuildings. Electrical service with a minimal number of outlets and light sockets was run into the house in the mid-twentieth century and updated in the 1990s. A plumbing pipe which runs from the spring to the sink in the kitchen at the southeast corner was replaced c.1990. Water no longer runs to the sink. A wood stove is in the kitchen, age not known. An oil heater was added in the northern section of the house in 1972 at the fireplace opening.³ The heater was removed a few years later when the personal effects of the last son, Gilbert, were auctioned off. The fireplace was blocked off and is not operational. The surround to the stair in the pantry has been replaced, likely in the 1990s.

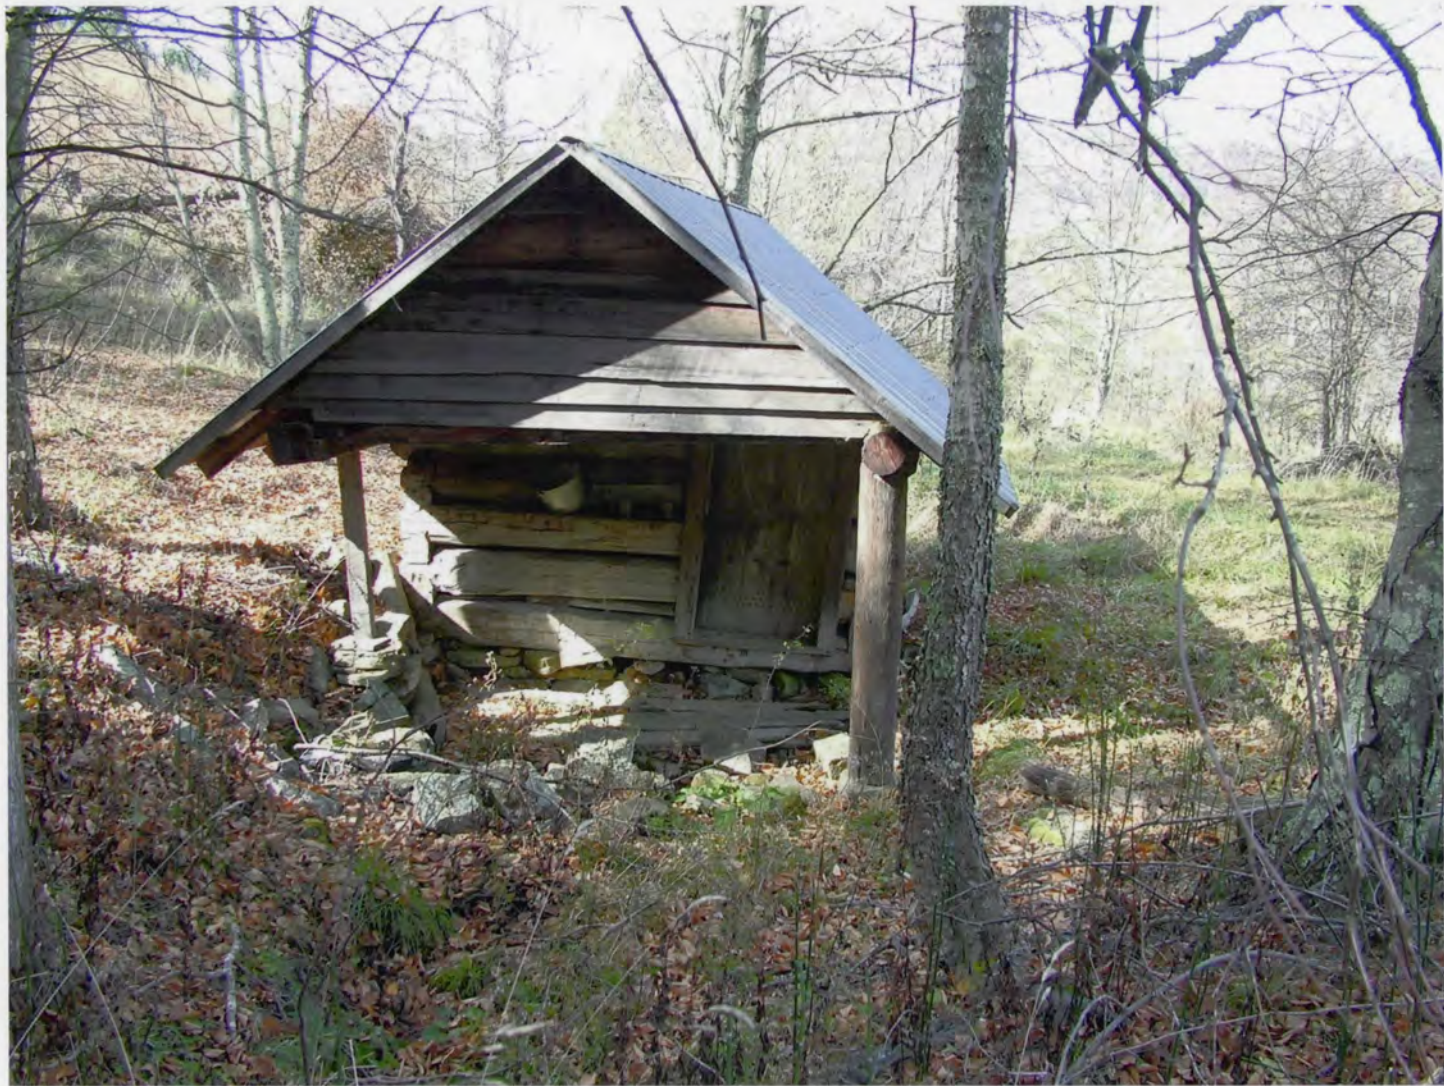
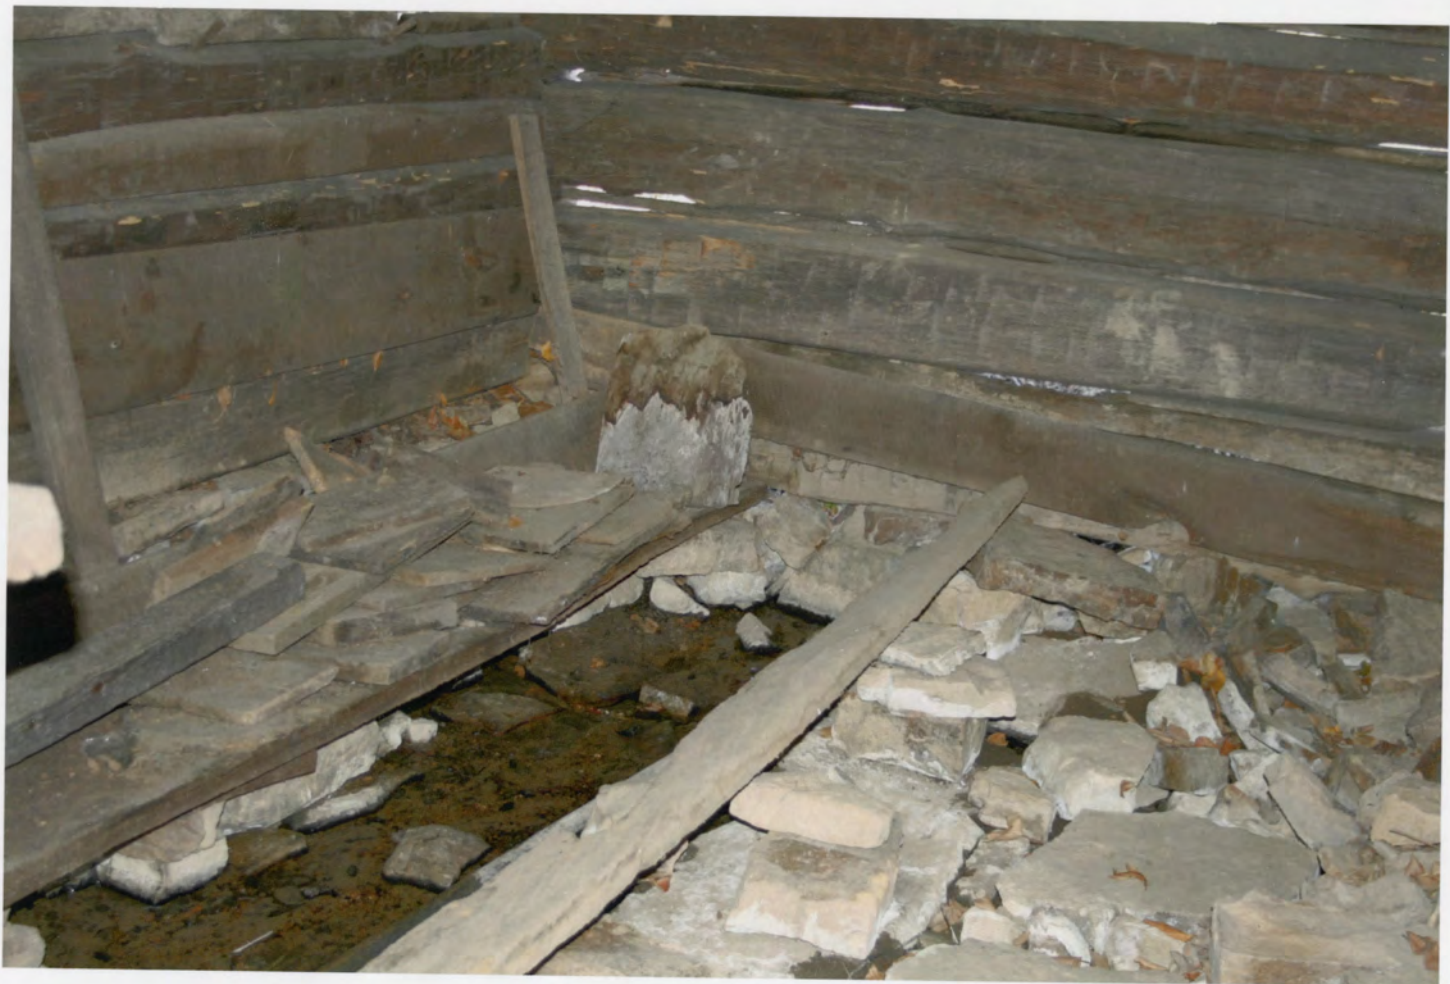
Pitsenbarger Farm
Pendleton Co., WV
Photo 7 of 20

The spring house is made of squared-off logs set on local stones. It has a low-pitched gable roofline with exposed rafters and standing seam metal roof added c.1990. The previous roof was of wooden shakes. A wood door on the east elevation faces the head of the spring. Spring water runs through the building and there are still large stones and some wood shelving inside where food would have been stored. Concrete cisterns capture the water which used to run to the old house and still runs to the newer log cabin used by the current owners. The spring house is near the house to the south. The base of the building is 11'4" x 9'10" and the roof overhangs the east side approximately 9', creating a porch. The roof overhang on the north and south sides is about 2' deep.

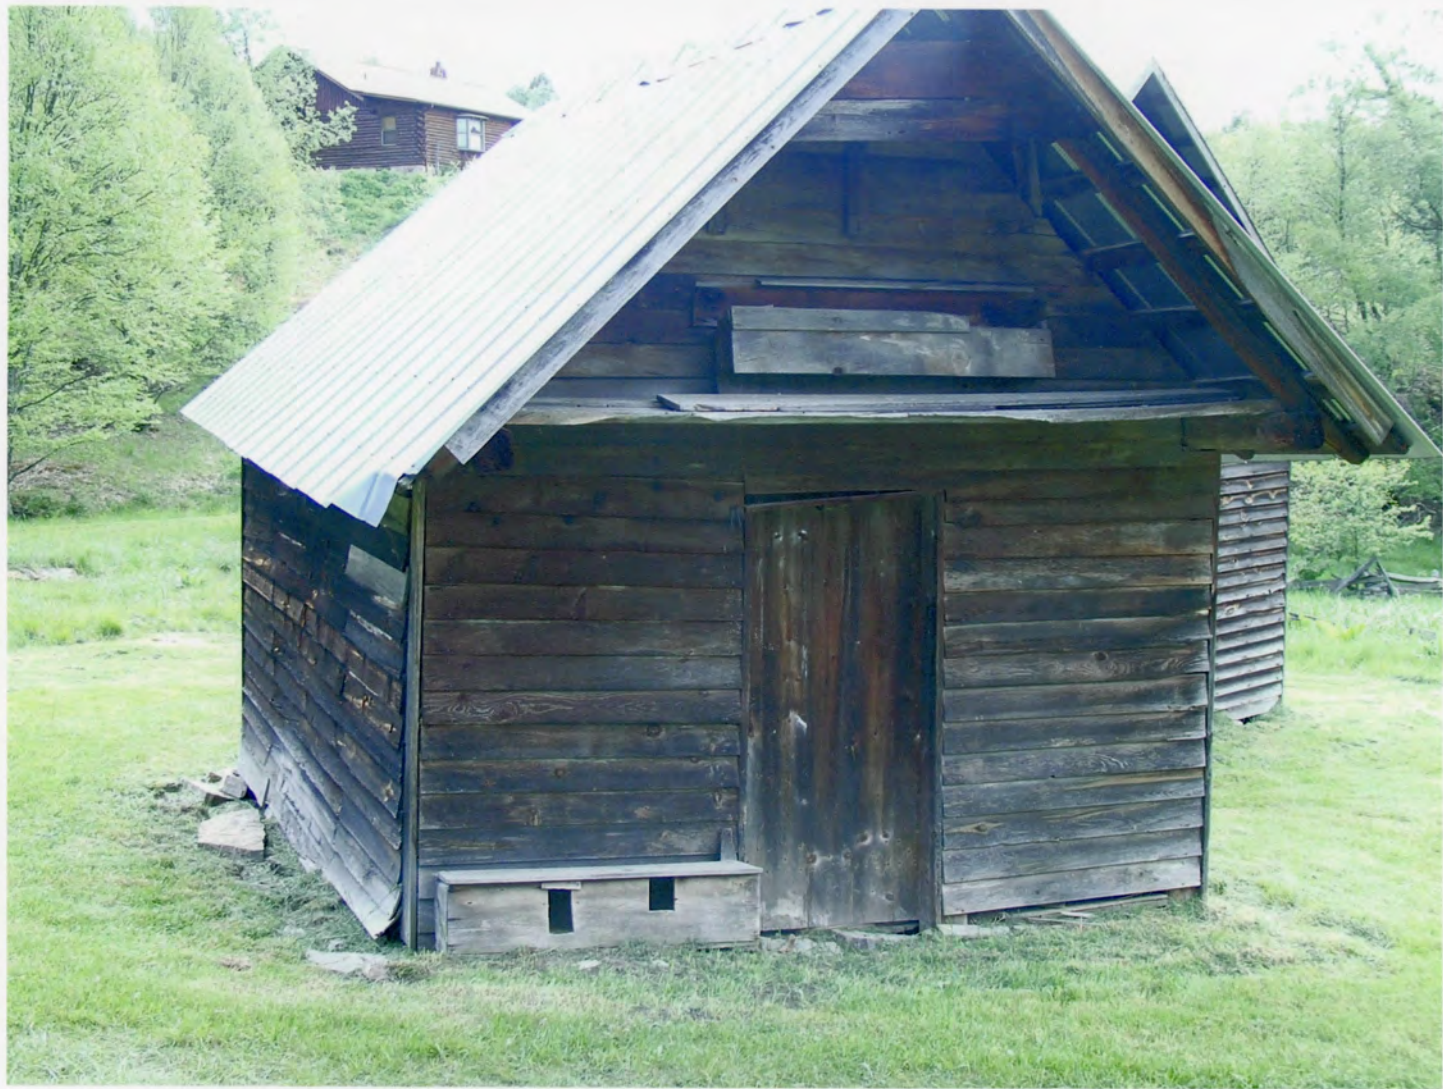
Pitsenbarger Farm
Pendleton Co., WV
Photo 9 of 20

This building is an 11'4" x 14'2" log and beam framed (mortise and tenon) structure resting on large stones, covered with weatherboard. It is rectangular in shape and has a gable roof (standing seam metal) with overhang. The door, constructed of wood planks, is on the north elevation and a small window is on the south elevation within the gable. There are two roosting boxes on the exterior of the building, one above the door and one to the left of the door, and several inside. Slanted boards lead down from the sides under the roosting boxes to funnel chicken manure into a moveable wooden box. A mule or horse-drawn sledge was used to remove this box and carry it to a field in need of fertilizer.

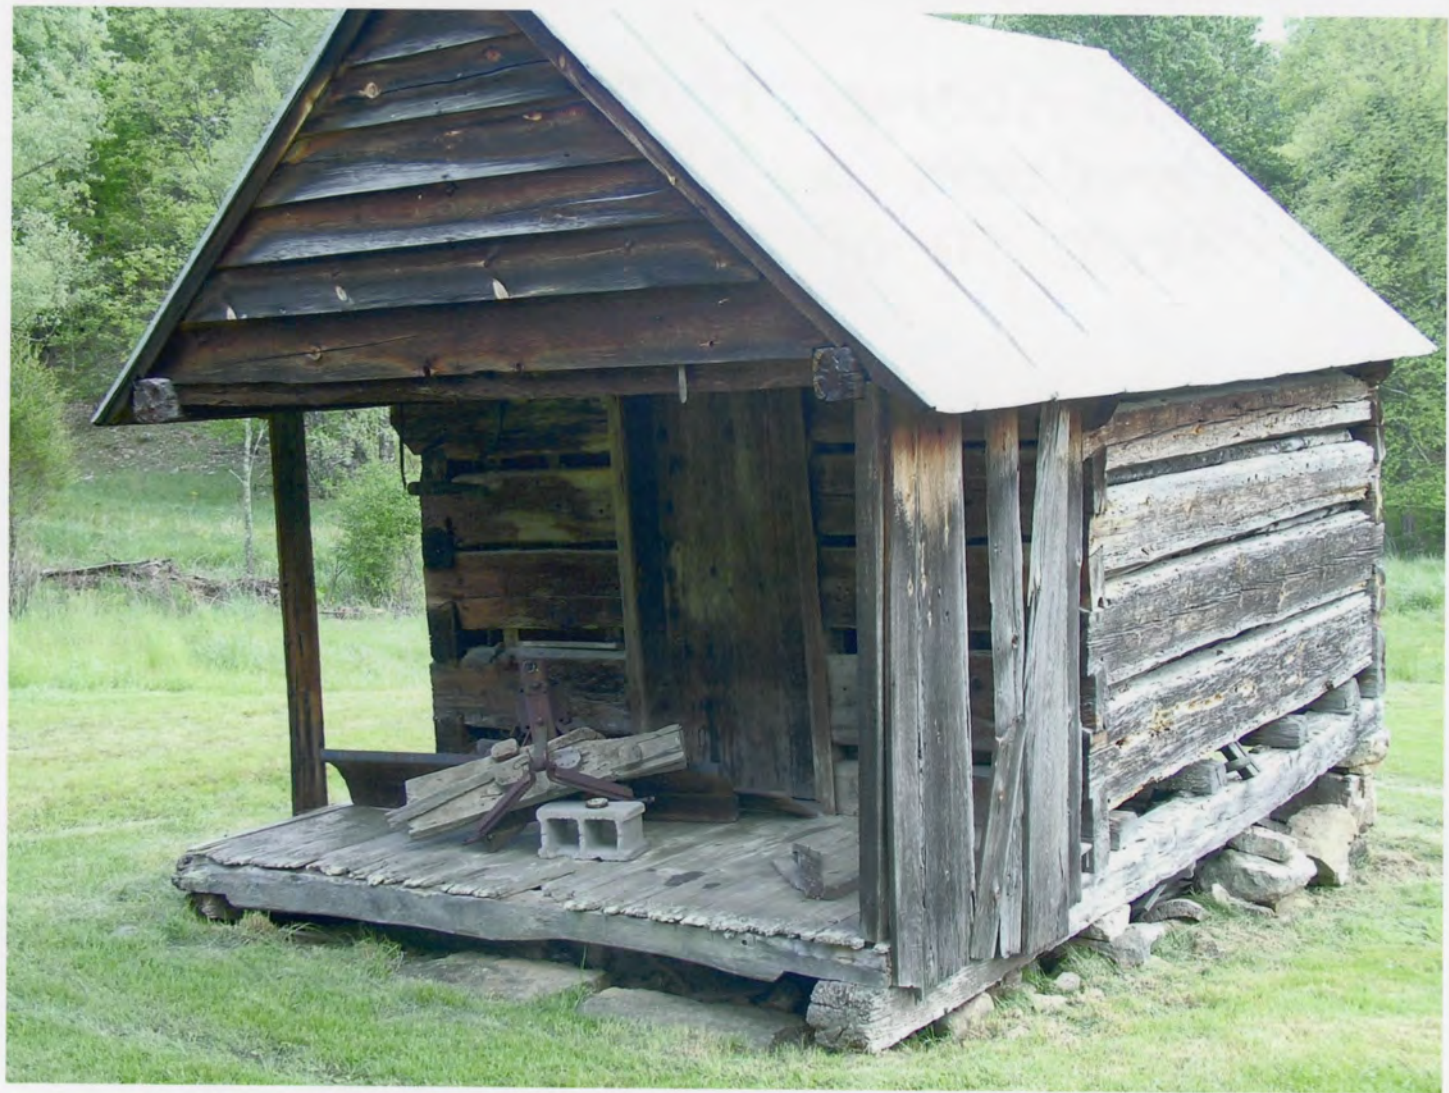
Pitsenbarger Farm
Pendleton Co., WV
Photo 10 of 20

The granary is 13'4" x 11' and was made of massive 12-16" squared-off logs set on large stones. It has a standing seam metal (replacement), gable roof. The logs are joined with a half-dovetail notch method. There are waist-high wooden bins inside on either side of a central walkway. The floor is wood, with very tight floor joints. There are no windows. The door is on the north elevation and is constructed of wood planks with iron hardware. This building has a deep roof overhang of 5'3", creating a recessed porch on the north facade.

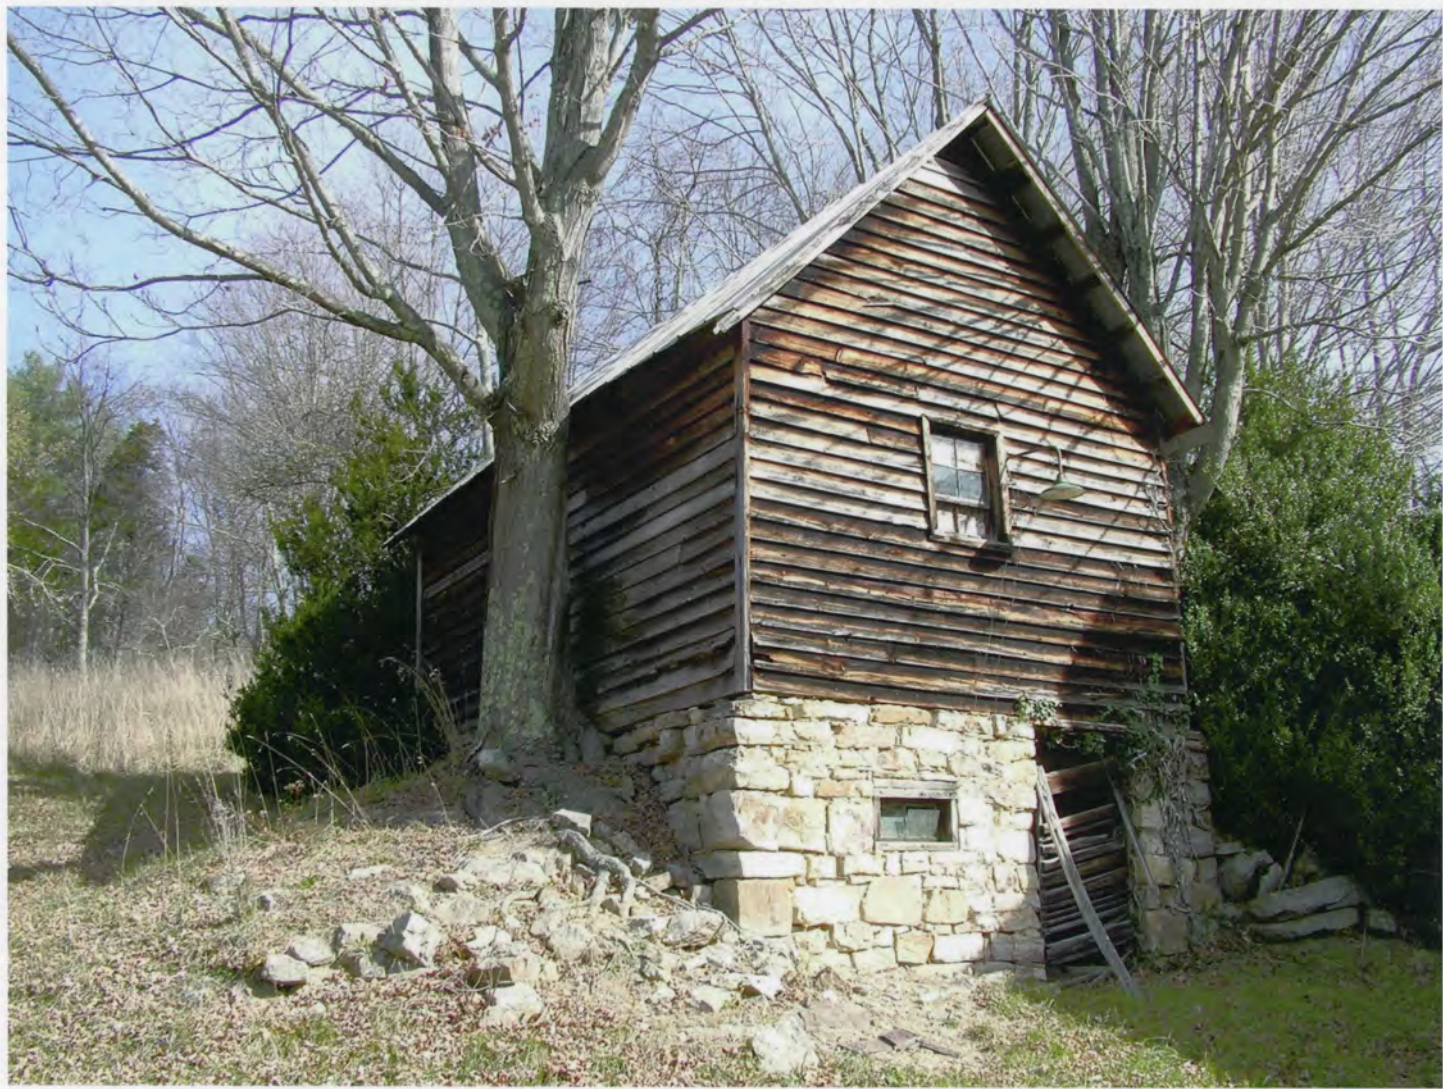
Pitsenbarger Farm
Pendleton Co., WV
Photo 11 of 20

The cellar house, built into a hillside, is a rectangular building with gable roof and exposed stone foundation on the south elevation. It measures approximately 17'6" x 12' 5". This building is post and beam construction, covered with clapboards. The exposed, full-level foundation includes a door opening and window. A small, double-hung sash window is centered above. The remains of wooden bins and a cider barrel remain inside. A door on the east elevation leads to the upper level, likely the kitchen. A square opening on the north elevation leads to the loft area and is reached by a wood ladder.

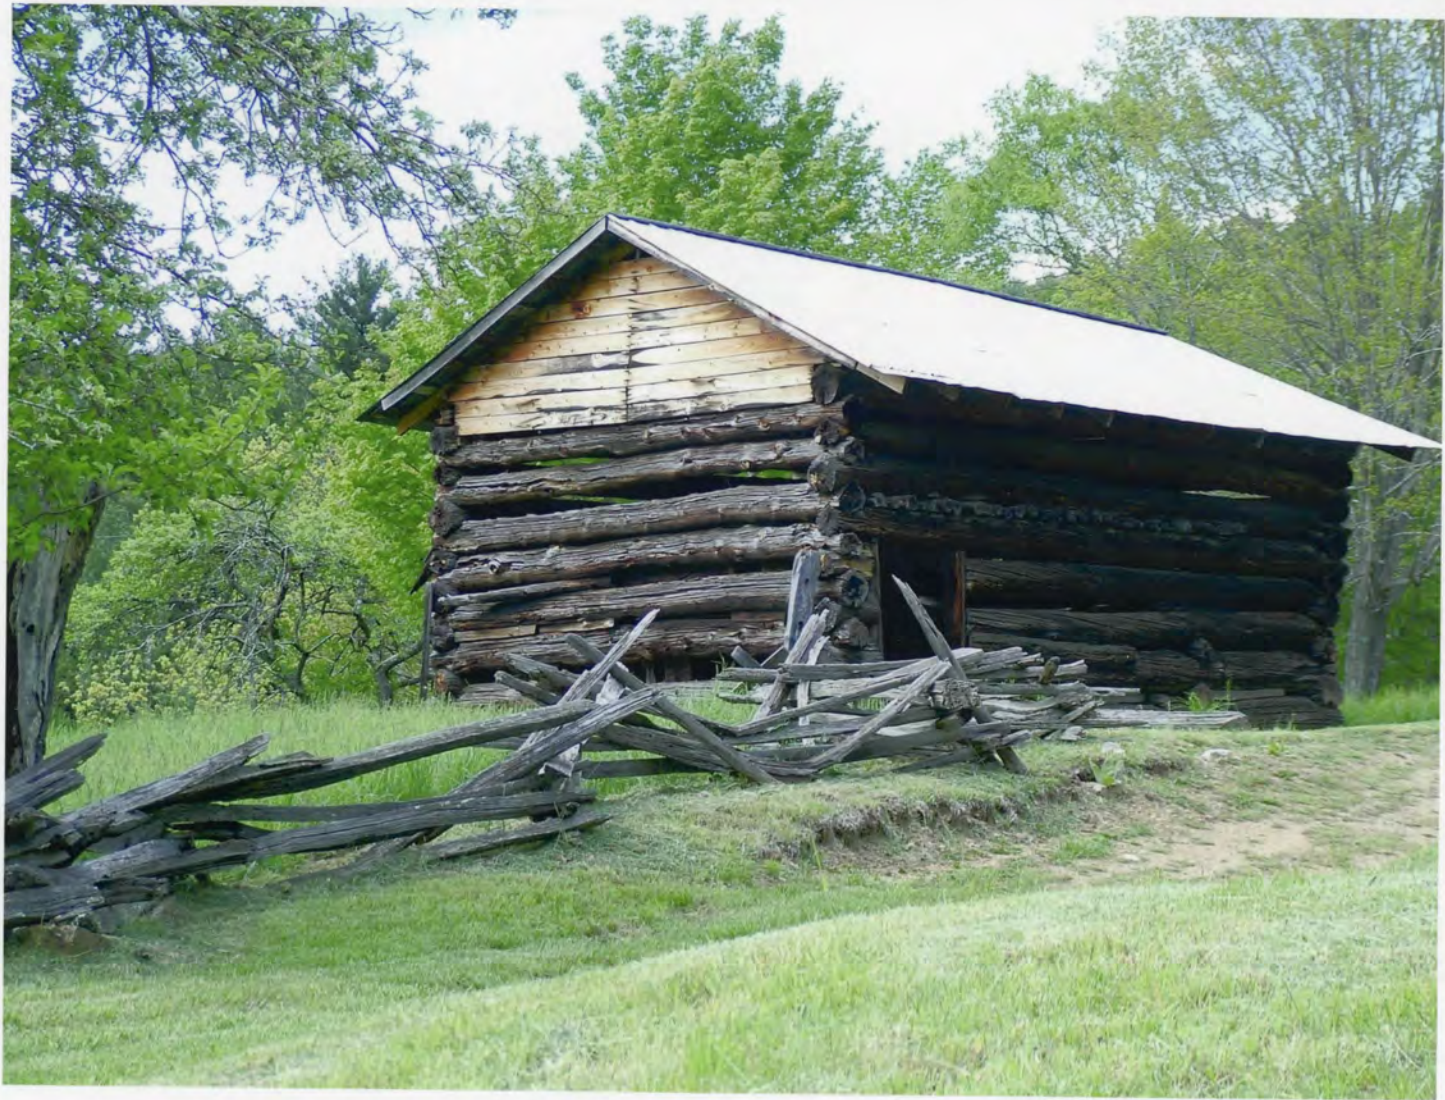
Pitsenbarger Farm
Pendleton Co., WV
Photo 12 of 20

The stable is a round-log, rectangular building, approximately 18' x 21', set on local stones with doors on the north and east elevations. The notching is saddle V-shape. There are two stalls, or cribs, inside. A floor for the hayloft above is made of round wooden poles installed during construction. The building includes two doors; one on the east and one on the north façade with the door on the east for animals. Of note are the original wooden hinged doors. Some of the wooden hinges remain today. The gable roof is now standing seam metal with exposed rafters, constructed c.1990. The weatherboards in the gable end replaced the original boards c.1985.

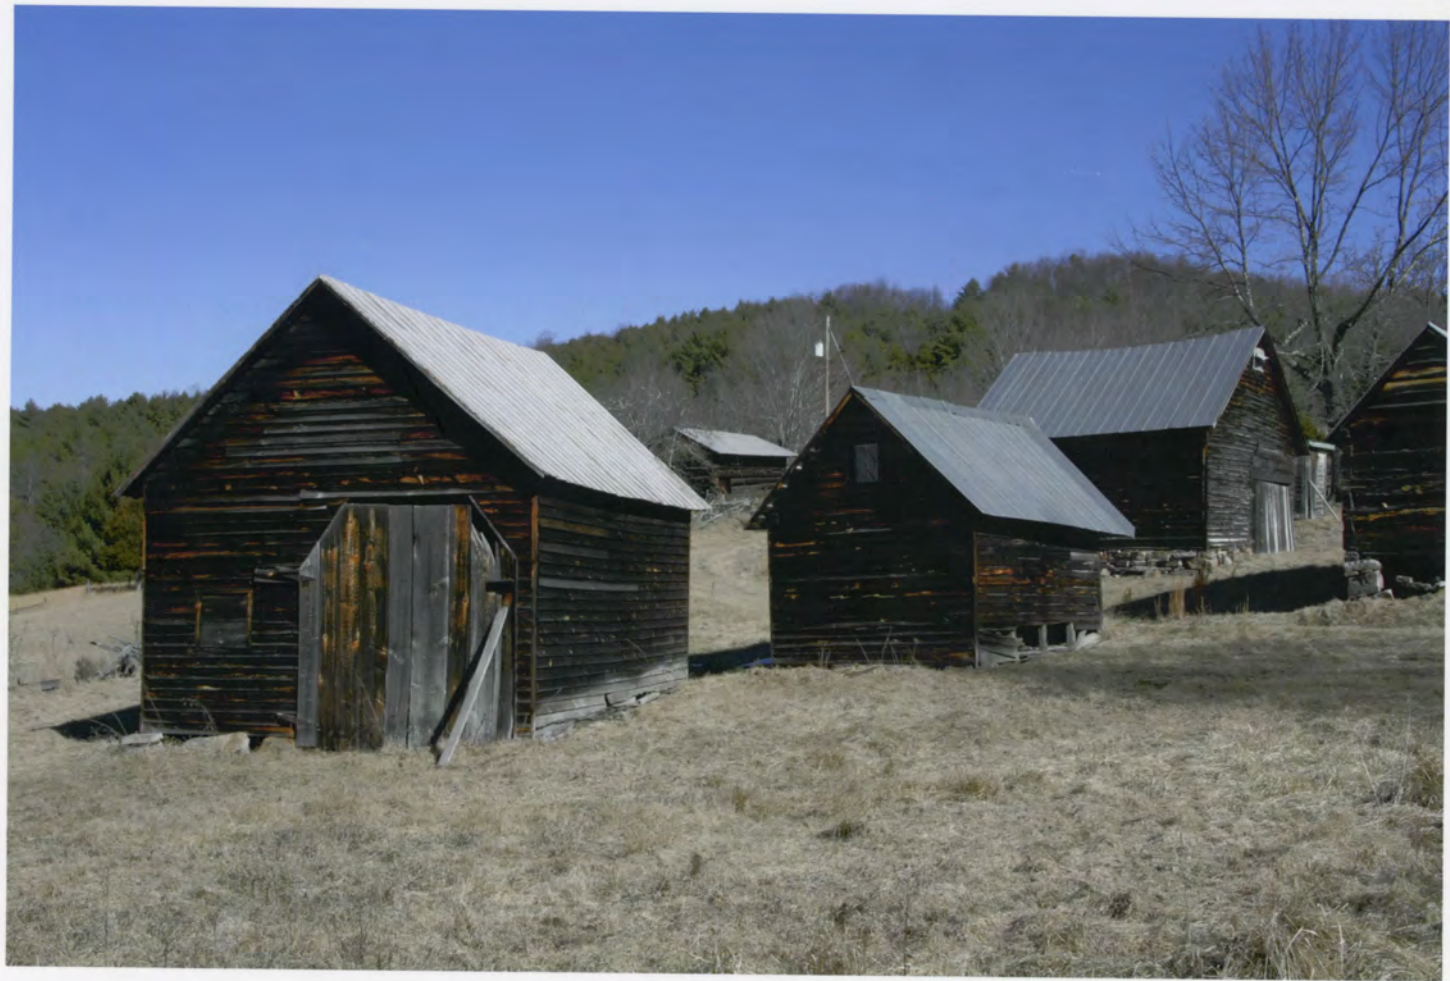
Pitsenbarger Farm
Pendleton Co., WV
Photo 13 of 20

This building is made of post and beam framing set on large stones, with weatherboard siding. It has pass-through doors large enough for a carriage or wagon, and a side area on the west side with work shop. There is one window on the south side and a tin roof. The building is 20'4" x 16'3" and sits adjacent to and just southwest of the house.
