National Register of Historic Places
Registration Form

historic name Pitsenbarger, Ananias, Farm

state West Virginia code WV county Pendleton Code 071 zip code 26807

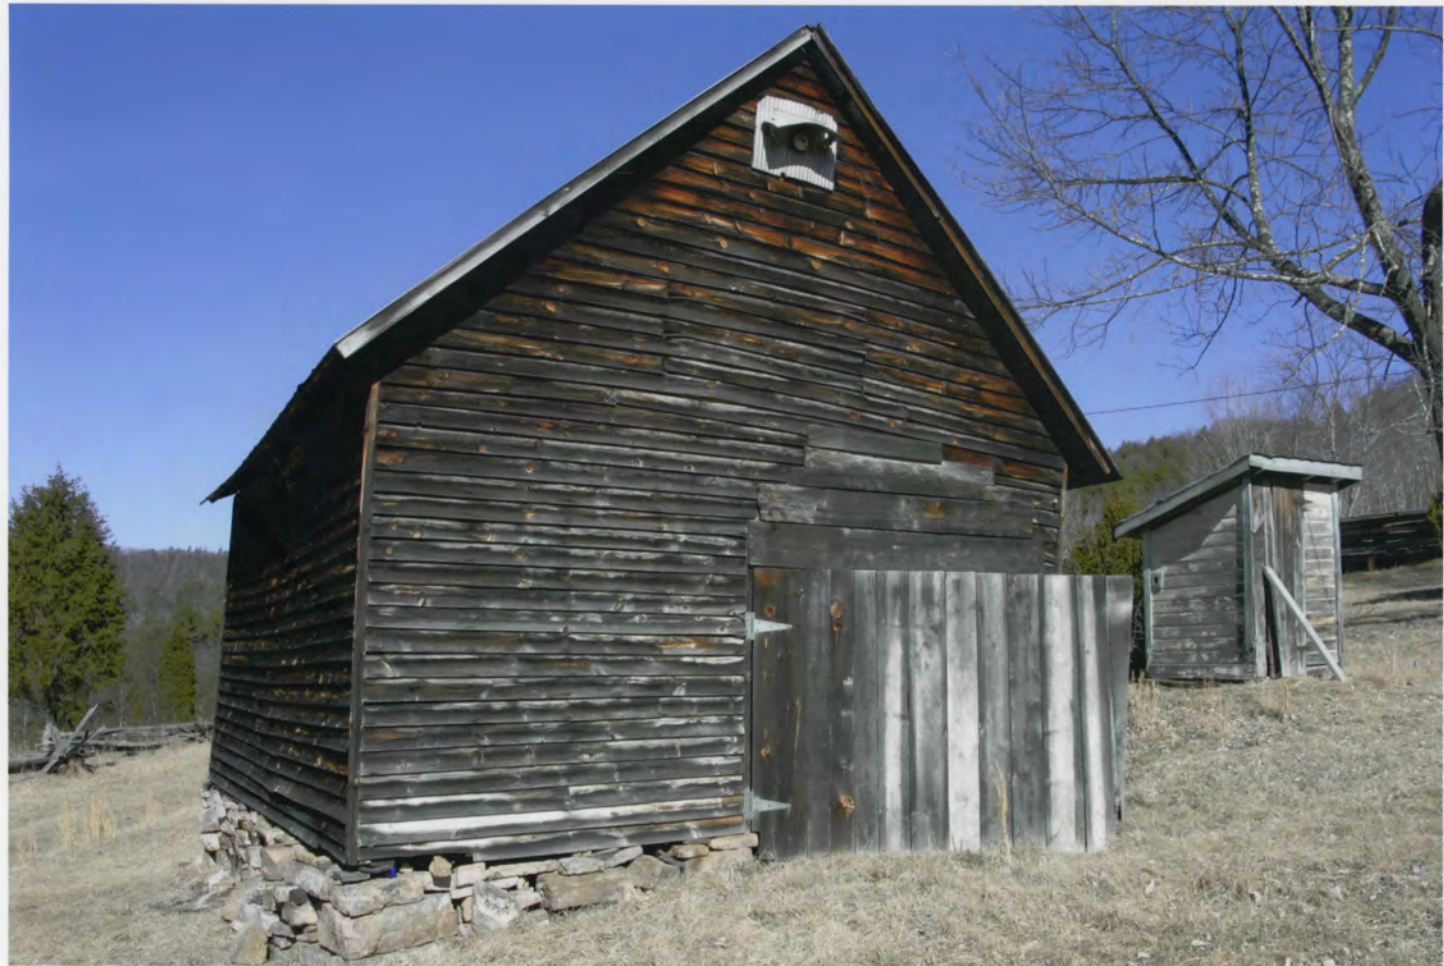
Pitsenbarger Farm
Pendleton Co., WV
Photo 14 of 20

Gable-front building post-and-beam framing set on large stone foundation with weatherboard covering. It has pass through doors large enough for a carriage or wagon and a side area on the south side with a

workshop. The interior includes a long workbench and vise. There is one window and a standing seam metal roof. The roof was made of wooden shakes until the late 1980s or early 1990s. The building is 22'4" x 17'6" and is located just west of the house.

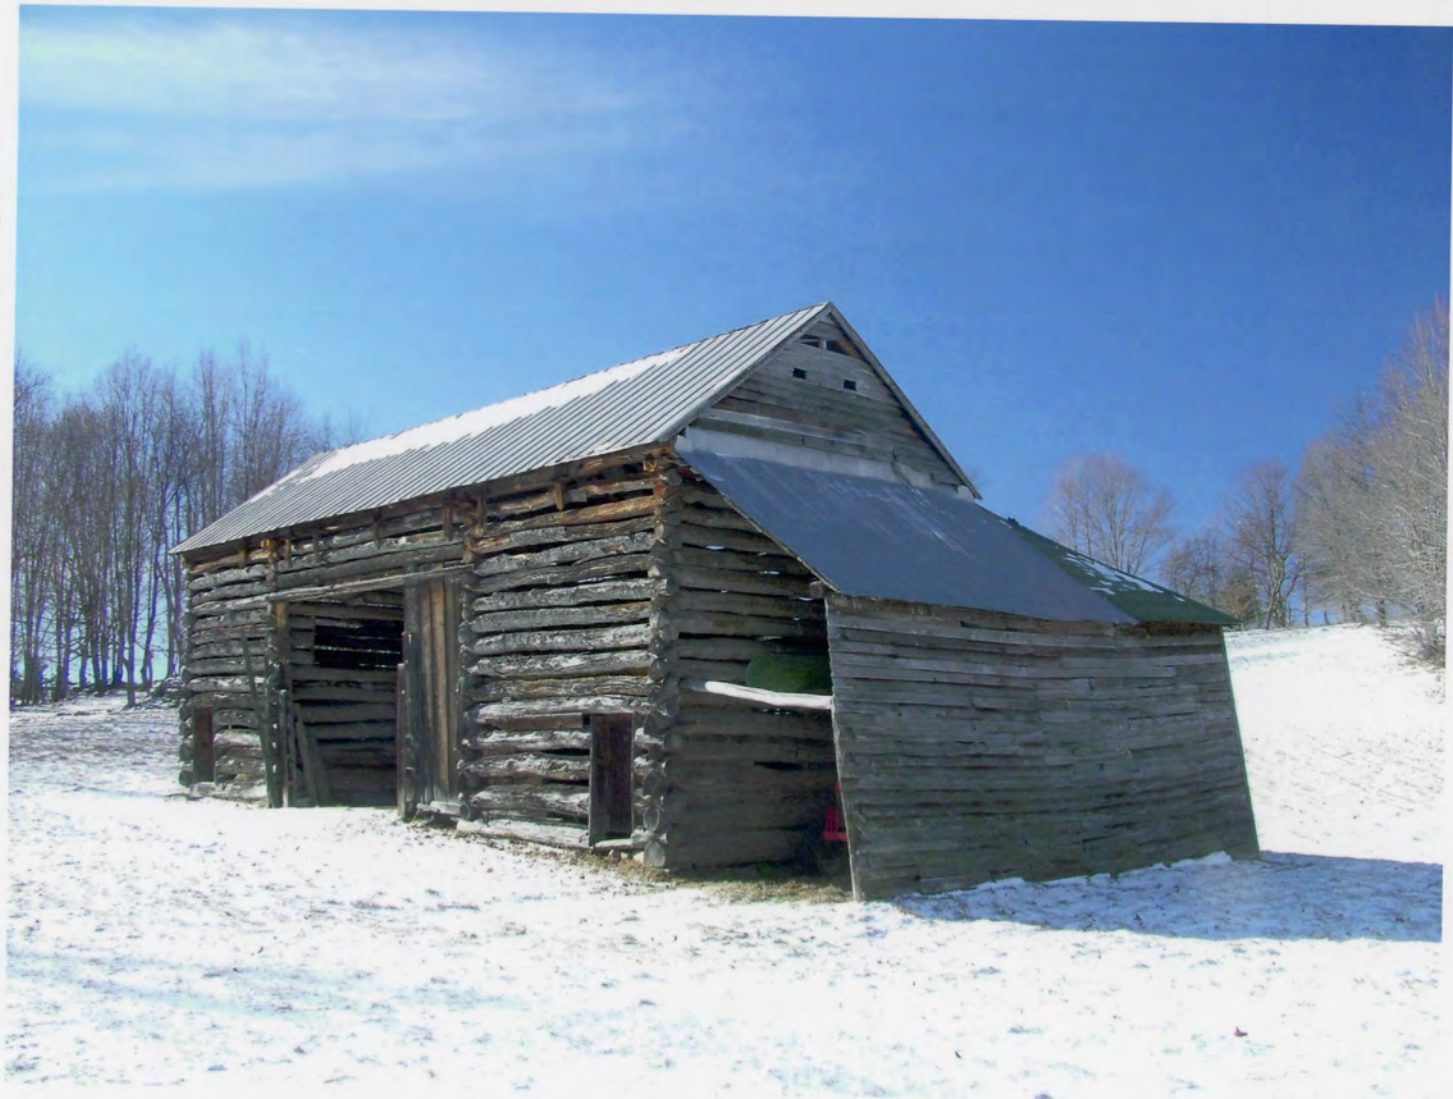
Pitsenbarger Farm
Pendleton Co., WV
Photo 15 of 20

Double-crib log barn with side gable roof and open breezeway and saddle V-notching and logs left round. This 43' x 52', three-bay building used to be open at the center back so hay wagons could drive through after depositing hay in the upper lofts. The door opening on the front (east) elevation is 17' wide. The back (west) elevation is now closed in with wood planks. The north and south elevations of the barn have two levels providing for a hay loft with pole log floors on each end, over a storage area, once likely used for animal shelter. The floor in the center section is made of large wood planks, some wider than 12", placed closely together. There is a door for each of the storage rooms on the east side, each with wooden hinges. The north elevation has a shed-roofed lean-to.

Settlers to the area brought two distinct barn types with them. One of these, the double-crib barn (photo 15), is found on the Pitsenbarger Farm. In general, the double-crib log barn is one-and-one-half stories in height and includes two cribs (log rooms) constructed under one roof. Animals were housed in the cribs and hay was stored in the upper floor, sometimes called "mows." The area between the two cribs was often used as the "threshing floor."²³ The double-crib barn at the Pitsenbarger Farm was likely constructed c.1900.

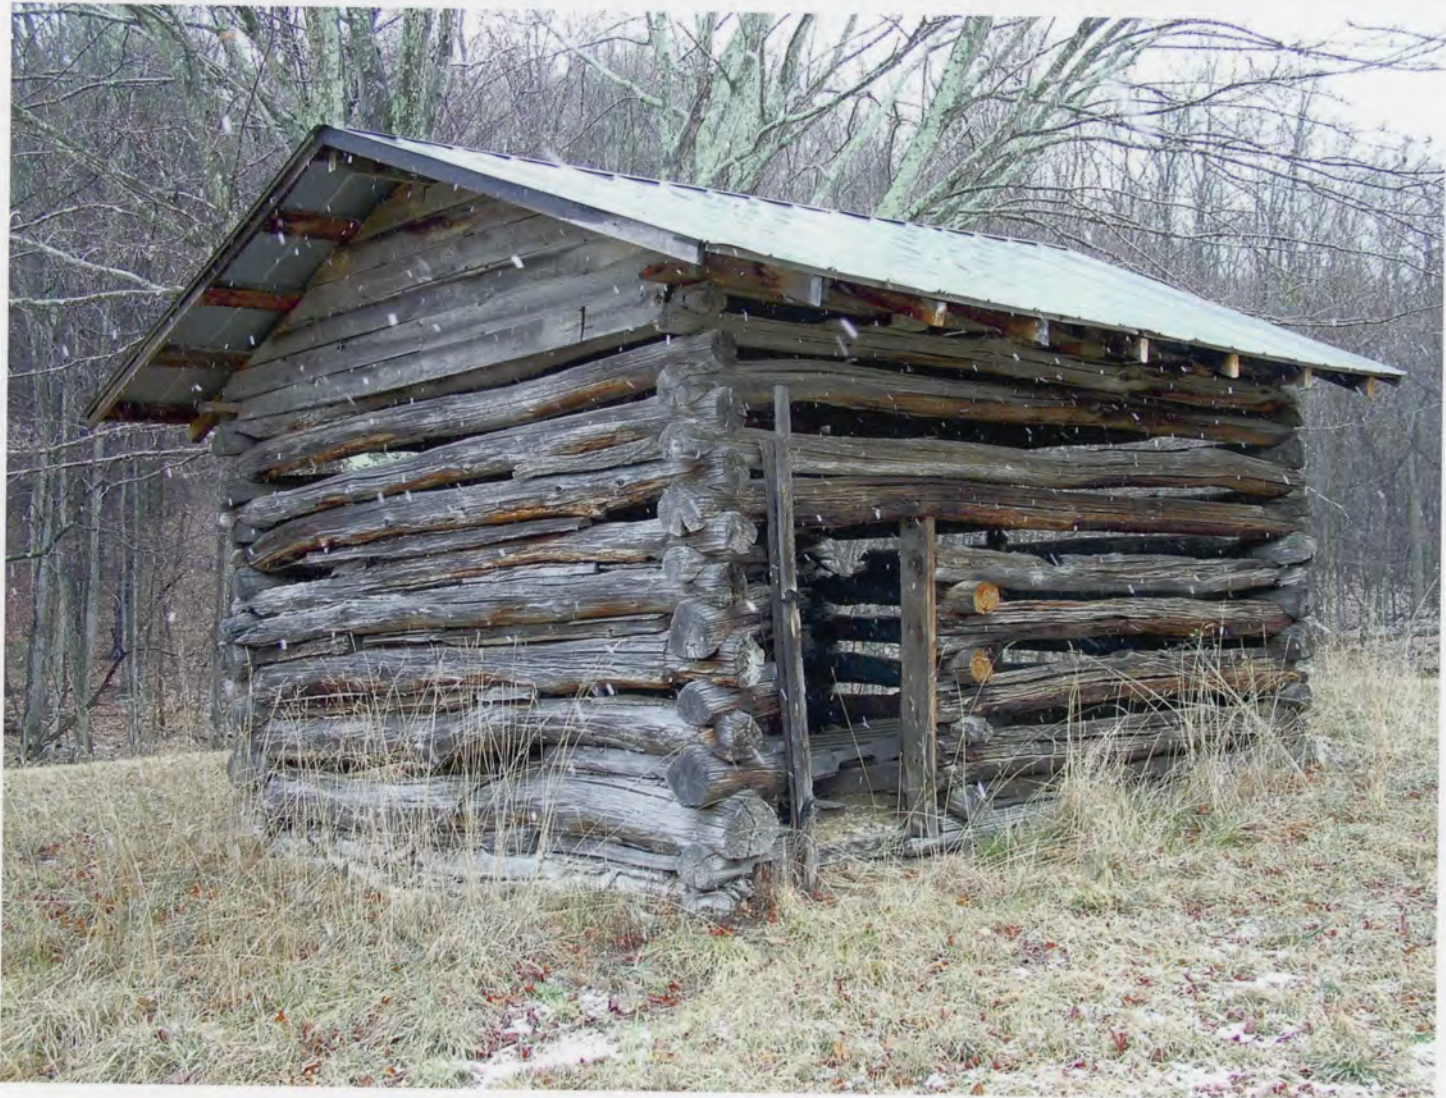
Pitsenbarger Farm
Pendleton Co., WV
Photo 16 of 20

Three of the four hay fields near the house have round-log hay barns which are each approximately 12' x 15'. All have German dovetail joints and two of the three barns have doors with wooden hinges. The roofs were replaced c.1990 with gable, standing-seam metal roofs. At the time the roofs were replaced, the top courses of logs were removed, reducing these to one-story buildings. This does not affect the overall integrity of these buildings. These hay barns were used to store rectangular hay bales until 2008 when larger round bales were made instead. The hay barn in the field next to Henry Amick's grave had a pole press roof well into the 1960s⁴.

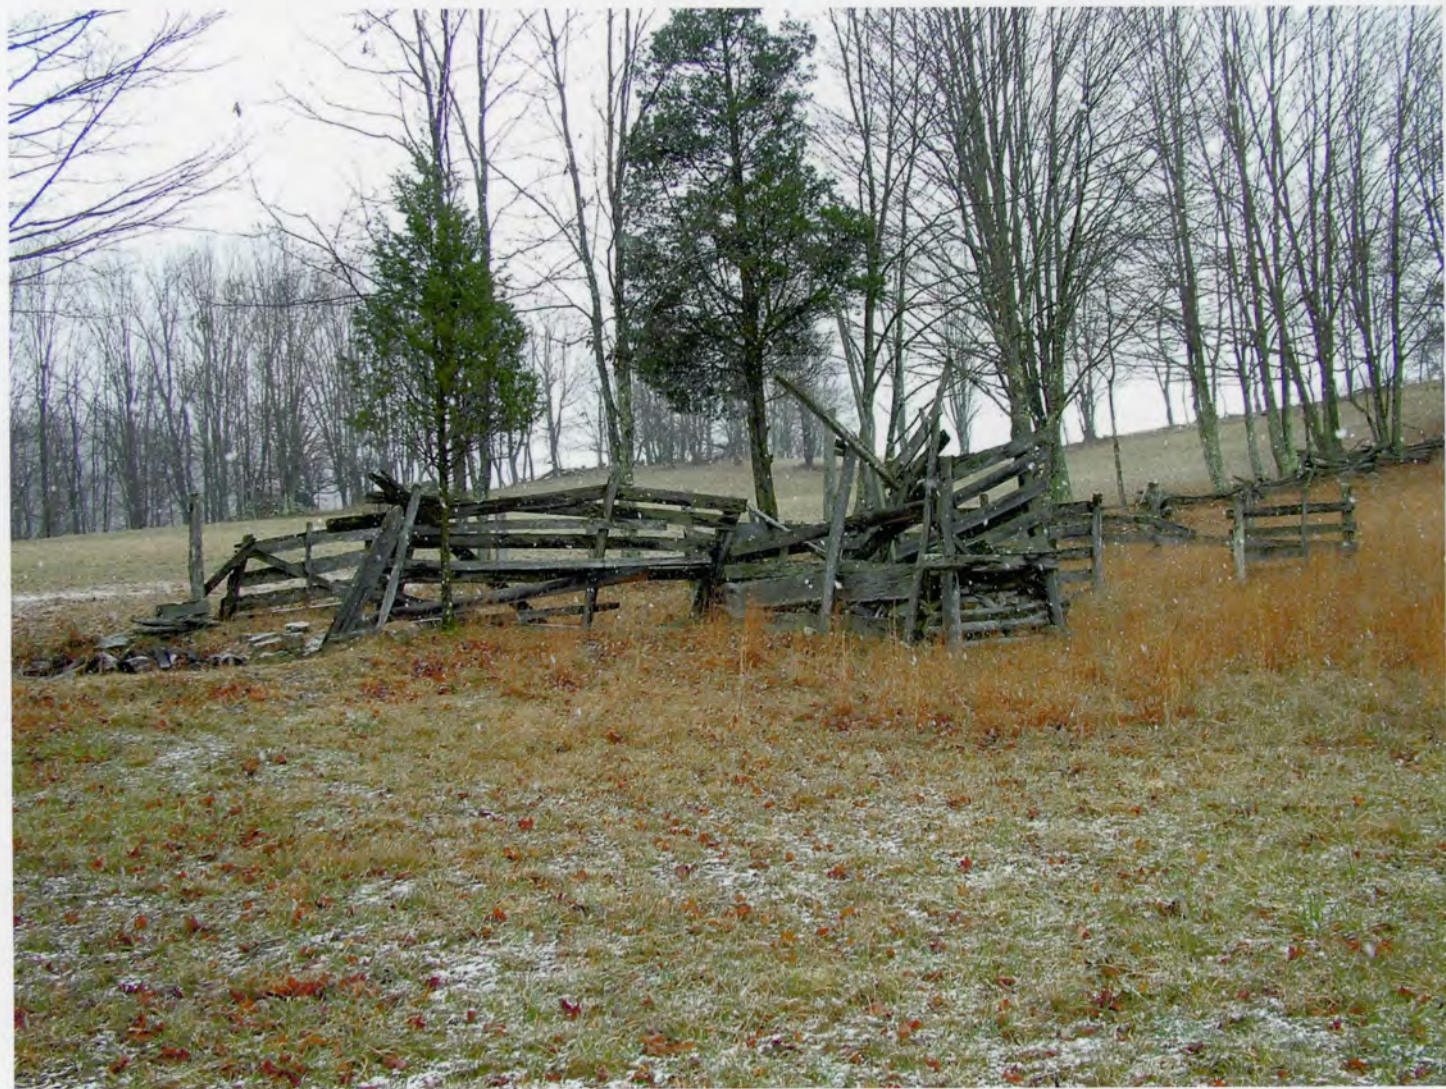
Pitsenbarger Farm
Pendleton Co., WV
Photo 17 of 20

The rock foundation of this building remains. It was situated just north of the large two-crib log hay barn. The wood plank fencing remains next to the foundation showing the holding pen area and the ramp to load cattle into wagons or trucks.

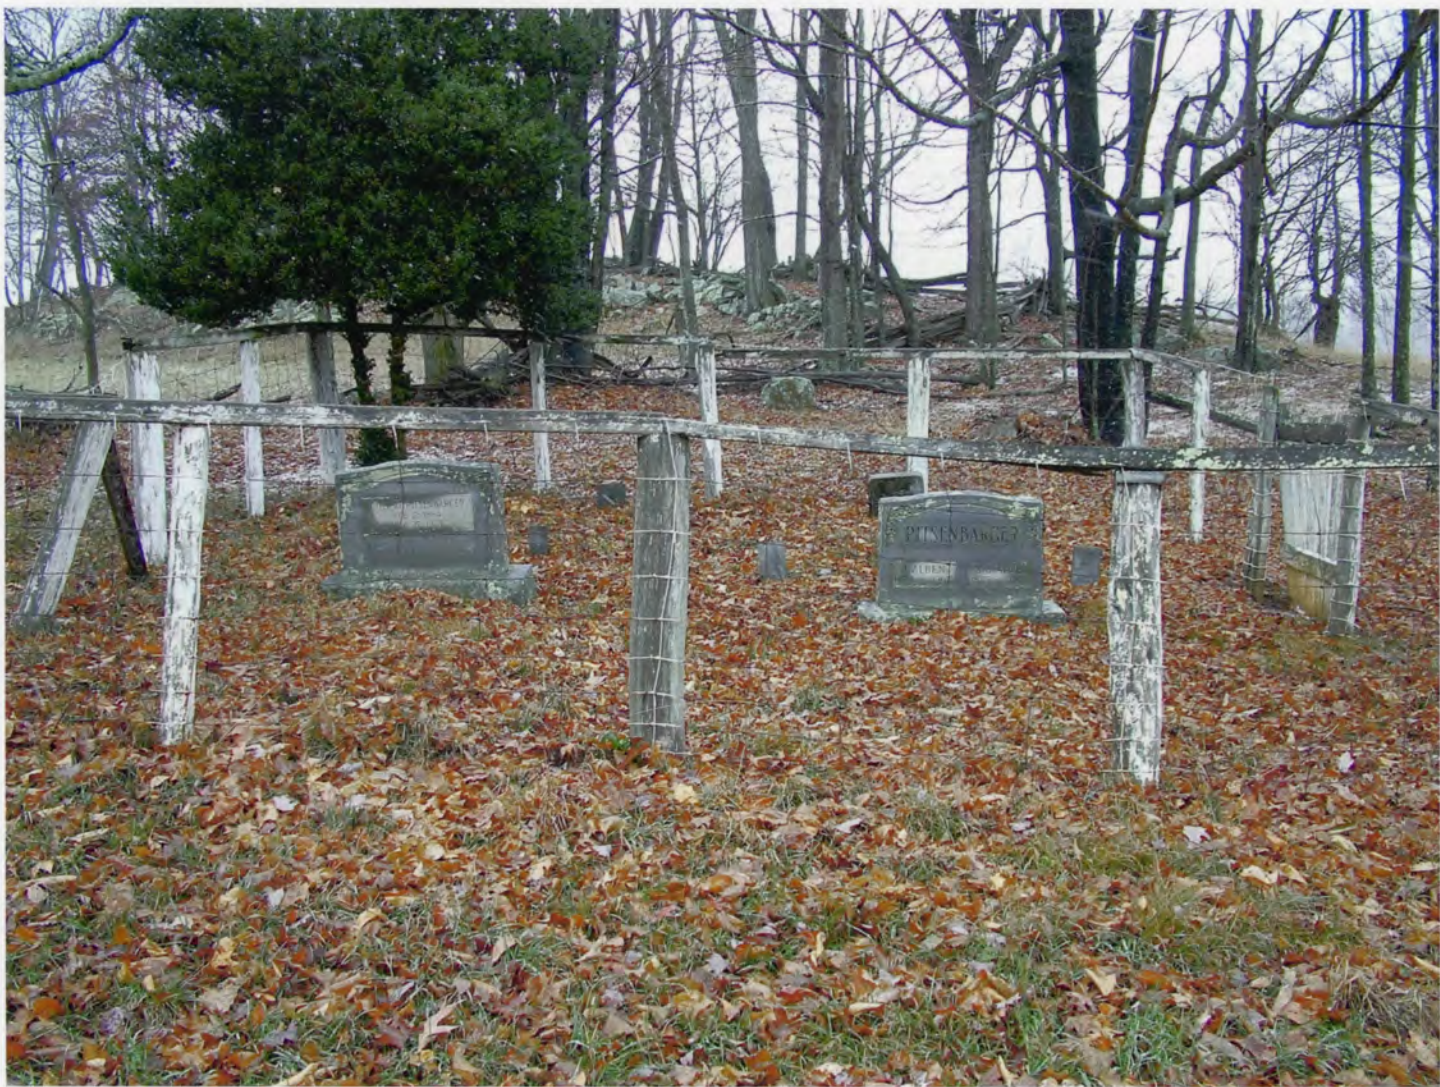
Pitsenbarger Farm
Pendleton Co., WV
Photo 18 of 20

Photo 14 of 20:	Woodworking shop (#8) and WPA privy (#18); camera facing northwest (photo by Aubrey Von Lindern, SHPO, April 2011)
Photo 15 of 20:	Double-crib barn (#9); camera facing southwest (photo by Aubrey Von Lindern, SHPO, April 2011)
Photo 16 of 20:	Hay barn (#13); camera facing northeast
Photo 17 of 20:	Cattle scale ruins (#17); camera facing south
Photo 18 of 20:	Pitsenbarger cemetery (#21); camera facing south

(photo 18)

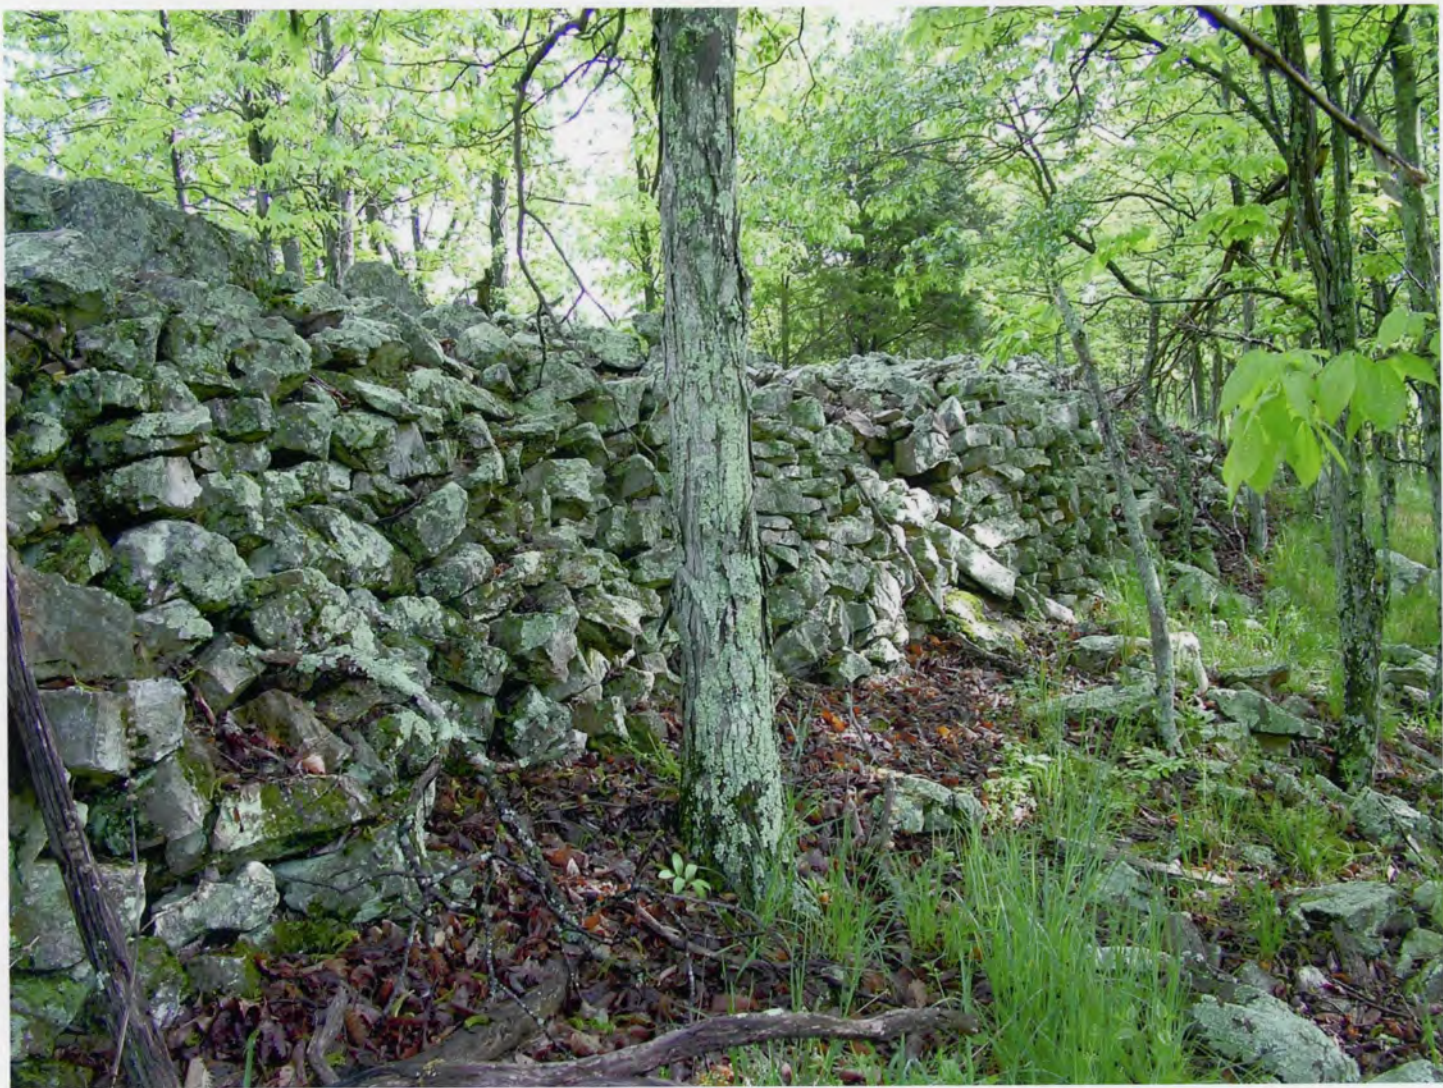
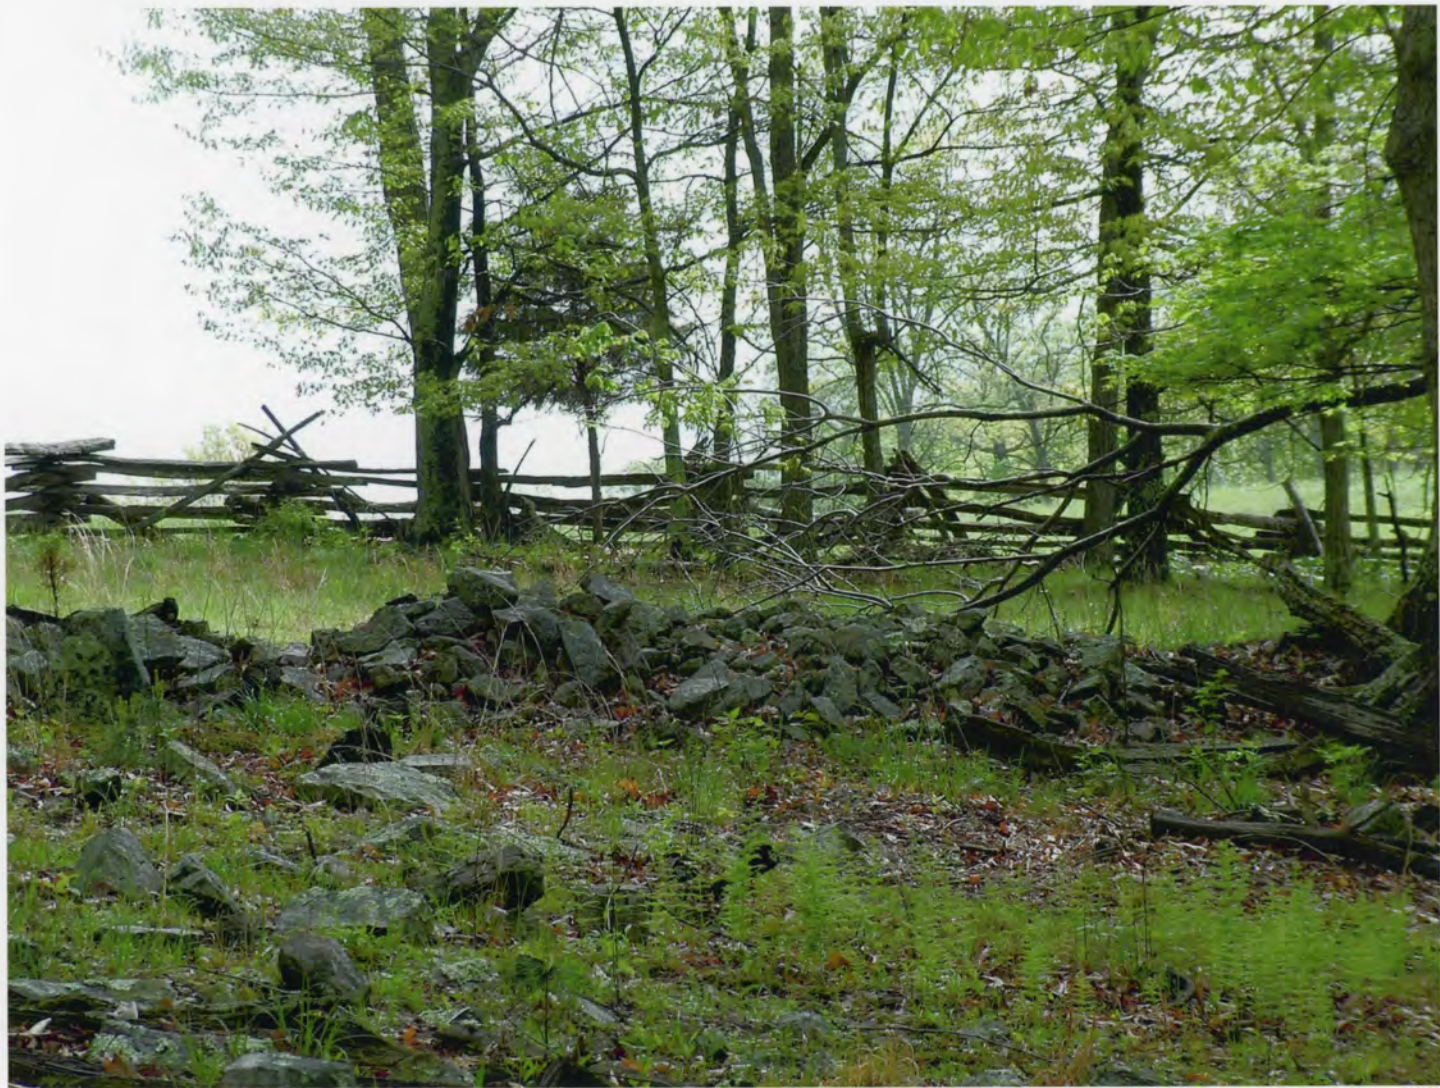
Pitsenbarger Farm
Pendleton Co., WV
Photo 19 of 20

Split rail fencing of chestnut is situated throughout the property mostly along the west and northeast property line. Some is in better condition than other areas.

Walls of rubble stone stacked approximately 3' to 6' high throughout the property.
