National Register of Historic Places Registration Form

Historic name: Strassburger, Reuben and Elizabeth, Farmstead

Other names/site number: Hartzell-Strassburger House

Street & number: 407 Keystone Dr.

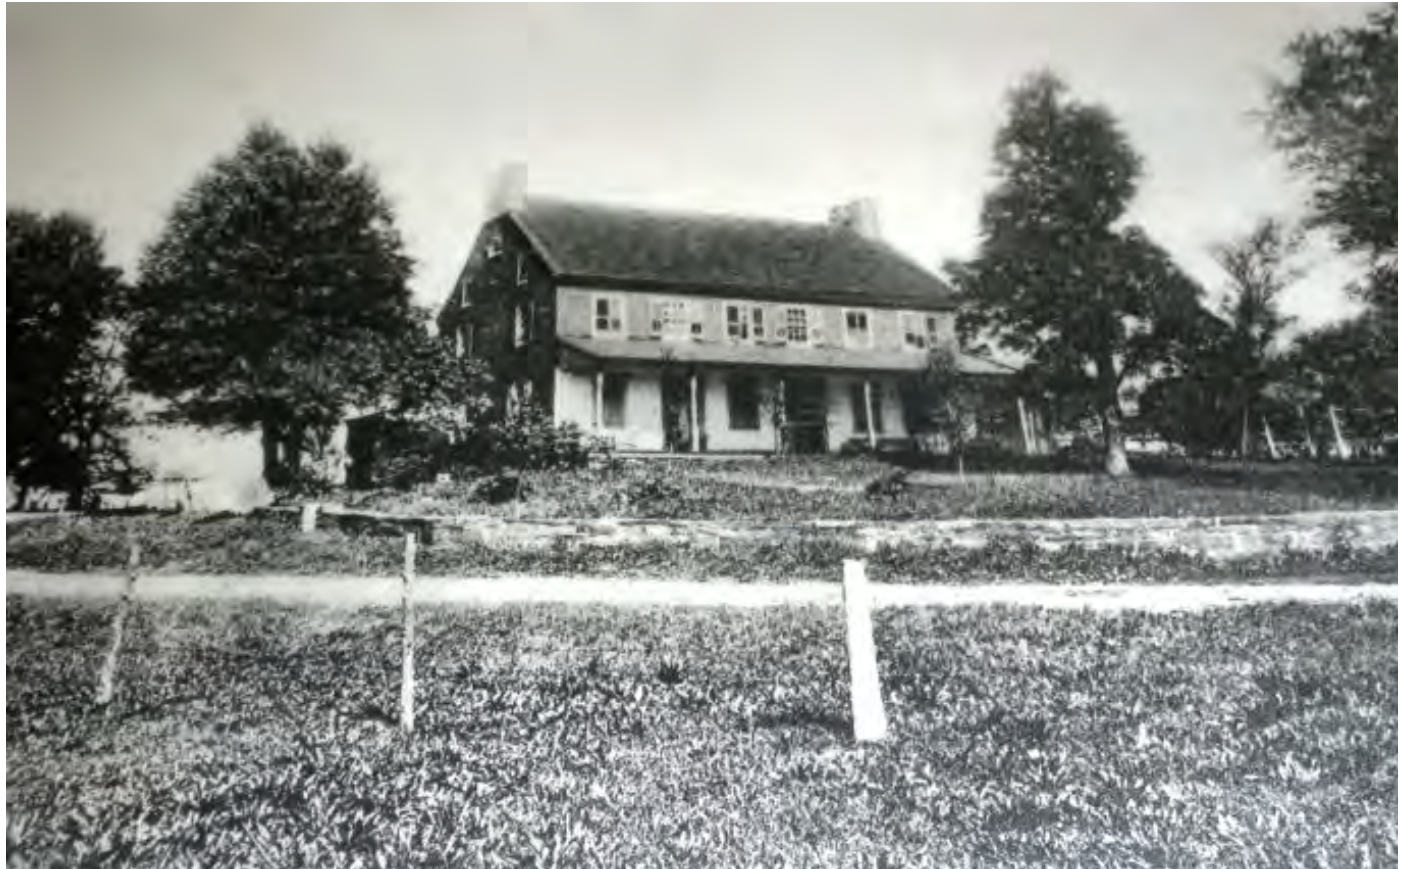
Figure 20

Photo of Reuben and Elizabeth Strassburger Farmhouse
Taken c.1900

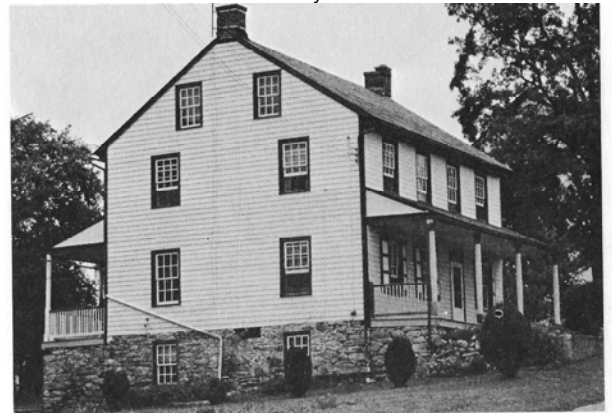
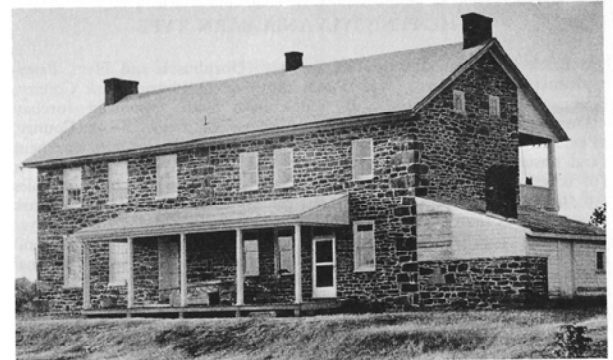
FIGURE 17

A. North of Thurmont, Frederick County, Maryland (March, 1968). B. Southwest of Millersville, Lancaster County, Pennsylvania (July, 1967). A and B represent the usual subtypes of the most common Mid-Atlantic house type: both have four openings on the front of the first story; A has two windows and two doors (as in Fig. 16 E); B has three windows and one door. Both have the small internal gable end chimneys, and the symmetrical arrangement of windows on the ends which are characteristics of the type which includes them. Both also have the window shutters and front porches and B has the partially above-ground basement found on many Mid-Atlantic houses. C. East of Gettysburg, Adams County, Pennsylvania (October, 1967). Basically two houses built end to end, this house has a built-in, two-story porch on the rear of a kind found regularly in south-central Pennsylvania and adjacent Maryland.

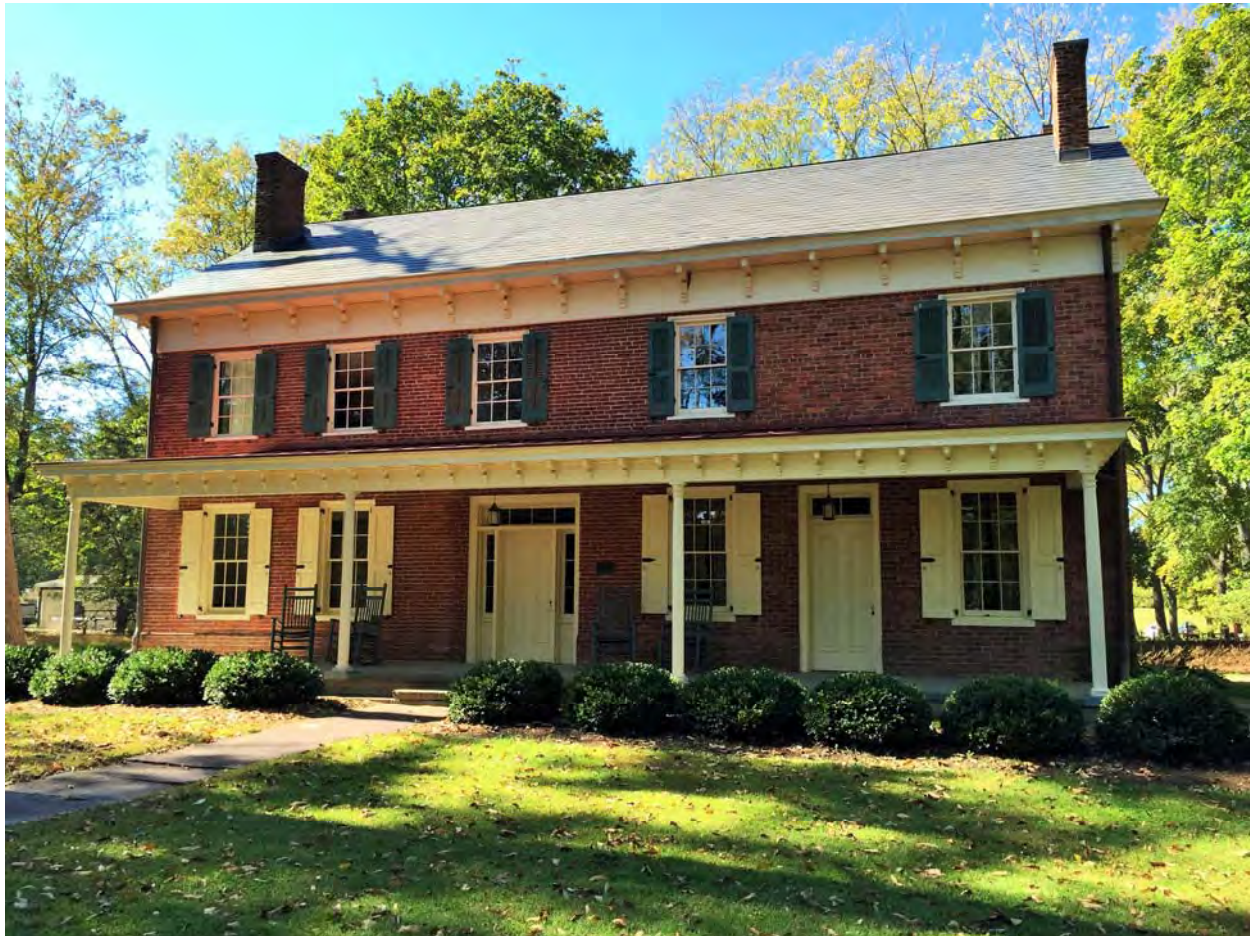
Figure 22

Erwin-Stover House, c.1800, Tinicum Township, Bucks County, PA
Comparable Property for the Strassburger Farmstead
Photo taken by David Kimmerly, October 2015
Strassburger Farmstead
Bucks County, PA

a rear addition, the Erwin-Stover house in Tinicum Township, Bucks County is a property with similar characteristics to the Strassburger Farmhouse. The Erwin-Stover house is Federal in style and had a c.1860 Italianate style update as well. The Italianate features are the brackets along the cornice. The house has two front doors in the same configuration as the Strassburger farmhouse. (See Figure 22.) The fenestration of the Erwin-Stover House is not as symmetrical as the Strassburger farmhouse, however, which gives the appearance that it may have been built in two phases. However, there is no seam on the main façade that would indicate two phases of construction. The door on the left part of the main façade of the Erwin-Stover House is wider and more formal with side lights and a transom above. Unlike the Strassburger farmhouse, the wider door is not double leaf. On the right side of the main façade is a smaller door, less formal, narrower and without side lights. Side lights and transoms around doors are very typical of Federal architecture. The Erwin-Stover House also has a rear addition that gives the building an overall T-shape like the Strassburger farmhouse. The barn on the property of the Erwin-Stover House also has similar architectural characteristics as the Strassburger barn. It is a standard, closed forebay barn with Peilerecks and has a small ramp shed opening that is enclosed. (See figure 23.)

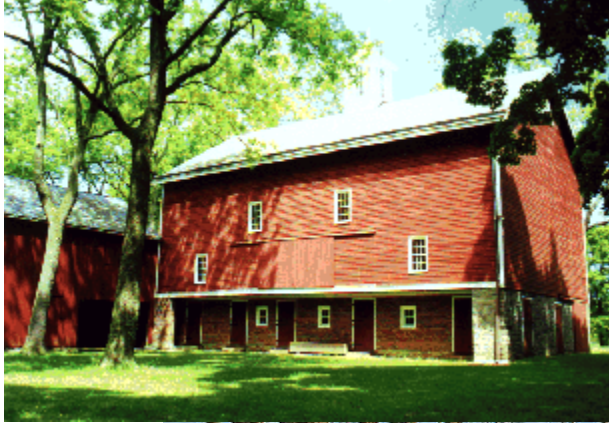
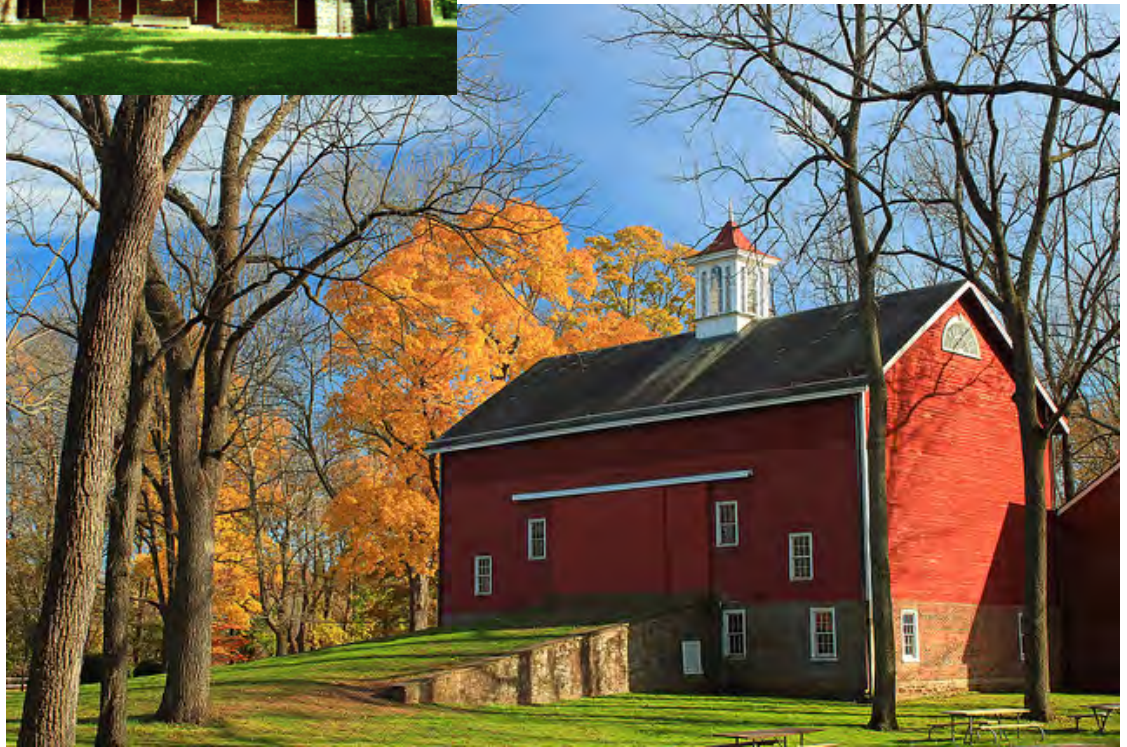
Figure 23

Erwin-Stover Barn, c.1850 Tinicum Township, Bucks County, PA
Comparable Property for the Strassburger Farmstead
Source: Delaware and Lehigh National Heritage Corridor web site
Campsite Reports web site, accessed 2015
Strassburger Farmstead

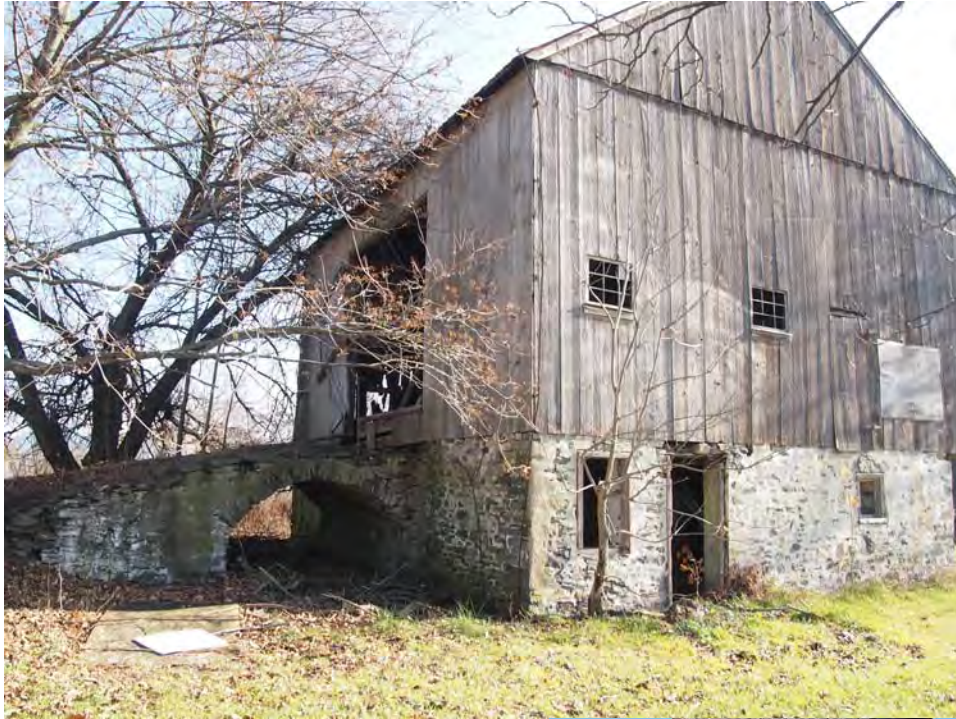
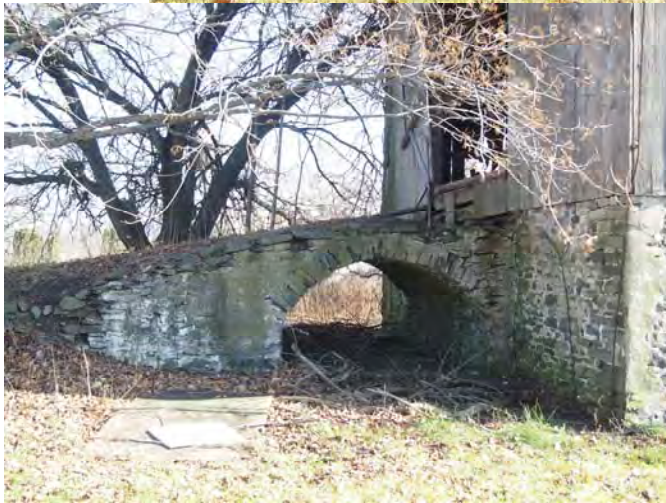
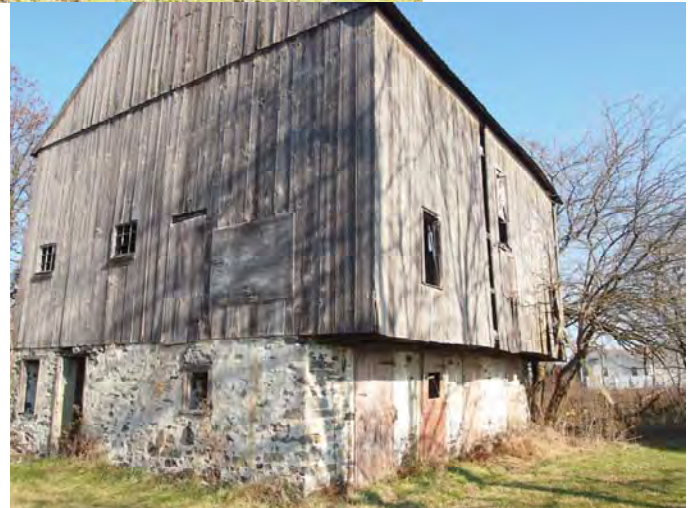
Figure 24

Tylersport Barn of Augustus Thomas, Salford Township, Montgomery
County, PA

In the village of Tylersport in adjacent Salford Township, Montgomery County there is a barn with a ramp shed similar to the Strassburger Barn. (See Figure 24.) It is located on the southeast corner of Allentown Road and Ridge Road. This barn appears to be older than the Strassburger Barn and the ramp shed is better described as a ramp bridge, since it does not have height sufficient for storage and is formed by a stone arch. According to an 1848 and 1871 map of Salford Township (then Upper Salford Township), the property was a combination of residence, store, and was farmed, based on the presence of the barn. This is similar to the multiple functions of the Strassburger Farmstead. The Tylersport property was owned by Augustus Thomas, a dry goods merchant who operated the business for many years. The house on the property was recently demolished. The barn retains a high degree of integrity but is in fair condition at best. This property was identified as part of the reconnaissance survey conducted for this nomination and historic map research assisted in the historic research for the property.

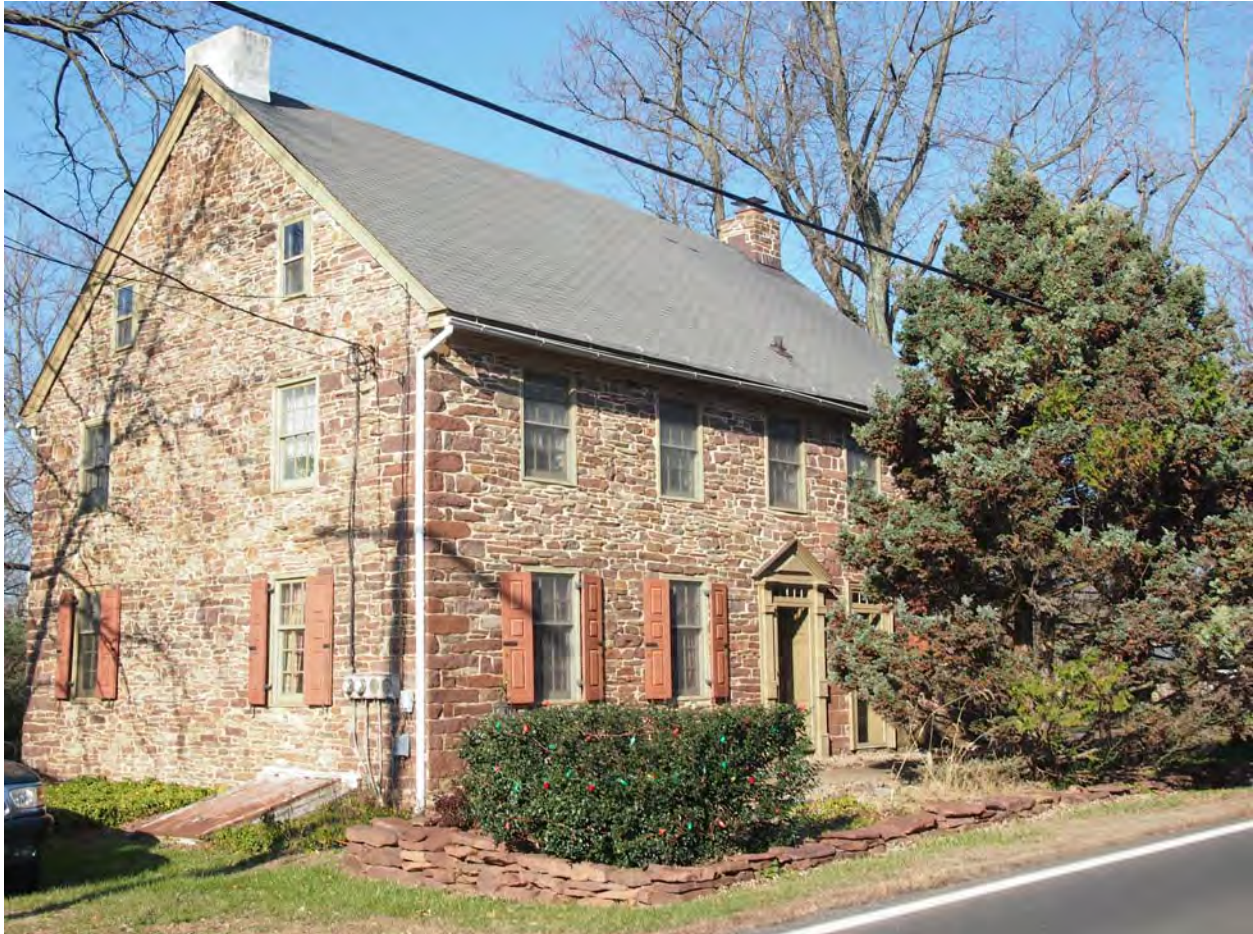
Figure 25

732 Hilltown Pike, (John Frick House and Store) Hilltown Township,
Bucks County, PA
Comparable Property for the Strassburger Farmstead
Photo: David Kimmerly, 2015
Strassburger Farmstead
Bucks County, PA

Another property found as part of the windshield survey is located at 732 Hilltown Pike (See Figure 25). This house displays more high style elements of Federal architecture than the Strassburger Farmhouse. It is built of stone and has a main entrance door that has a pediment above, transom, and fluted trim. These elements are Federal features and are a contrast to the more reserved features of the Strassburger farmhouse. The house was also a store, which may have been in the small addition accessed by the second entrance door on the main façade. According to 1850 and 1876 historic maps of Hilltown the property was owned by John Frick and was a store. There is a large, but unremarkable barn on the property. John Frick was a farmer according to the 1870 federal census. Therefore, the store function was not the primary use of the building and in fact may have been leased by John Frick to a merchant.

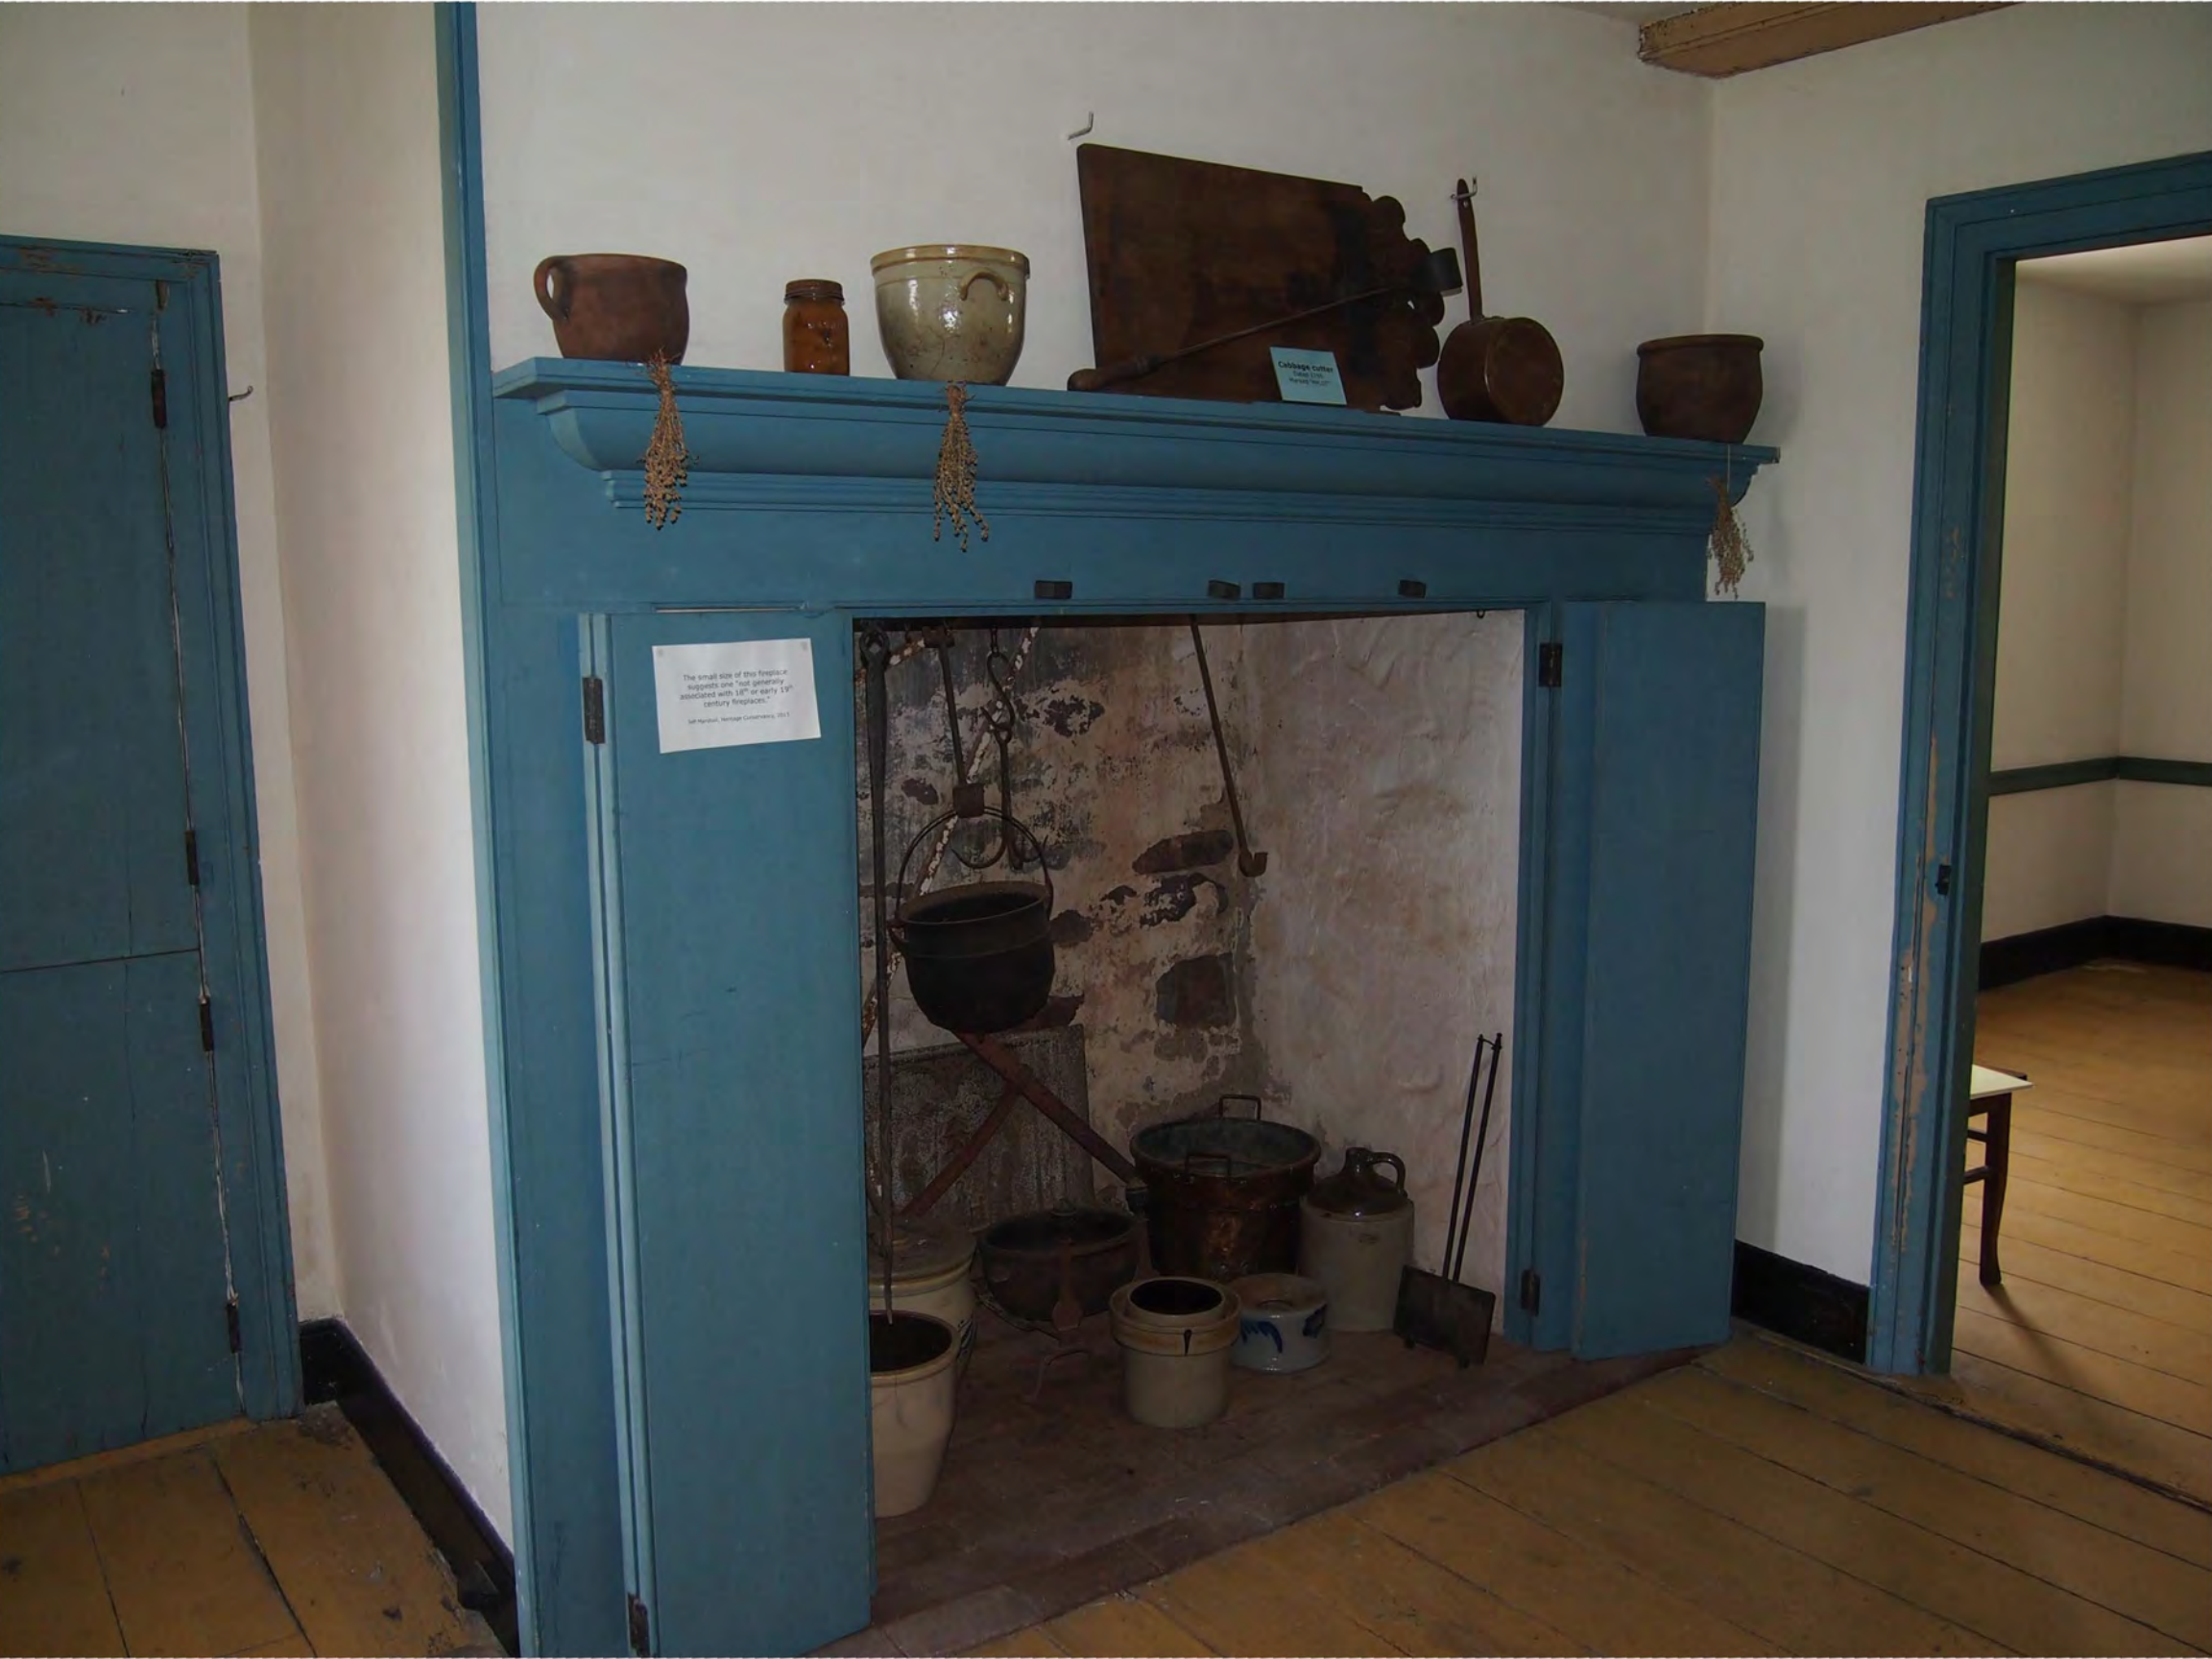
The small size of this fireplace suggests one "not generally associated with 18th or early 19th century fireplaces."
- Bill Reynolds, Heritage Conservancy, 2011

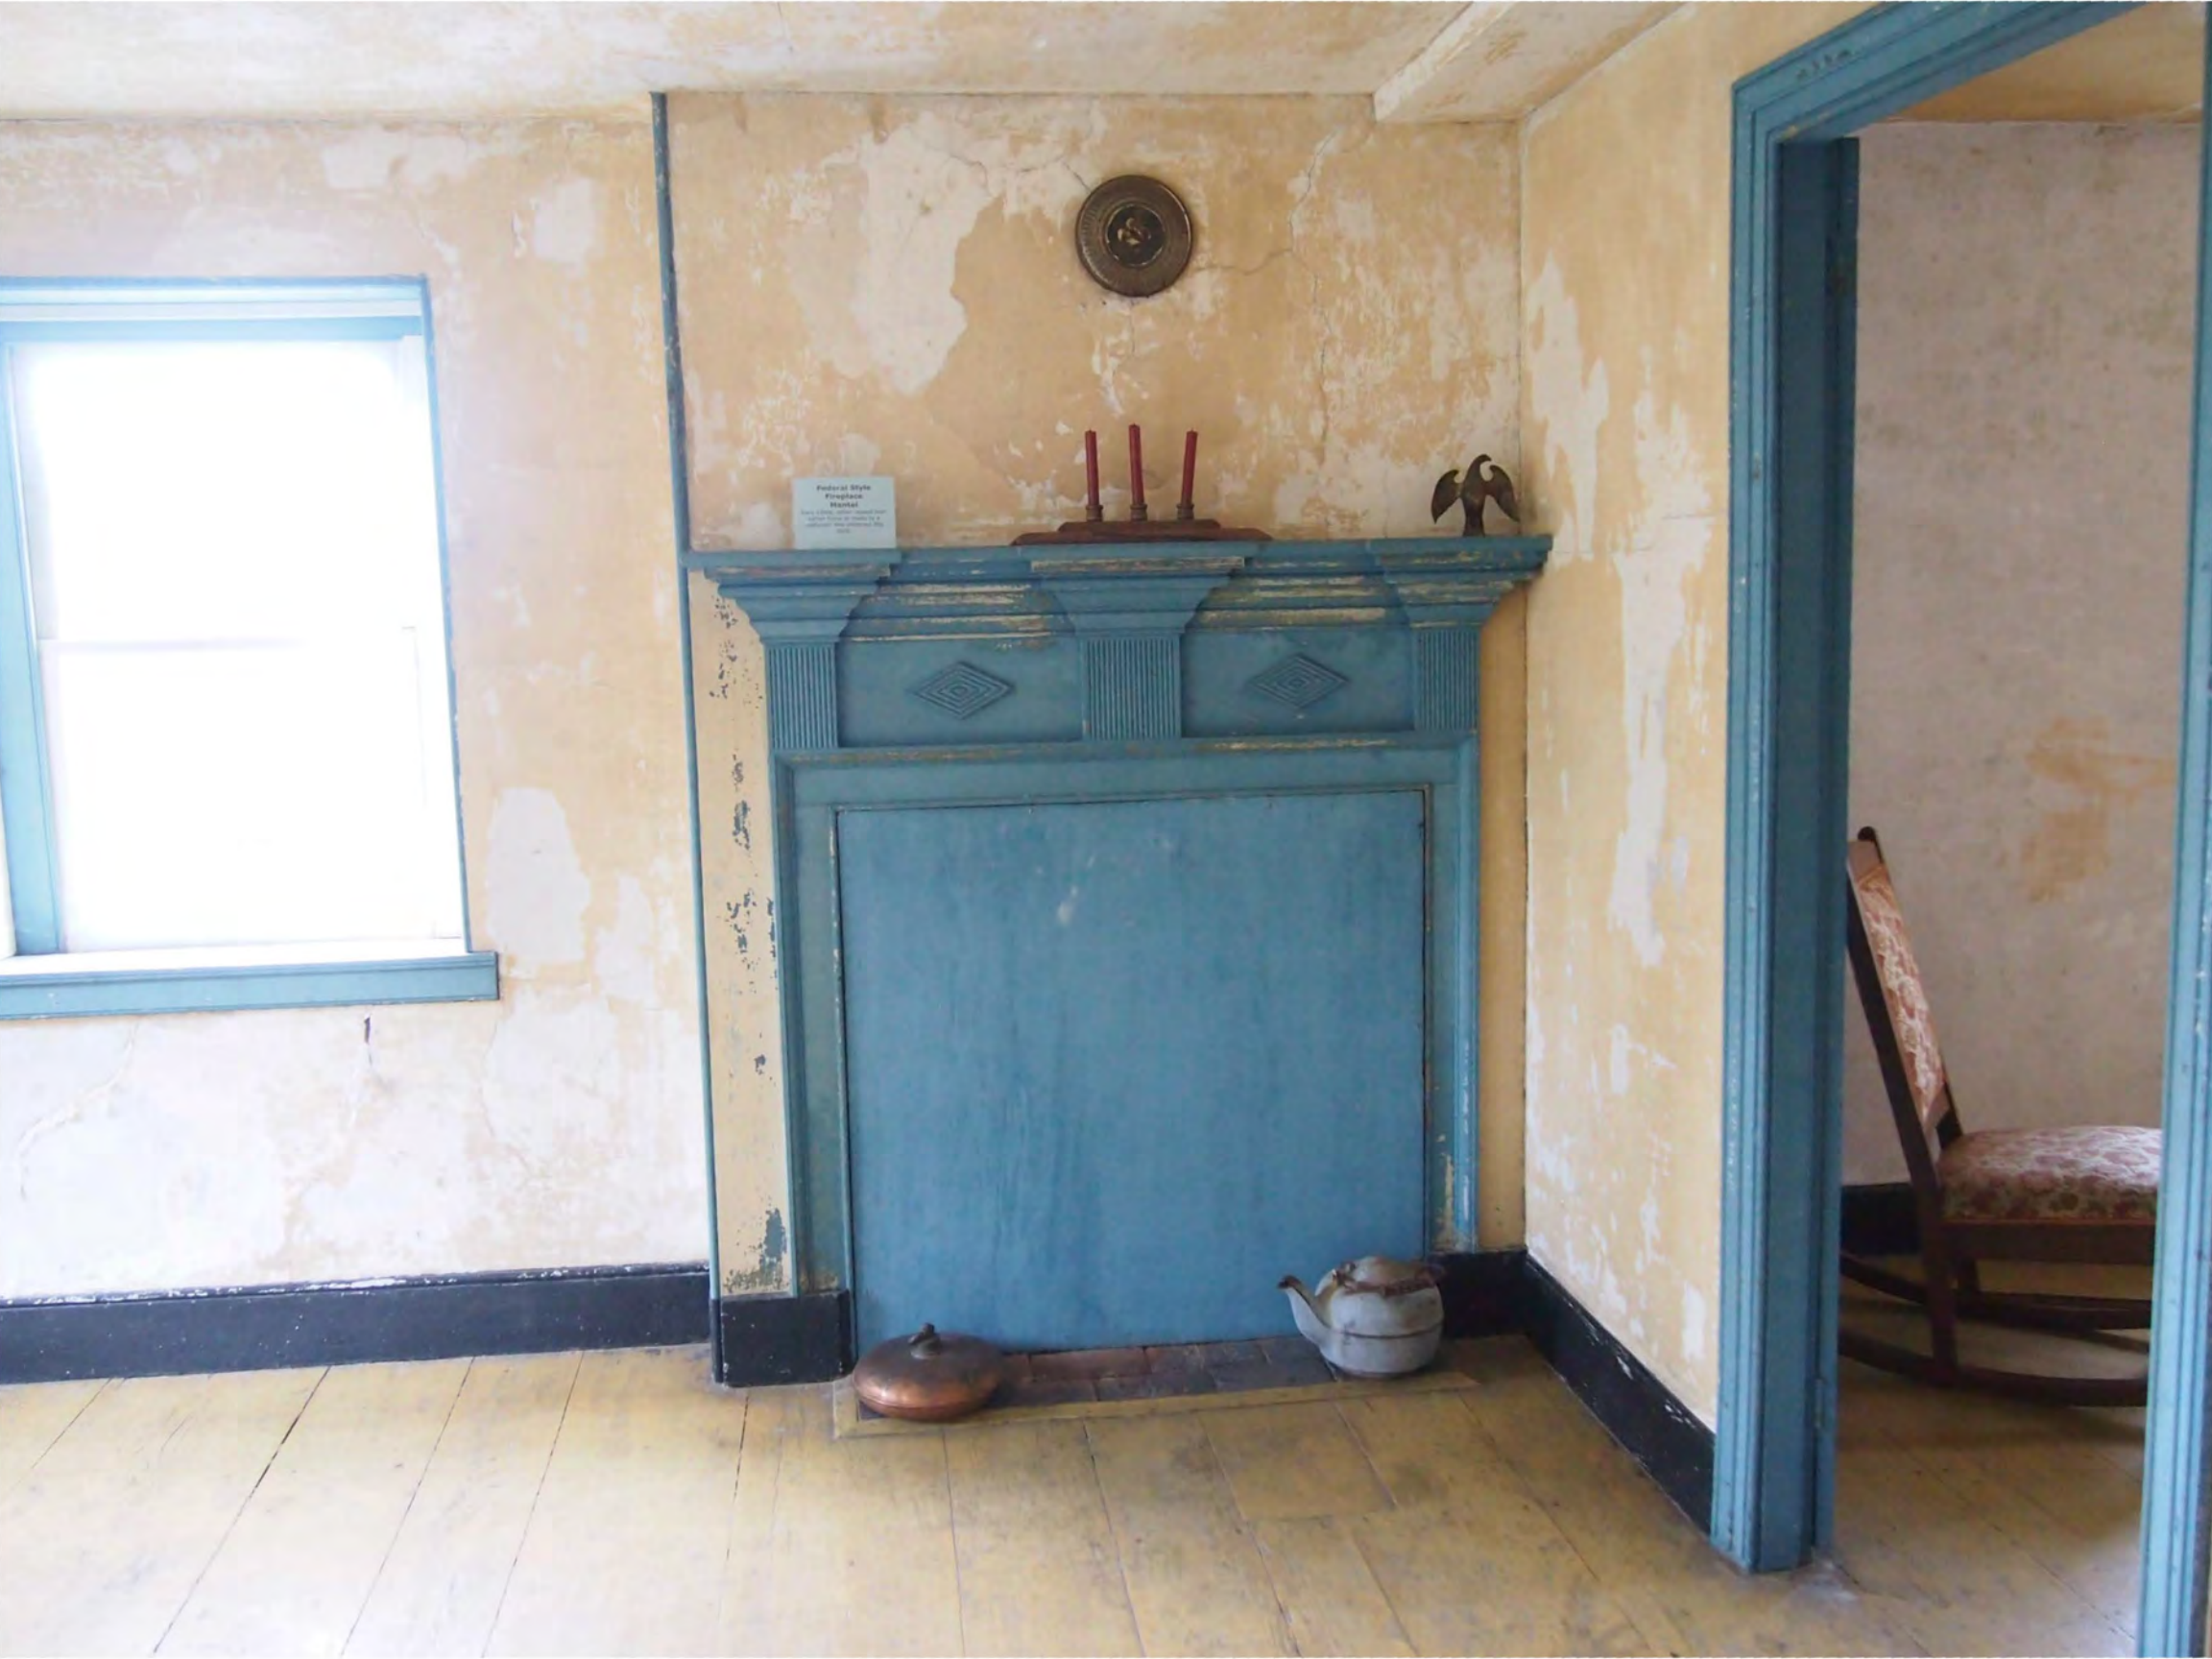
Federal Style
Fireplace
Mantel
