Saint John's Presbyterian Church
San Francisco, California

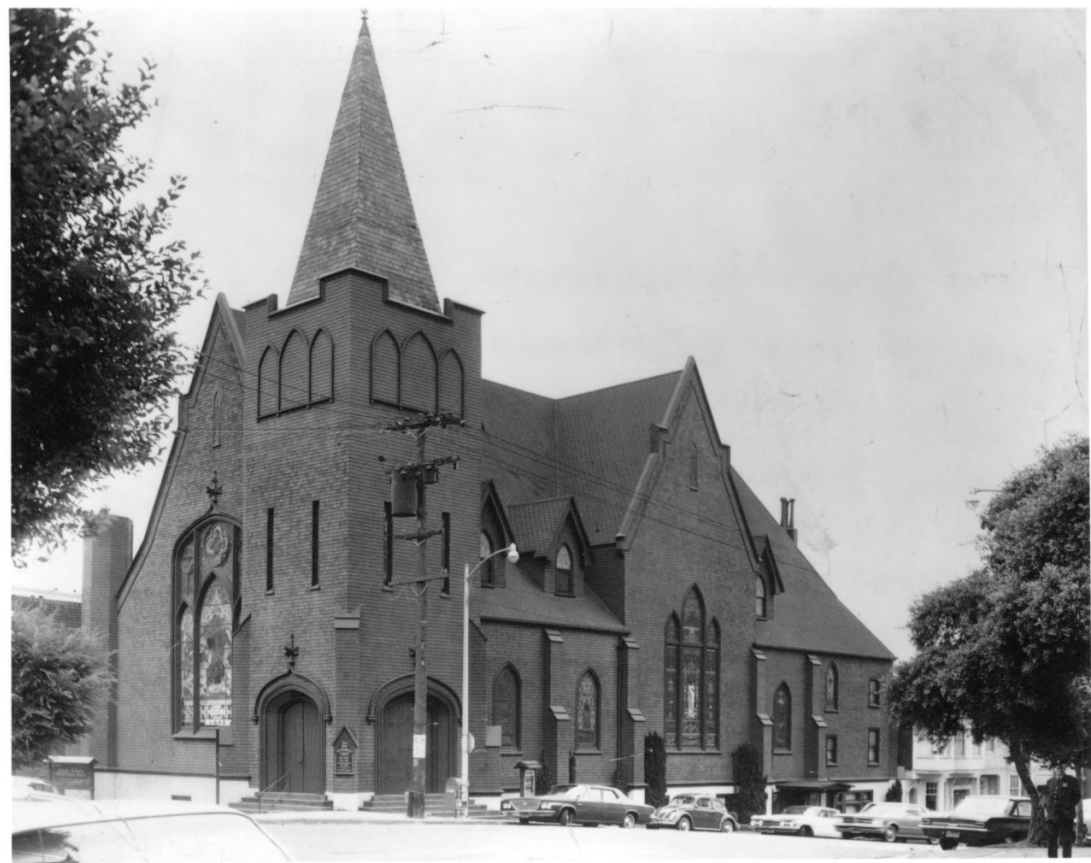
Photo No. 1

Looking Southwest at Northeast Corner of
Saint John's Presbyterian Church. The east
or Arguello facade is left of the steeple.
The North or Lake Street facade is on
the left.

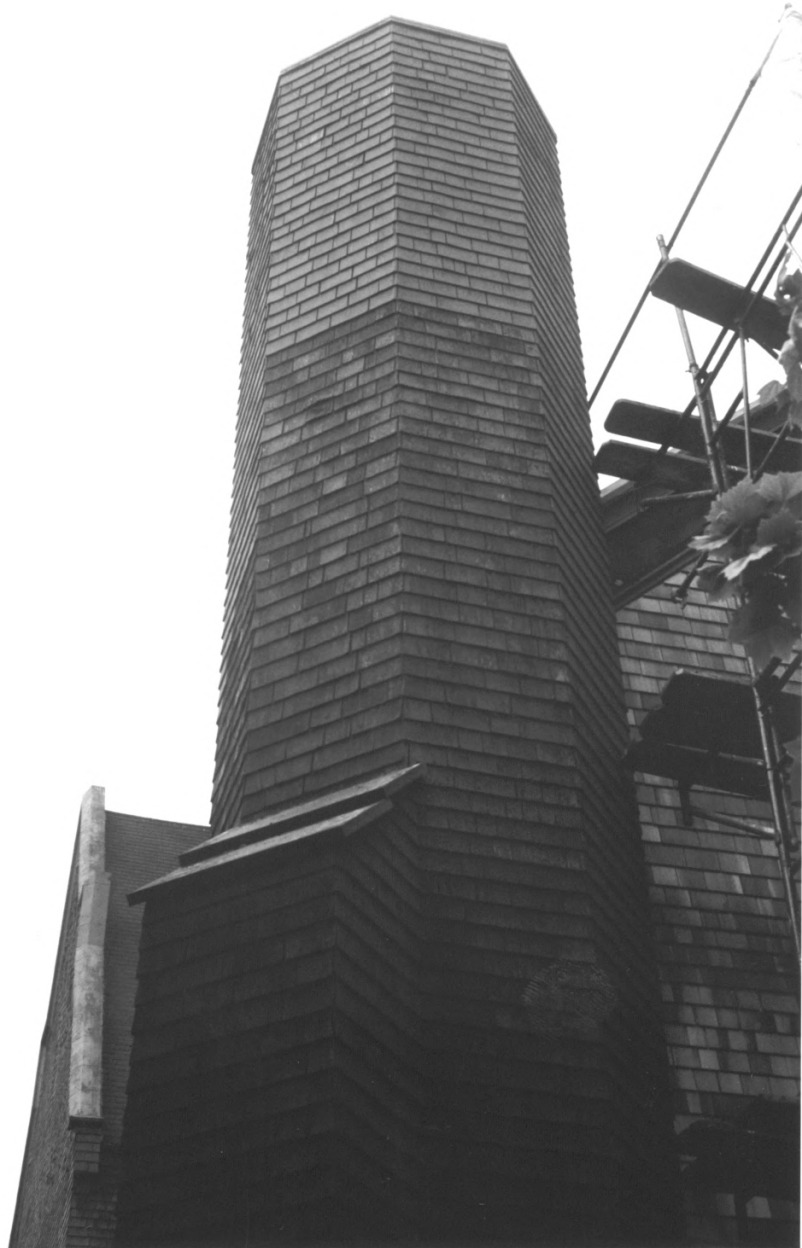
Photo No. 2

Looking Northwest at the hexagonal tower with the lower gabled roof of the South facade behind. The buttress topped with slanted, layered coping is in the foreground.

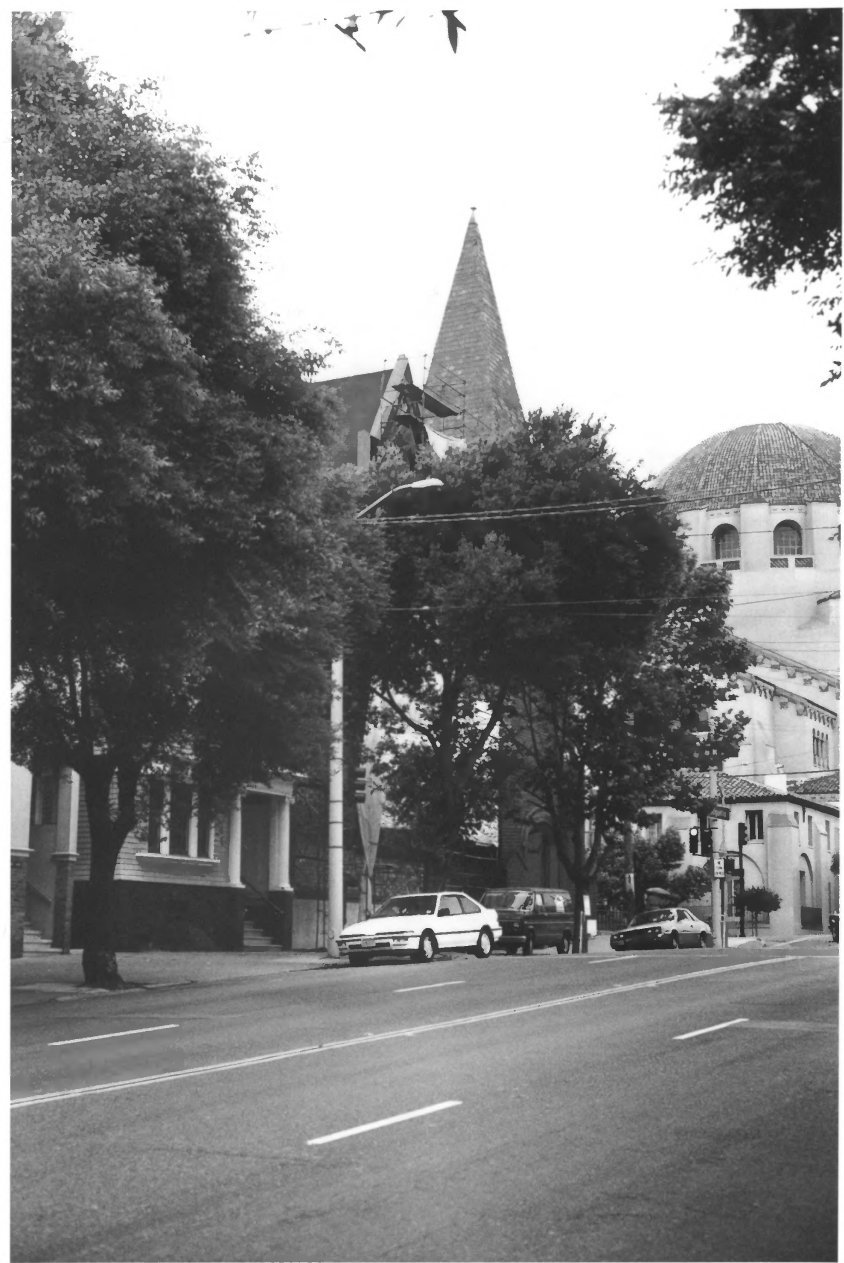
Photo No. 3

Looking Northwest at the Arguello Street
facade hidden behind street trees. On the
right center is Temple Emanuel (1925).

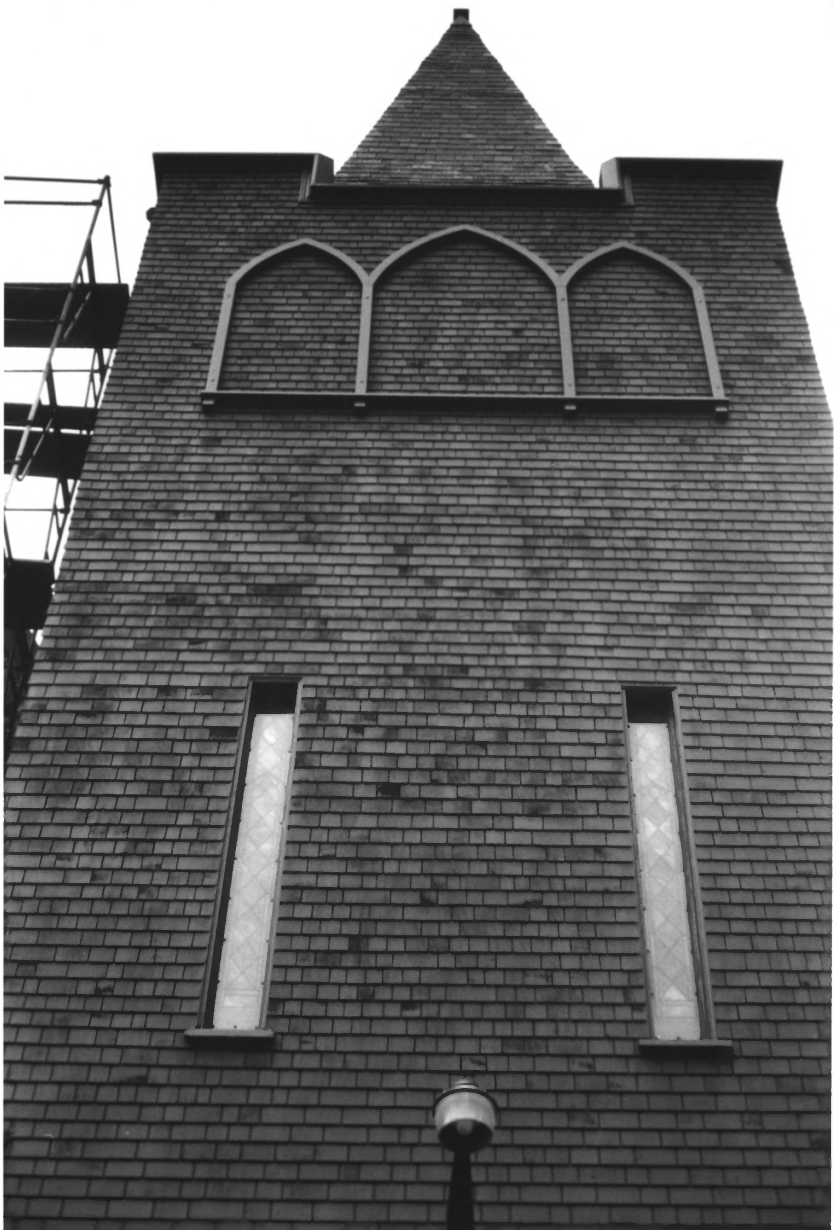
Photo No. 5

Looking at the North facade of the tower
punctuated by long, narrow recessed window
openings on the bottom and tripartite
molding outlines on the top.

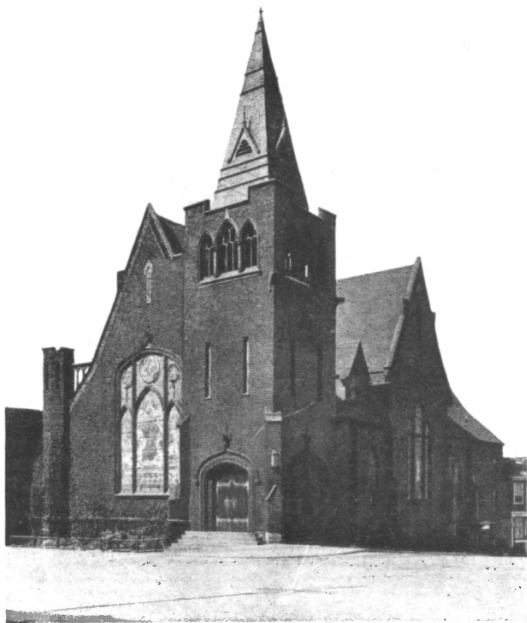
Photo No. 6-H

Reproduction of 1920 Golden Jubilee program
cover. Photo is taken looking Southwest at
Northeast corner of the church.

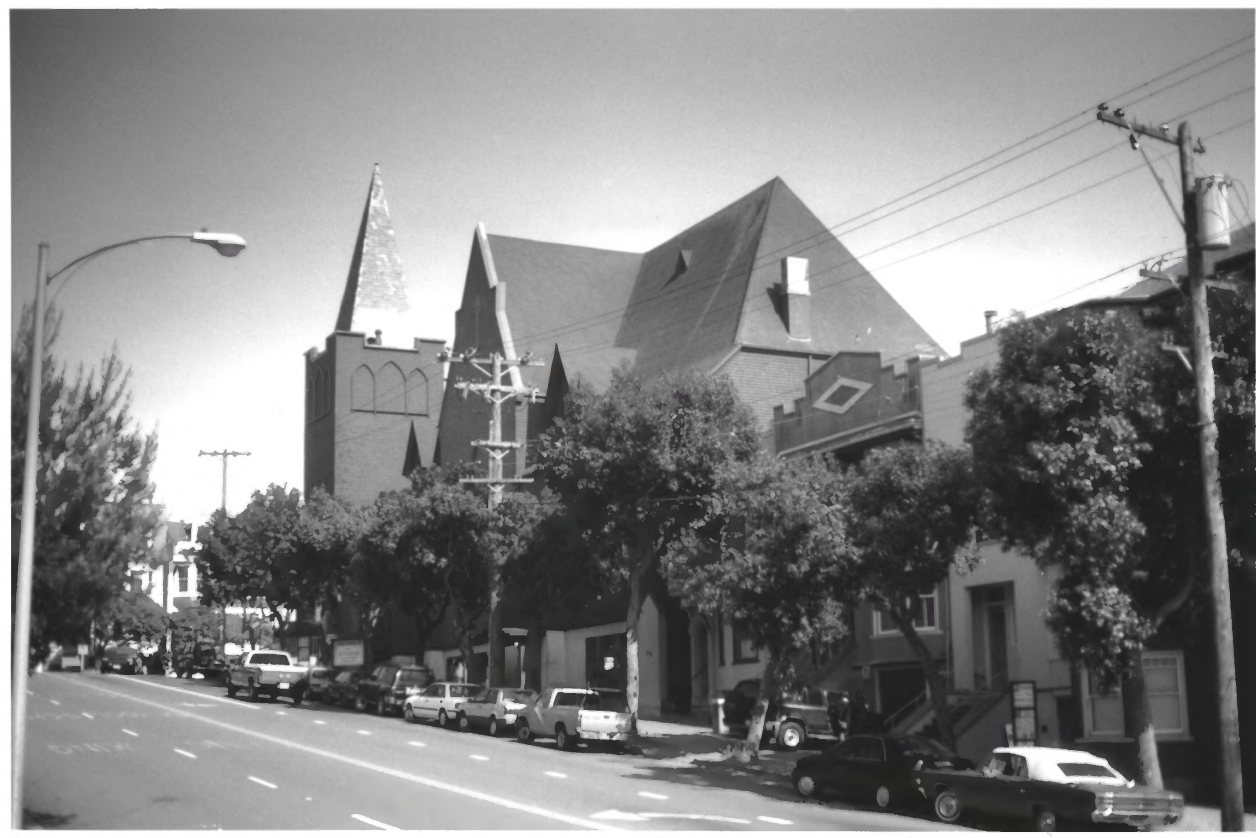
Photo No. 7

Looking Southeast at the north and west
facades of Saint John's with Lake Street
in the foreground. Note street trees and
neighboring residences.

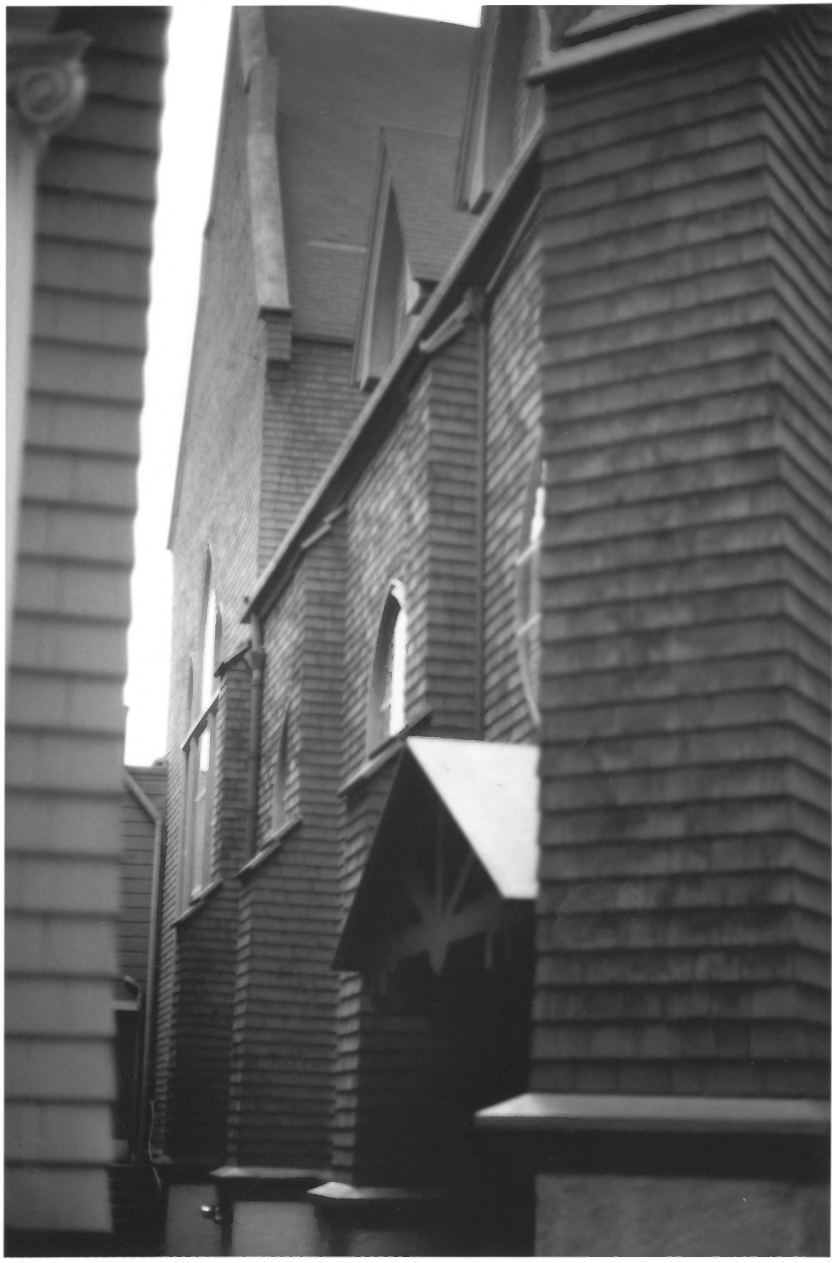
Photo No. 9

Looking Northwest at South facade of
Saint John's Presbyterian Church.
1913 and 1949 addition is glimpsed
perpendicular to westerly end of the
Church.

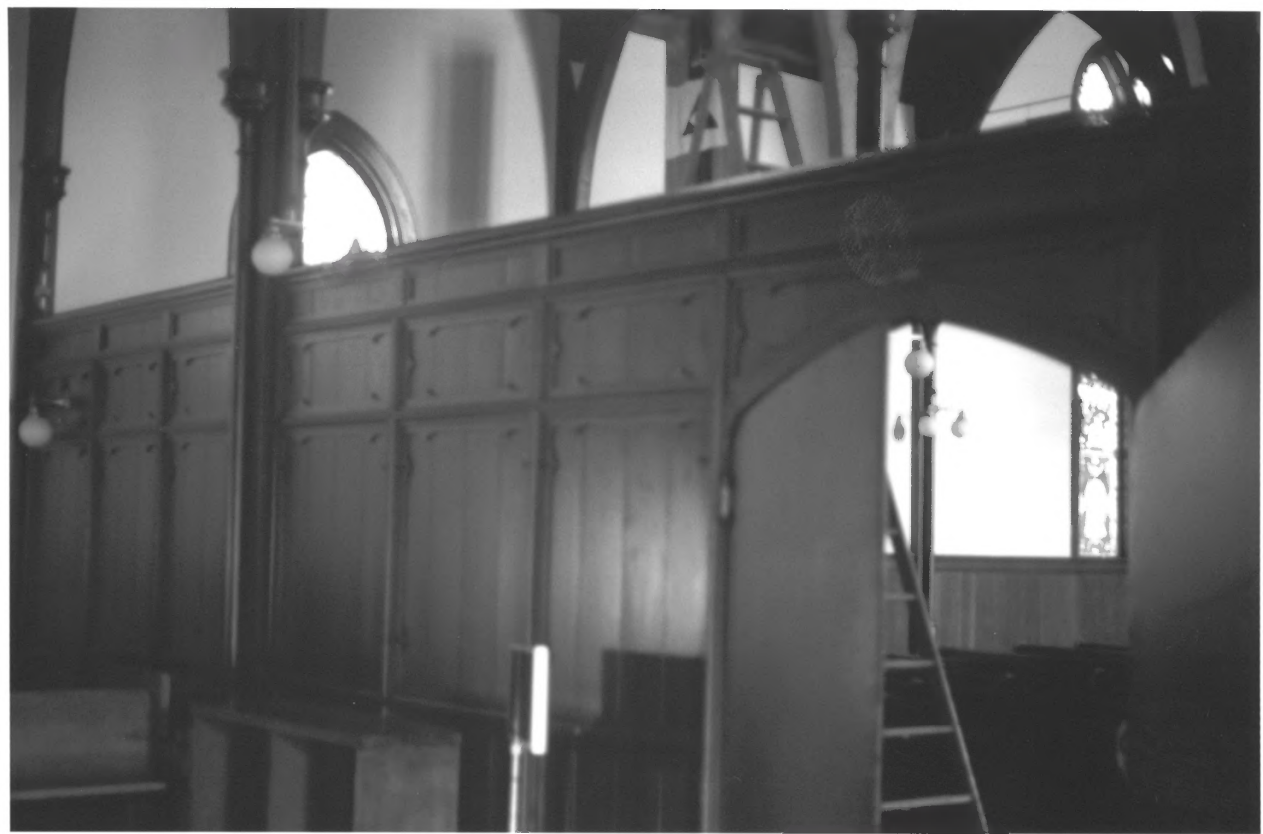
Photo No. 10

Looking Southwest from the Narthex at
the South wall of the Sanctuary at the
operable screen in the foreground.

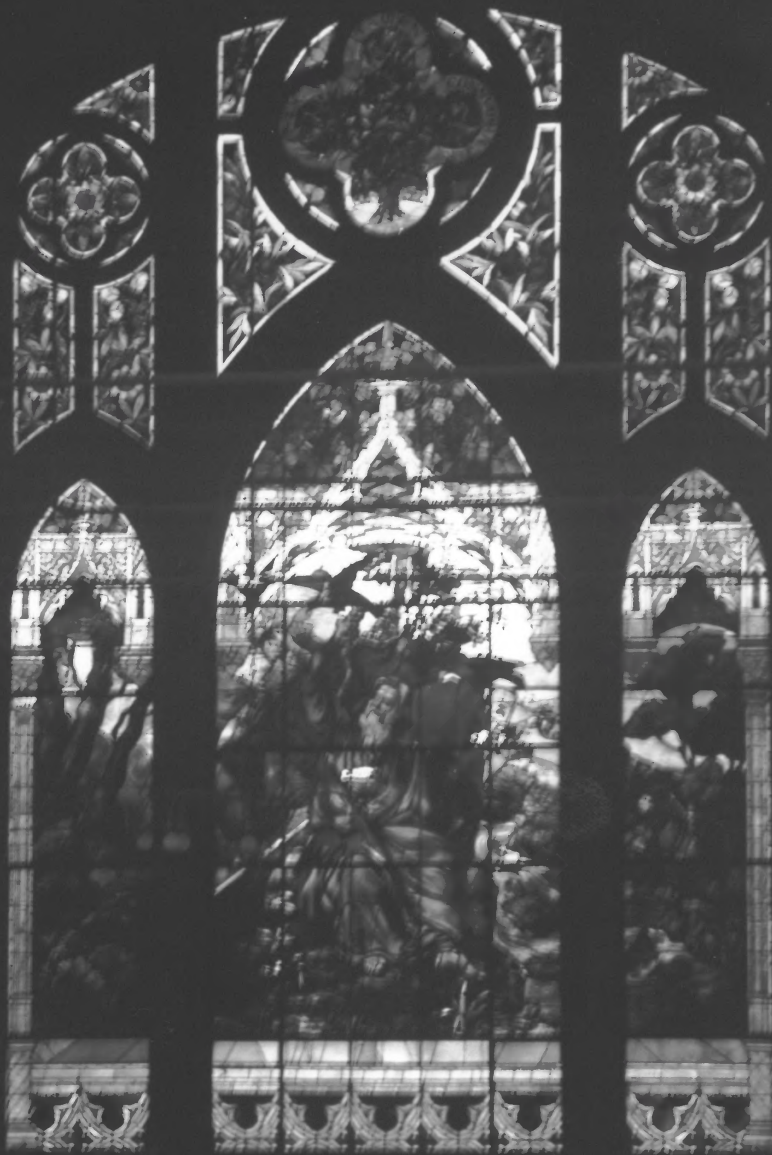
Photo No. 11

Looking east from inside Saint John's
at the Foster Window.

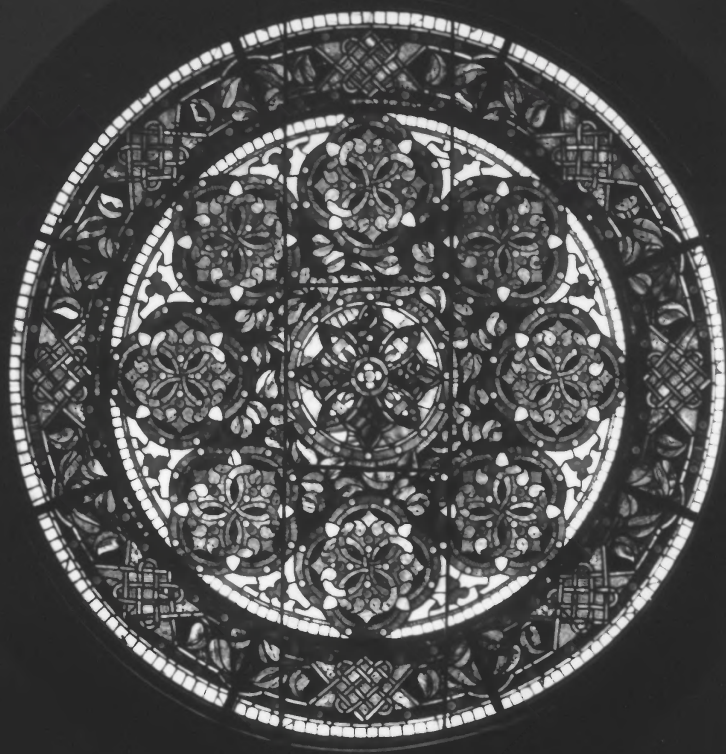
Photo No. 12

Looking South at the Rose Window (1869),
taken from the Narthex.

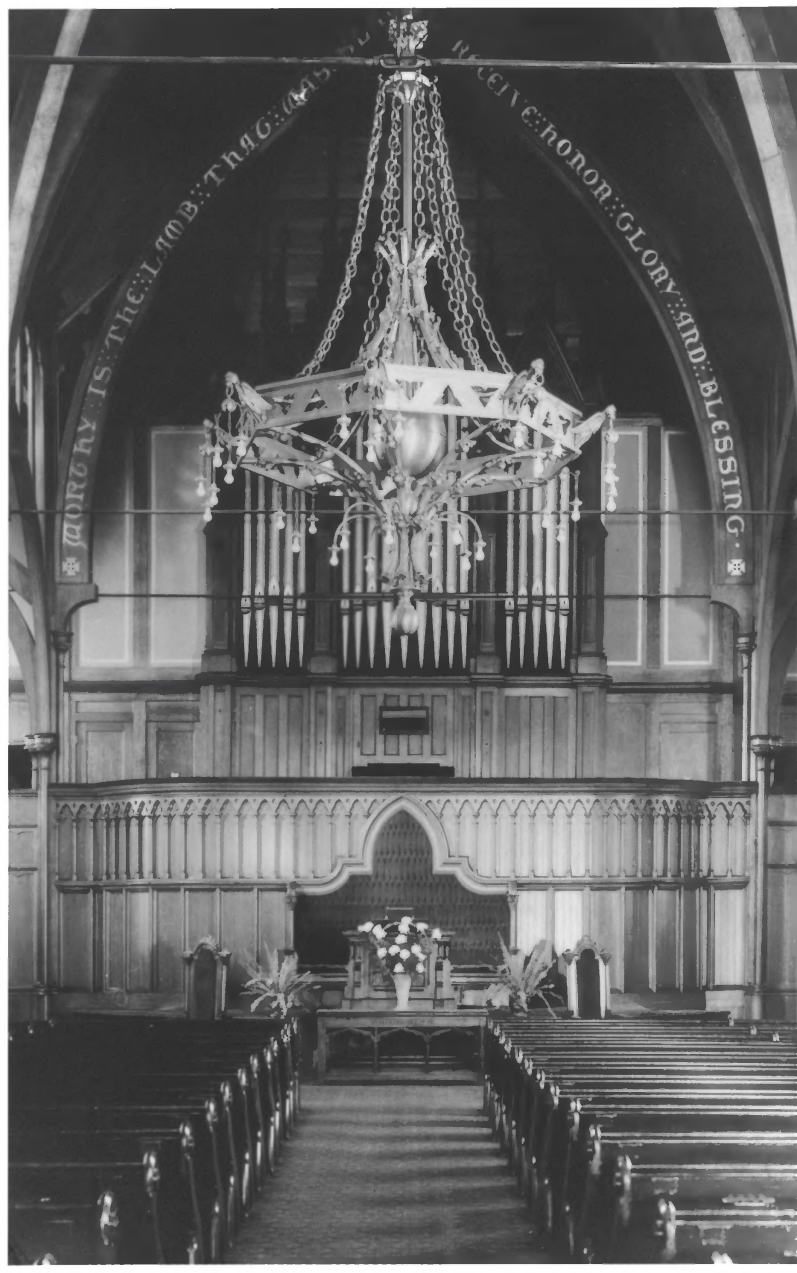
Photo No. 13

Looking west down the main aisle at the
chancel, pulpit and organ beyond. At the
top center is the Craftsman Chandelier.

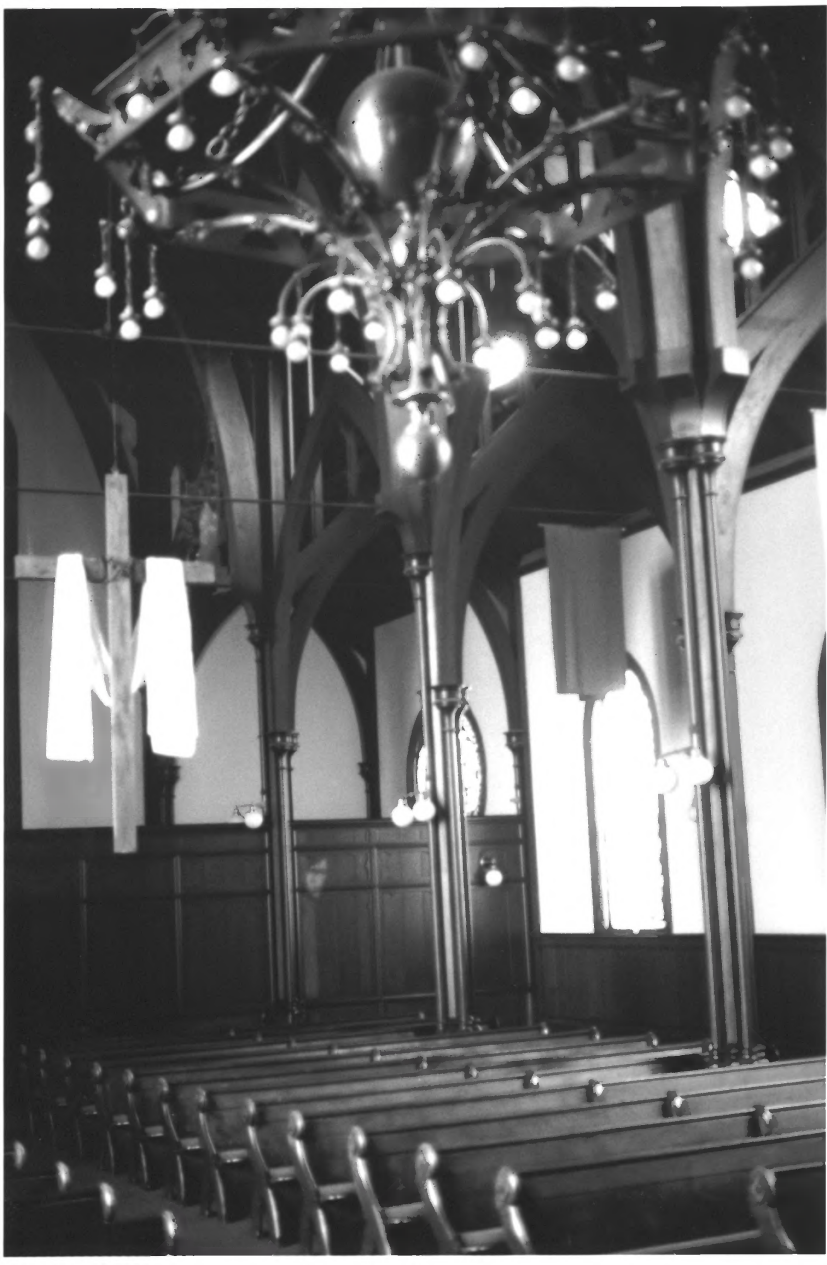
Photo No. 14

Looking Southeast from the Sanctuary toward the Narthex with pews (1867) in the foreground. Beyond is the screen ~~on the South wall~~ separating the Sanctuary and the Narthex. The Rose Window is partially visible beyond the screen on the South wall. Portions of the double nave arcade with transverse arches are visible to the right, masked somewhat by the Craftsman Chandelier at the top of the photograph.

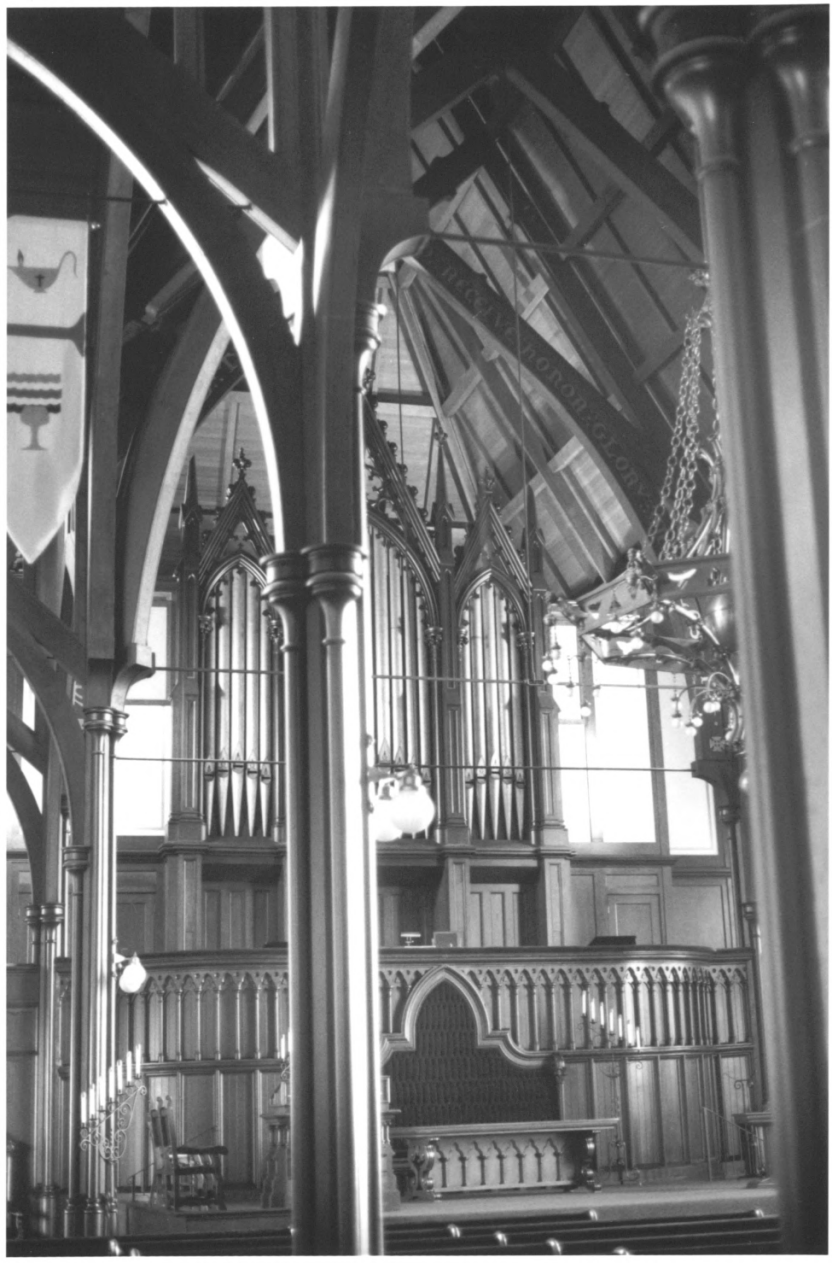
Photo No. 15

Looking Northwest at the Chancel and pulpit with the Choir loft and organ beyond on the Building's West wall. In the foreground, on the left, one sees a portion of the South gallery and portions of the Central arch and truss system. Also visible is a portion of the Central Chandelier.

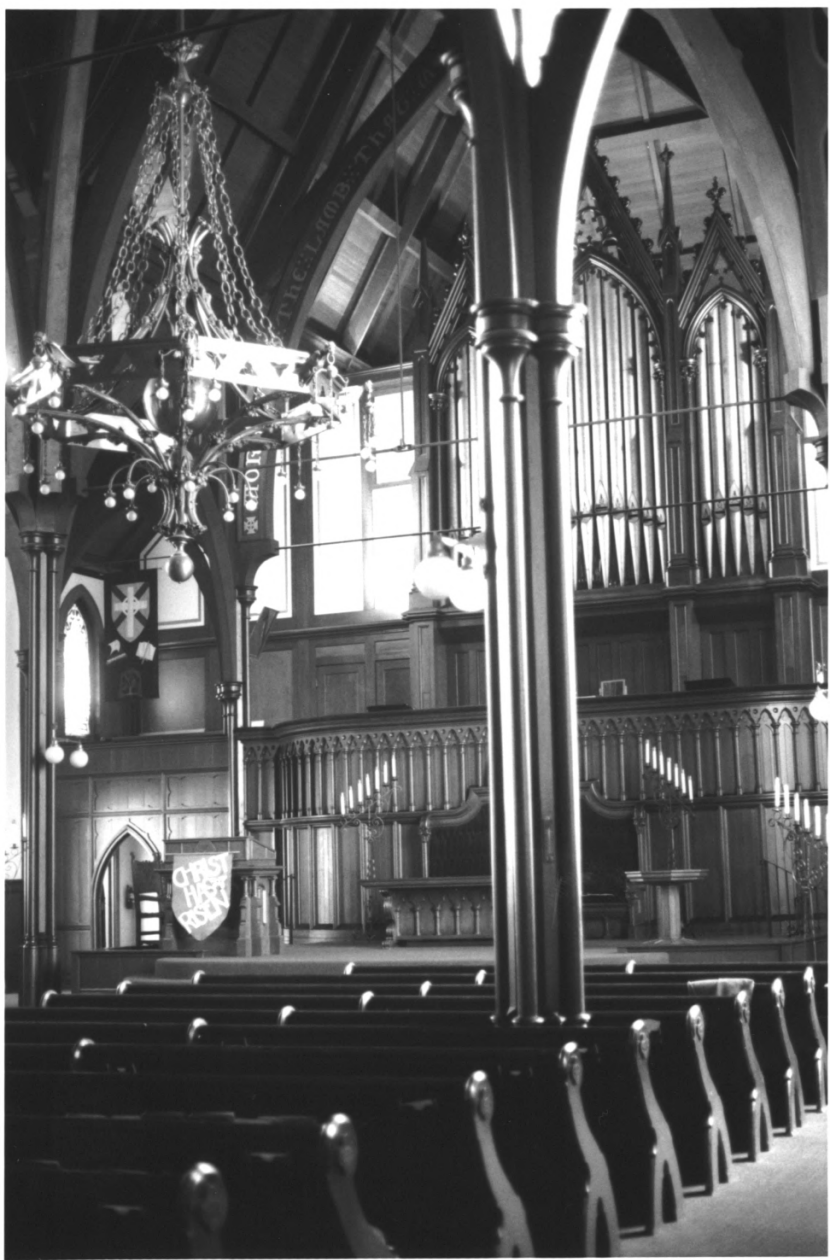
Looking Southwest across the Sanctuary. In the foreground are the pews with an annulated clustered pier coming down to rest on one of the pews. Visible under and to the left of the Chandelier is one of the pair of 1920's lancet windows. Below that is the southerly obtuse angle arched doorway leading to church offices. Also visible is the chancel and the organ beyond.

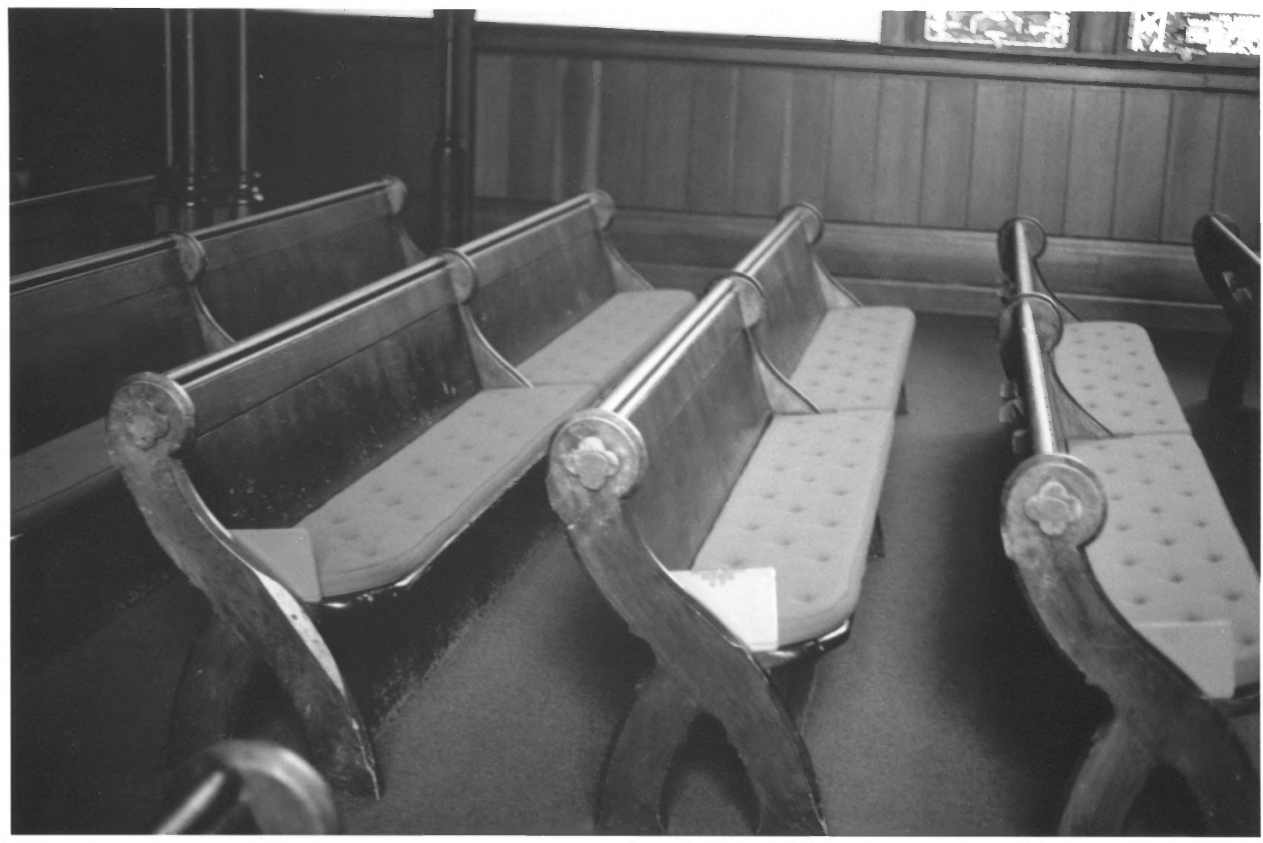
Photo No. 18

Looking southeast at the wainscotting on
the south wall of the Sanctuary with 1867
pews in the foreground.

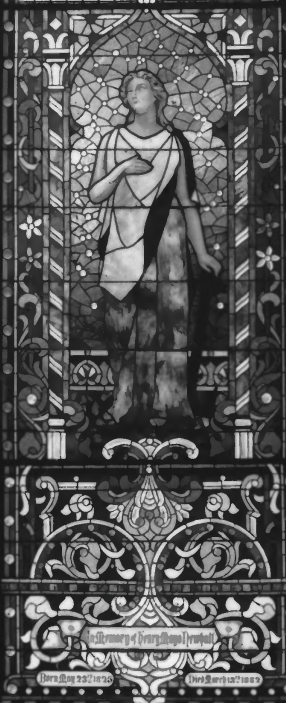
Photo No. 19

Looking Northwest at the Newhall Window
(1899) on the North wall of the Sanctuary.

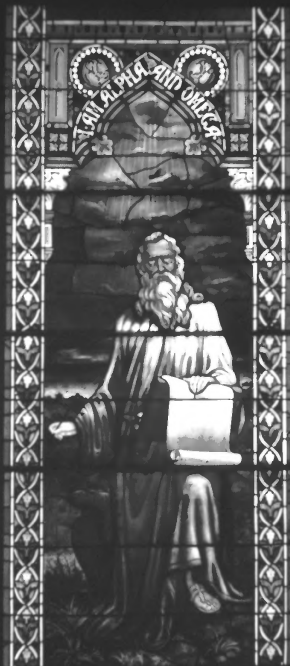
Photo No. 27

Looking Southwest at the Saint John Window,
honoring the Rev. William Anderson Scott, on
the South wall of the Sanctuary.

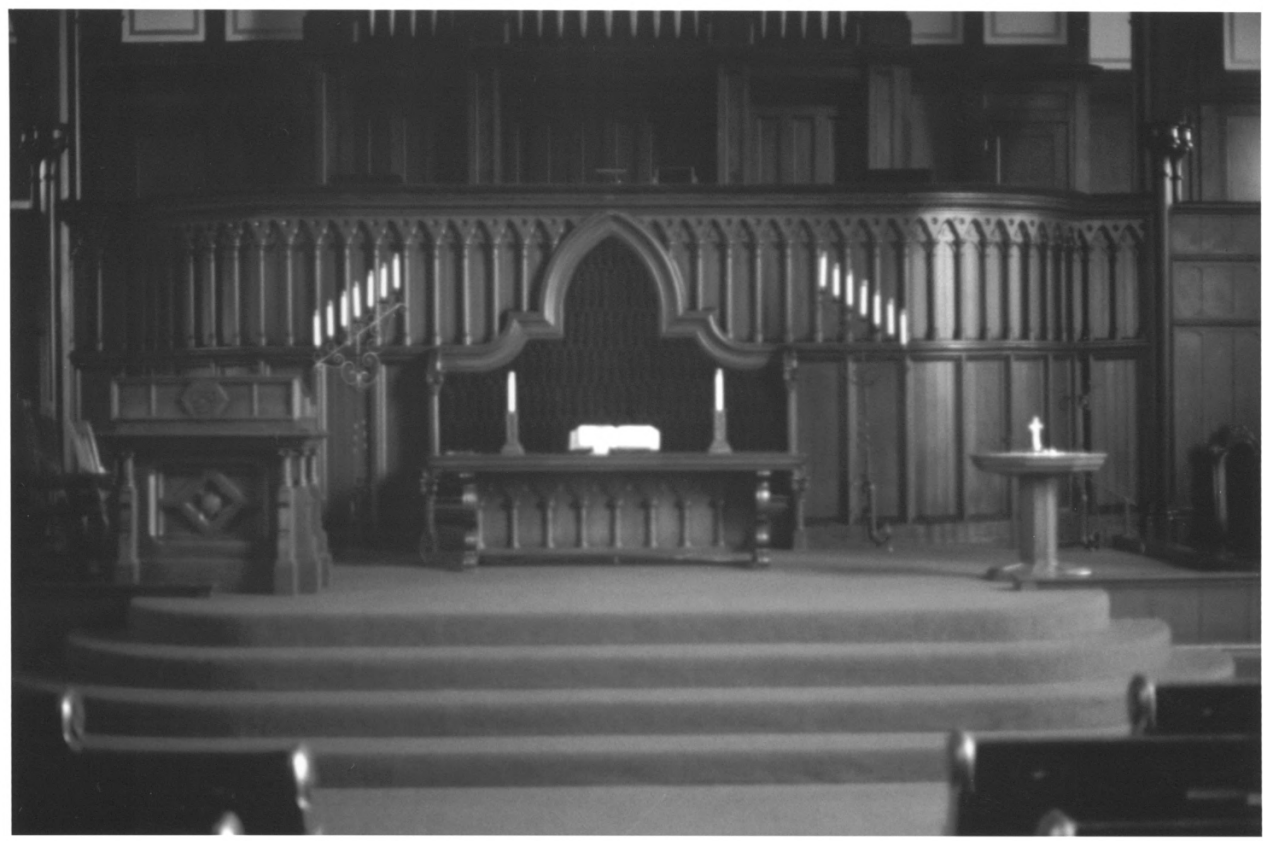
Photo No. 20

Looking West at the Chancel and pulpit
furniture.

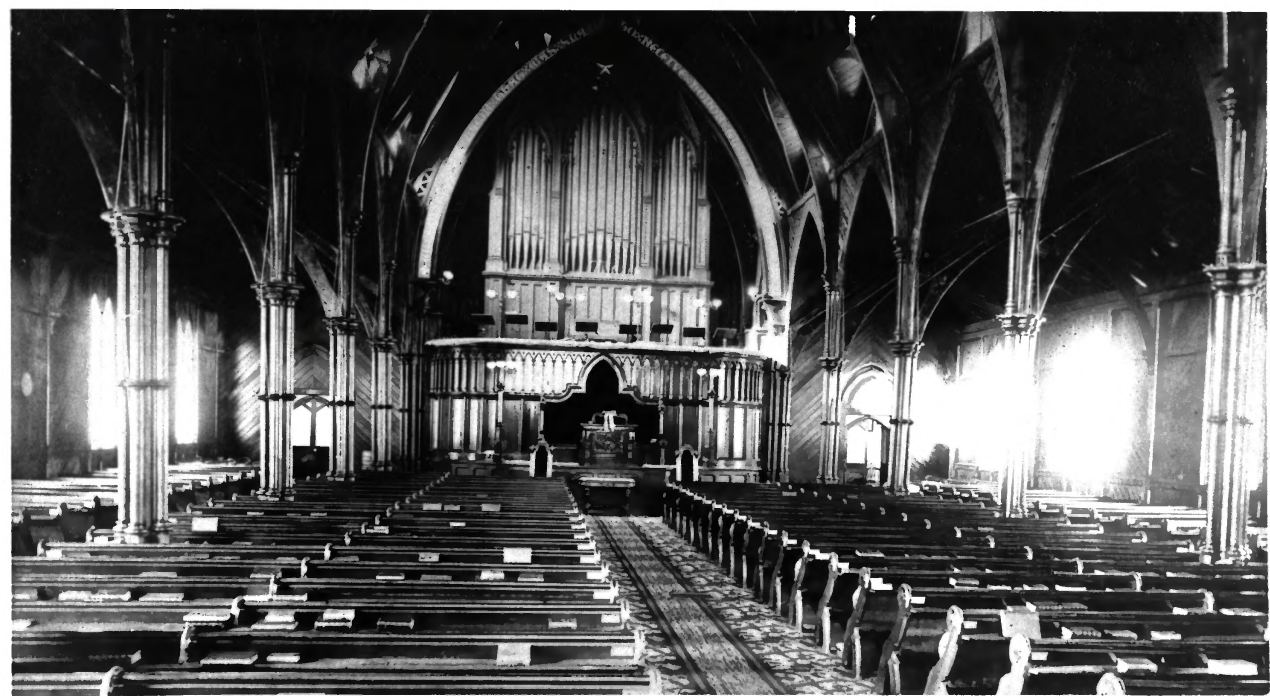
Photo No. H-21

View of the interior of the Sanctuary in
the original Saint John's Presbyterian Church
which was constructed 1866 - 1867, but is no
longer extant.

Photo taken ca. 1872 - 1888.

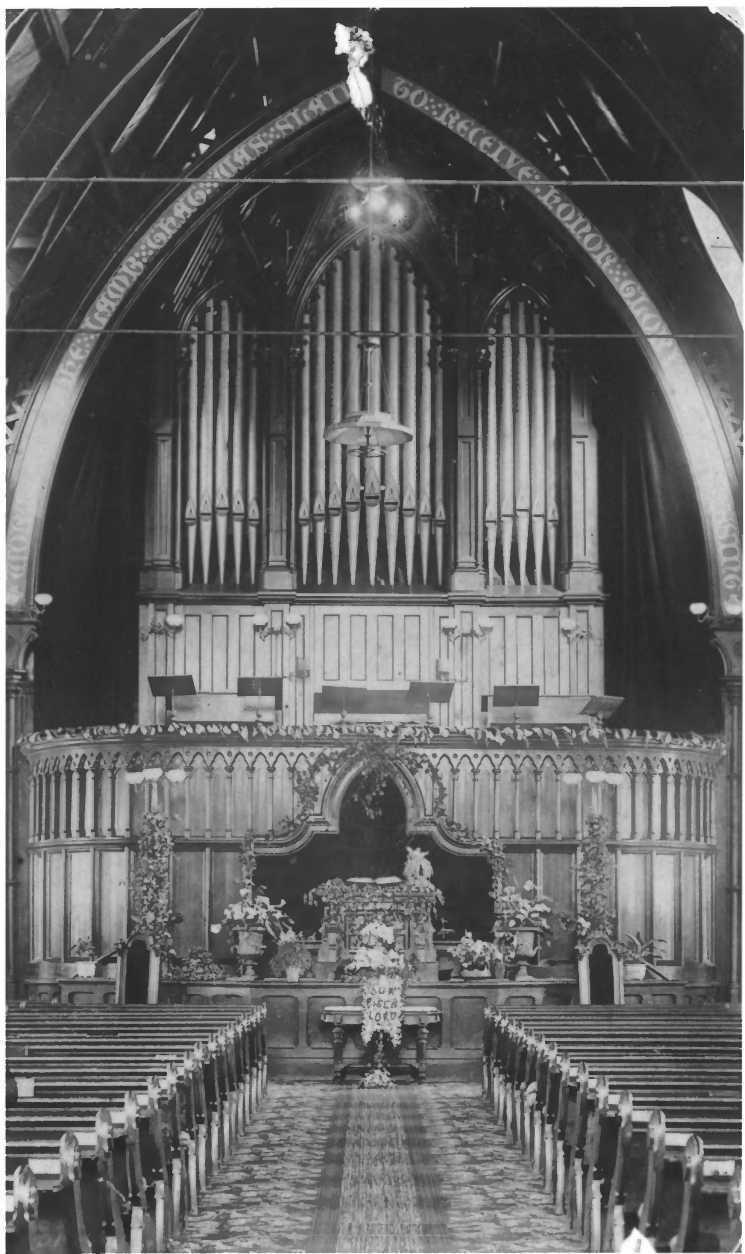
Photo No. H-22

A close-up view of the pulpit and organ in
Saint John's original 1867 church. All elements
are contained within the present church.

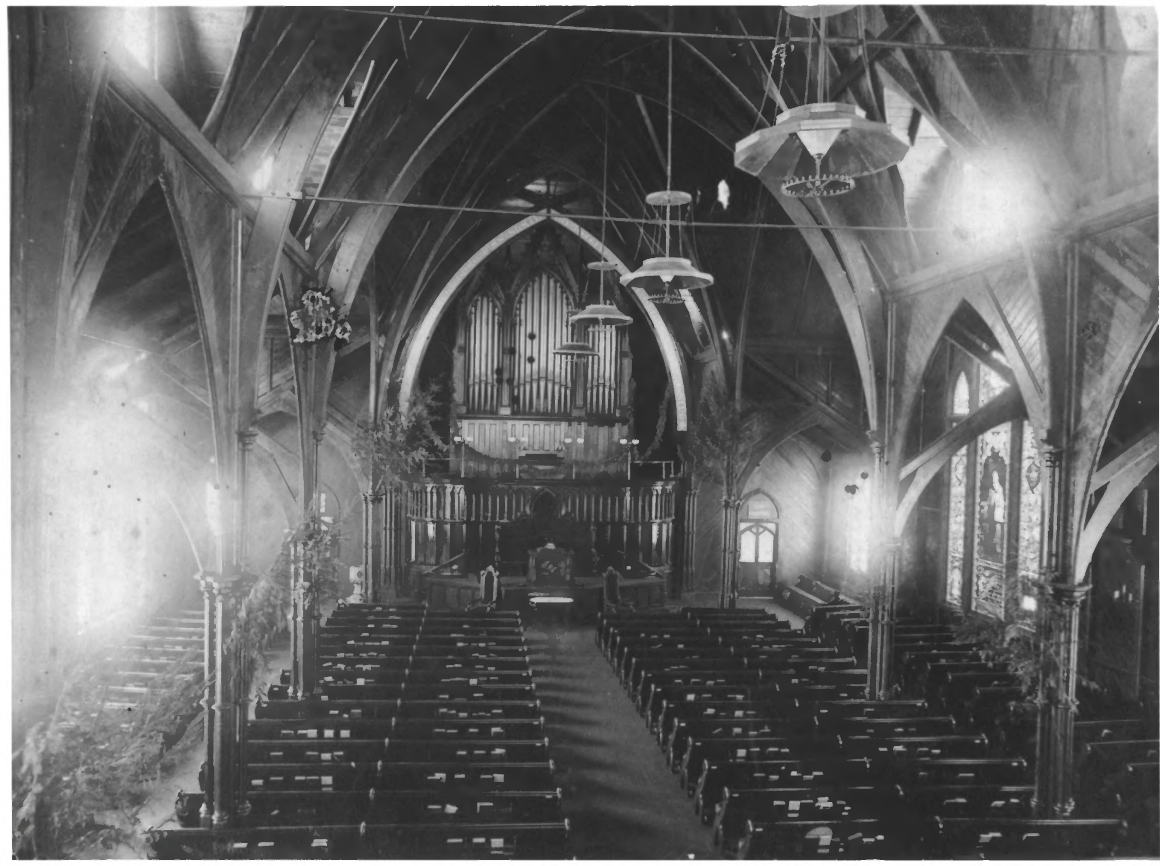
Photo No. H-23

Looking the length of the Sanctuary at
Saint John's second location at California
and Octavia Streets. Note the Saint John /
William Anderson Scott Window at center
right.

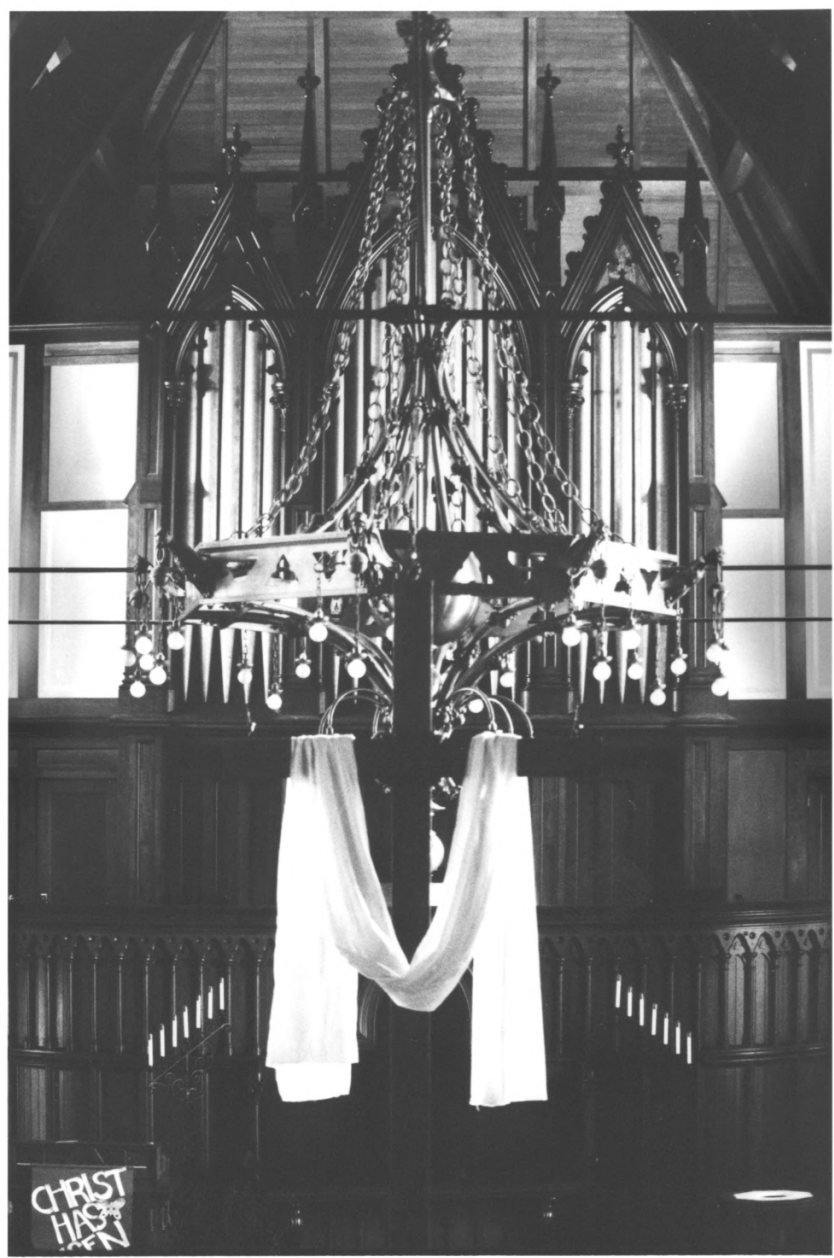
Photo No. 24

Looking West within the Sanctuary with
the Chandelier in the foreground and the
1872 organ beyond.

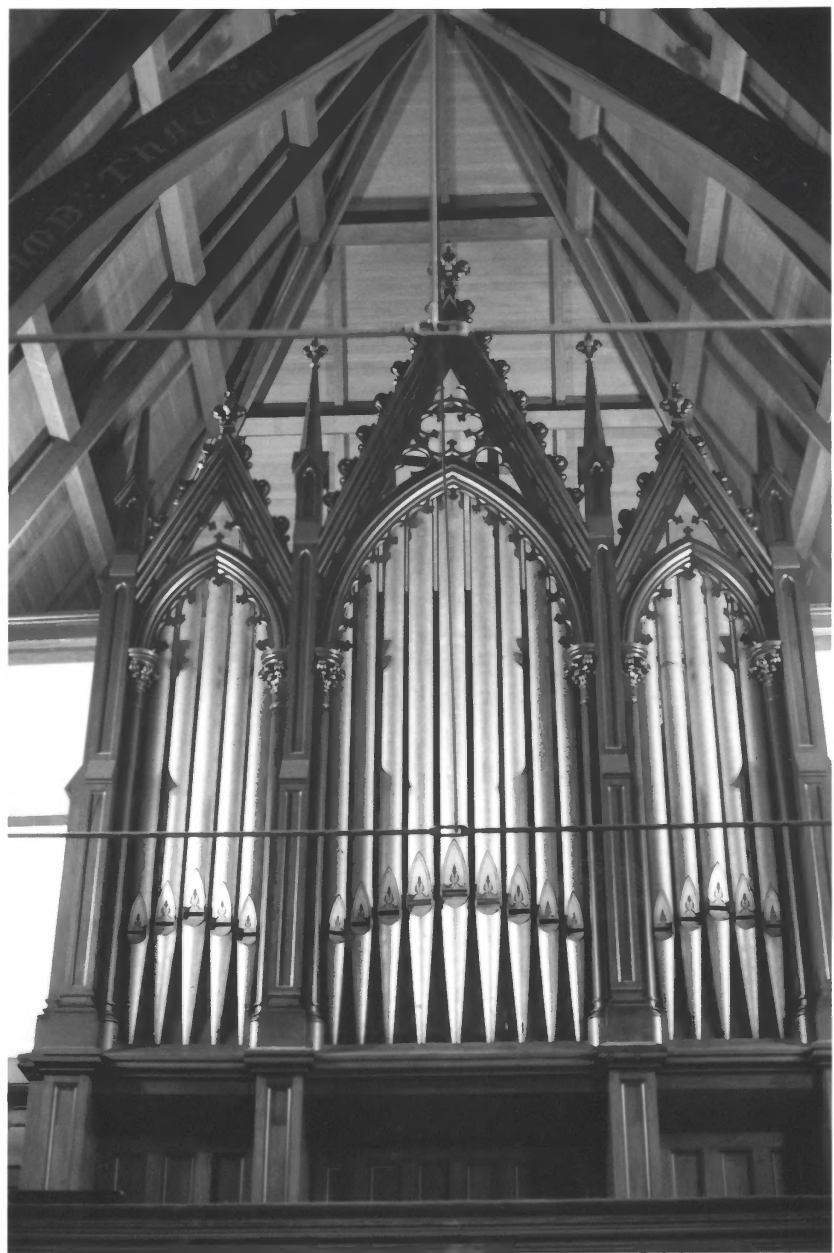
Photo No. 25

Looking West at the Johnson organ (1872) with
its Gothic framing, against the ceiling/roof
construction beyond.

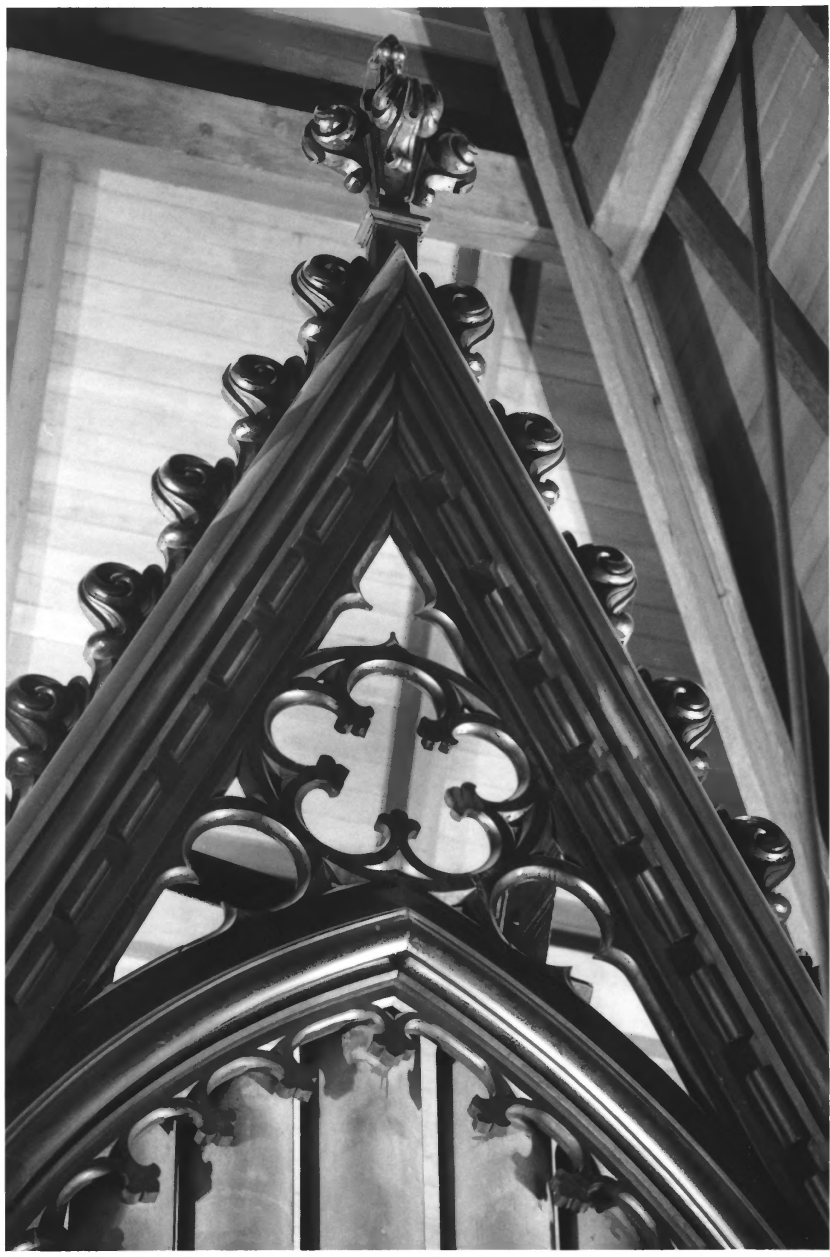
Photo No. 26

Looking West, a close-up view of the central portions of the Gothic organ enframement. Note similarity between finial design here and those used on the exterior of the Church.
