Saint John's Presbyterian Church
San Francisco, California

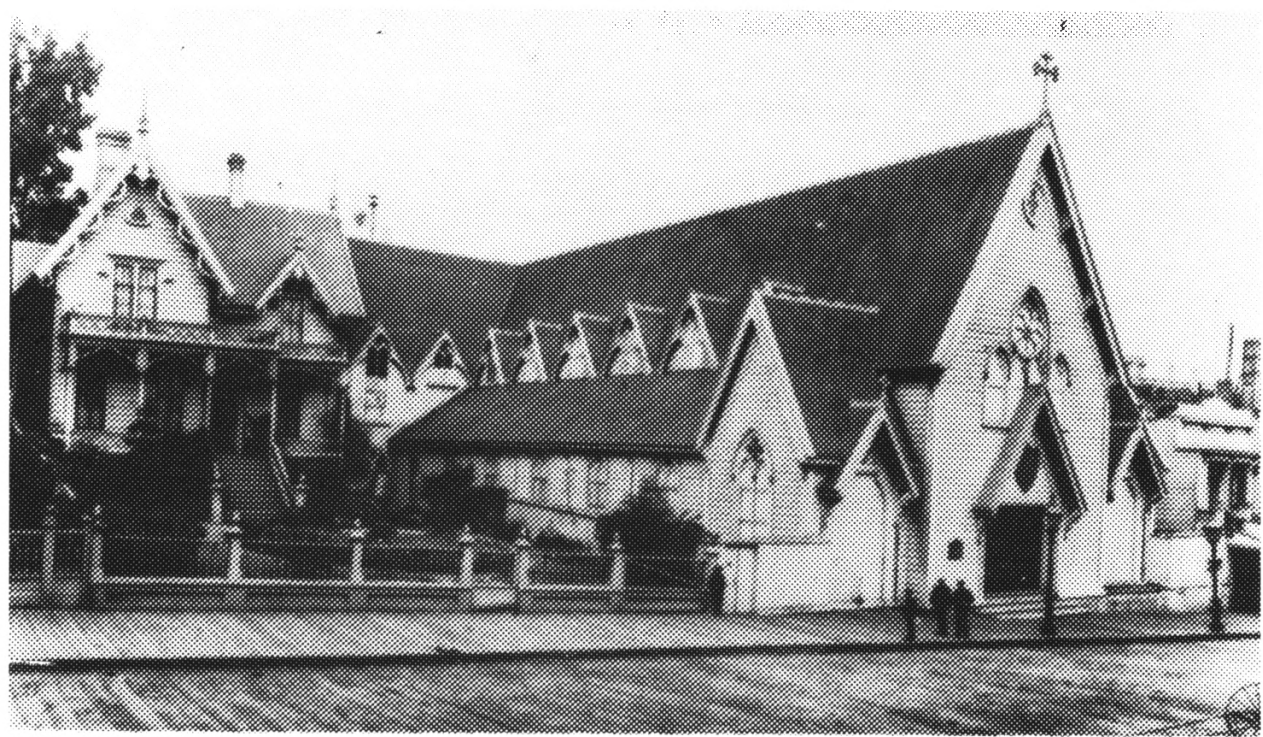
Photo No. 28

Looking Northeast at the original Saint John's Church built for Saint James Episcopal Church at Post and Mason Streets. Note Rose Window, steeply pitched cross-gabled roofs, and steeply pitched gabled hoods over clerestory windows and entrances.

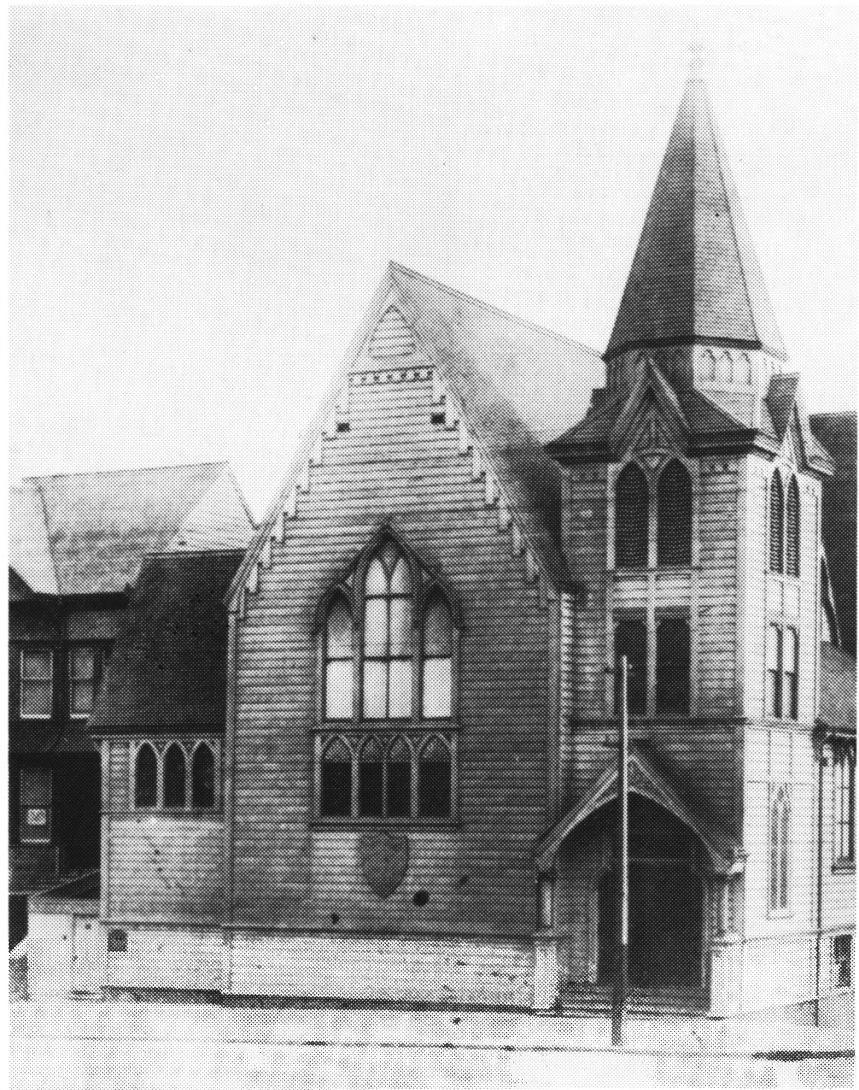
*St. John's Presbyterian Church —
California and Octavia Streets.*
