El Paso and Southwestern Railway Water Supply System (Bonito Pipeline) NOV-2 | 1979 vicinity of Nogal, Lincoln Co., New Mexcio Lane Ittelson, August, 1978 SEP 18 1979

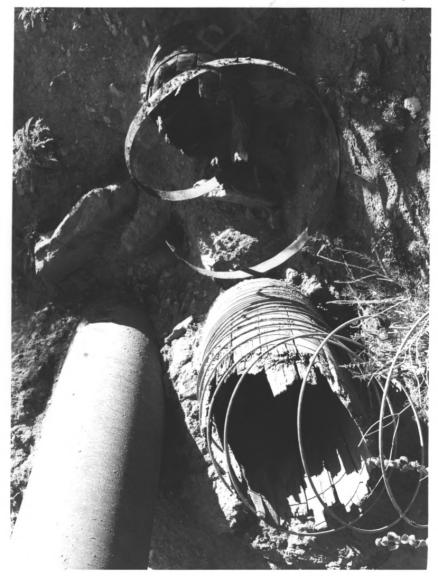
exposed section of pipeline showing 1908 flat steel wrapped pipe, c. 1914 round wire wrapped replacement pipe, and currently used metal pipe Photo #143

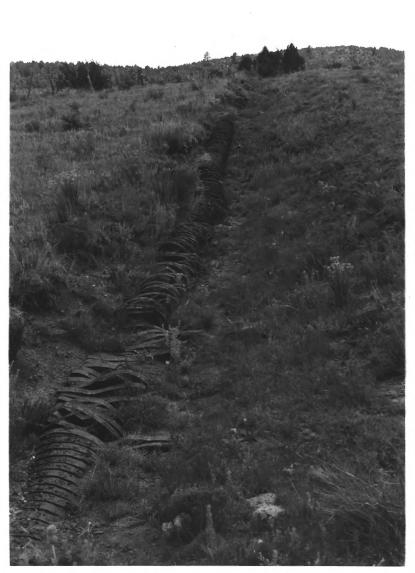
El Paso & Southwestern Railway Water Supply System (Bonito Pipeline) vicinity of Nogal, Lincoln Co., New Mexico Lane Ittelson, August, 1978 NOV 2 1979 exposed section of 1908 flat steel wrapped pipe; photo looking south Photo #293 SEP 18 1979

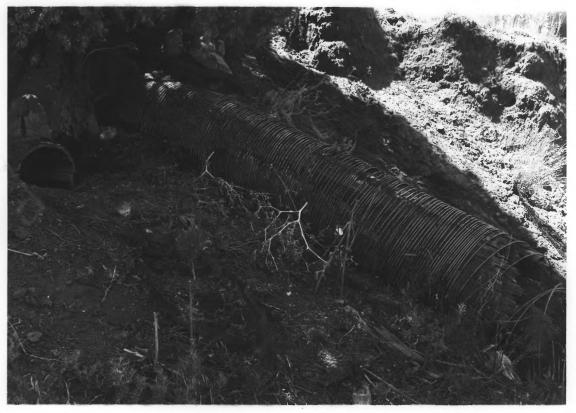
exposed section of 1908 flat steel wrapped pipe and c. 1914 round wire wrapped replacement pipe SEP + 8 1979 Photo #3/3
