National Register of Historic Places  
Registration Form

historic name Home for Aged Couples

other names/site number Elizabeth Carleton House

street & number 409, 419 Walnut Avenue, and 2055 Columbus Avenue not for publication

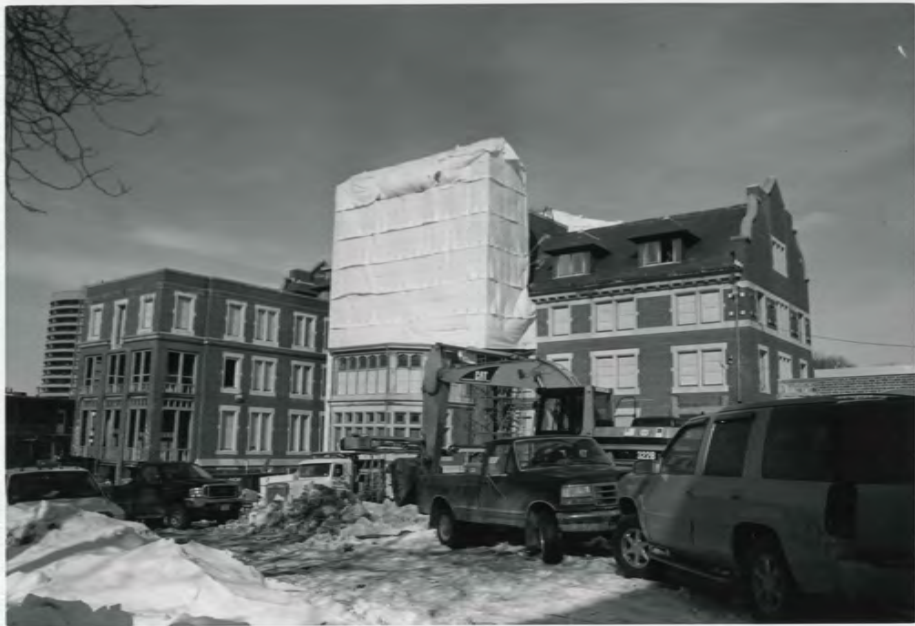
Columbus building, home for Aged  
Couple  
Suffolk County, Massachusetts  
photo #2

The ell is three bays across and projects five bays from the rear elevation. The decorative treatment mirrors that of the rest of the building, with tabbed, limestone-trimmed fenestration and limestone beltcourses carrying across from the adjacent facades (**photo #2**).

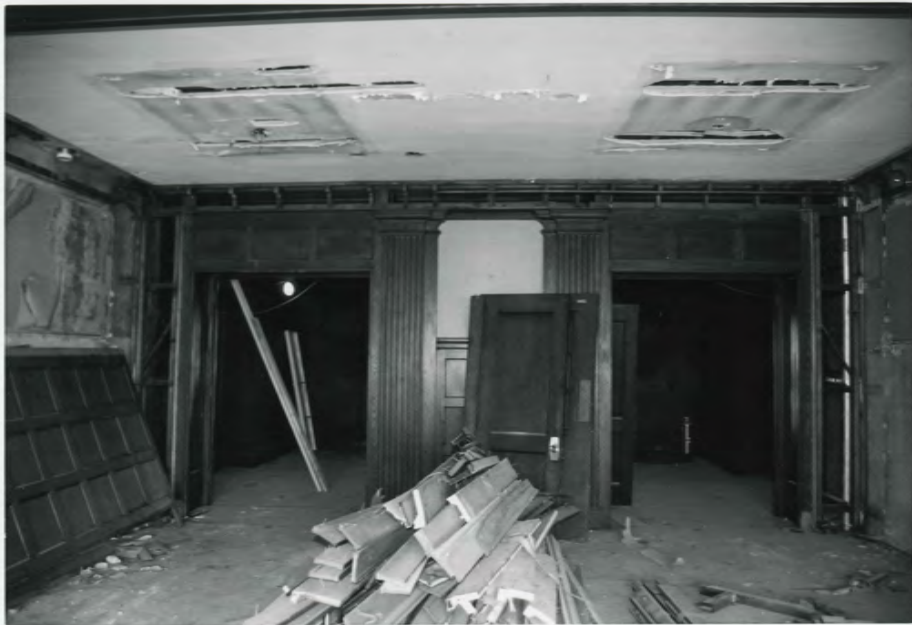
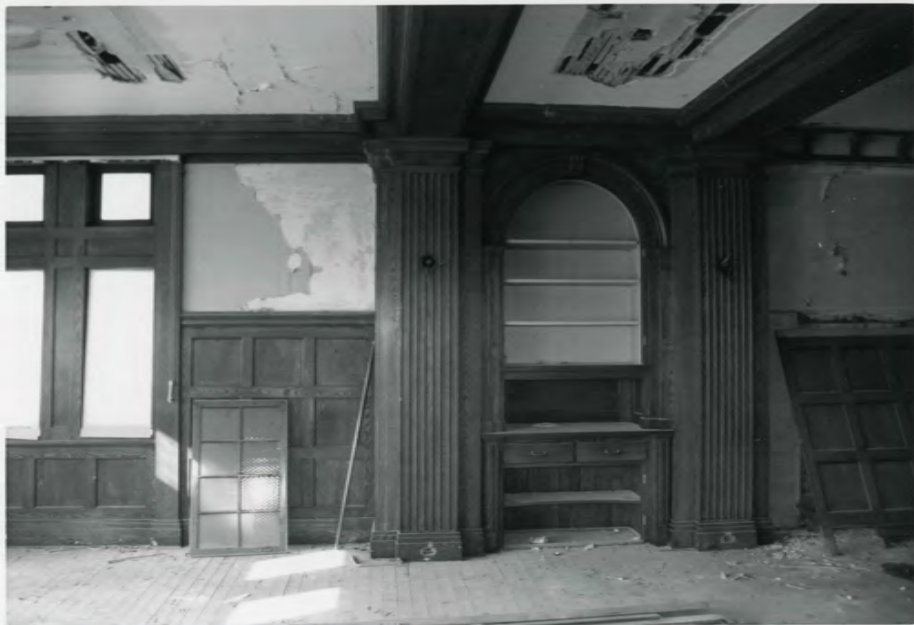
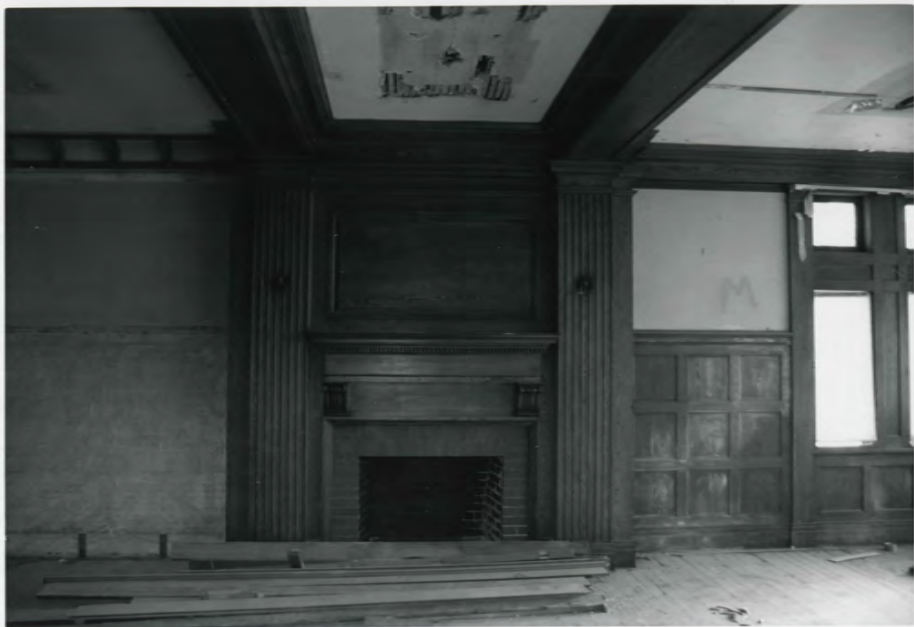
Columbus building, interior  
Home for Aged Couples  
Suffolk County, Massachusetts  
photo # 4

Columbus building interior  
Home for Aged Couples  
Suffolk County, Massachusetts  
photo #5

Columbus building, interior  
Home for Aged couples  
Suffolk County, Massachusetts  
photo #6

Interior finishes that will remain after the renovation (**photos #4-6**) include window and interior door trim, and the elaborate wood paneling, built-in cabinets, and fireplaces in the rooms that occupy the rear polygonal bay. Many interior partitions have been removed to accommodate larger living spaces.

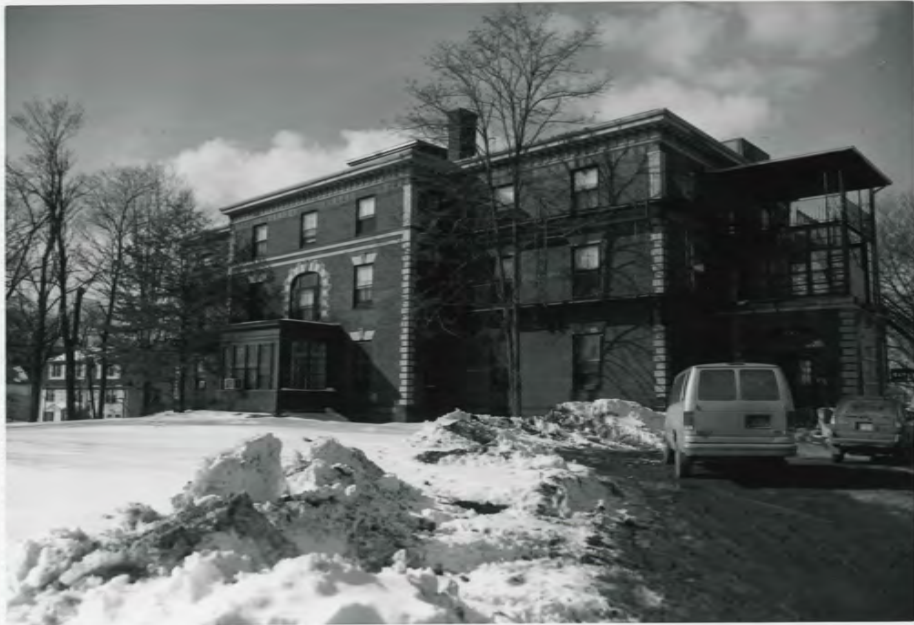
Suffolk County, Massachusetts  
photo # 7

Walnut building, Home for Aged  
Couples

The **Walnut Building (photo #7)**, erected in 1892, is a roughly rectangular, Colonial Revival, red brick building three stories in height, seven bays across, and three bays wide. A central pavilion projects slightly from the front and rear elevations, and three story porches project from the central bay of the lateral facades. A flat tar and gravel roof caps the building. Wood brackets support the eaves, and yellow brick quoins enhance all corners of the building. A yellow brick beltcourse between the second and third stories on both facades of the pavilion provides additional decorative detail (**photo #1-A**).

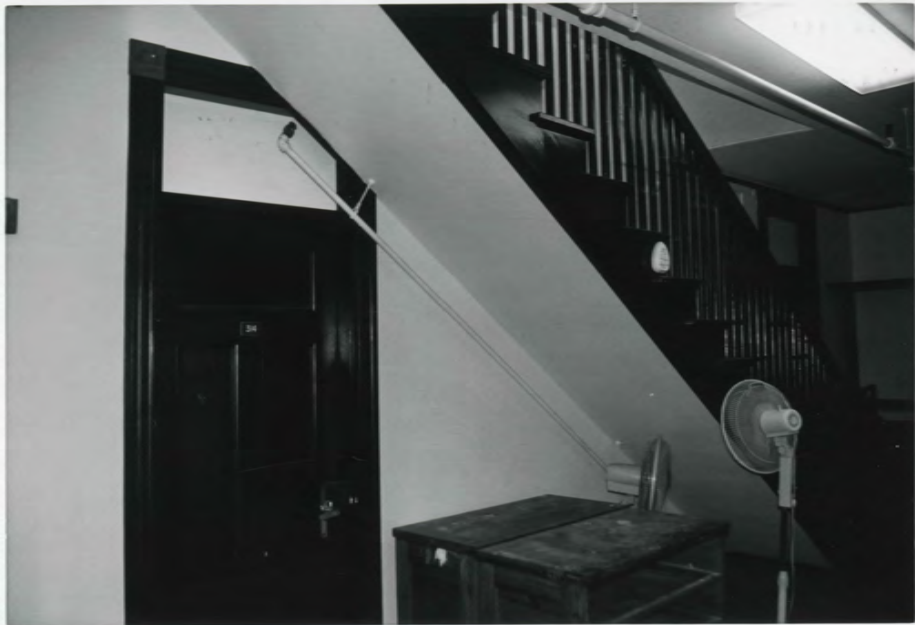
Walnut building, interior  
Home for Aged Couples  
Suffolk County, Massachusetts  
photo #9

The plan of the Walnut Building consists of a large square block flanked by two smaller square blocks, which are flanked by two smaller square, undivided, entrance pavilions. Central, double-loaded corridors connect the three main spaces. Rooms to either side function as office and community space on the main floor, with bedrooms in the western portion of the building, and throughout the upper floors. Circulation is facilitated by staircases in each of the flanking blocks (**photo #10**); these are located along the south walls of the corridors. A staircase located in the central block on the third floor accesses the roof (**photo #9**).

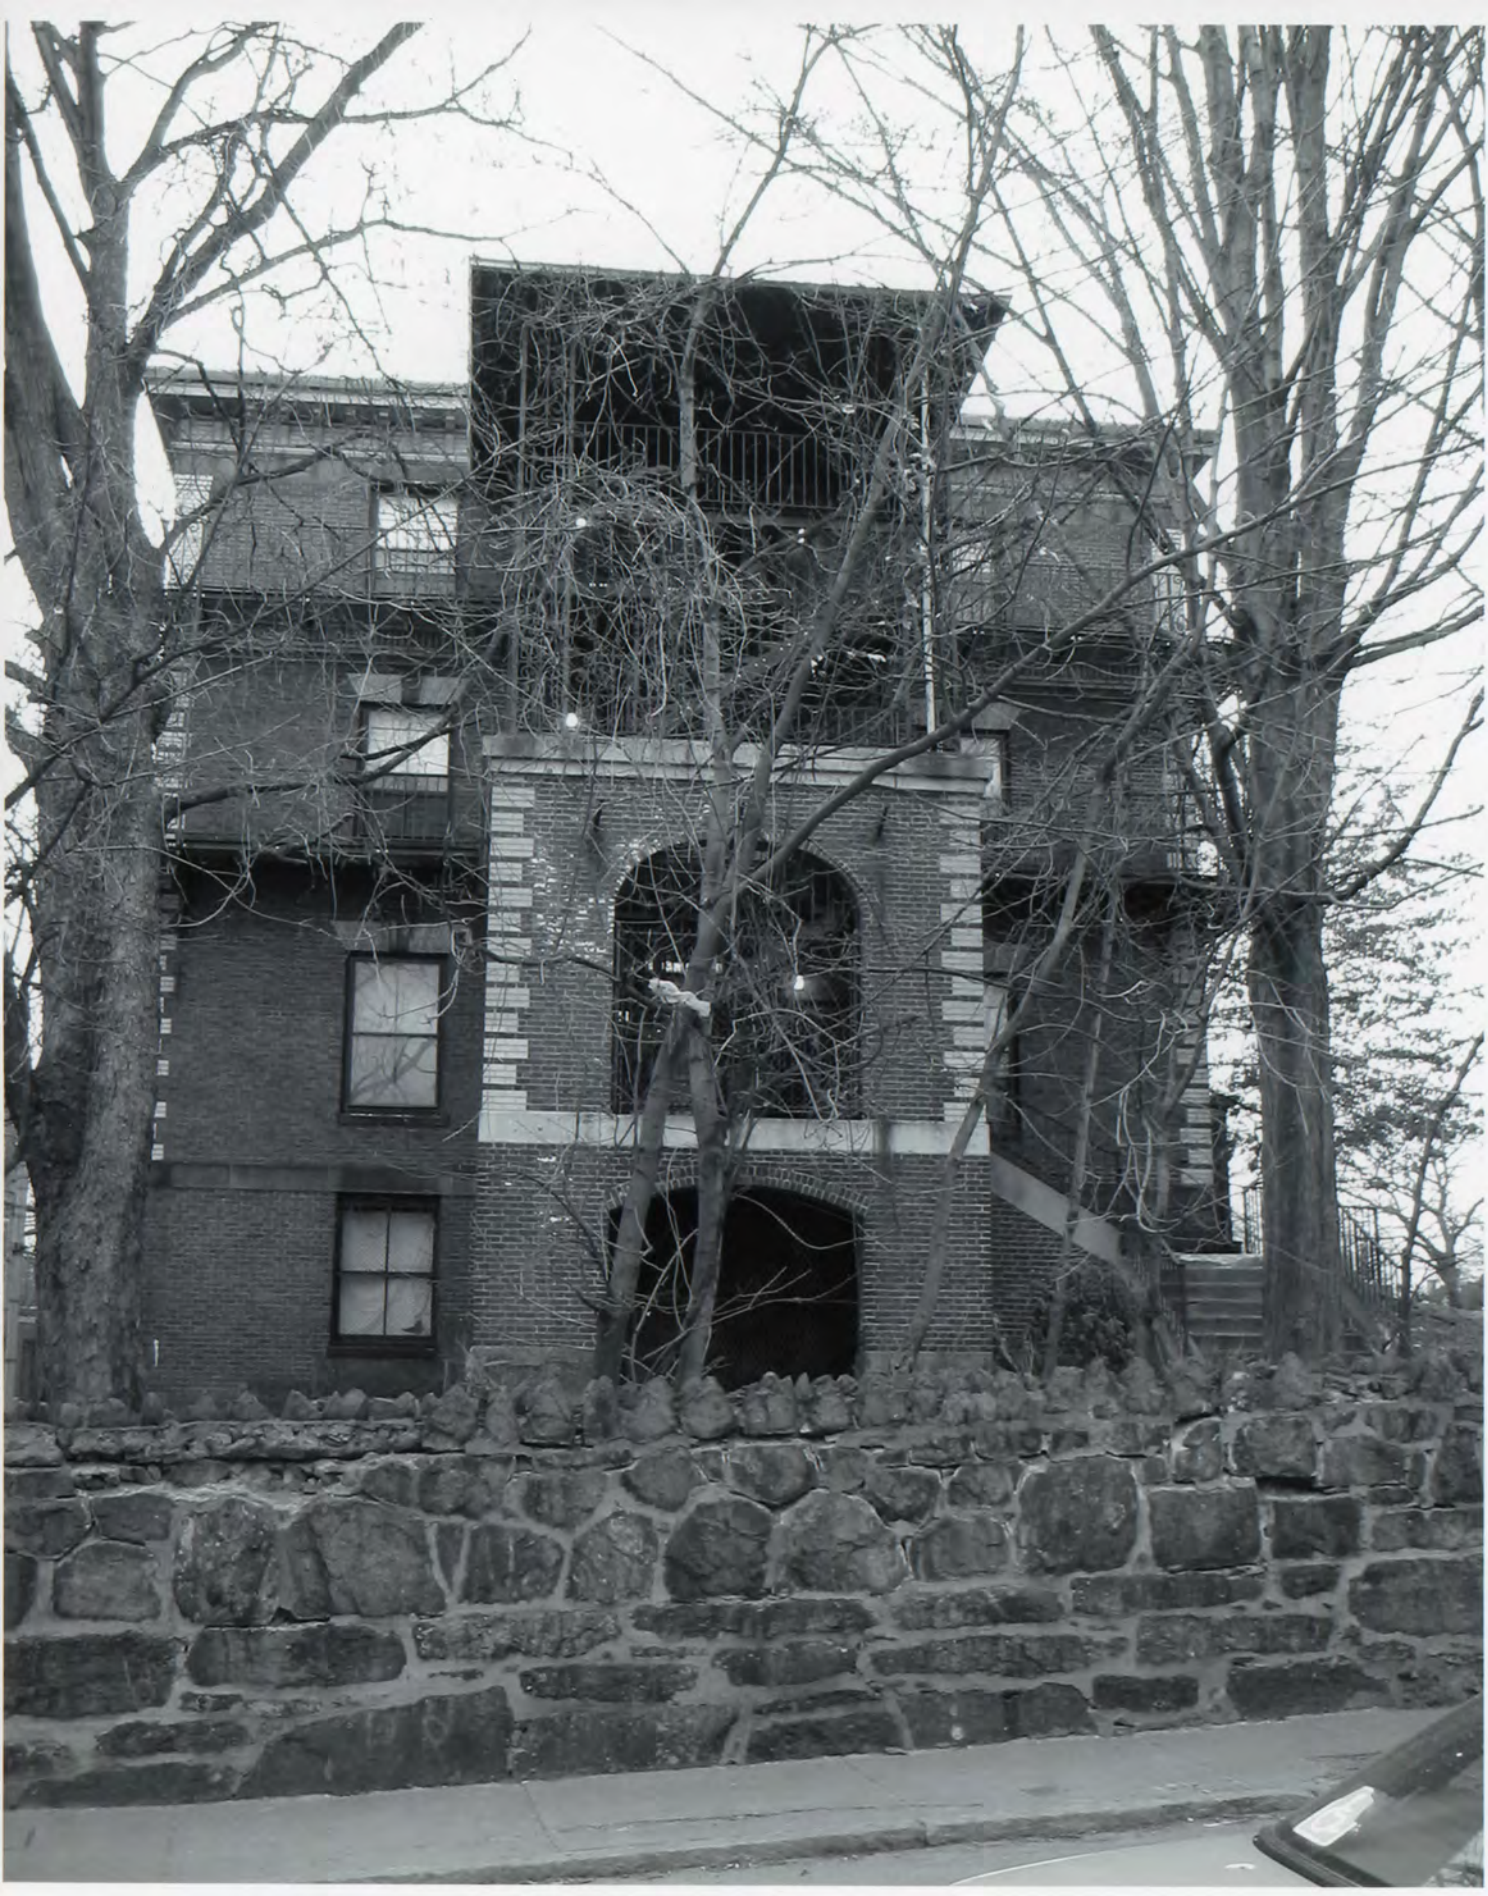
#2-A

Walnut Building  
Home for Aged Couples  
Boston, MA.

Three story porches project from the central bays of the lateral (east and west) facades of the Walnut Building (**photo #2-A**). The ground level stories of these porches are constructed of red brick with yellow brick quoining. Unglazed segmental arches pierce each ground level elevation of the western porch, while this level of the eastern porch is enclosed. The filled segmental arch on the eastern porch accommodates an entry embellished with a fan light and side lights. Above the brick bases, cast iron porches with decorative scrollwork (**photo #8**) at the corners rise to the cornice line of the building, and are capped with flat roofs. The second story porch on the eastern lateral façade has been partially glazed. Alterations to the porches extending from the eastern elevations accommodated the two story corridor connecting the Walnut and the Badger buildings.

A puddingstone retaining wall surrounds the property (**photos #2-A, 4-A, 10-A**). Granite capstones rest atop the puddingstone on the Walnut and Columbus Avenue portions of the wall. A low, cast iron fence rests on the capstones along Columbus Avenue. To accommodate entry into the site, the boundary wall is broken at the Badger and Columbus Building entrances on Columbus Avenue. A gated archway leads to the Badger building entrance. The portions of the retaining wall lining School Street and the rear of the property are less refined than the Walnut Street and Columbus Avenue portions. The wall along these boundaries is twice as high and unfinished along the top.

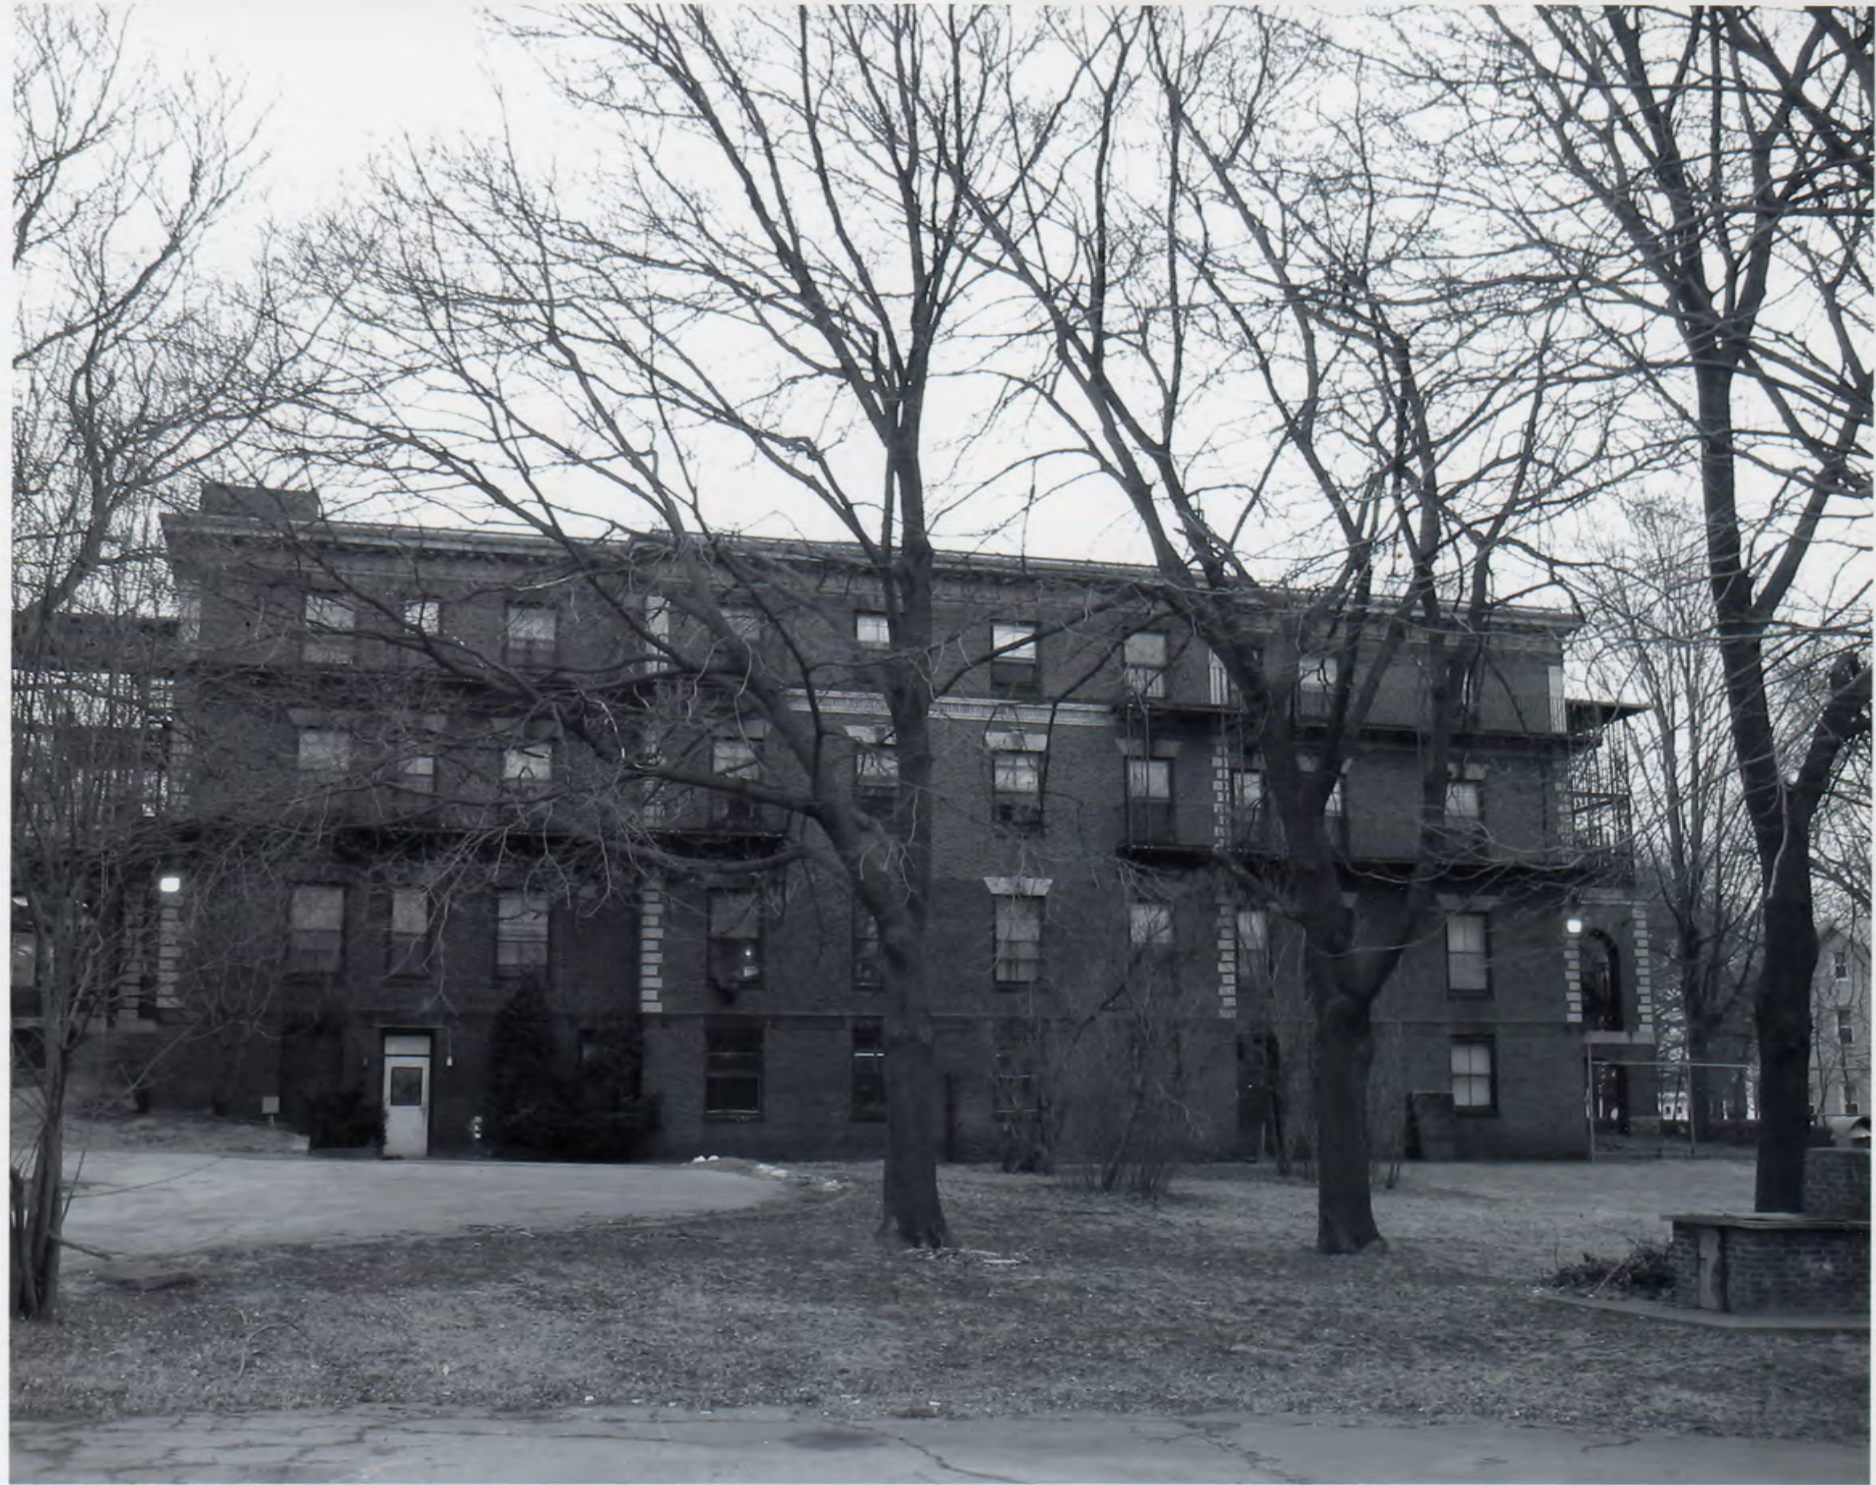
#3-A

Walnut Building  
Home for Aged Couples  
Boston, MA.

The fenestration of the rear (north) elevation of the Walnut Building resembles the main façade in its details and arrangement (**photo #3-A**). However this elevation includes a basement level, unadorned by quoins, to accommodate the slight grade change. Additionally, the central pavilion is pierced by four windows on each story rather than three, and its flanking facades feature three windows rather than two. Entry is through a small, unadorned door at the basement level.

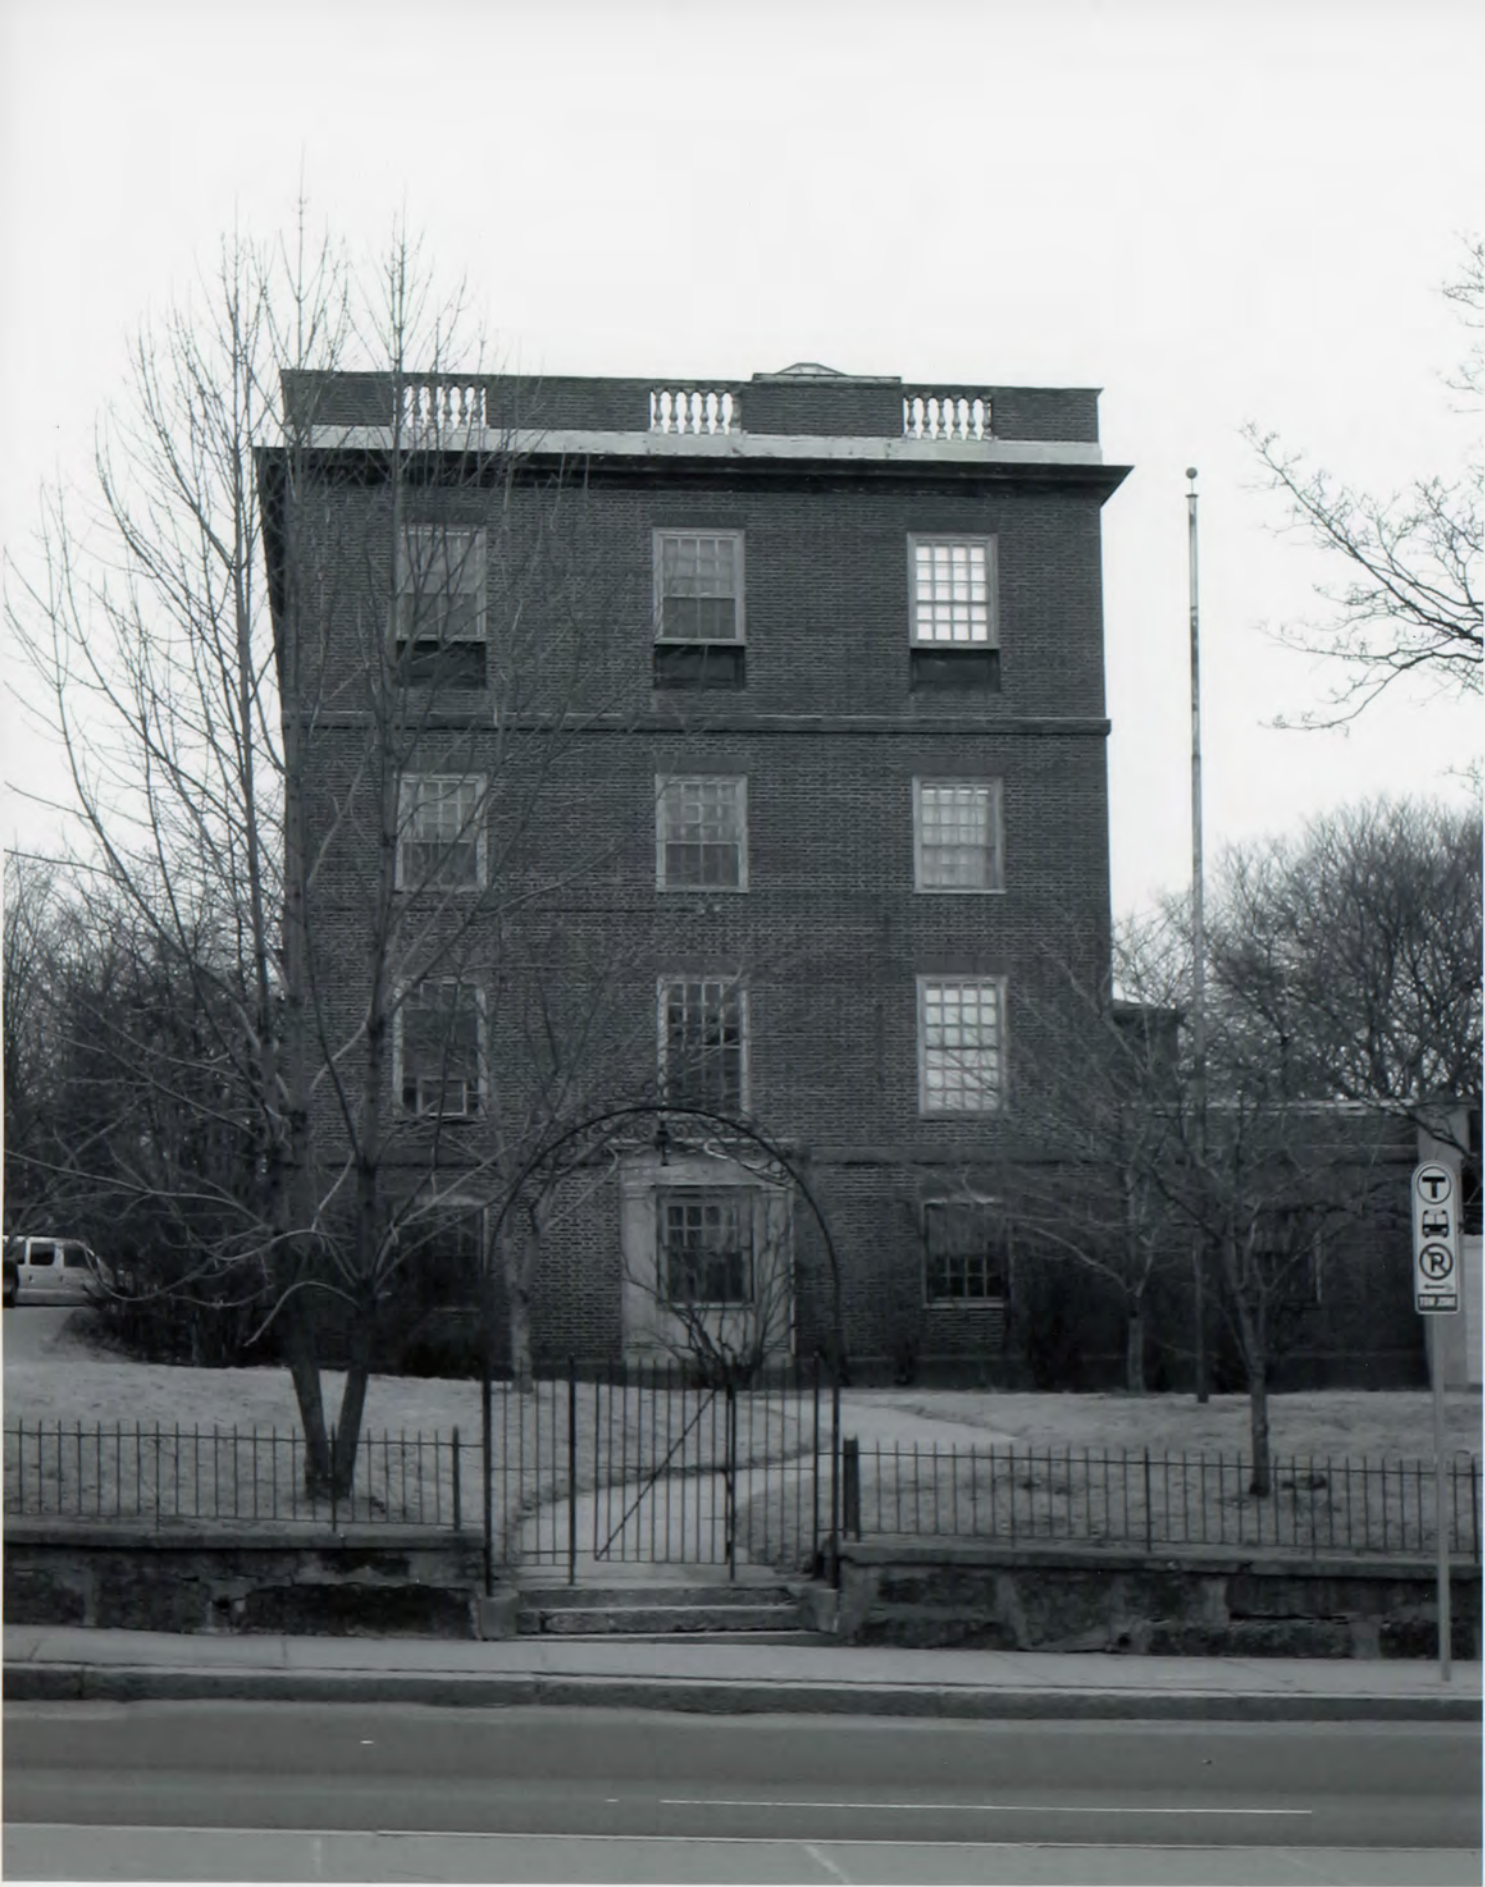
#5-A

Badger Building  
Home for Aged Couples  
Boston, MA.

The Columbus Avenue (east) (**photo #5-A**) elevation is the Badger Building's primary facade. A central entry at the ground floor level draws on classical precedent with engaged columns flanking the entry, and supporting an entablature. To either side of the entry, 8/8, double hung wood sash windows beneath segmental arches light the ground floor level. Above the ground floor, the three bays of the first, second, and third stories are lit with 12/12, 12/8, and 12/8 double hung wood sash, respectively. The third story windows rest on recessed wood panels.

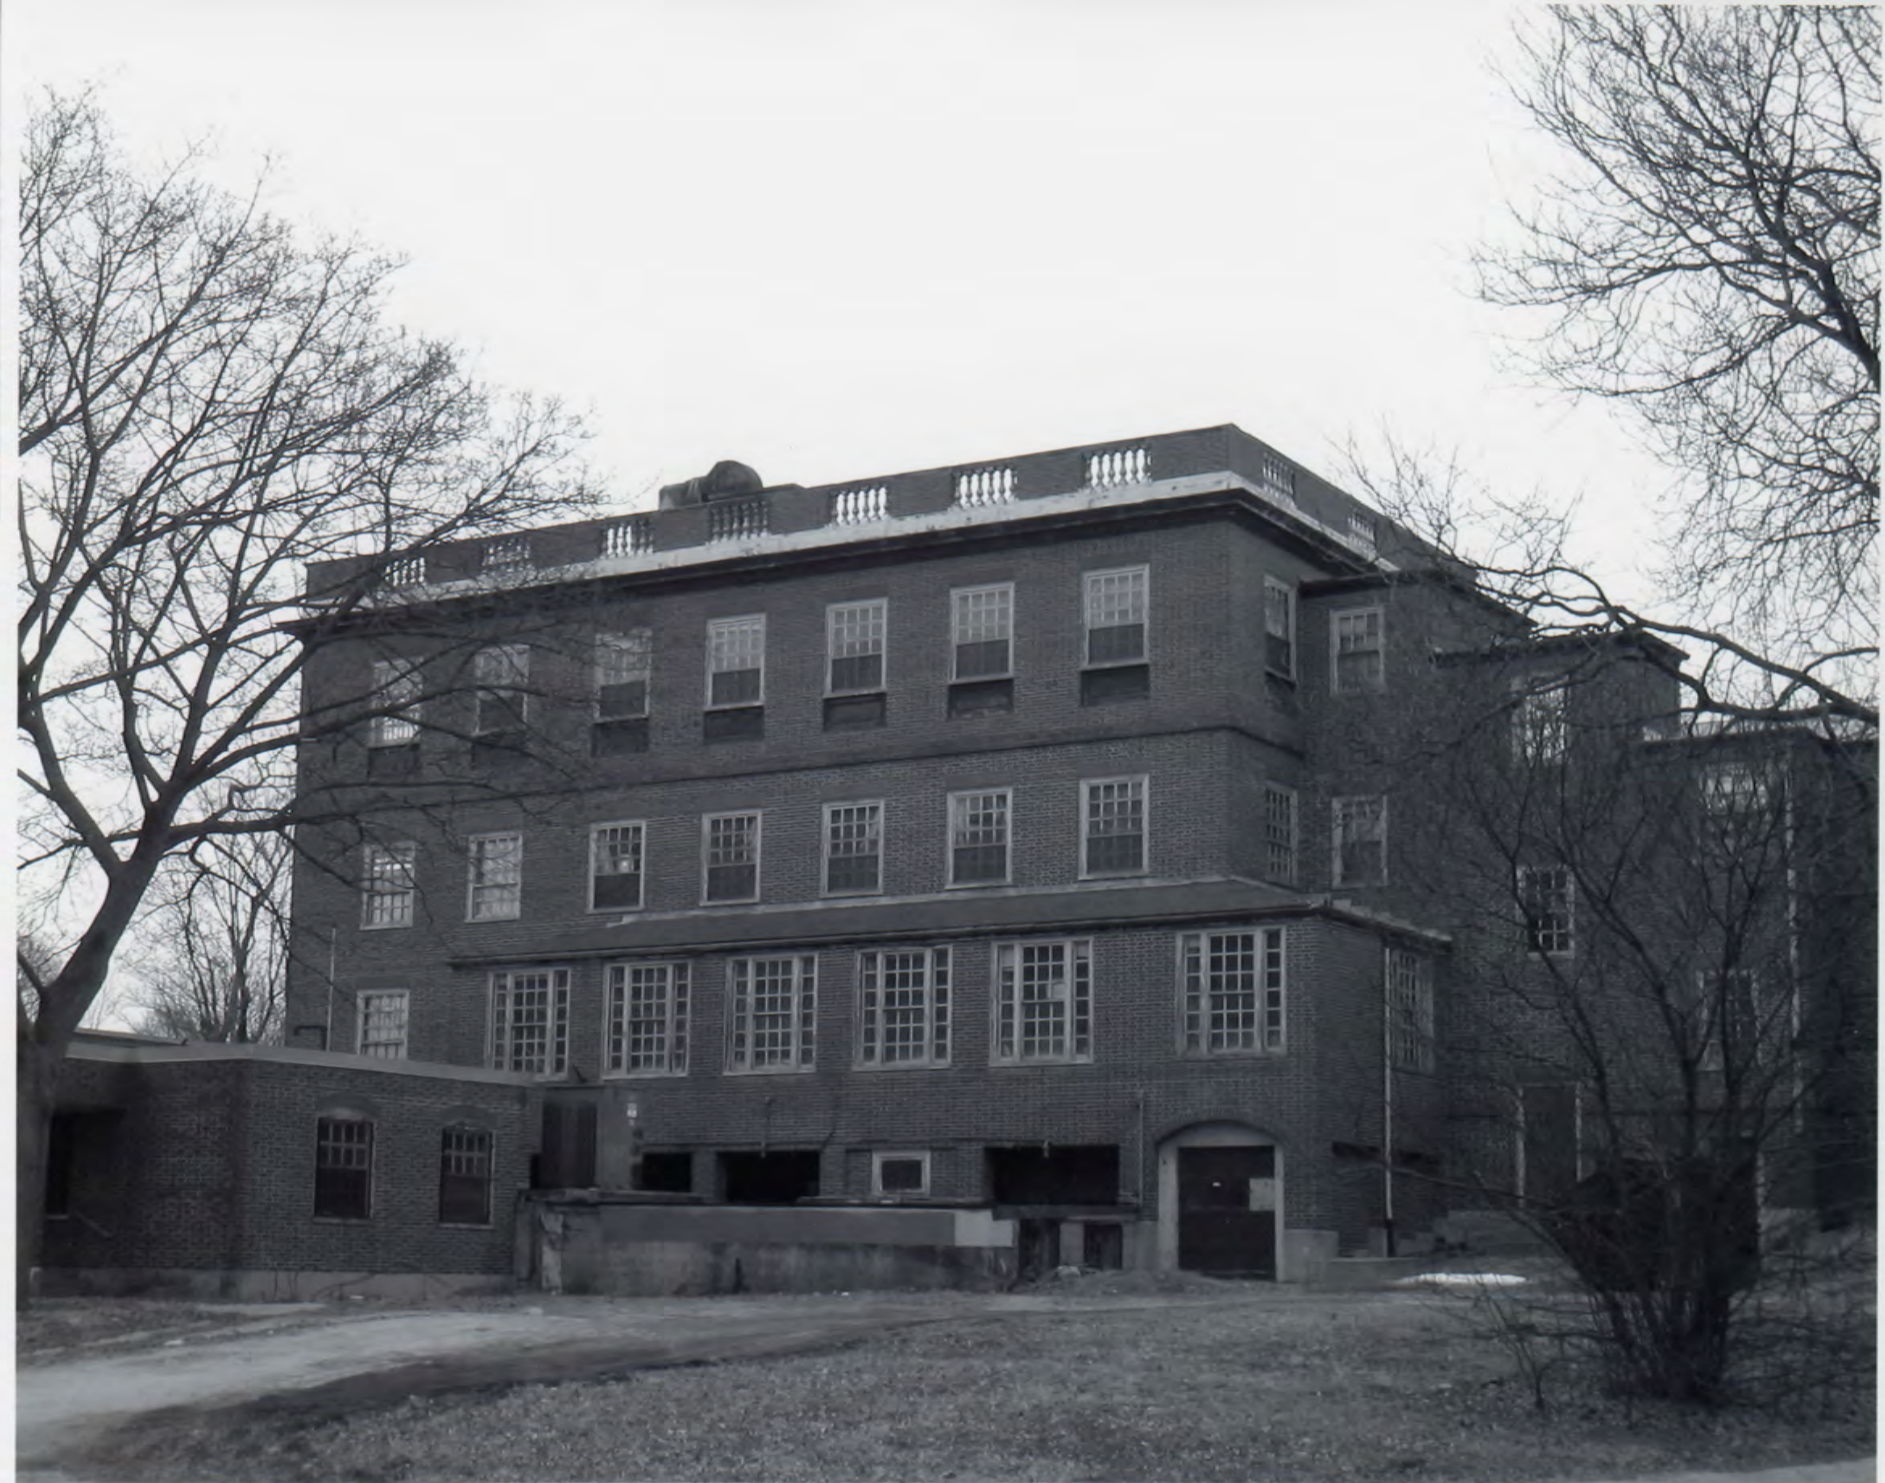
#6-A

Badger Building  
Home for Aged Couples  
Boston, MA.

The west elevation of the Badger Building (**photo #6-A**), originally probably identical to the Columbus Avenue (east) elevation, has been obscured by the addition of the pedestrian corridor linking the Walnut Building and the Badger Building, and by the hip roofed addition on the north facade which extends across the ground and first floor stories of the west facade.

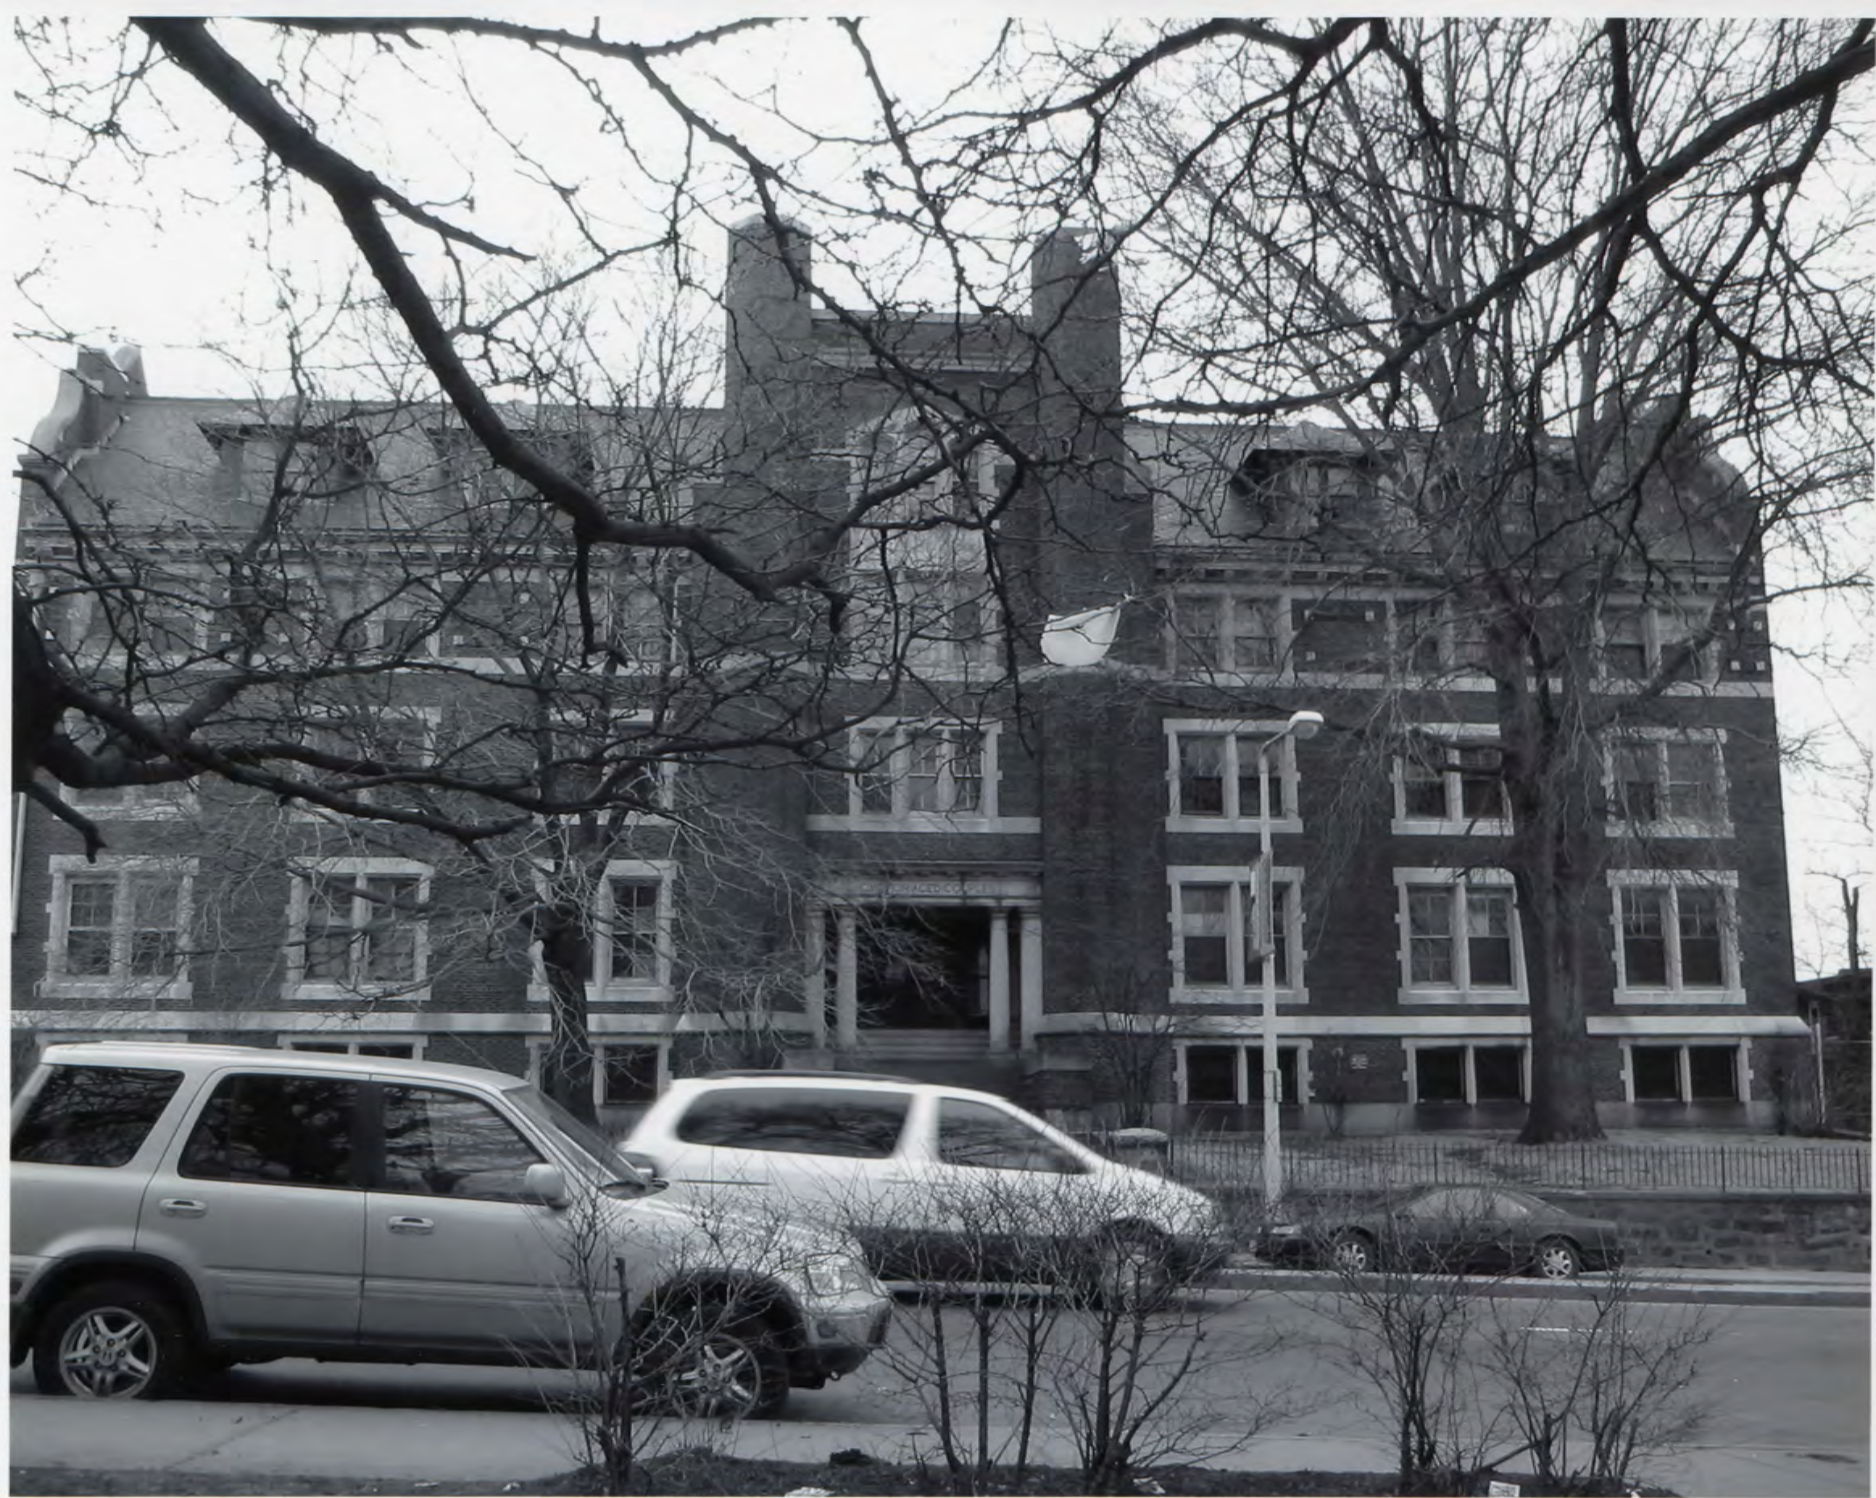
Columbus Building  
Home For Aged Couples  
Boston, MA.  
# 7-A

The dominant feature of the Columbus Building is the strongly articulated central pavilion. Flanked by octagonal turrets, the pavilion rises a full four stories, and is pierced by a recessed entry at the first floor level, and a trio of windows on each floor (**photo #7-A**). The entry, executed in limestone, is classically inspired with a pair of free standing round and engaged squared columns supporting an entablature inscribed, "HOME FOR AGED COUPLES." Limestone beltcourses differentiate the first and second stories. The trios of 4/4, double hung, wood sash windows are trimmed in tabbed limestone. The center window of the fourth story trio rises slightly above those to either side, creating a segmental arch of limestone trim.

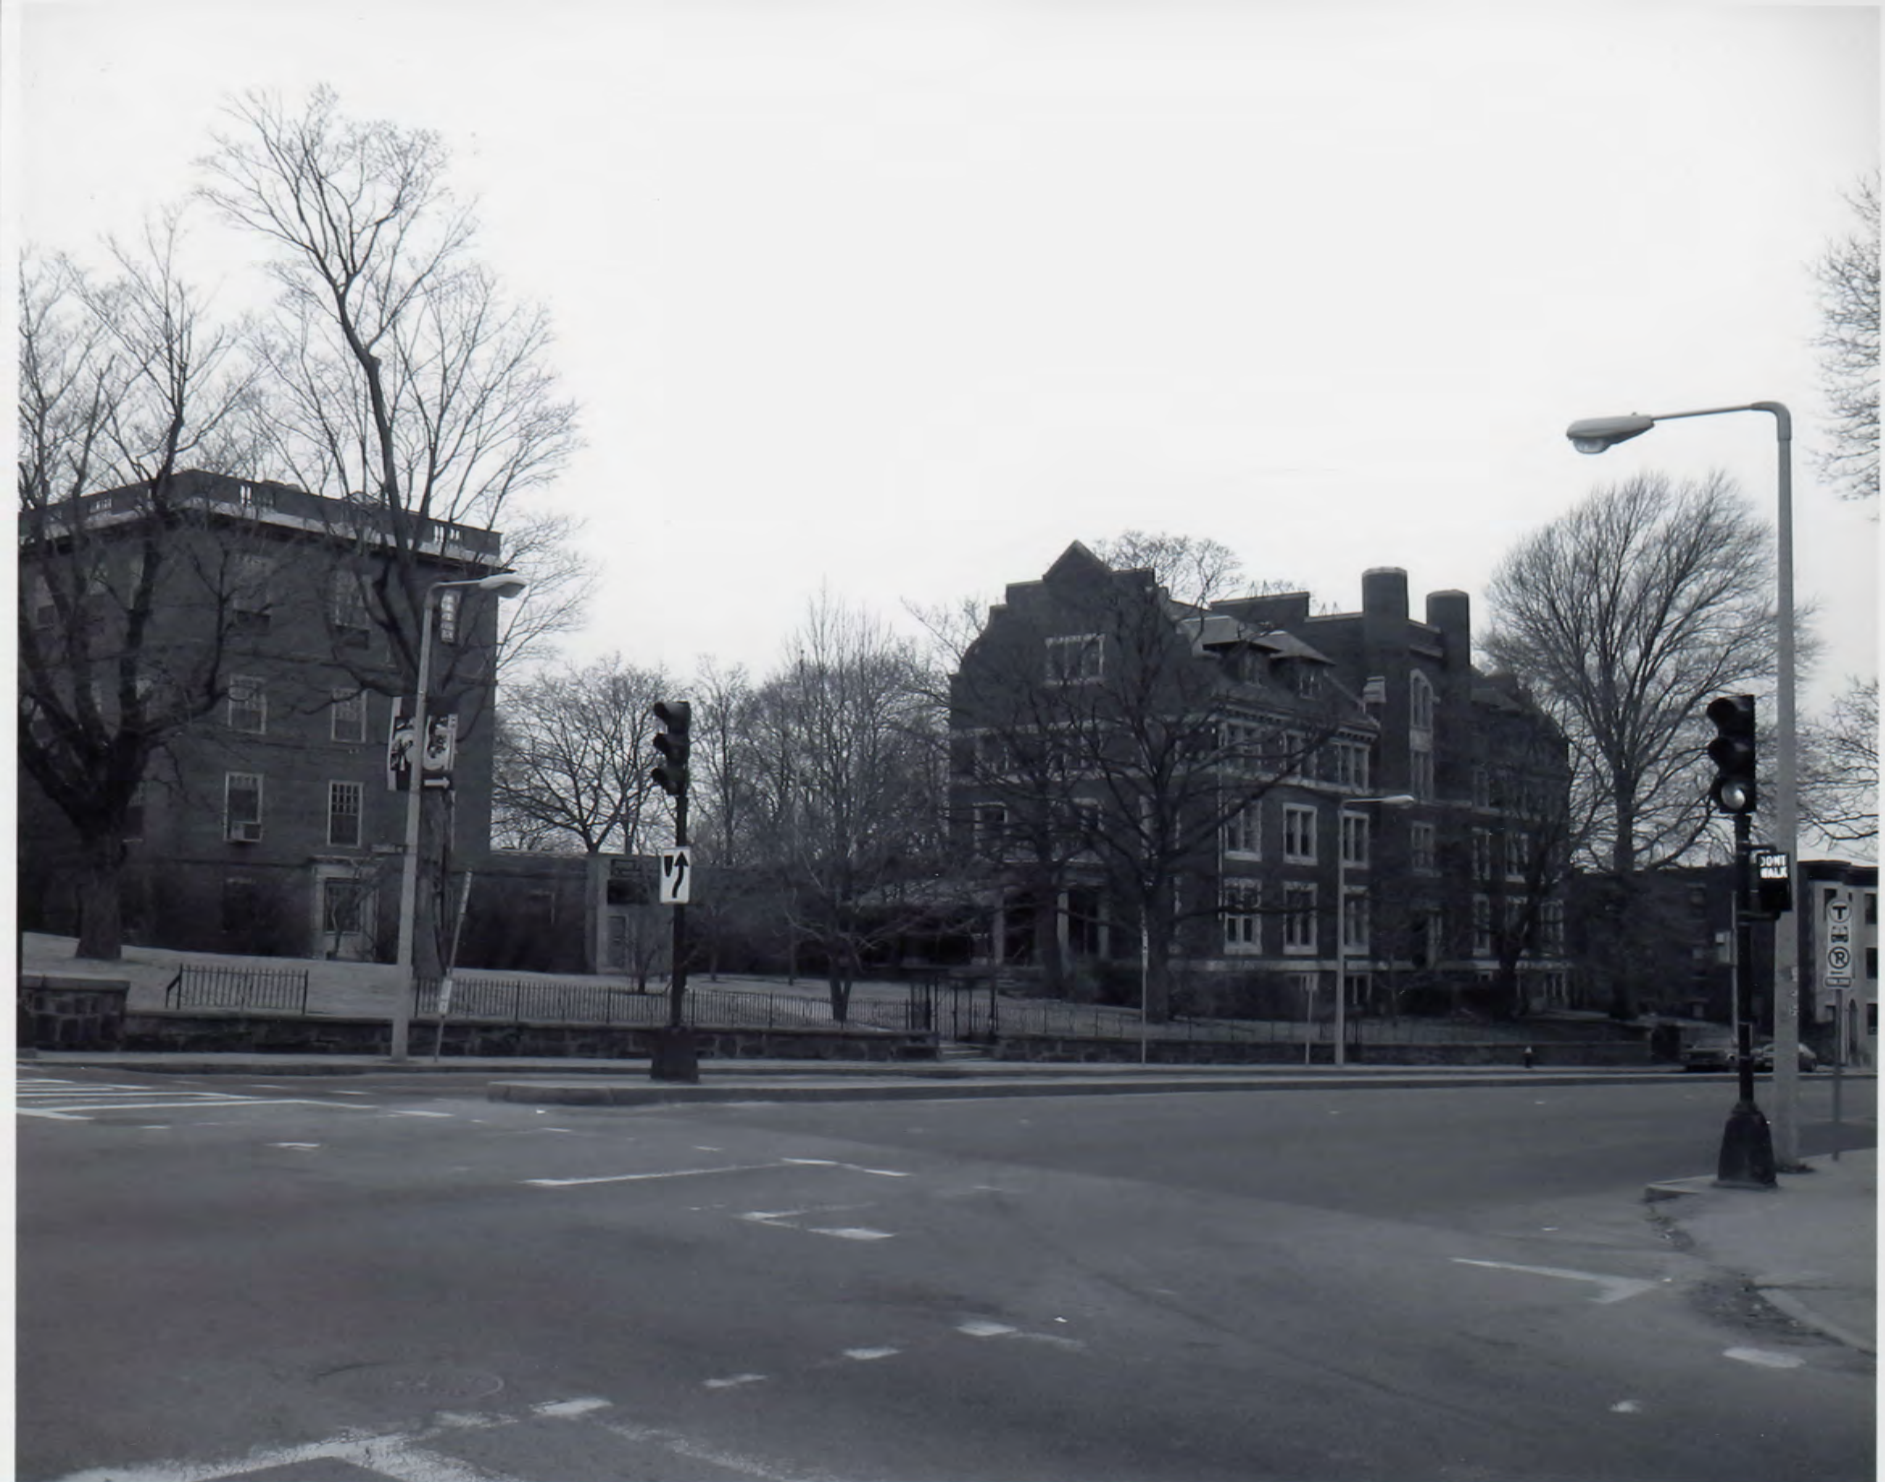
Home for Aged Couples  
Boston, MA.  
# 10-A

L-R  
Badger Building, Columbus Bldg.

**The Columbus Building (photo #10-A)**
