National Register of Historic Places
Registration Form

historic name Rulon, John C., House

John C. Rulon House
Name of Property

Gloucester County, New Jersey
County and State

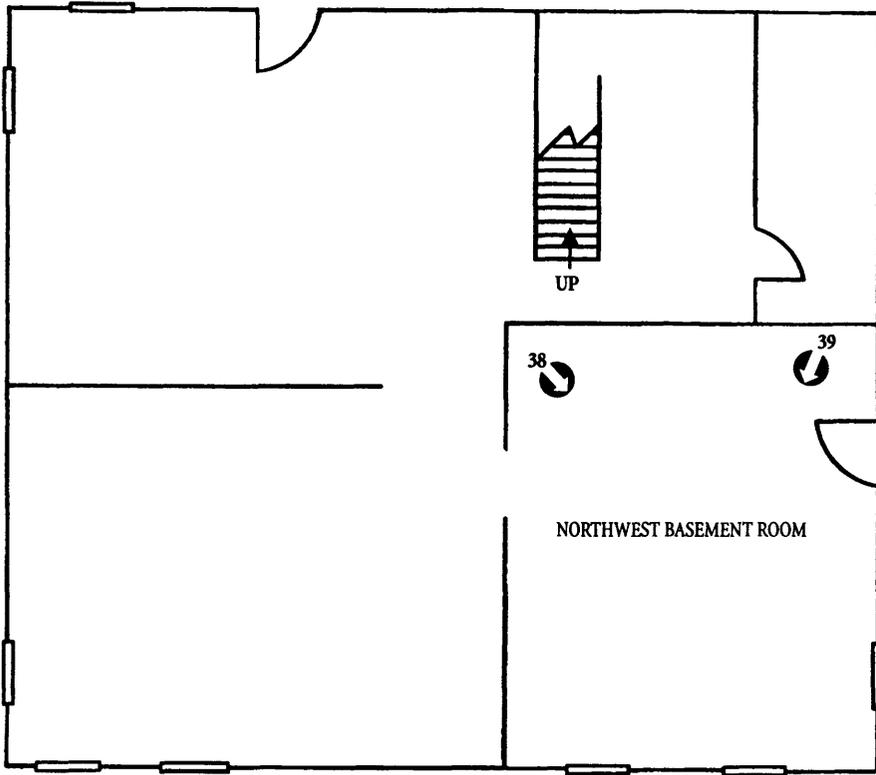
Basement Plan

The structure of the house is visible in the attic and the basement. The framing runs north-south in all three sections with the exception of the framing under the center hall, which runs east-west. A brick bearing wall across the eastern half of the house reduces the span of the joists. The c.1814 section is delineated by thick stone foundation walls. Pegged mortise-and-tenon joinery is used in the c.1820 section. The attic is divided into two parts by the brick bearing wall on the west side of the hall. In the eastern, c.1820 half, the wood is vertically-sawn with pegged mortise-and-tenon joinery. In the western half, which was reframed in 1883-84 when the last quarter was built, the framing members are paired and butted circular-sawn. The framing in the cross gable is the same as in the western half, tying it to the 1883-84 period.

One unusual feature of the house is found in the basement. The northwest corner room, under the c.1814 section of the house, was finished for use as a room (photograph 38). Approximately six inches above the dirt floor begin plaster walls, with evidence of a missing baseboard. The dirt floor level in this room is much lower than the later concrete floors in the rest of the basement. A wood chairrail circled the south, west, and north walls about three feet above the former location of a finished floor. It has been removed from the west and north walls, but the outline in the plaster remains. The ceiling is also plastered. On the south wall, there is a doorway, converted to shelving. On the west wall, there is a nineteenth-century six-panel door similar to those found on the third floor. The middle two panels have been replaced with glass. The door trim has been removed. To the north of the door is a six-over-six double hung sash with a three-quarter transition bead at the jamb surrounded by an inch of plain trim. This trim is found around windows and doors in the c.1820 section of the basement also. On the north wall there are two three-over-six single-hung sash. One has the same trim as the west window, the other has wide, although still unmolded, trim. These windows are now both located beneath the porch, but in earlier configurations of the house may have been exposed. In the northeast corner of the room, there is an outline of a quarter-turn stair running from the northeast corner up along the east wall (photograph 39). This outline, presumably of the stair for the c.1814 house, corresponds with a patch in the wood flooring above this corner on the first and second floors. An opening was created in the southeast corner of the room for access from the c.1820 section of the basement. In addition, the ceilings in the eastern half of the basement were plastered at one time, and the walls in the southeast quarter are still plastered.

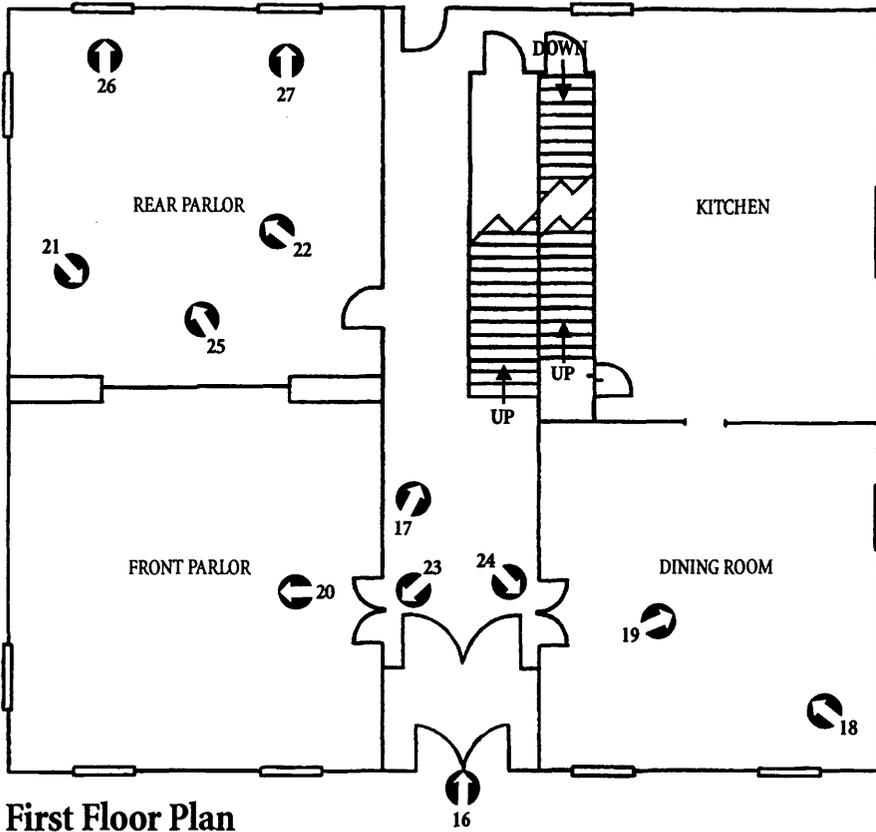
First Floor Plan

The existing first floor plan is a nearly symmetrical, double-pile, center hall plan, with adjoining parlors separated by a set of large pocket doors on the east side, a dining room in the northwest corner (photograph 18), and a kitchen behind it. The front entrance is separated from the hallway by a vestibule (photograph 16). Sets of five-panel double doors lead from the hallway to the dining room and the front parlor. The half-turn staircase with a landing is located along the west wall of the hallway (photograph 17), while a single door on the east side leads from the hallway to the rear parlor. The hallway continues behind the stair, under the landing, where one door leads to the kitchen and another to the closet under the stairs. A door at the south end of the hallway leads to the exterior deck and another single door links the dining room and the kitchen.

On the interior, a full center hall, double-pile plan was created. The main stair was either altered or rebuilt and the c.1820 basement stair was removed from beneath the main stair and rebuilt in the east side of the new kitchen in the southwest quarter, beneath the new back stairs. It also appears that the wall between the two parlors was moved north approximately one foot, perhaps to allow construction of the new pocket door system with the old wall still in place for bearing purposes. The window, door, and baseboard trim was replaced throughout the house and all the six-panel doors were replaced with new four-panel doors and new double doors into the front parlor and dining room, although a few of the six-panel doors were re-used in inconspicuous locations. The finish on all the new wood elements was a light cherry graining.

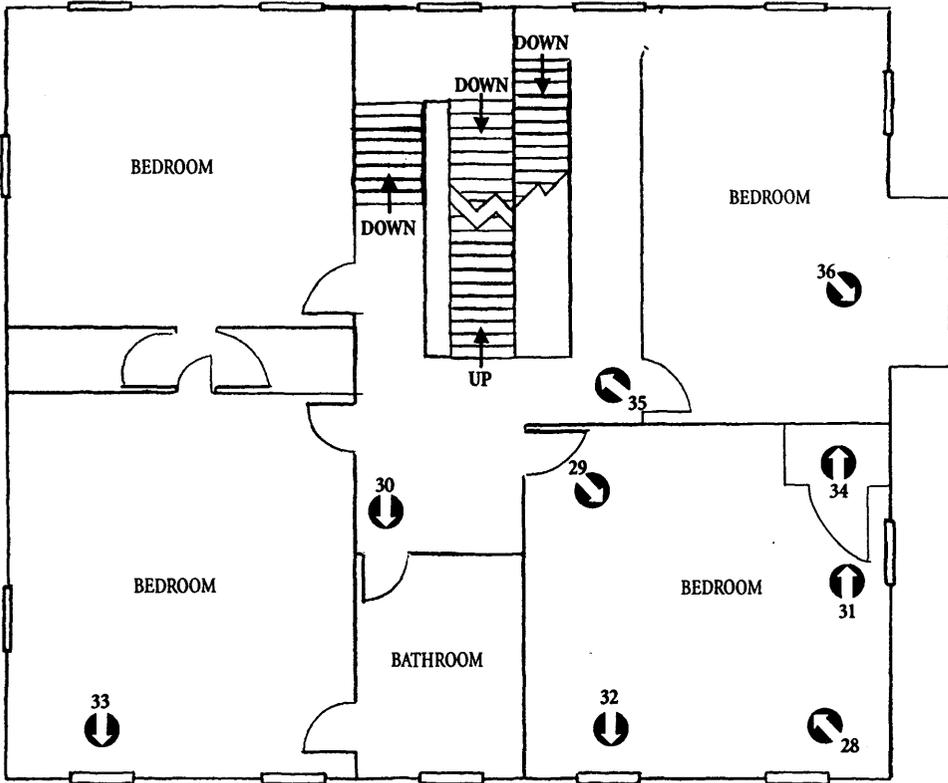
Second Floor Plan

The second floor layout, while essentially retaining the center hall, double-pile plan, is made noticeably asymmetrical by the inclusion of the back stair and hallway, which are located to the west of the main stair. The east wall of the southwest room is angled at the south end, near the top of the back staircase. This room contains the bay window, which is separated from the room by a plaster arch springing from scroll impost blocks (photograph 36). The second floor also has a bathroom across the front center of the house, over the vestibule. A sink, toilet, and tub have been installed along the west wall of the bathroom. The two eastern bedrooms are connected by a single door, through a small hall created by two closets, the one on the west opening into the north room and the one on the east opening into the south.

The second floor of the southwest quarter was divided into three spaces: the back stairs and hallway, and two narrow bedrooms, each with a door opening onto the new back hallway. In an effort to keep the rear elevation somewhat symmetrical, the window in the back hallway was located directly above the first floor window and an equal distance between the new location of the stair landing window to east and the second floor window to the west. This made it necessary, on the interior, to angle part of the partition wall between the hallway and the rear bedroom towards the west to accommodate the window location. The doorway into the rear room is located on the angled section of wall. This rear room, the floors of which were painted black, had two windows, one on the south wall and one on the east. The front room in this section included the oriel bay.

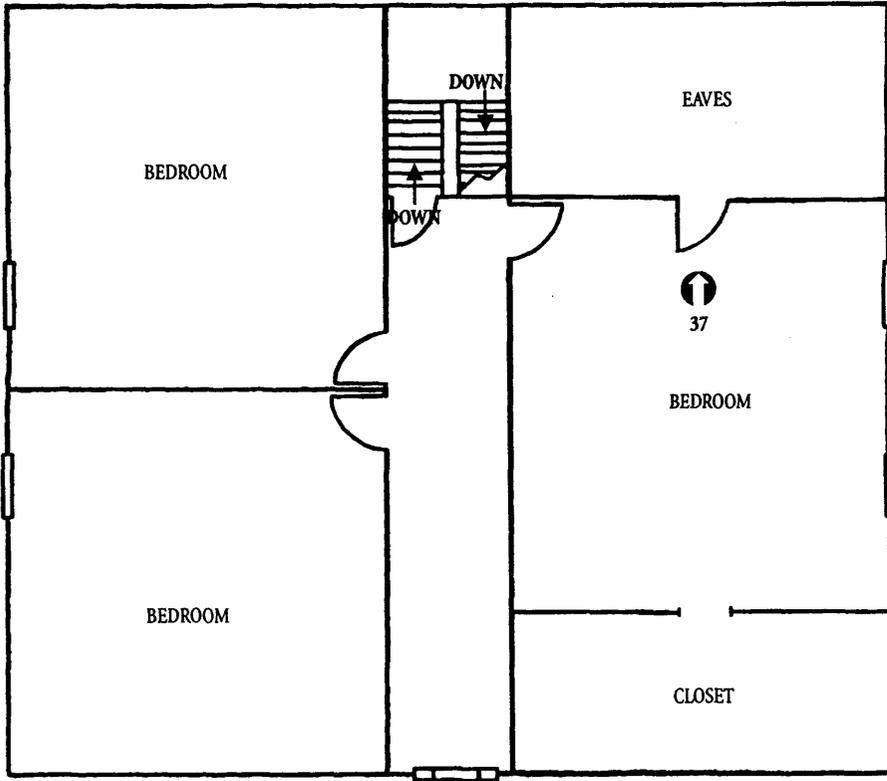
Third Floor Plan

The third floor layout includes a center hall with a single room to the west and two rooms to the east. An unfinished eave space is located to the south of the west room and is connected to it by a doorway, while a finished closet space is located on the north side and is also connected by a door. On the east side, the north and south sides of the ceilings in the north and south rooms respectively are sloped due to the roof.
